# 1030 Denman Street

Landscape Inventory, Analysis and Recommendations

Date: November 14th, 2008

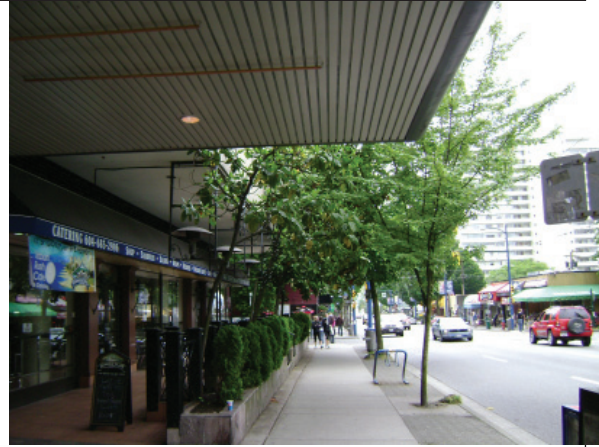
One of the existing Magnolia trees at south end of Denman Street entrance is in poor health. Other Magnolia trees are still in fairly good condition. However it is a poor selection of species for this location. Cedar hedge is in fairly good condition, but owing to it's height it is a poor choice for urban streetscape.

Denman St. large Magnolia trees at South end of Denman St.

- Remove magnolia tree at north end
- Move and group existing pots at North end of loading bay.
- Add aggregate as base for pots.
- Power wash all paving surfaces

- Replace magnolia trees and cedar hedge with shorter flowering shrubs.
- Replace benches and planters at corner of Denman and Nelson Street

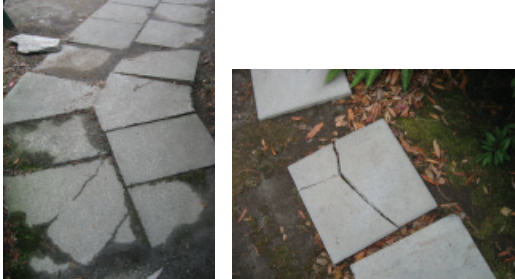
<p>Shrubs are generally in fair condition</p>	
<p>Paving slabs:</p> <ul style="list-style-type: none"> <li>• Heaving and uneven</li> <li>• Mossy</li> <li>• New pavers not properly lain: cracking and chipping</li> <li>• Uneven pavers pose a safety hazard.</li> </ul>

- Remove and replace existing benches - hazard
- Lift, power wash and reset unit paving at patio and fire exit in nature walk
- Ensure unobstructed access to fire exit
- Replace unit pavers with aggregate paths (with edging)
- Add aggregate paths to replace dirt paths and maintenance access paths
- Remove trees in poor condition
- Prune trees (pine trees) and shrubs to remove dead branches.

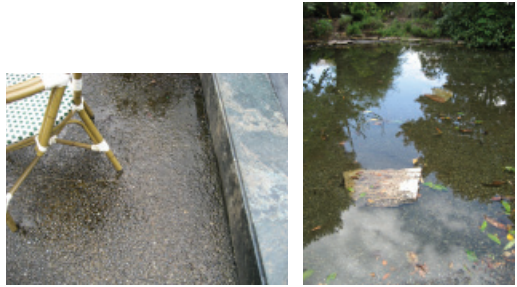
<p>Water feature:</p> <ul style="list-style-type: none"> <li>• Leaks badly</li> <li>• Dirty</li> <li>• Curb wall in poor condition - hazard</li> <li>• Boulders in good condition.</li> </ul>

- Replace dirt paths with aggregate path
- Remove trees in poor condition
- Prune trees and shrubs as needed
- Replace curb walls (with unit Block wall) or re-tile surface - current hazard
- Decommission water feature:
  - open and clean maintenance drain, leave drain open permanently
  - add leaf filter
  - remove dirt and algae from pond
  - leave pond liner, do not fix , do not remove
- Fill drained water feature with river cobble and boulders to create low maintenance “Zen “ garden.

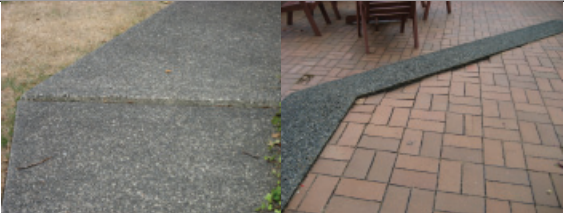
Herb garden is in good condition.	
Paving: <ul style="list-style-type: none"> <li>• Exposed aggregate paving is cracked and heaving in areas.</li> <li>• Tile paving around gazebo is uneven, cracking and chipping poses safety hazard.</li> </ul>

- Lift and reset unit paving in areas where tripping hazard exists
- Clean and repair all concrete
- Prune trees and shrubs - remove dead branches.
- Remove any permanent benches that are rotting and unsafe
- Replace gazebo roofing
- Aerate, top dress and fertilize lawn as per specifications
