16.0 Photo Selection

Units 149, 155, 159, 165, 169, and 175 Grouse Walk (Little Mountain Site)

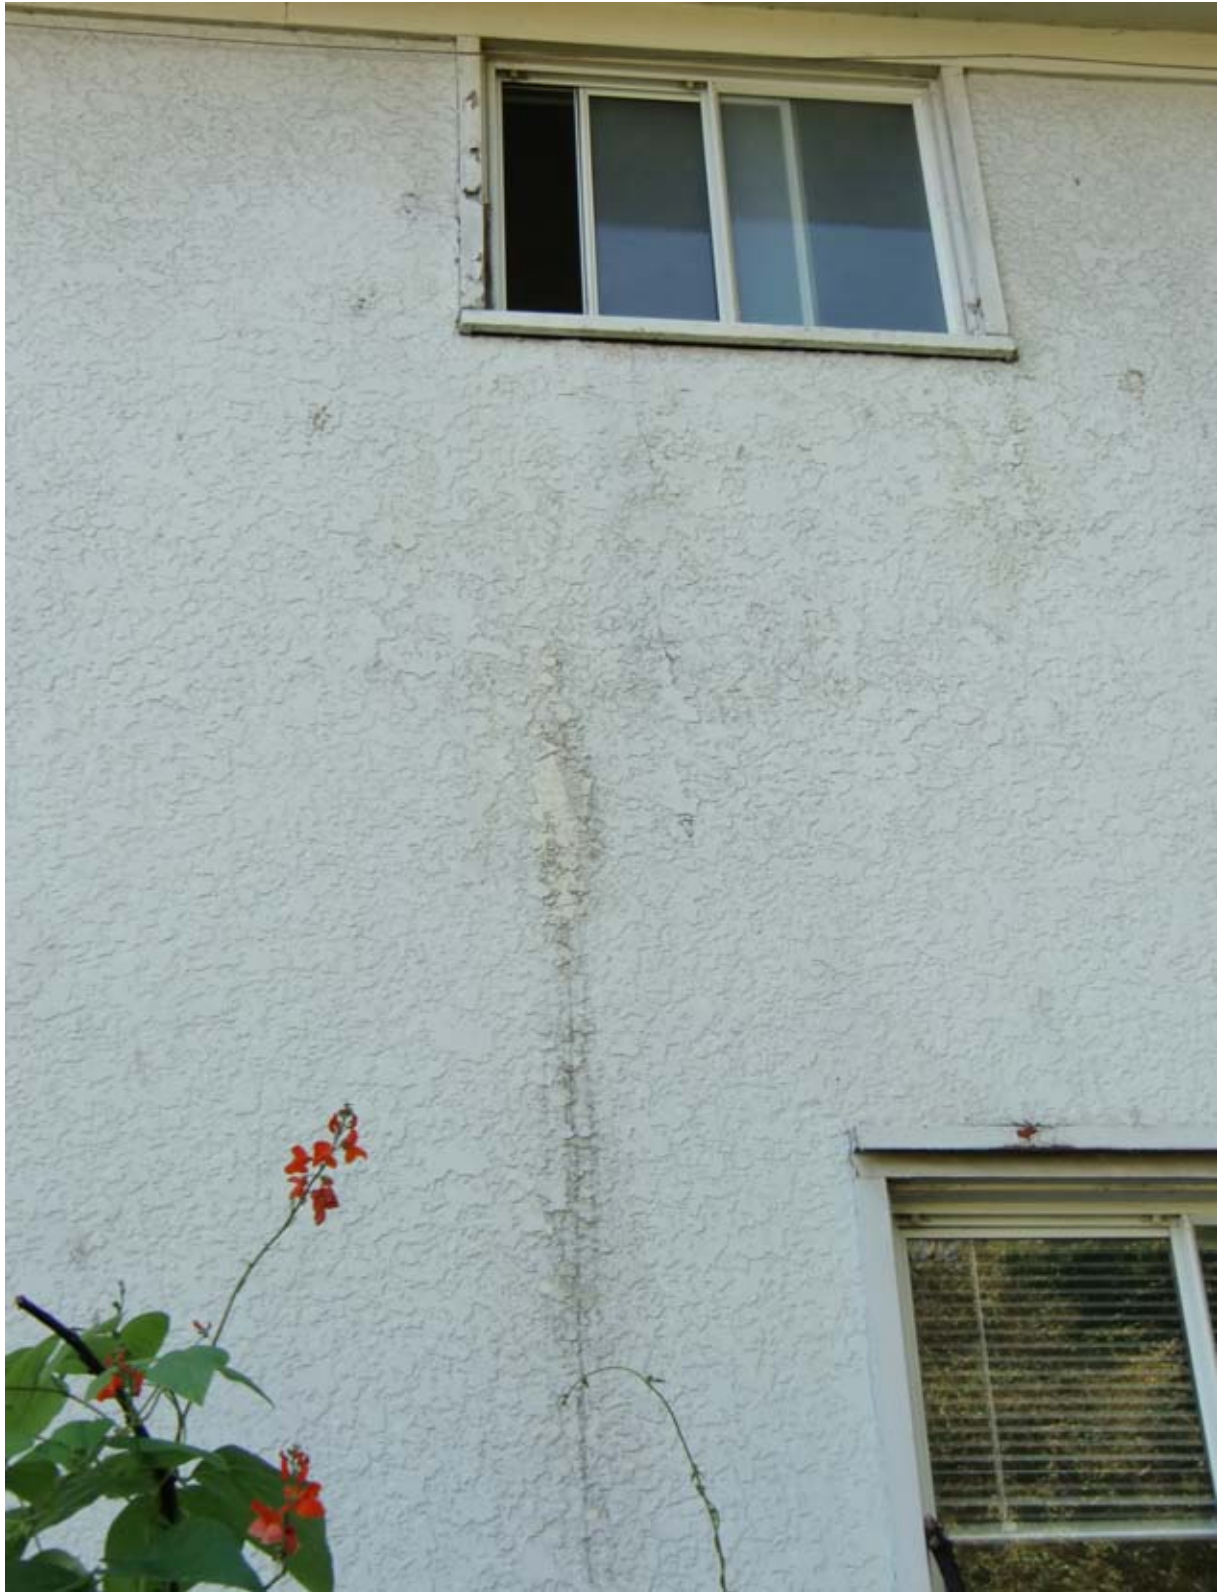
Vertical hairline cracks visible on the south and north walls due to expansion and contraction, possibly from internal moisture problems. (Refer to Section 6.0)

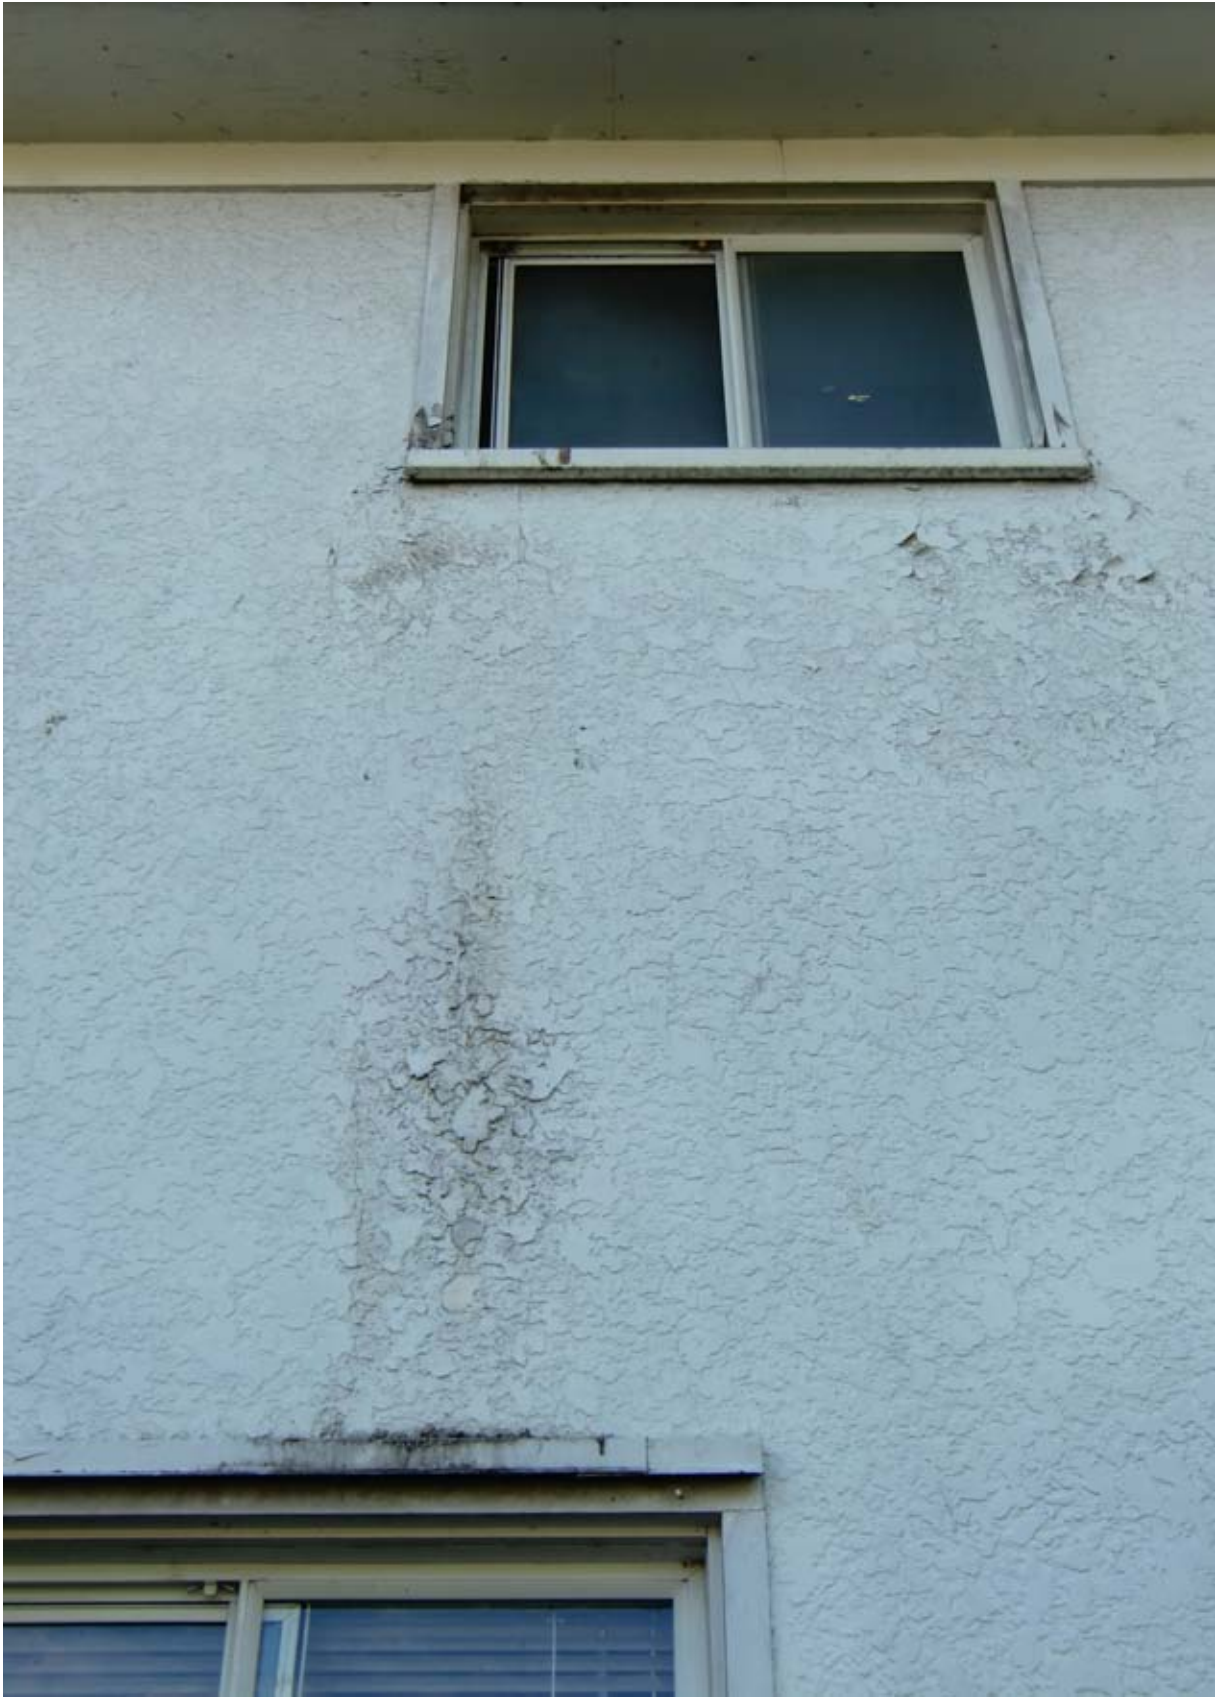
Peeling paint and stained stucco below the bathrooms (Refer to Section 6.0)

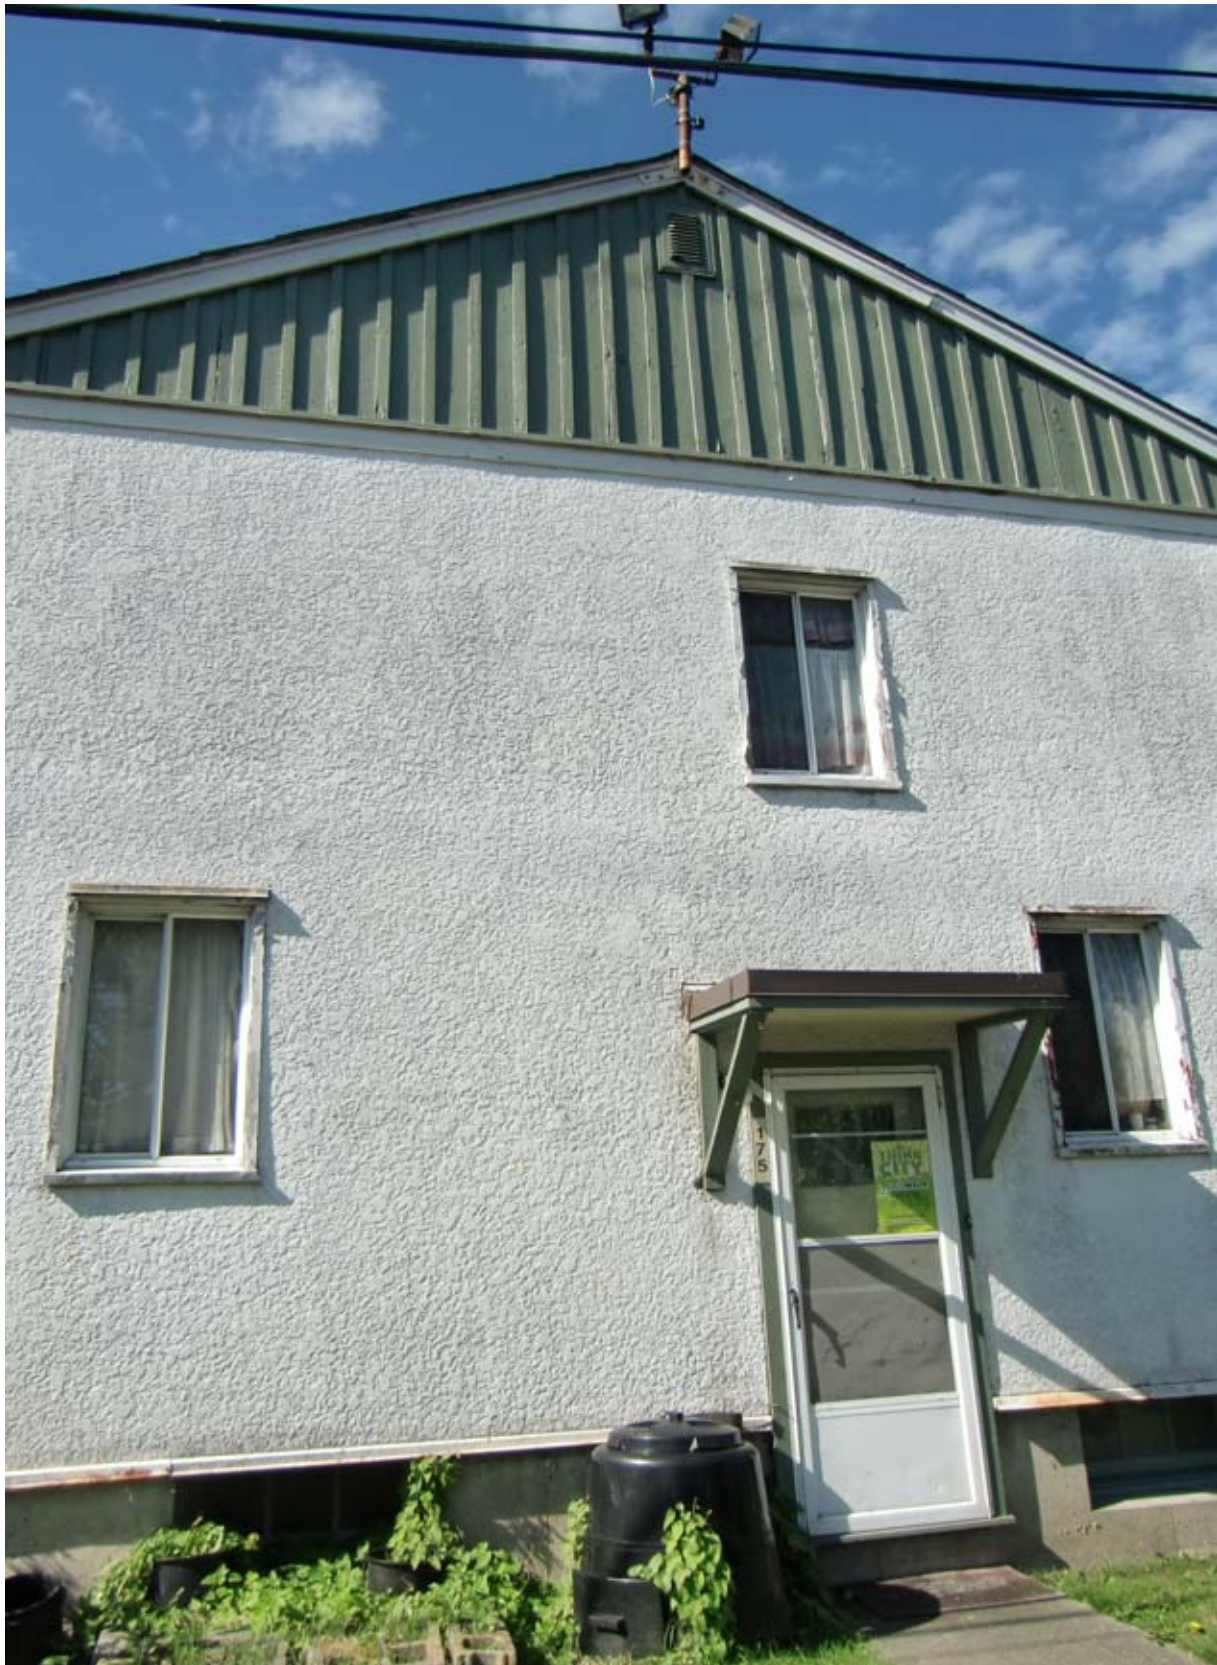
Shower windowsill could be possible point of water penetration. (Refer to Section 6.0)

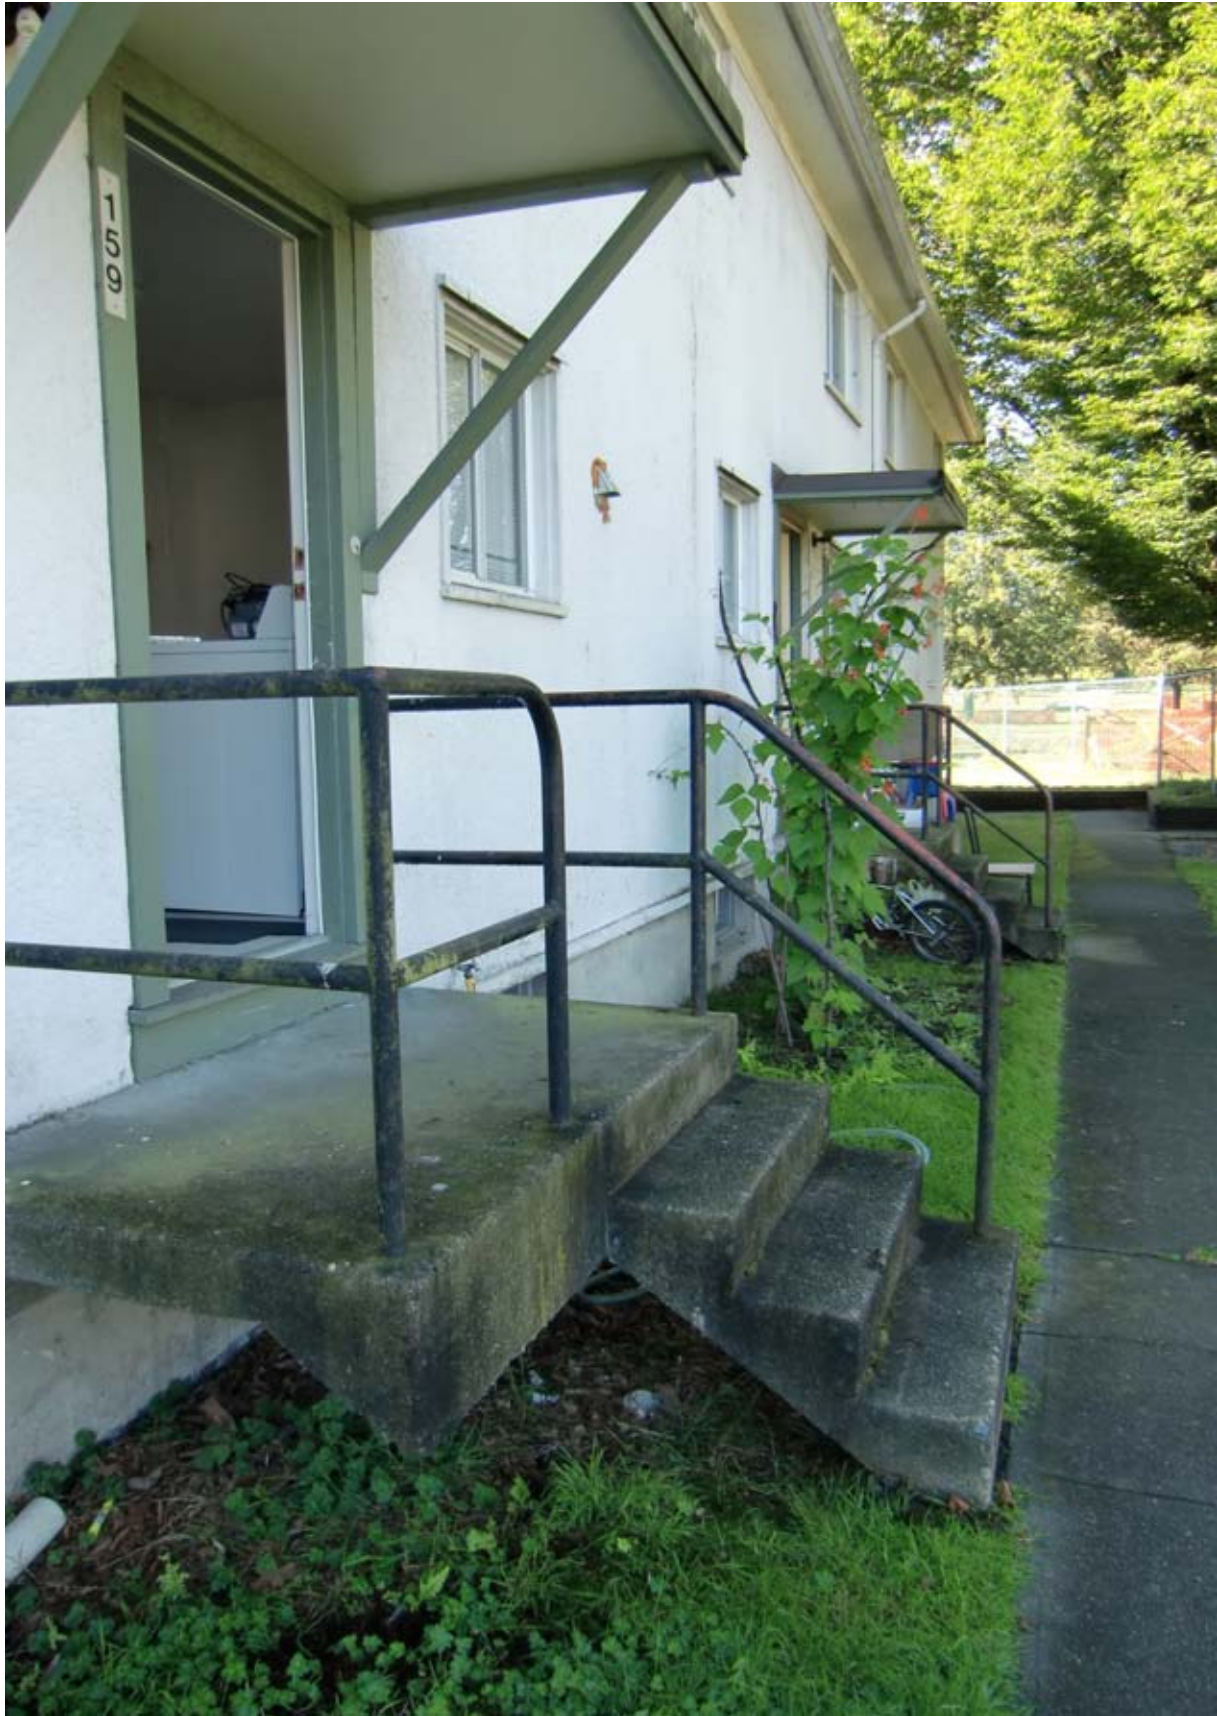
The slabs are functional but the adjacent soils have settled and the steps in general are unsafe. (Refer to Section 7.0)

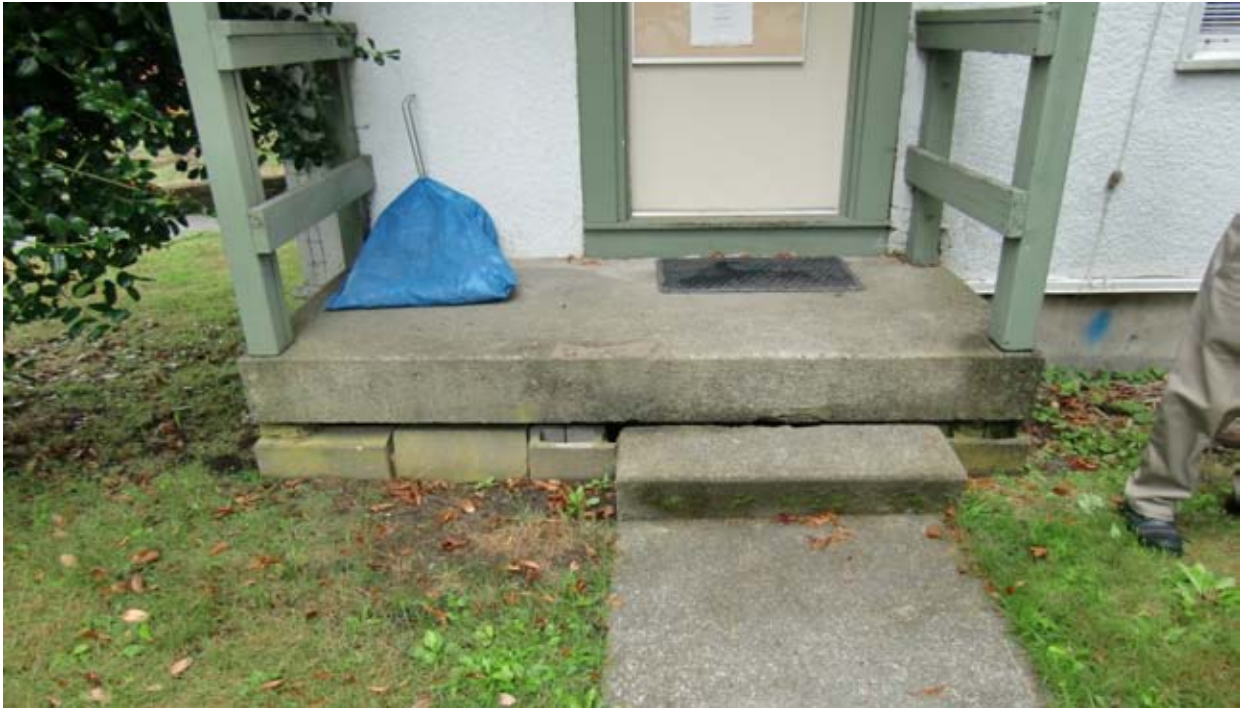
Both the metal and wood guards are also technically unsafe. (Refer to Section 7.0)

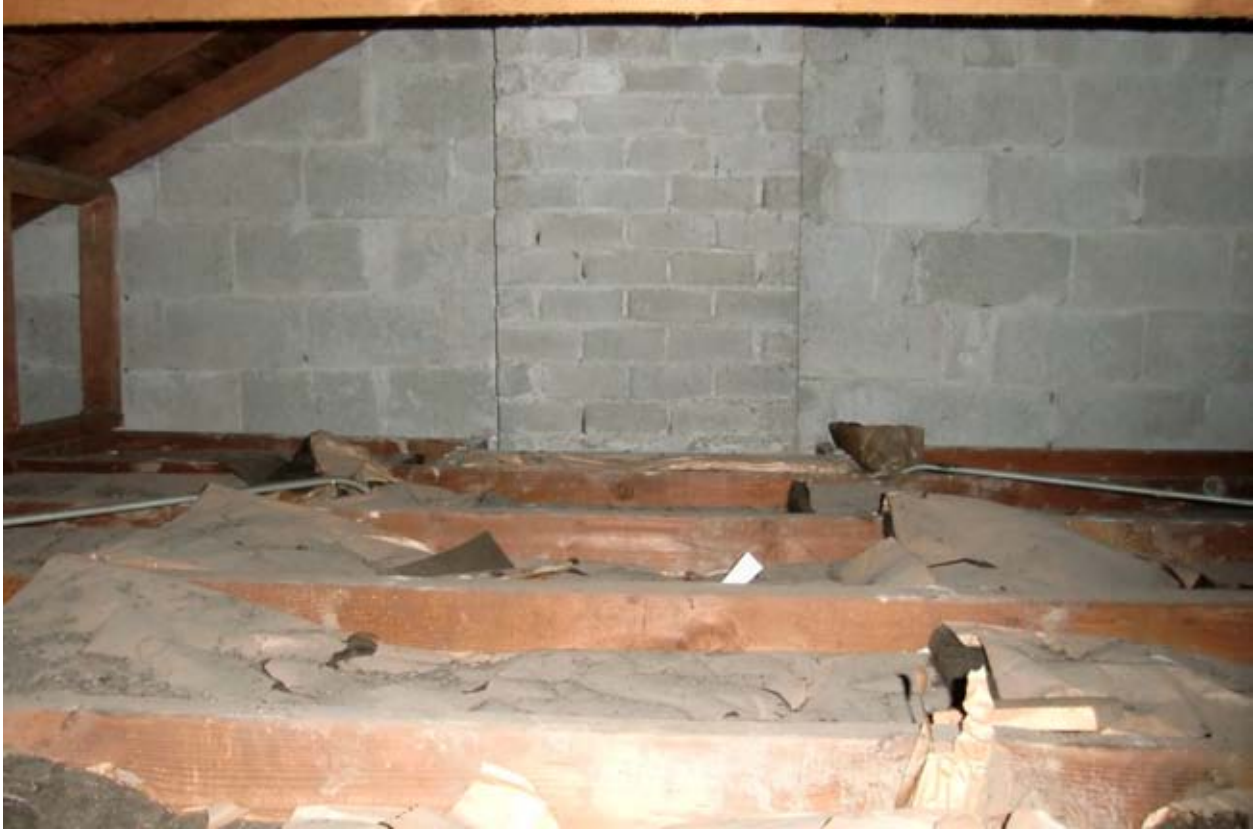
The insulation is the original paper-backed mineral/steel wool batts (estimated R4 value) over a tar impregnated Kraft paper air barrier. (Refer to Section 9.0)

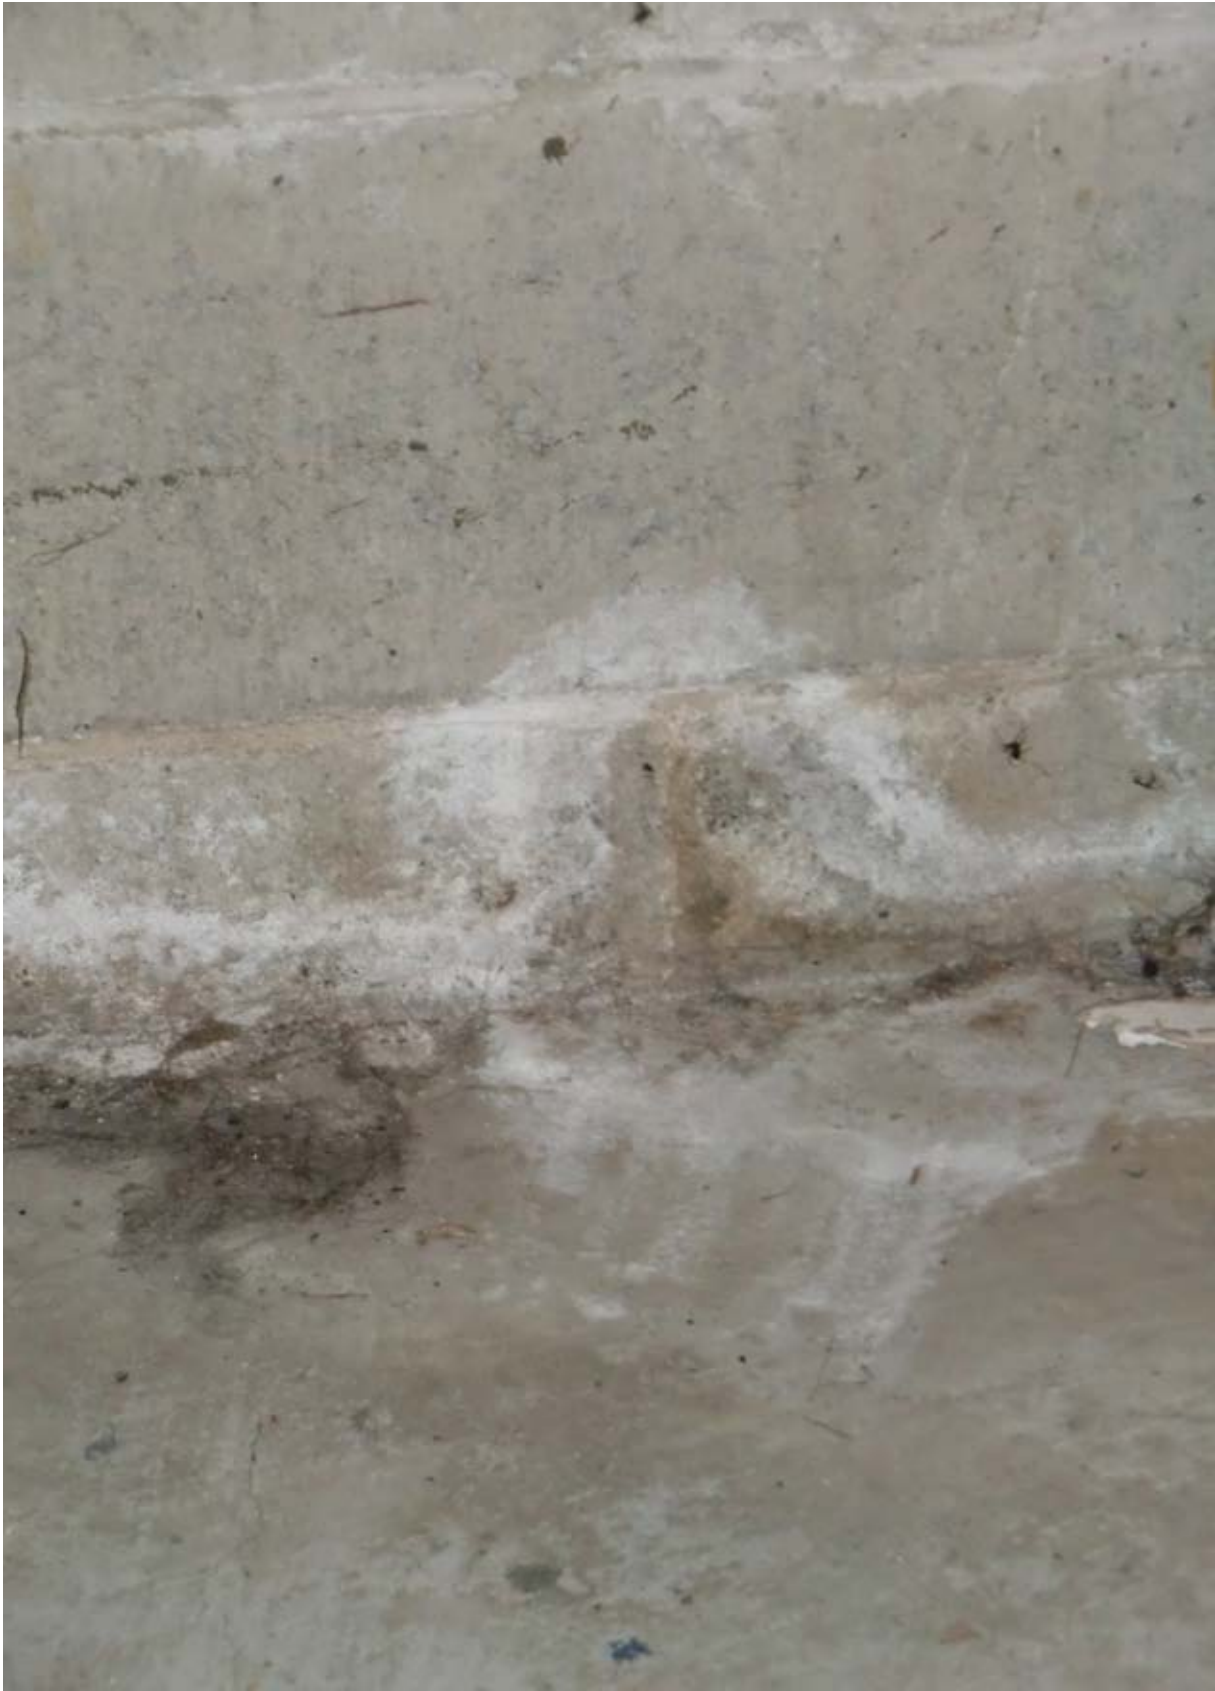
Efflorescence/staining indicating past ground water penetration in basement. (Refer to Section 10.0)
