## **APPENDIX B**

### **Past Condition Inspection Reports**

**Bridge No. D-8**  
**Dunsmuir Viaduct**  
**between**  
**Beatty St. & Main St.**

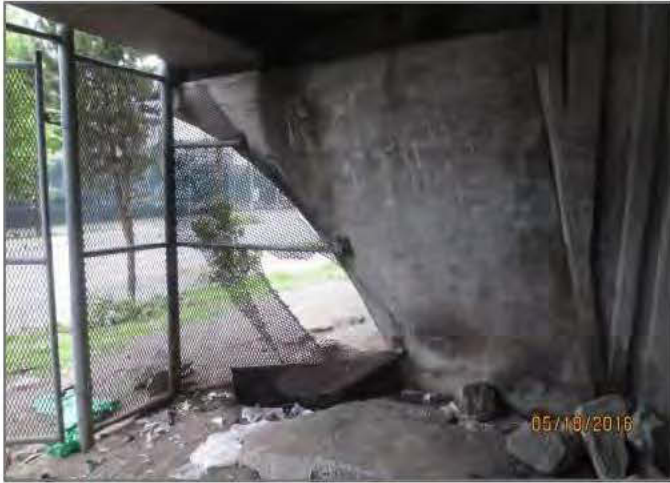
D1. Damaged fencing at on-ramp abutment enclosure (DM2).

| Component | Location | Activity Description | Qty. | Unit | D | % | R | U | S | Photo # |
|---|---|---|---|---|---|---|---|---|---|---|
| 5. Abutments | DM2-N | Determine if repairs to the fencing is necessary. | 1 | m <sup>2</sup> | 3 | 5 | 1 | R | | D1 |

| Component | Location | Activity Description | Qty. | Unit | Unit Rate | Base Cost <sup>+</sup> | D | % | R | U | S | Photos |
|---|---|---|---|---|---|---|---|---|---|---|---|---|
| 5 Abutments | DM2-N | Determine if repairs to enclosure fencing is necessary. | 1 | m <sup>2</sup> | \$250 = | \$250 | 3 | 5 | 1 | R | | D1 |

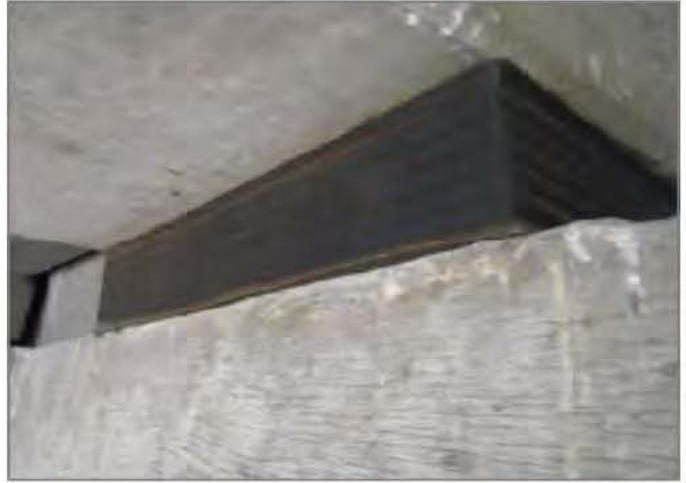
D2. Slight overhang of bearing pad at west abutment (D23).

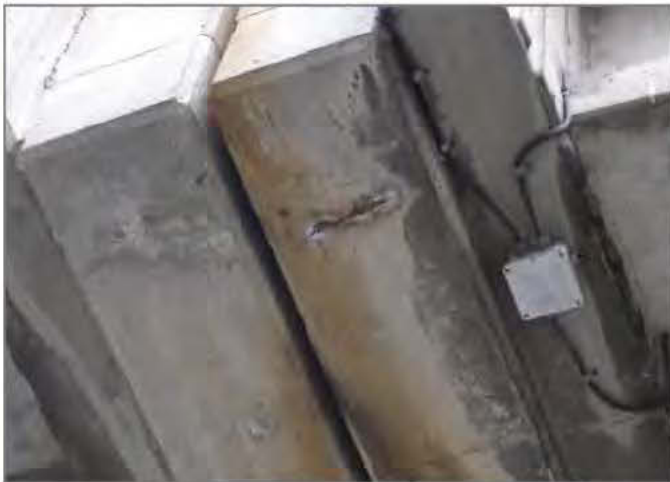
10. Caps: Small spall with exposed rebar on south overhang soffit of Pier DM5 (above skate park) [Photo D3].

D3. Pier cap soffit spall with exposed rebar at Pier DM5.

| Component | Location | Activity Description | Qty. | Unit | D | % | R | U | S | Photo # |
|---|---|---|---|---|---|---|---|---|---|---|
| 10. Caps | DM5-S | Monitor – Existing spall (with exposed rebar) which will fall onto skate park if future spalling occurs. | 0.01 | m <sup>2</sup> | 1 | 1 | 1 | M | | D3 |

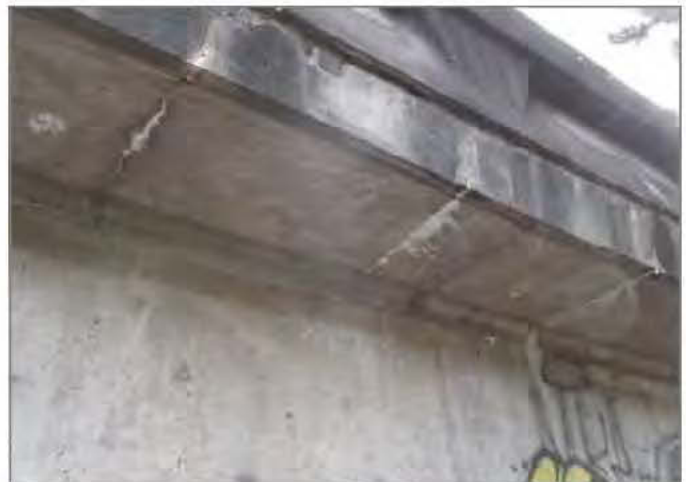
27. Sub Deck: Transverse cracks with efflorescence consistent along north and south overhangs of on-ramp approach [Photo D4].

D4. Cracks on deck overhang along on-ramp approach.

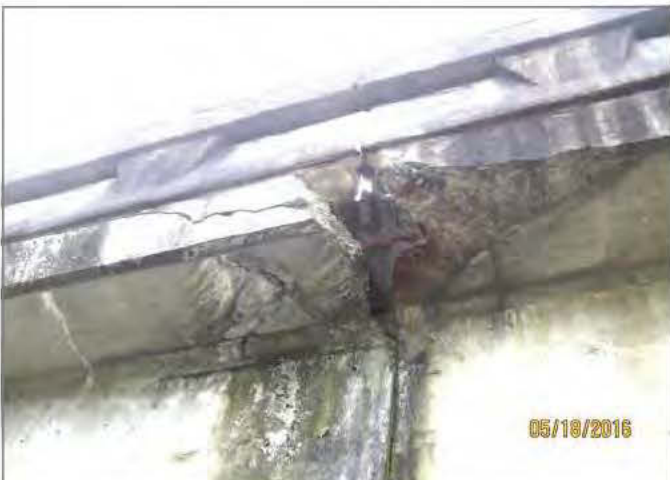
27. Sub Deck: Large spall of deck overhang at base of north barrier in two locations of on-ramp approach (DM1 -DM2). Surrounding concrete appears sound [Photo D5].

D5. Deck overhang spall on on-ramp approach.

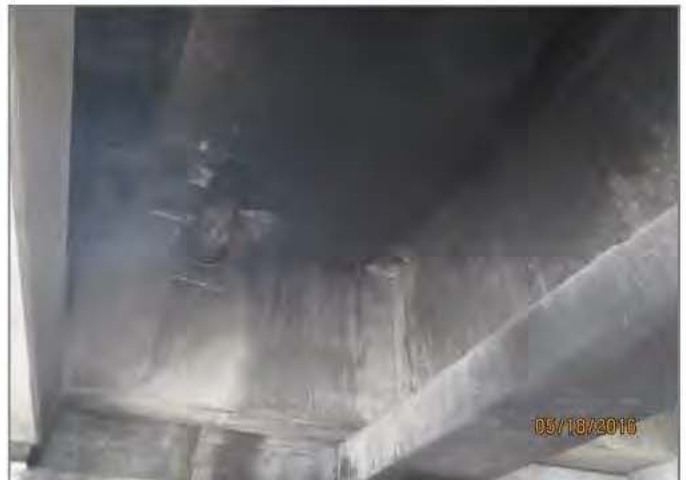
D6. Staining of deck soffit from fire at on-ramp abutment.

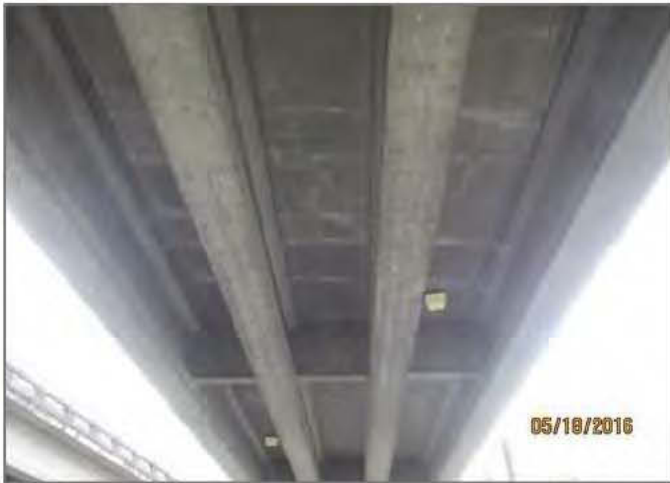
D7. Deck soffit cracks of on-ramp span between DM4-DM5.

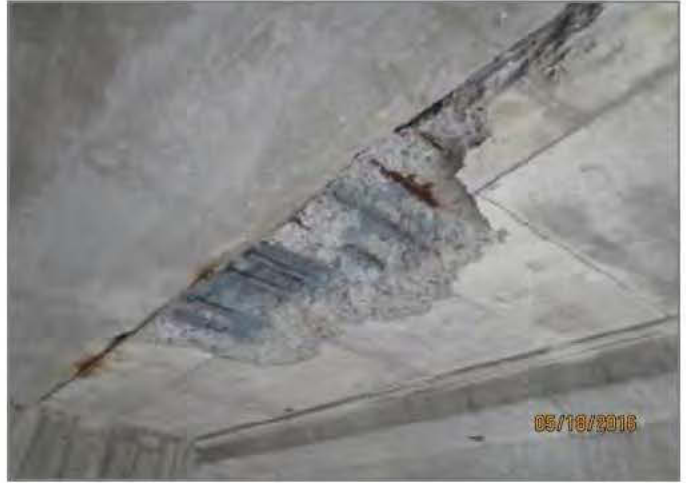
27. Sub Deck: Large deck soffit spall with exposed reinforcement on east side of Pier D6 at transition with off-ramp (above skate park). All loose material removed exposing new 200 mm x 200 mm area with (uncoated) corroded reinforcement [Photo D8].

D8. Deck soffit spall with exposed rebar at Pier D6.

| Component | Location | Activity Description | Qty. | Unit | D | % | R | U | S | Photo # |
|---|---|---|---|---|---|---|---|---|---|---|
| 27. Sub Deck | D6 | Monitor – Existing spall (with exposed rebar) which will fall onto skate park if future spalling occurs. | 0.2 | m <sup>2</sup> | 2 | 1 | 2 | M | | D8 |

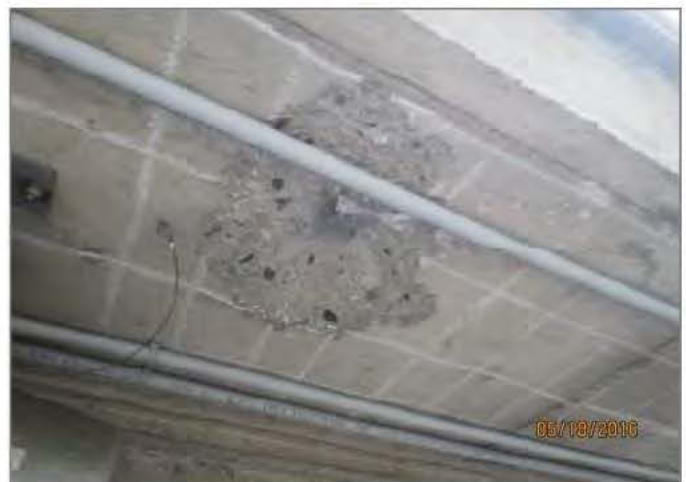
D10. Deck soffit spall at south overhang in span D18-D19.

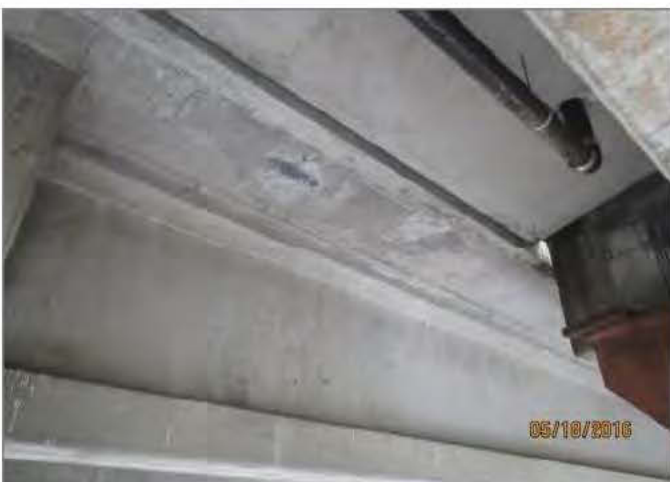
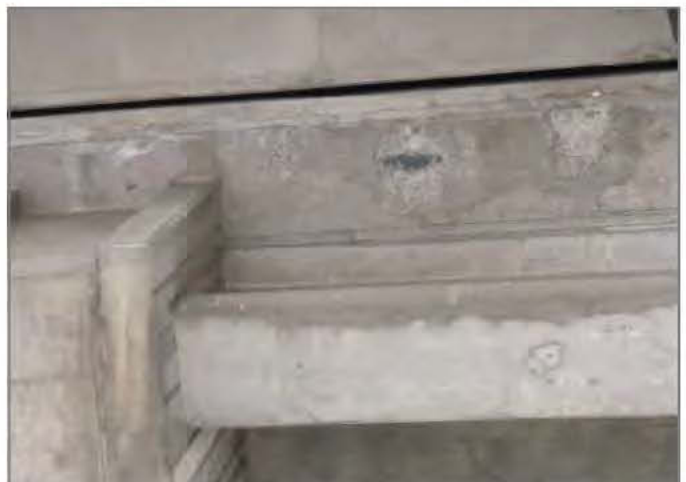
27. Sub Deck: Removed loose mortar and confirmed soundness of three small patches on soffit overhang on south side of Span D18-D19 (over Rogers Arena Plaza) [Photo D10], and four small patches on soffit overhang on south side of Span D19-D20 (over Costco sidewalk) [Photo D11]. Two of the patches in Span D19-D20 are delaminated but could not be removed by hand [Photo D12].

D11. Deck soffit spall at south overhang in span D19-D20.

D12. Deck soffit spall at south overhang in span D19-D20.

| Component | Location | Activity Description | Qty. | Unit | D | % | R | U | S | Photo # |
|---|---|---|---|---|---|---|---|---|---|---|
| 27. Sub Deck | D19-D20 South | Monitor – Two 200 mm x 200 mm delaminations of previous patch repairs in deck overhang above sidewalk outside Costco. | 0.1 | m <sup>2</sup> | 1 | 1 | 2 | M | | D11 D12 |

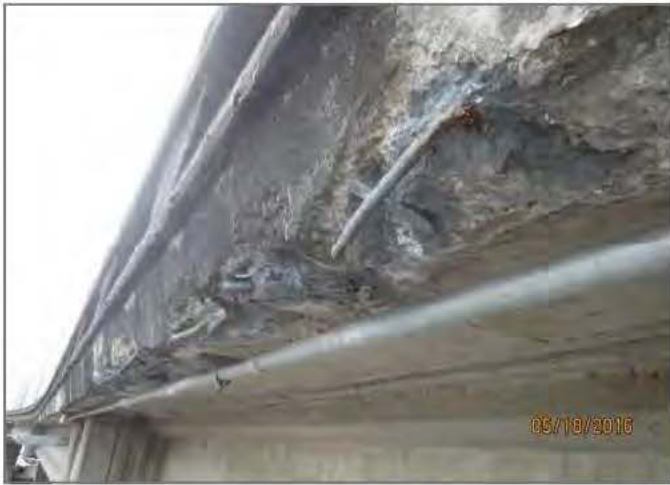
D13. Spalled concrete on north deck overhang span D20-D21.

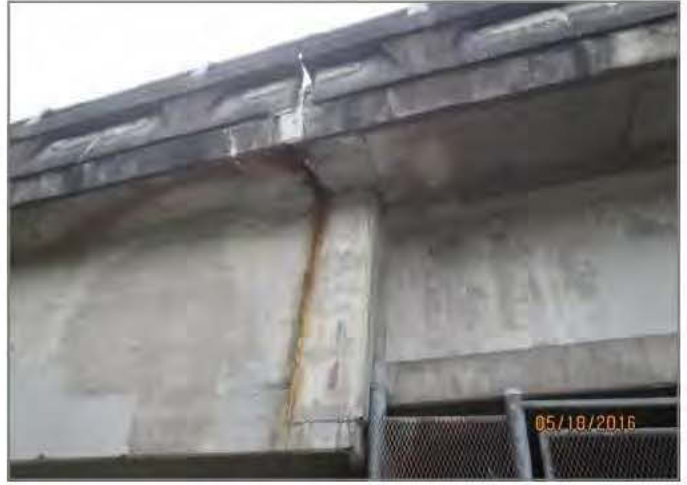
D14. Typical corrosion staining at expansion joint locations.

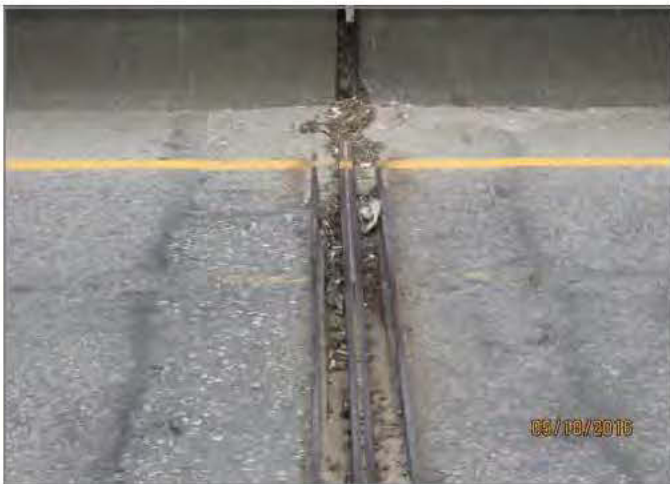
29. Deck Joints: All deck joint seals are in poor condition. Most seals are visibly torn or recessed and filled with debris [Photo D15].
32. Parapets: Damage to top rail of barrier on south side of on-ramp approach entrance. No risk of fall at this location [Photo D16].

D15. Typical condition of deck joints; torn seals and debris.

| Component | Location | Activity Description | Qty. | Unit | D | % | R | U | S | Photo # |
|---|---|---|---|---|---|---|---|---|---|---|
| 29. Deck Joints | All | Monitor – Condition of all expansion joint seals is poor. Ensure seals are not protruding above roadway surface or resulting in other hazard for bridge users. | 8 | ea. | 4 | 100 | 1 | M | | D15 |

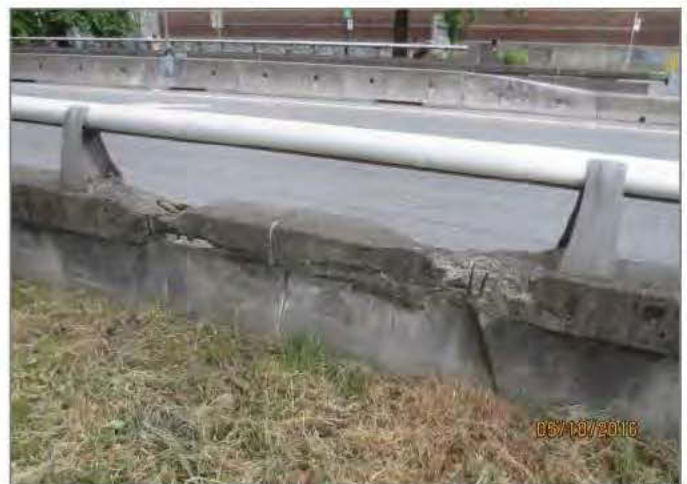
D16. Damage to barrier concrete of on-ramp approach (DM1).

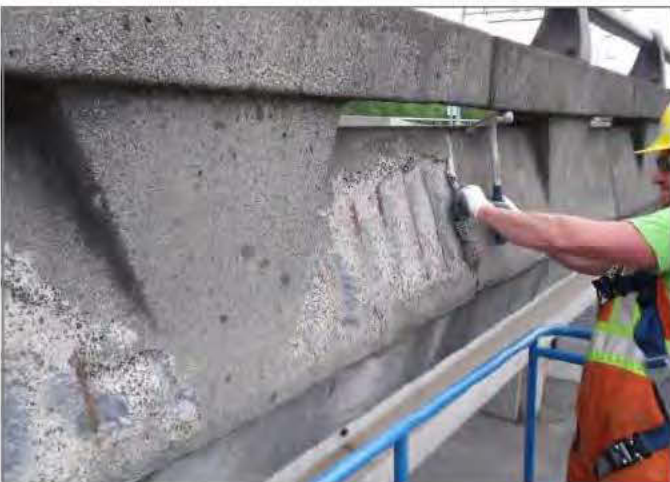
32. Parapets: Spalling on outside face of barrier observed at ten locations along south side of on-ramp approach.
32. Parapets: Loose concrete removed from 9 existing spalls on outside face south barriers, and one failed deck soffit patch in Span D14-D15 over parking lot. Four locations in Span D15-D16 and 5 locations over Abbott St. not worked on due to cars below [Photo D17].

D17. Loose concrete at existing parapet spalls D14-D15.

| Component | Location | Activity Description | Qty. | Unit | D | % | R | U | S | Photo # |
|---|---|---|---|---|---|---|---|---|---|---|
| 32. Parapets | D15-D17 South | Monitor – Nine spall locations were not assessed for loose concrete due to vehicles below. Based on condition of nearby spalls, current threat of loose material assumed to be low. | 9 | ea. | 2 | 1 | 2 | M | | D17 |

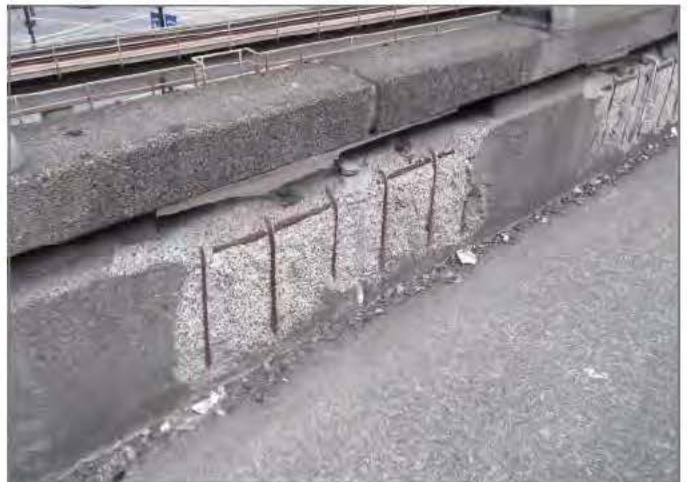
32. Parapets: Shallow surface spalling with exposed reinforcement on south face of north parapet typical on 185 of 464 panels throughout length of structure. Majority of bars are coated with zinc-rich paint but have continued to corrode [Photo D18].

D18. Typical spalls on south face of north parapets.

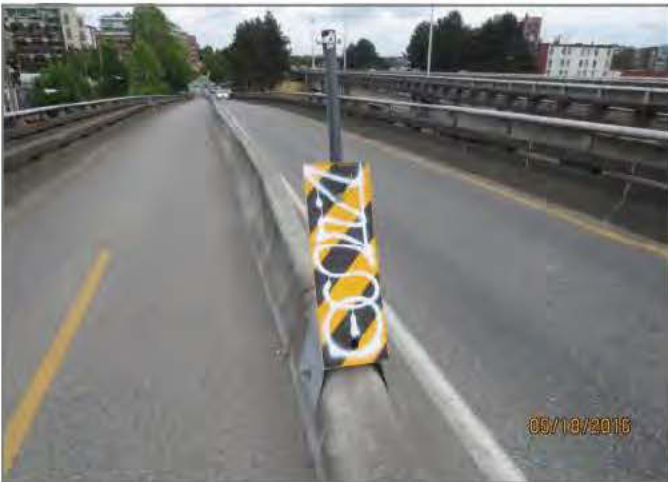
D21. Broken hazard sign at on-ramp bike lane taper.

| Component | Location | Activity Description | Qty. | Unit | D | % | R | U | S | Photo # |
|---|---|---|---|---|---|---|---|---|---|---|
| 36. Signing | DM5 | Repair hazard sign for bike lane taper. | 1 | ea. | 1 | 1 | 1 | R | | D21 |

| Component | Location | Activity Description | Qty. | Unit | Unit Rate | Base Cost <sup>+</sup> | D | % | R | U | S | Photos |
|---|---|---|---|---|---|---|---|---|---|---|---|---|
| 36 Signage | DM5 | Repair hazard sign for bike lane taper. | 1 | ea. | \$250 = | \$250 | 1 | 1 | 1 | R | | D21 |

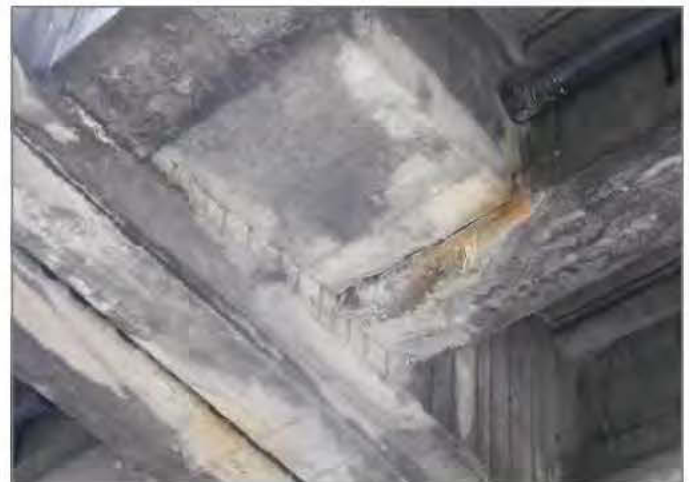
D22. Staining of concrete at base of utility box at Pier D9.

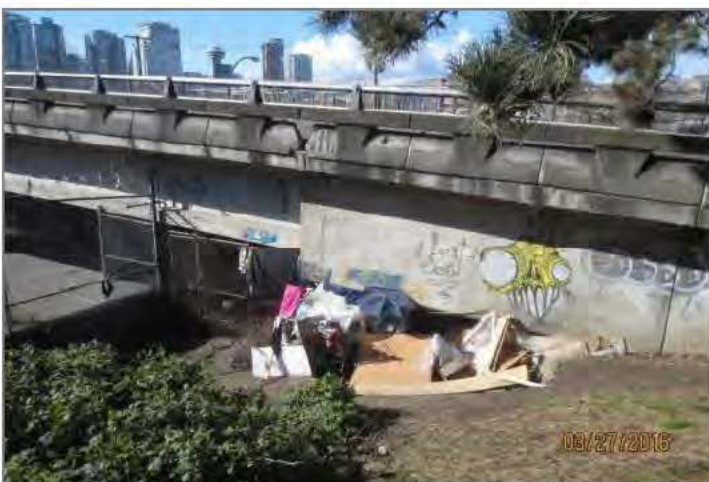
P1. Encampment established at east abutment of on-ramp.

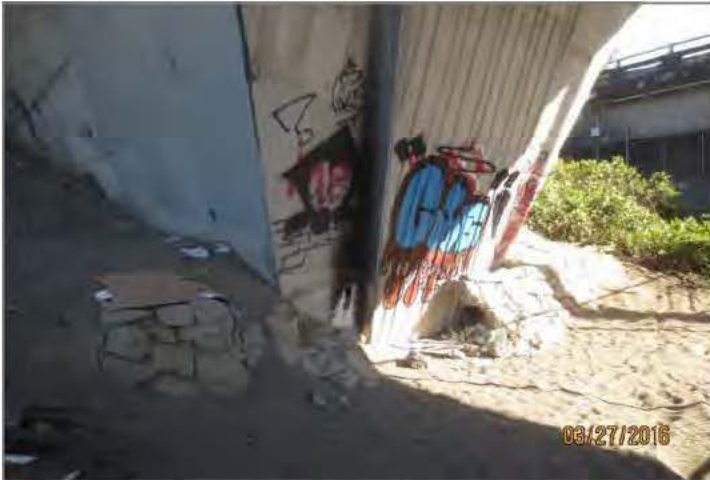
P3. Deficient retaining wall at base of east abutment that is permitting the erosion of soil.

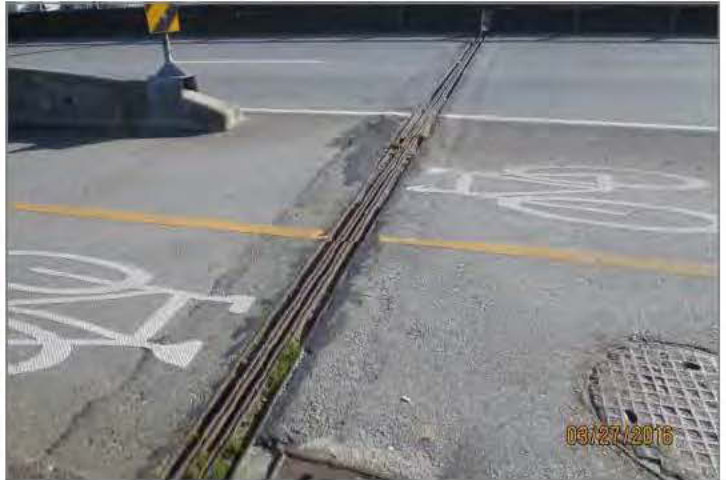
P4. Typical deck joint with large recesses and filled with debris.

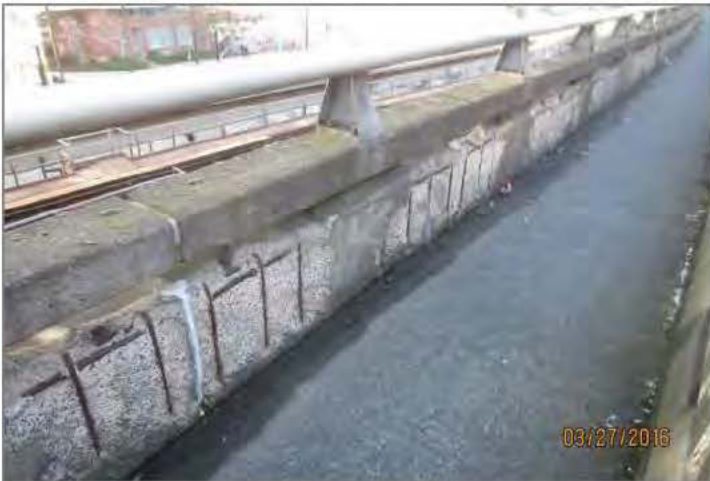
P5. Spalling to outside face of parapet at north sidewalk north of Rogers Arena.

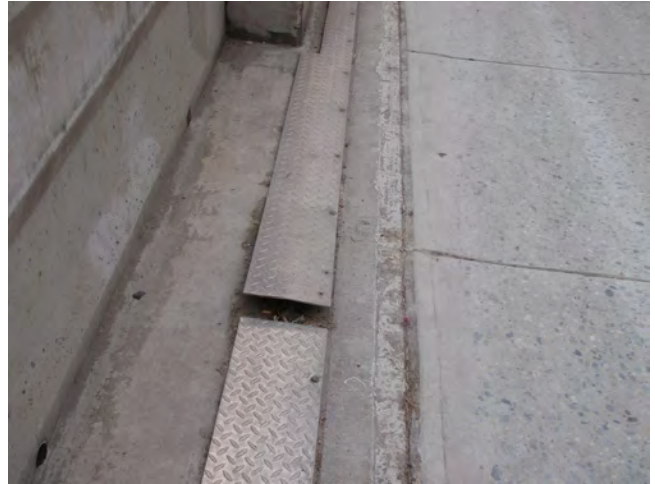
D-8 D-02.jpg

Longitudinal joint in sidewalk, note cover plate lifting.

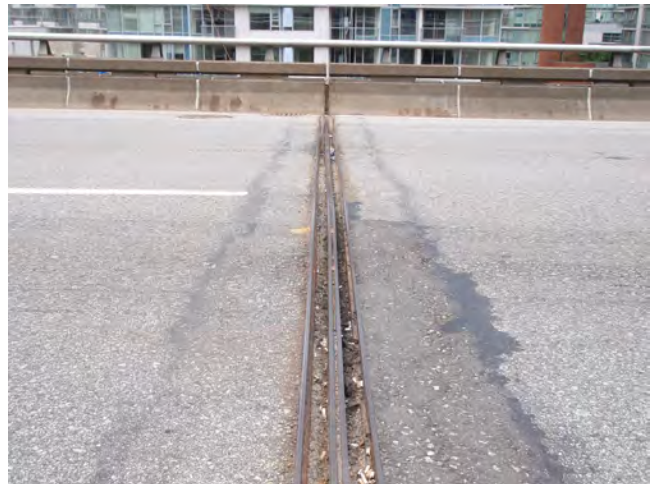
D-8 D-07.jpg

D17 Deck joint, note failed seal element and debris filling joint gap.

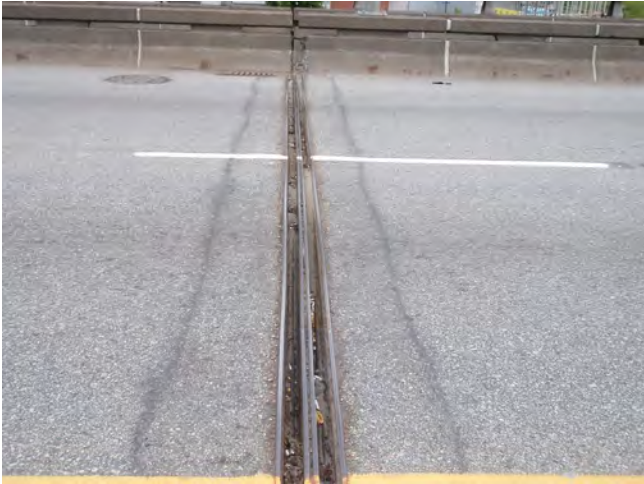
D-8 D-08.jpg

D14 Deck joint, note failed seal element and debris filling joint gap.

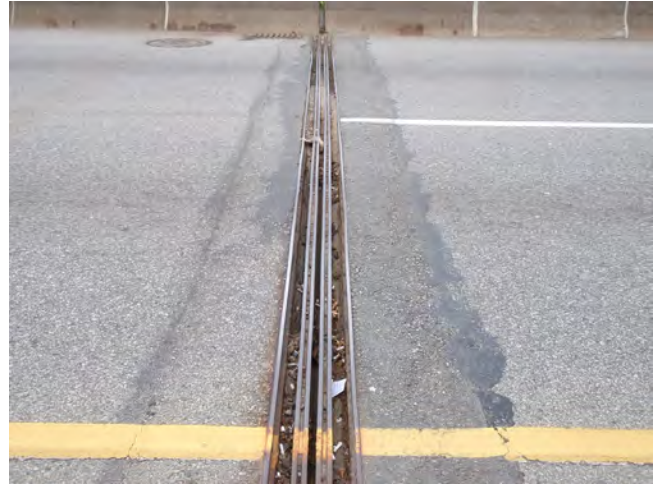
D-8 D-09.jpg

D11 Deck joint, note failed seal element and debris filling joint gap.

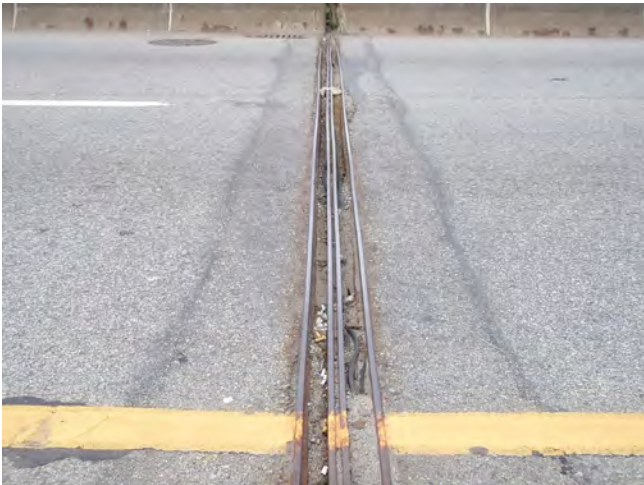
D-8 D-10.jpg

D9 Deck joint, note failed seal element and debris filling joint gap.

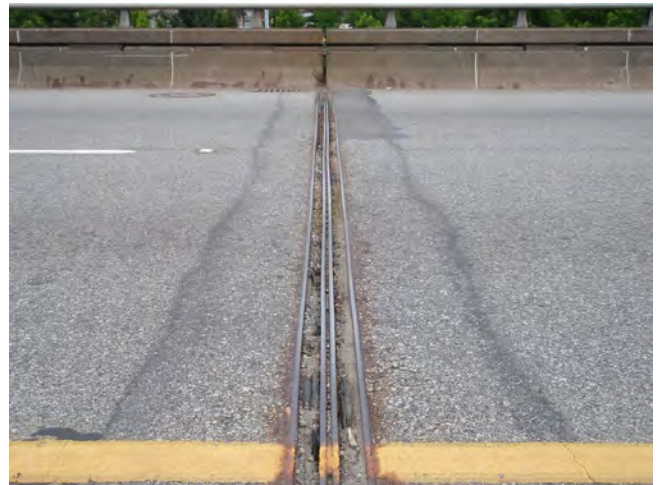
D-8 D-11.jpg

D7 Deck joint, note failed seal element and debris filling joint gap.

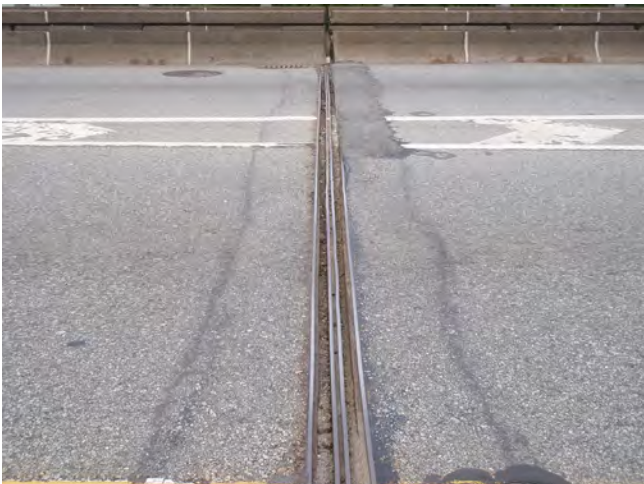
D-8 D-12.jpg

D7 kink in deck joint armour.

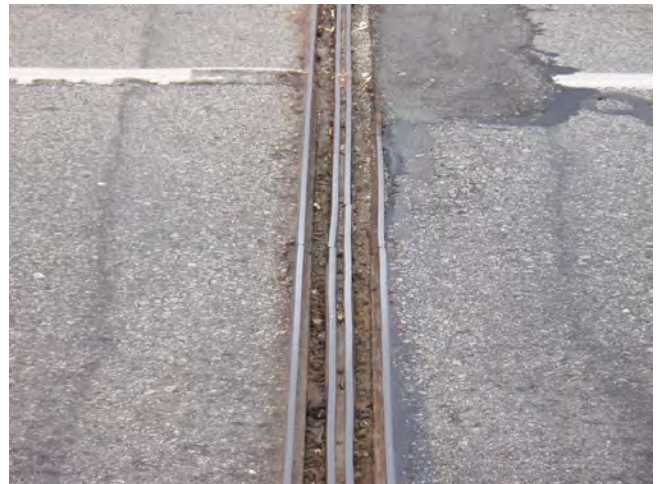
D-8 D-14.jpg

DM5 Deck joint, note failed seal element and debris filling joint gap.

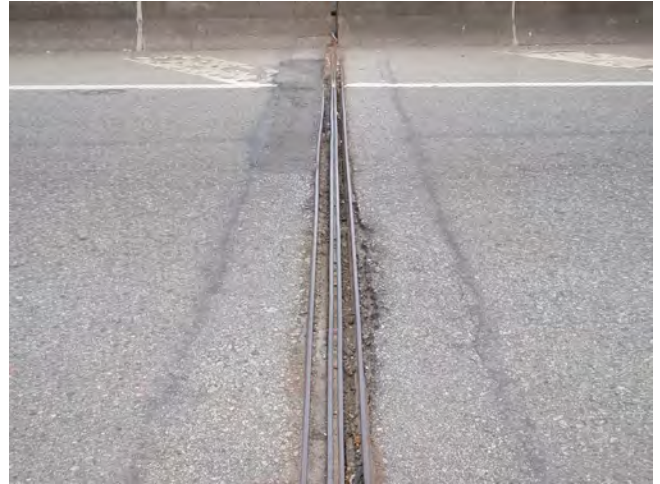
D-8 D-16.jpg

D2, East abutment deck joint, note missing seal, corroded armor and gap filled with debris.

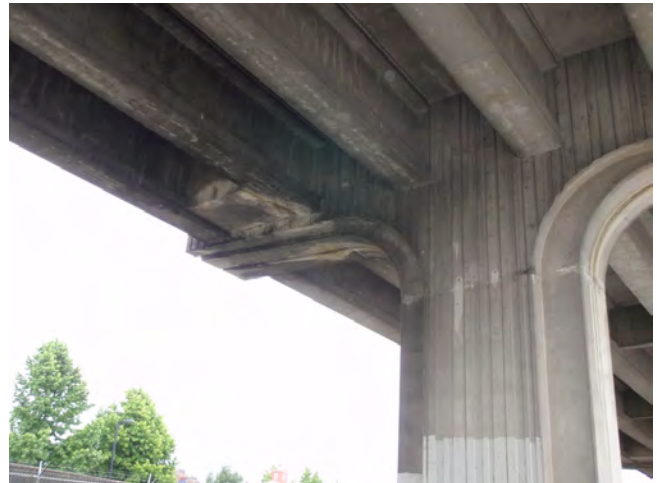
D-8 D-30.jpg

Water and rust staining from cold joint between catch basin chamber and precast girder at pier D8.

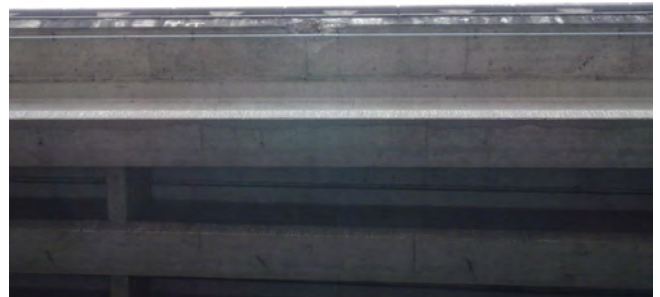
D-8 D-36.jpg

Water staining and efflorescence at expansion joint on D7.

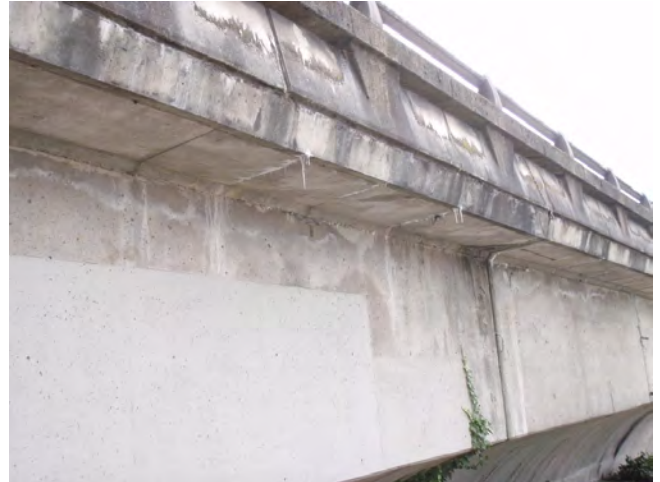
D-8 D-40.jpg

Sag in PVC surface water drain by Pier D8

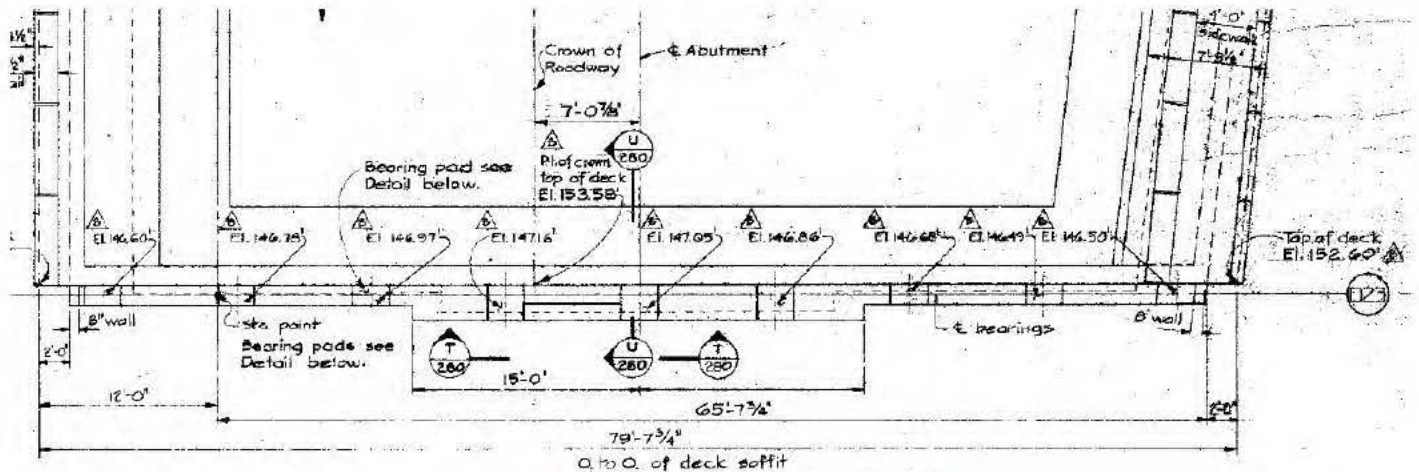
Figure 9. West abutment girder seat lengths, plan view

Girder seat lengths at the west abutment were checked using the empirical method outlined in CAN/CSA S6-14, and were found to be deficient for some girders. Due to the varying geometry of the abutment front wall (Figure 9), six of the nine girders at the abutment (all but the three middle girders) have insufficient bearing seat length, which could lead to span D23-D22 collapsing during a seismic event.

The three most interior girders have sufficient seat length. We recommend extending the seat length at the six remaining girders by at least 300 mm. This can be accomplished by building a concrete corbel at the bearing seat level and dowelling it into the abutment front wall (Figure 19). Figure 20 shows an example developed for a different project.
