BCA Report

Pine Tree Apartment

Address 300 Pine Street

Report Generated On:2017-03-23 15:01:25

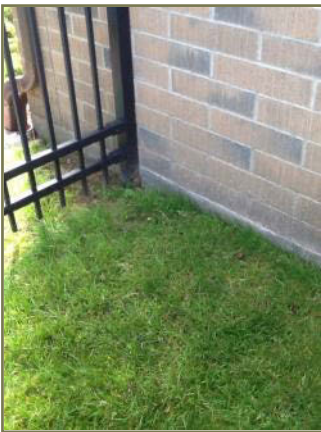
Element.497.v4o3m7g4.aod.jpg

Category	A10 - Foundations
Element Number	1
Last Major Action	1982
Brief Description	Concrete with spancrete, 6 to 8 feet deep footing below grade.
Commentary	No issues observed
Overall Condition	■ Good

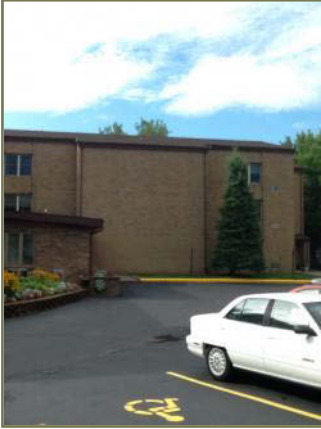
Element.499.ns29brvh.34v.jpg

Category	B10 - Superstructure
Element Number	1
Last Major Action	1982
Brief Description	Solid brick with metal studs
Commentary	
Overall Condition	■ Good

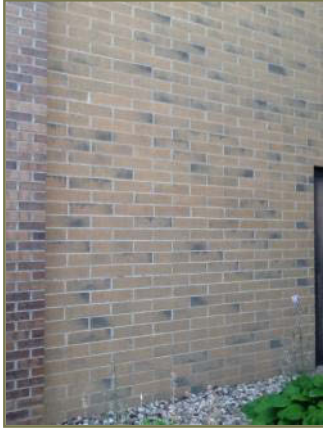
Element.501.3c90t308.11u.jpg

Category	B2010 - Exterior Walls
Element Number	1
Last Major Action	2000
Brief Description	Metal studs with brick exterior. M3.5" fiberglass insulation
Commentary	North side was re-bricked in spots due to wind penetration.
Overall Condition	■ Good

Action Summary:	Repair exterior walls.
Action: Commentary	
Action Type	Repair
Year	2037
Repeat Interval	37
Priority	Low
Priority Score	19.00

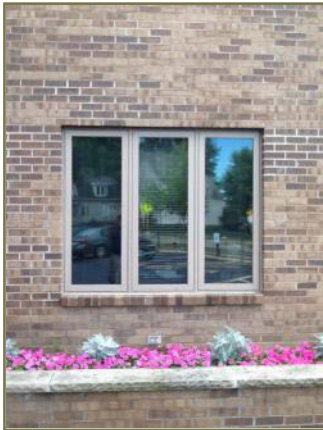
Element.502.2h6anx8t.uqo.jpg

Category	B2020 - Exterior Windows*
Element Number	1
Last Major Action	2005
Brief Description	Vinyl double hung low energy glass windows.
Commentary	Replaced in 2005.
Overall Condition	■ Good

Action Summary: Replace exterior windows.

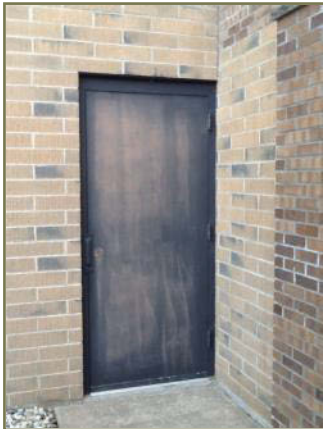
Element.503.qfcvnlis.vub.jpg

Category	B2030 - Exterior Doors*
Element Number	1
Last Major Action	2002
Brief Description	Main entrances are sliding glass doors. Other entrances are metal service doors with glass windows.
Commentary	A fix of original doors, which have some rusting, and doors replaced in 2002. Replacing with fiber glass doors in 2015, last added new doors as part of addition in 2002
Overall Condition	■ Fair

Action Summary: Replace exterior doors

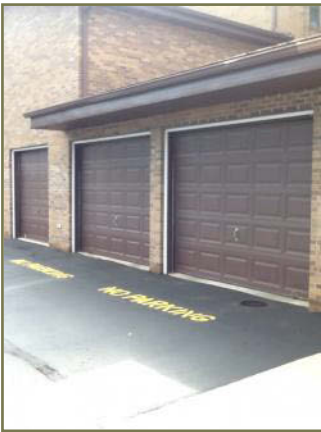
Element.504.pwloqqo5.zg2.jpg

Category	B2040 - Industrial Doors*
Element Number	1
Last Major Action	2002
Brief Description	(3) insulated overhead garage doors.
Commentary	The garage doors are in good condition.
Overall Condition	■ Good

Action Summary:	Replace industrial doors
Action: Commentary	
Action Type	Replacement
Year	2022
Repeat Interval	40
Priority	Low
Priority Score	16.50

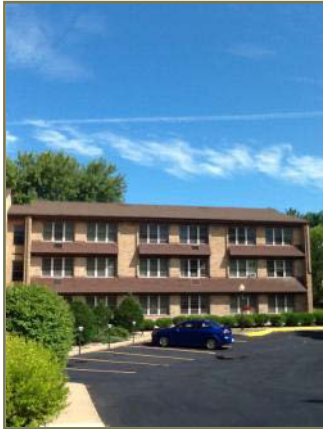
Element.505.pknm7kgd.w1w.jpg

Category	B30 - Roofing
Element Number	1
Last Major Action	2013
Brief Description	Metal shingle Decro product
Commentary	Replaced in 2013 with a 50 year warranty. The eaves-trough was buried into the storm sewer in 2000.
Overall Condition	■ Good

Action Summary:	Replace roofing
Action: Commentary	
Action Type	Replacement
Year	2035
Repeat Interval	22
Priority	Low
Priority Score	15.00

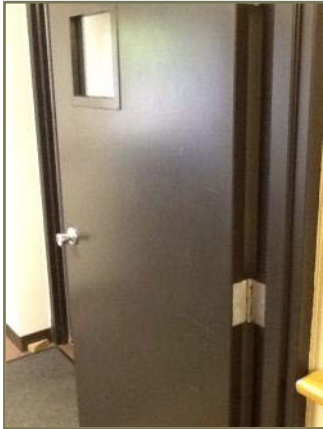
Element.564.rvwx14y.o1x.jpg

Category	C1050 - Interior Doors - Common Area
Element Number	1
Last Major Action	1982
Brief Description	Wood doors and metal fire doors leading to the stairwells
Commentary	Doors do not appear to be original but there is no record of them being replaced.
Overall Condition	■ Good

Action Summary:	Replace common area doors
Action: Commentary	
Action Type	Replacement
Year	2032
Repeat Interval	25
Priority	Low
Priority Score	12.00

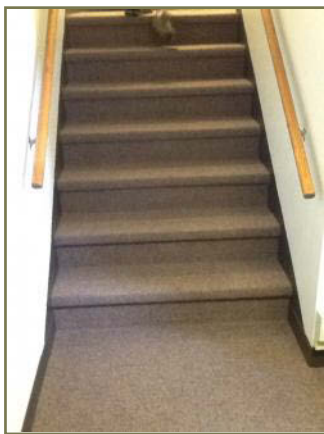
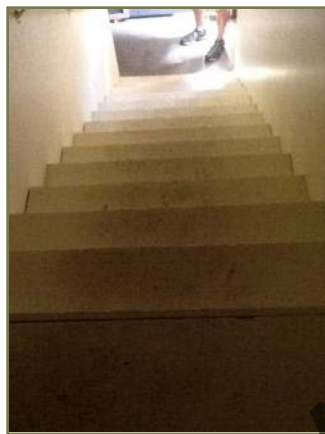
Category C20 - Stairs
Element Number 1
Last Major Action 1982
Brief Description (6) Stairways in the building.
Commentary They are original and in good condition.
Overall Condition ■ Good

Action Summary: Repair stairs
Action: Commentary
Action Type Repair
Year 2026
Repeat Interval 22
Priority Low
Priority Score 17.50

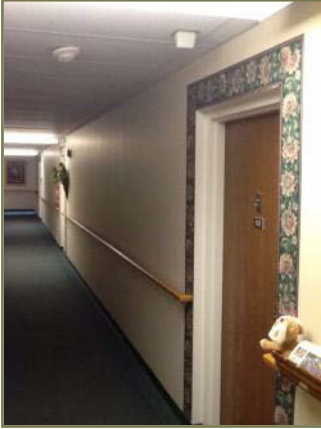
Element.565.dio3x0zs.xaj.jpg

Category C3050 - Wall Finishes - Common Area
Element Number 1
Last Major Action 2008
Brief Description Painted drywall in the common areas
Commentary Building painted in 2008, entrance was repainted in 2013.
Overall Condition ■ Good

Action Summary:	Replace common area walls
Action: Commentary	
Action Type	Replacement
Year	2020
Repeat Interval	12
Priority	Low
Priority Score	12.75

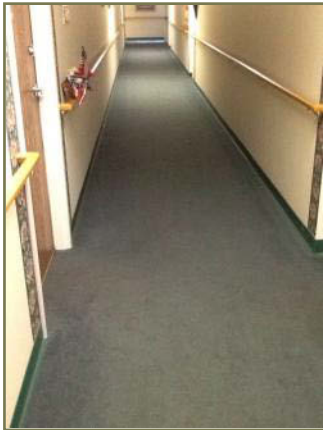
Element.566.p5ojdbgi.qh9.jpg

Category	C3070 - Floor Finishes - Common Area
Element Number	1
Last Major Action	1982
Brief Description	Carpeting in the common areas on the 1st and 3rd floors
Commentary	1st & 3rd floors are in need of replacement.
Overall Condition	■ Poor

Action Summary:	Replace carpeting on the 1st and 3rd floors.
Action: Commentary	
Action Type	Replacement
Year	2017
Repeat Interval	24
Priority	Medium
Priority Score	30.25

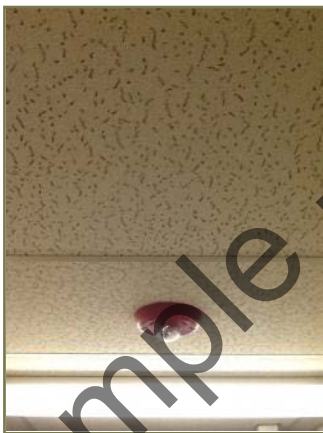
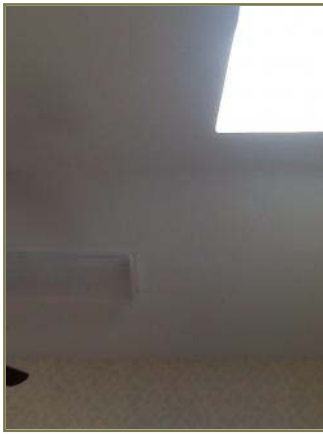
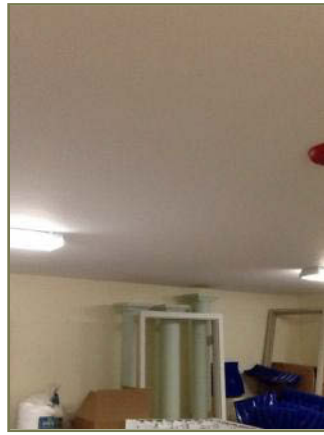
Category C3090 - Ceiling Finishes - Common Area
Element Number 1
Last Major Action 1982
Brief Description Common areas have dropped ceiling and acoustic tiles.
Commentary Acoustic tiles are replaced as needed.
Overall Condition ■ Good

Action Summary: Replace common area ceilings

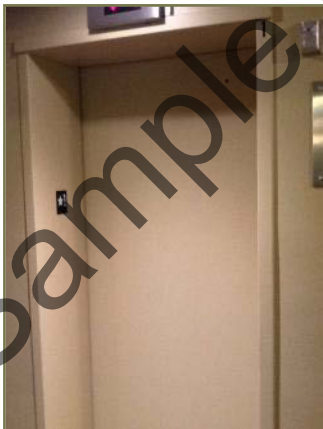
Element.510.l4jqvihk.uxl.jpg

Category	D1010 - Elevators & Lifts
Element Number	1
Last Major Action	2009
Brief Description	(2) Elevators, (1) Hydrolic elevator, (1) Electric service elevator with front and back doors.
Commentary	Upgraded operators controls in 2009.
Overall Condition	■ Good

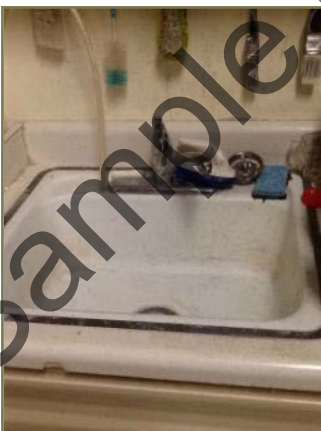
Element.568.yuk6p3fl.lbs.jpg

Category	D2010 - Plumbing Fixtures
Element Number	2
Last Major Action	1982
Brief Description	There are slop sinks in the garage, and bathroom sinks in the common area.
Commentary	Believed to original, and would be beyond their predicted lifespans
Overall Condition	■ Fair

Action Summary: Replace common area piping

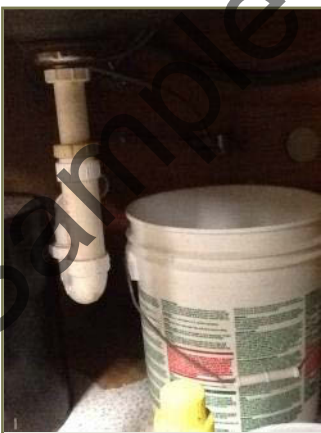
Element.513.j9g1obbt.6aa.jpg

Category	D2030 - Sanitary Waste*
Element Number	1
Last Major Action	1982
Brief Description	Sanitary waste piping: Visible piping under sinks is PVC and metal drain lines, but the main drain lines are concealed behind walls.
Commentary	Concealed System: Appears to be in good condition with no reported problems, but very aged and should be replaced soon.
Overall Condition	<input type="checkbox"/> Fair

Action Summary: Repair drain piping

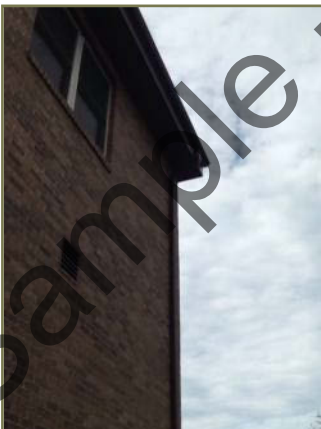
Element.514.y1woxk35.pwp.jpg

Category	D2040 - Rain Water Drainage
Element Number	1
Last Major Action	1982
Brief Description	Gutters with downspouts.
Commentary	Some areas have rust related holes.
Overall Condition	■ Fair

Action Summary: Replace gutters and downspouts

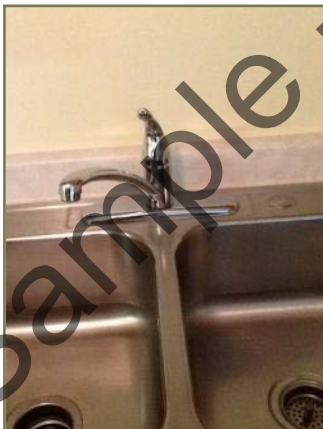
Element.512.l0ox0zja.xm5.jpg

Category	D2050 - Domestic Water Distribution - Units
Element Number	1
Last Major Action	1982
Brief Description	Copper supply lines and PVC drain lines in common areas and units.
Commentary	All appear to be in good condition.
Overall Condition	■ Fair

Action Summary: Replace unit piping

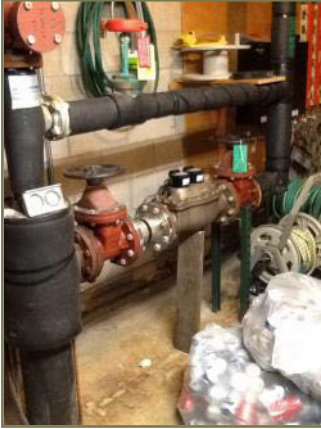
Element.577.d1tdjjic.7xc.jpg

Category	D2070 - Domestic Water Distribution - Main
Element Number	1
Last Major Action	1982
Brief Description	Main water distribution, hot water line has re-circulator pump on it, drain piping is PVC.
Commentary	Concealed System: the piping system is of an unknown age. There have been some pin hole leaks reported, so repair and replacement is recommended.
Overall Condition	■ Fair

Action Summary: Replace main water piping

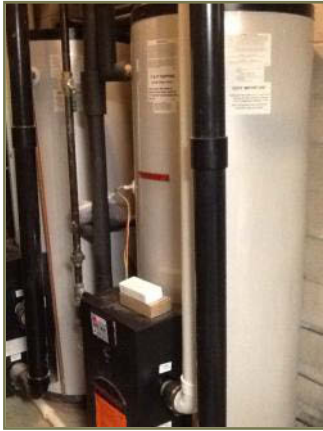
Element.515.f3rjzwt3.jau.jpg

Category	D2095 - Domestic Water Heaters
Element Number	1
Last Major Action	2006
Brief Description	(3) Voyager gas fired water heaters, 119 gal, 199,000 BTU/Hr,
Commentary	Replaced in 2006, upgrading control boards in 2015. The heaters are past their life expectancy, but remain functional in fair condition, so replacement can be deferred.
Overall Condition	■ Fair

Action Summary: Replace water heater

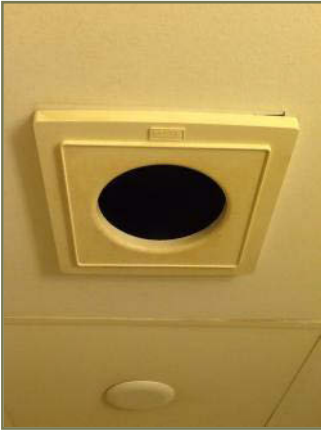
Element.538.psnxwv9u.2hj.jpg

Category	D3045 - Exhaust Ventilation Systems
Element Number	1
Last Major Action	1982
Brief Description	Bathrooms have their own exhaust fans. There are ceiling vents in community room.
Commentary	The exhaust fans are past their life expectancy, remaining functional in fair condition but should be replaced soon.
Overall Condition	■ Fair

Action Summary:	Replace exhaust vents
Action: Commentary	
Action Type	Replacement
Year	2017
Repeat Interval	25
Priority	Medium
Priority Score	21.50

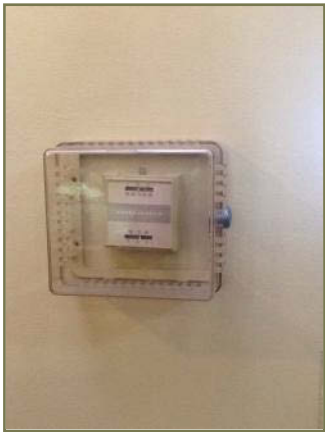
Element.545.jnlvbuy.aem.jpg

Category	D3060 - Controls And Instrumentation*
Element Number	1
Last Major Action	1982
Brief Description	Manual thermostat in lobby, in each bedroom and living room. Controls the baseboard electric heaters
Commentary	The thermostats are past their life expectancy, remaining functional in fair condition but should be replaced soon.
Overall Condition	■ Fair

Action Summary: Replace thermostats and controls

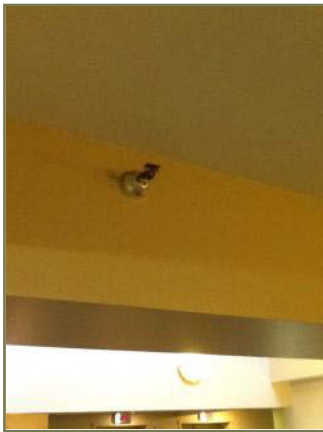
Element.546.100hssri.mc2.jpg

Category	D4010 - Sprinklers
Element Number	1
Last Major Action	1982
Brief Description	Sprinklers are only in front lobby.
Commentary	No issues reported, inspect and upgrade sprinkler system in accordance with the fire code. It is recommended to conduct a study to determine the remaining life & condition of the sprinkler system.
Overall Condition	■ Good

Action Summary:	Replace sprinklers
Action: Commentary	
Action Type	Replacement
Year	2029
Repeat Interval	47
Priority	Medium
Priority Score	21.00

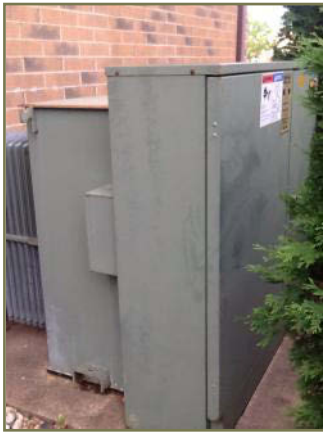
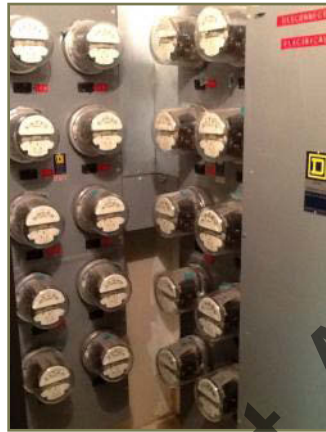
Commentary Some connections are broken. Electrical distribution is assumed to be beyond expected life and should be planned for replacement. Conduct an electrical study to determine remaining life and required repairs/upgrades.

Action Summary: Replace main electrical

Conduct a study of the electrical panels & wiring to determine remaining life and cost of required upgrades & repairs.

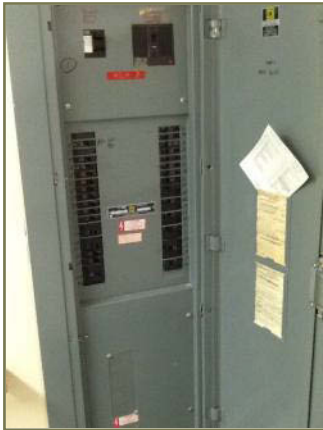
Element.575.oub61a05.3gx.jpg

Category	D5014 - Intermediate Electrical Service and Distribution*
Element Number	1
Last Major Action	1982
Brief Description	Square D brand electrical breaker boxes in hall on floor 1
Commentary	No issues noted or reported, unknown age. Electrical distribution is assumed to be beyond expected life and should be planed for replacement. Conduct an electrical study to determine remaining life and required repairs/upgrades.
Overall Condition	■ Poor

Replace intermediate electrical

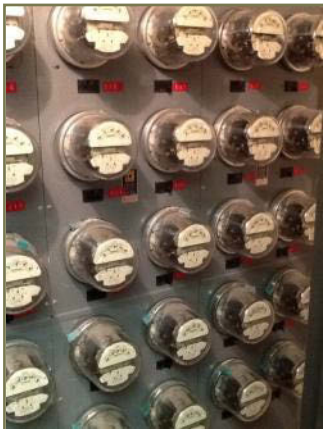
Element.576.sj2zsva4.fq4.jpg

Category	D5015 - Unit Electrical Service and Distribution*
Element Number	1
Last Major Action	1982
Brief Description	100 amp panels and meters for each unit.
Commentary	Breaker boxes in each unit appear to be original. No issues noted or reported. Electrical distribution is assumed to be beyond expected life and should be planed for replacement. Conduct an electrical study to determine remaining life and required repairs/upgrades.
Overall Condition	<input type="checkbox"/> Good <input checked="" type="checkbox"/> Poor

Action Summary: Replace unit electrical

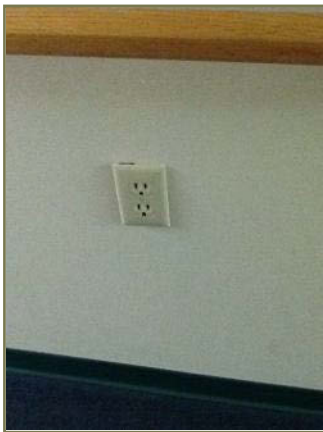
Element.549.awqvay7z.wma.jpg

Category	D5021 - Branch Wiring
Element Number	1
Last Major Action	1982
Brief Description	Wiring is original throught out building
Commentary	Concealed system: no issues reported, the wiring is of an unknown age. It is assumed that the wiring has surpassed its expected life and may require repairs or replacement in the short term. Conduct an electrical study to determine remaining life and required repairs/upgrades.
Overall Condition	■ Fair

Action Summary: Replace branch wiring

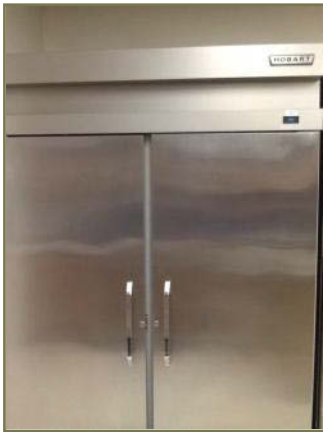
Element.559.7ucqzoyc.g0n.jpg

Category E1010 - Commercial Equipment
Element Number 1
Last Major Action 1995
Brief Description Hobart freezer, Maximum refrigerator, Southbend gas stove, and Duke warming ovens.
Commentary Commercial kitchen equipment is beyond expected life but was observed to still be in good condition.
Overall Condition ■ Good

Action Summary: Replace commercial equipment

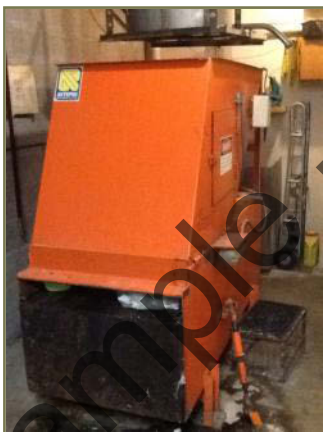
Element.562.76ka3es3.6tt.jpg

Category F1046 - Trash Compactors
Element Number 1
Last Major Action 1982
Brief Description (1) Trash compactor original to the building.
Commentary The trash compactor is past life expectancy but was observed to still be in good condition.
Overall Condition ■ Good

Action Summary: Replace trash compactors
