BLACK HOUSE

144 EAST 6TH AVENUE, VANCOUVER, BC

HERITAGE CONSERVATION PLAN

MARCH 2024

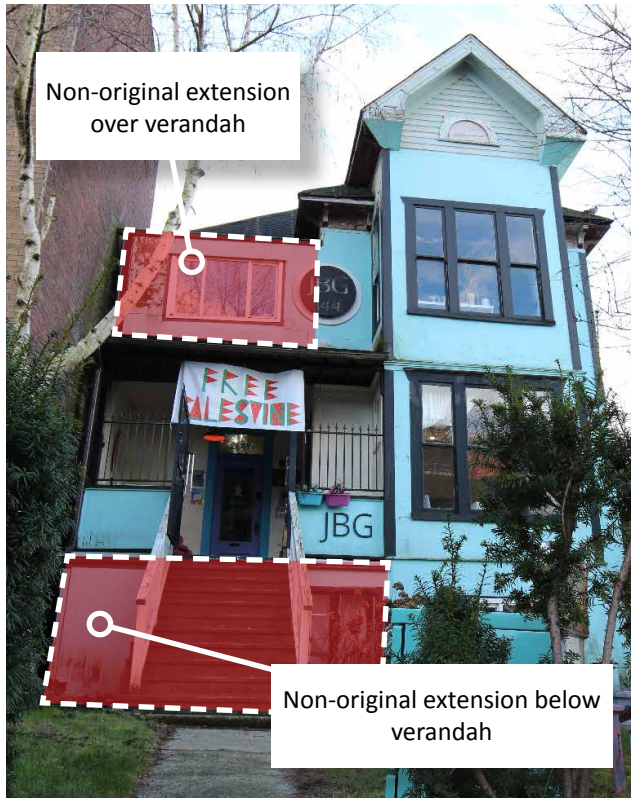
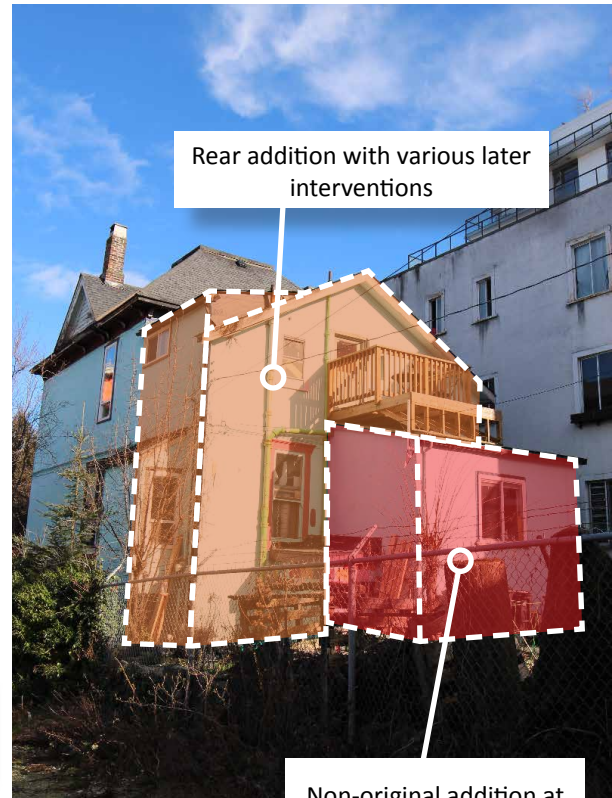
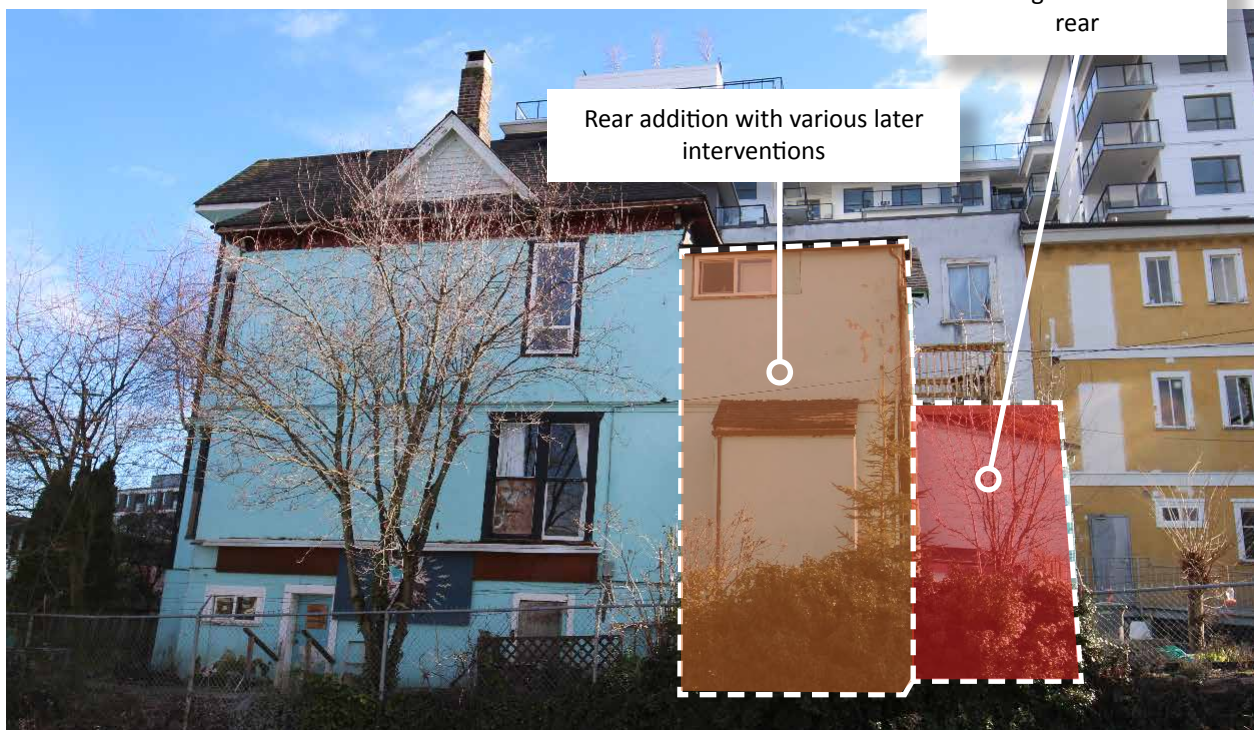
Major Identified interventions to the Black House including front facade extensions above and below verandah and robust full-width addition at rear. [Donald Luxton & Associates]

The one-storey shed addition at rear is not original to the time of construction and can be removed as part of the rehabilitation scheme. The two-storey rearing portion of the residence, which has been significantly modified with a shed addition at west and various roof modifications was also added to the residence after the time of construction. Further investigation is required to determine current structural condition, and appropriate rehabilitation scope for this addition.

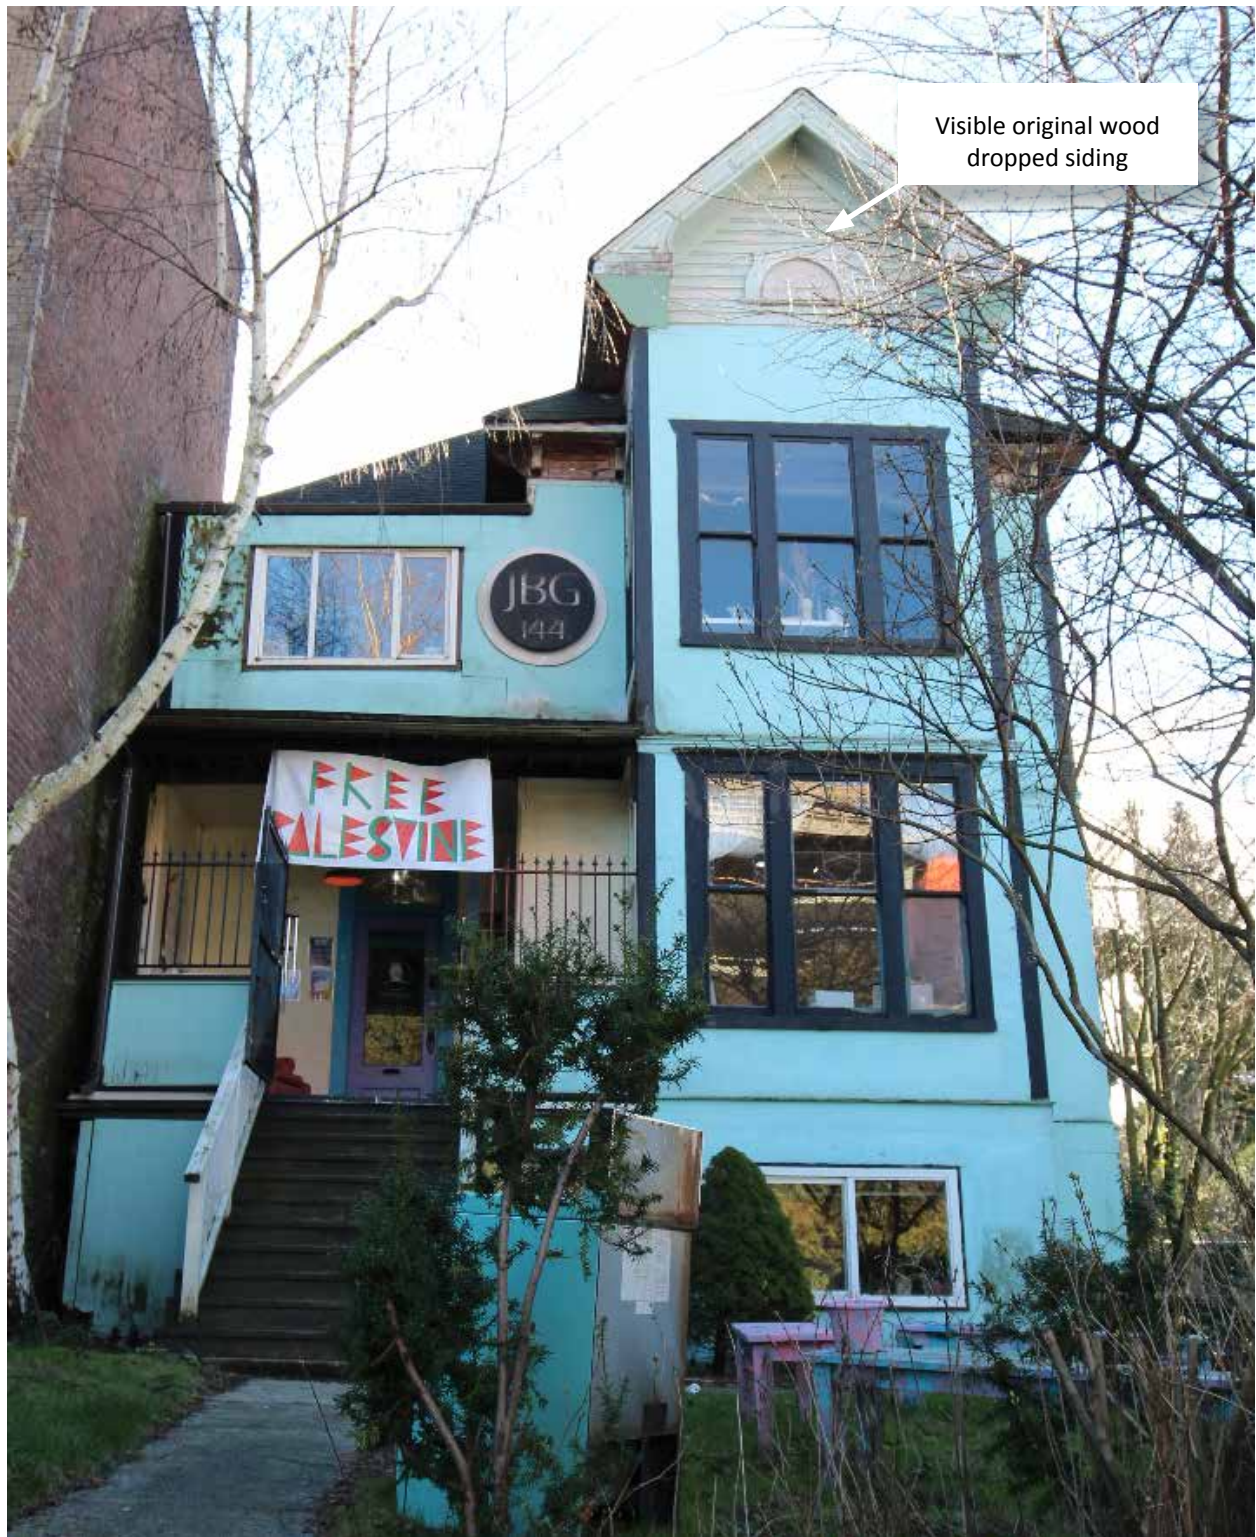
Condition review of front elevation with noted narrow wood dropped siding [Donald Luxton & Associates]

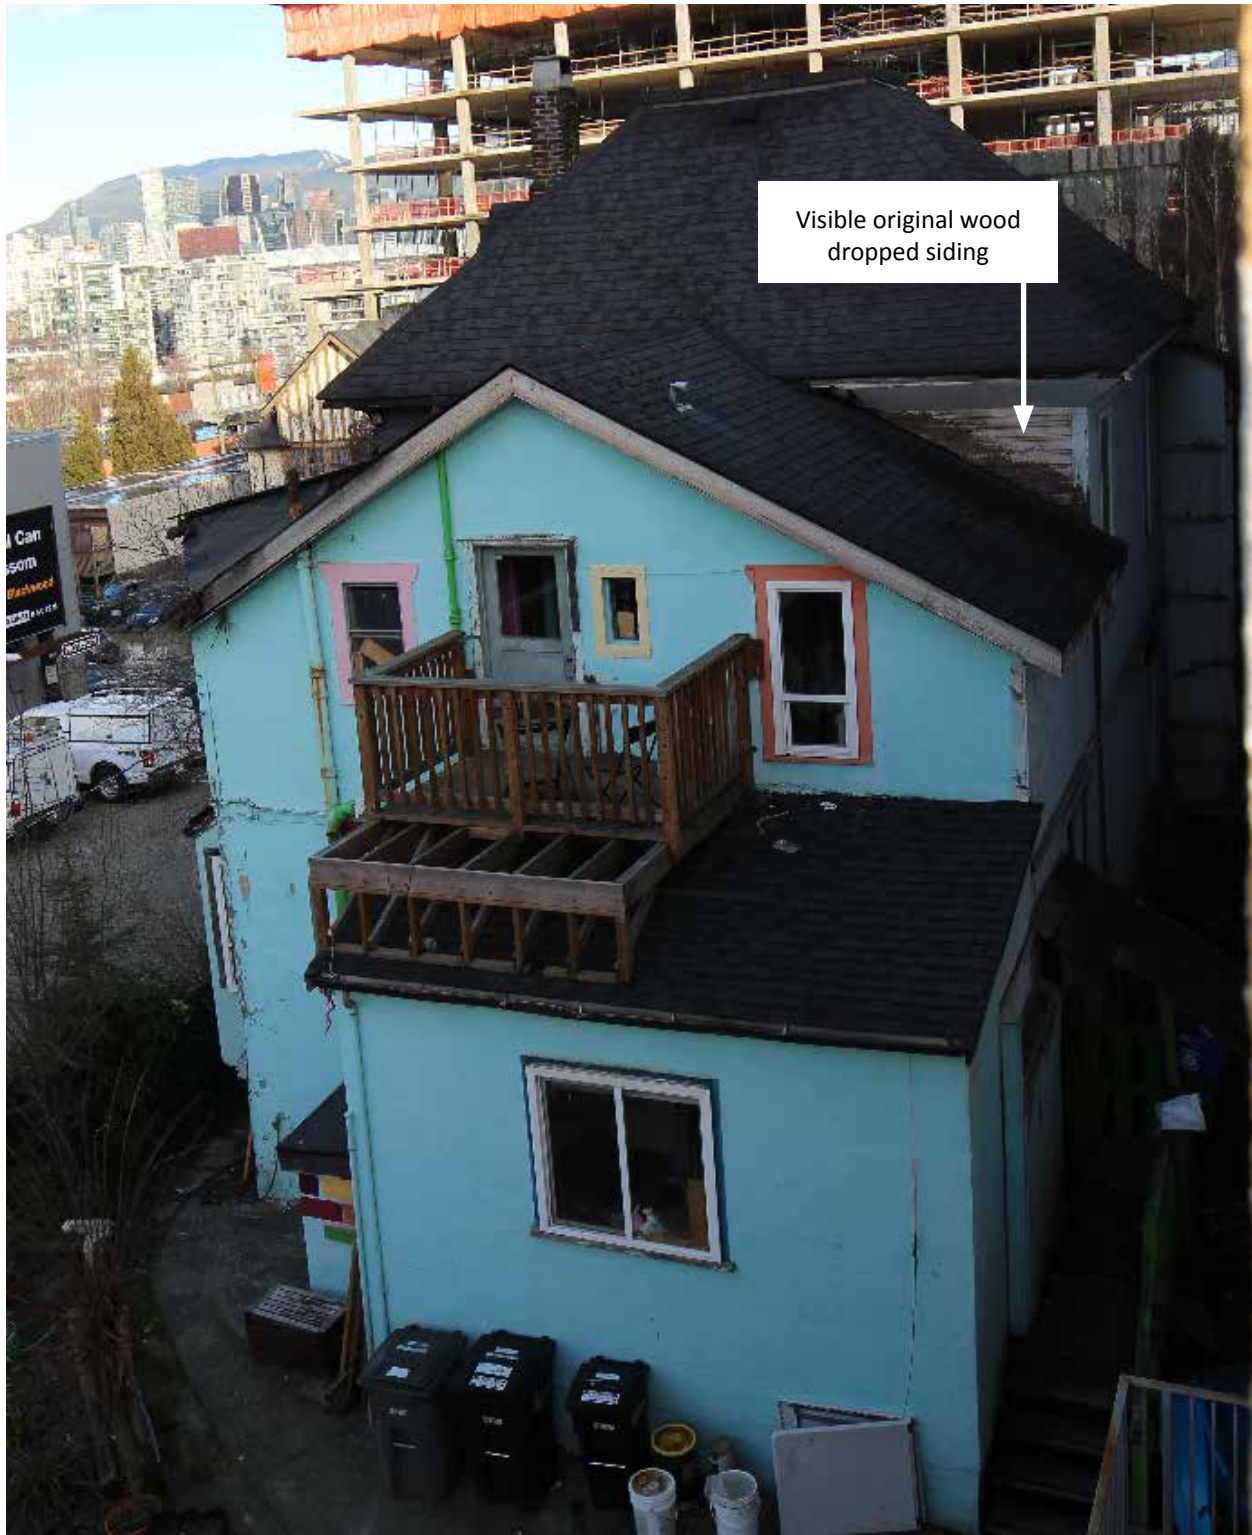
Condition review of rear elevation with noted narrow wood dropped siding [Donald Luxton & Associates]

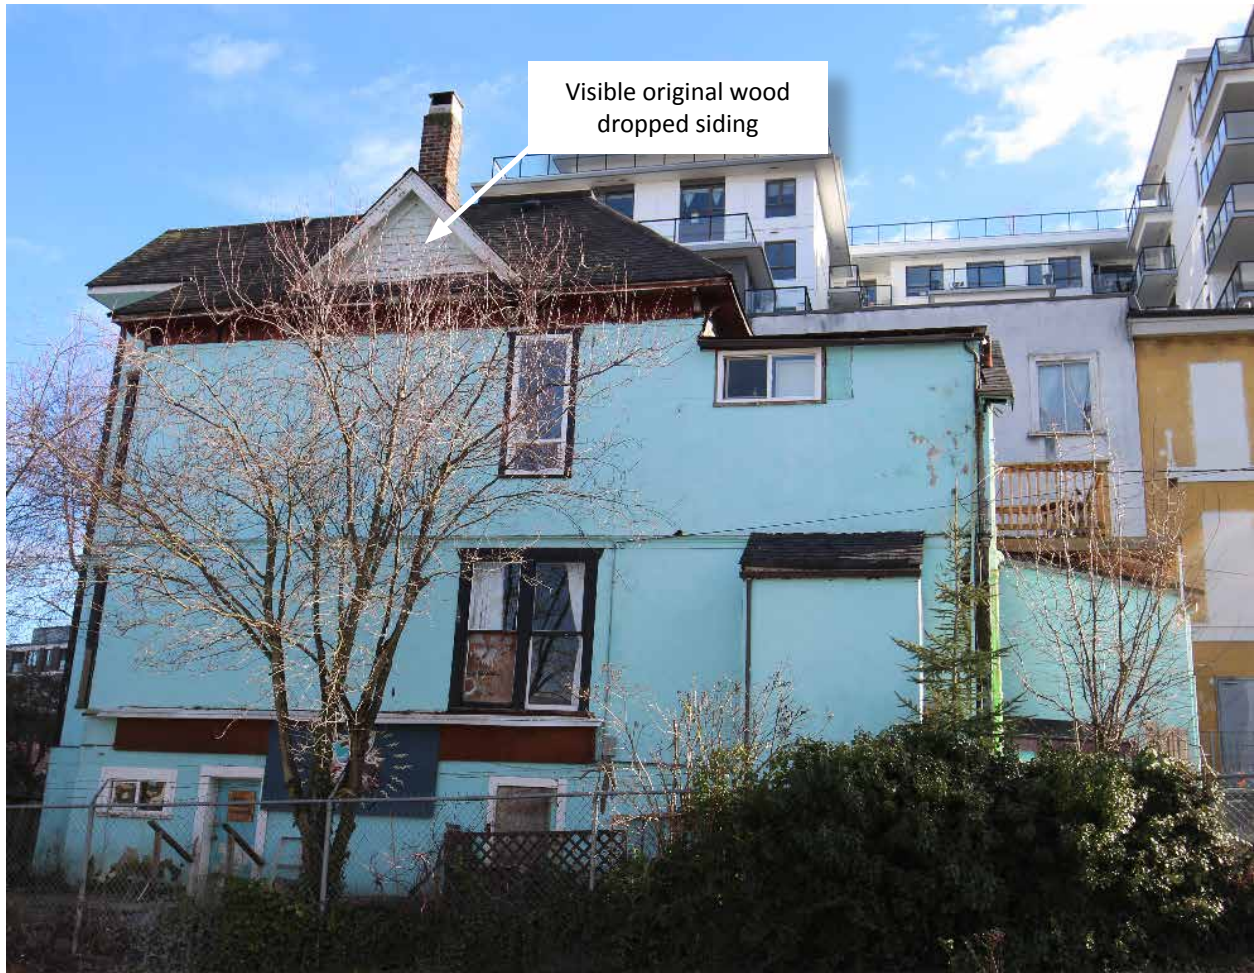
Condition review of side (west) elevation with noted narrow wood dropped siding [Donald Luxton & Associates]

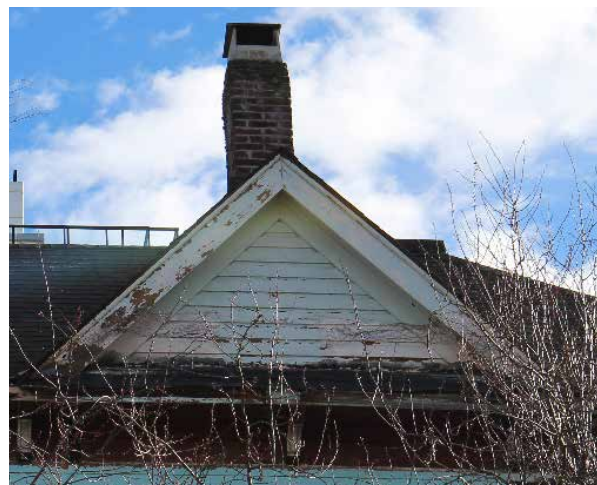
Close-up of noted narrow wood dropped siding [Donald Luxton & Associates]

The surviving areas clad in narrow wood dropped siding are believed to be surviving original elements, and further investigation at these areas is required when access is available. Documentation of the original profile and dimensions of the surviving wood dropped siding will allow for in-kind replacement to be completed in a manner that is both physically and visually compatible with the original.

- Document the composition, form, profile, dimensions and condition of visible original wood siding before undertaking any intervention.
- Preserve intact original wood siding in good or repairable condition.
- Carefully remove existing stucco. If original wood siding is identified in good, repairable condition, salvage and re-use where possible in the reinstatement of the exterior wood dropped siding.
- Restore original wood dropped siding at main and upper levels of residence.
- New wood siding to match original in material, size, profile, and thickness. Use surviving original wood siding as guide for restoration scope.
- Utilize Alternate Compliance Methods outlined in the VBBL for fire and spatial separations including installation of sprinklers where possible. Combed and/ or textured lumber is not acceptable. Hardi-plank or other cementitious boards are not acceptable.

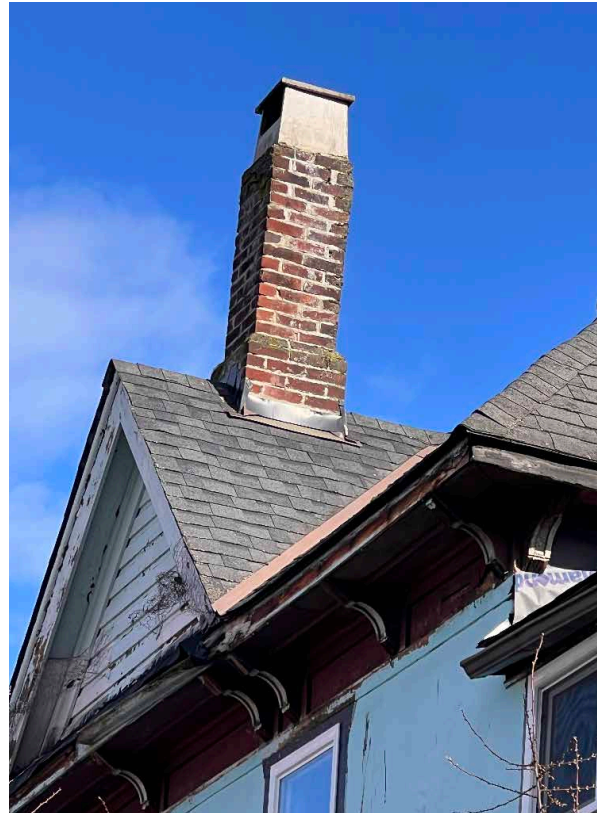
Top: Condition of surviving wood trim and chimney [Donald Luxton & Associates]

- Preserve original surviving trims and decorative elements. Restore missing or heavily deteriorated elements in-kind, using visually and physically compatible materials such as wood. Combed and/ or textured lumber is not acceptable. Hardi-plank or other cementitious boards are not acceptable.

- Preserve the chimney in its original configuration, if possible.
- Chimney may require structural stabilization due to relocation.
- Investigate condition of brickwork. If required, brickwork may be cleaned, repointed and deteriorated brickwork replaced in-kind.

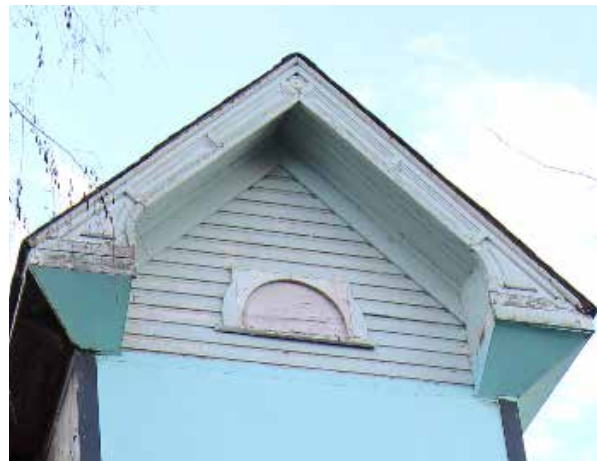
Bottom: Condition of surviving wood trim at front gable peak [Donald Luxton & Associates]

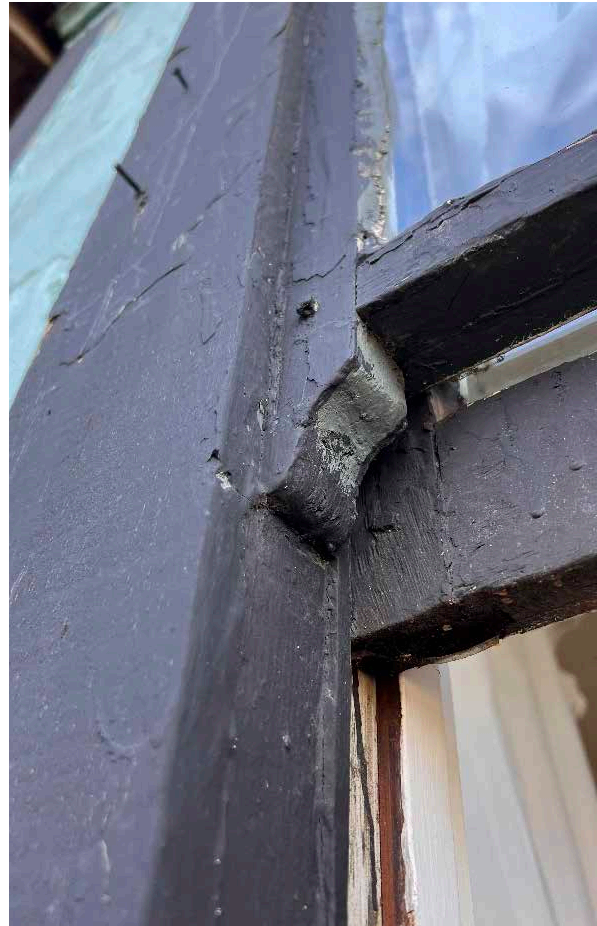
Integrated sash-horn detail at existing original windows [Donald Luxton & Associates]

- Inspect for condition to determine extent of recommended repair or replacement.
- Preserve surviving window openings that are original to the time of construction.
- Restore missing window openings to their original locations and sizes, where possible, based on physical evidence and archival images
- Preserve original wood frames and sashes, and repair as required, using in-kind repair techniques where feasible.
- Where missing or required, introduce new wooden windows that are compatible with the style, era and character of the historic place, or a replica based on documentary evidence including sash horns.
- Prime and repaint as required in appropriate colour, based on colour schedule devised by Heritage Consultant.
