DONNACONNA BLOCK

148 EAST 6TH AVENUE, VANCOUVER, BC

RECONSTRUCTION PLAN

MARCH 2024

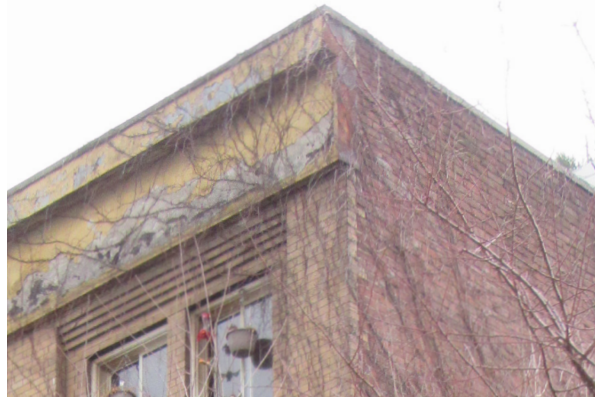
North of parapet has been covered, potentially concealing evidence of original cornice.

Based on the visual assessment of the north façade, there may have been a modest cornice on the face of the parapet that has since been removed or modified and portion of the brick covered. A small cornice would have been historically appropriate for this time period but further investigation is required. If through investigation and/or documentation it is determine a cornice did exist that differs from the extant, reinstate a matching cornice. If no further evidence is found as to the nature of the original cornice, review retaining the existing or install a period appropriate cornice.

- Investigate by removing existing cladding at parapet during deconstruction of the north façade. Document any evidence revealed as to the presence and design of a metal parapet cornice.
- Rehabilitate cornice to a historically appropriate cornice or, if archival evidence is found, restore to match original.
- The sheet metal work should be painted. Apply appropriate primer for galvanized surfaces. Paint in historically appropriate colour, based on colour schedule prepared by Heritage Consultant.

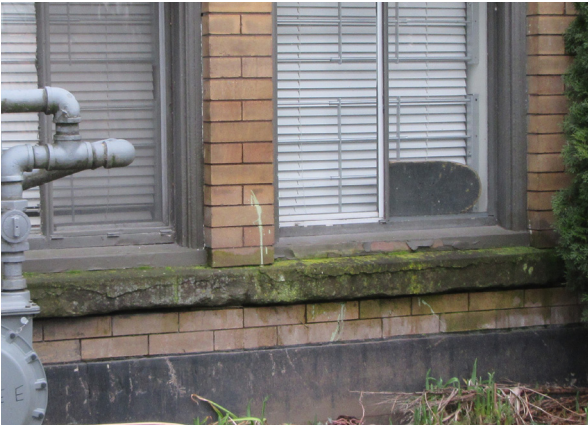
Sill deterioration under north elevation window.

delamination, biological growth, and mortar loss. Accelerated deterioration is notable on a number of window sills possibly due to moisture issues, the majority of which are on the south façade. Through the proposed redevelopment the north façade and its returns will be reconstructed in a new location directly north of its existing location. The sandstone sills will be inventoried, salvaged, cleaned, and repaired as required. Any units deemed too heavily deteriorated to preserve, will be replaced in-kind.

- Inventory and salvage original sandstone elements.
- Clean, stack, and store stone in a manner that will not cause any damage or deterioration to it.
- Replace in-kind stonework too deteriorated to repair. Matching new stone to the original stone.
- Cleaning, repair and pointing specifications to be reviewed by Heritage Consultant. Work should only be undertaken by skilled mason with qualified experience in heritage conservation work.
- Any repair work should be done using in-kind methods. Repair mortars are acceptable. Replacement of missing or heavily deteriorated elements is also acceptable using new units that match existing materials, physically and visually.
- Point mortar joints with new mortar to match existing in consistency, composition, strength, colour and pointing profile.

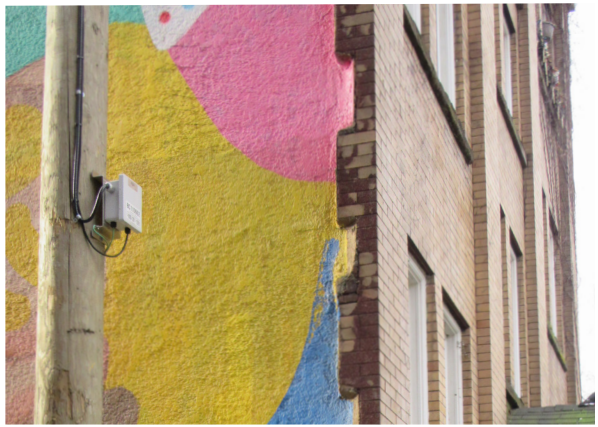
North-east corner showing brick quoining.

The east and majority of the west and south elevations are finished with stucco. Brick quoining at the north-east corner and a ledge along the top of the east foundation suggest that there could have been brick along the east laneway elevation that has been removed and replaced with stucco. Through the proposed redevelopment only the north façade and its returns will be reconstructed.

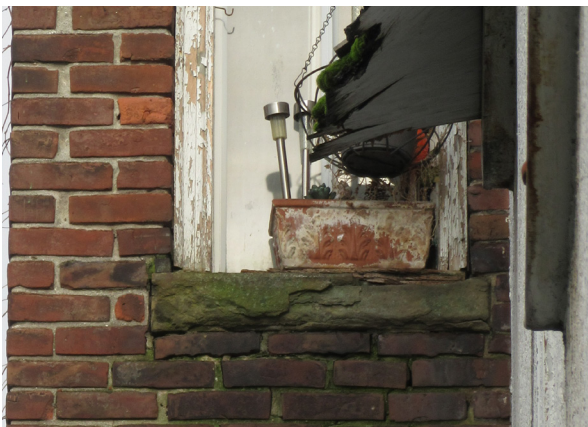
Masonry deterioration at sill on rear elevation window.

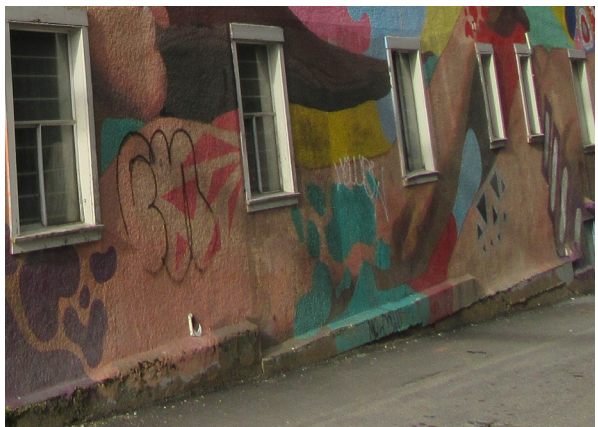
Stuccoed east elevation showing large ledge along top of foundation. Possibility that brick was also present on east elevation due to presence of sill, however, no concrete archival evidence has been found that shows this.

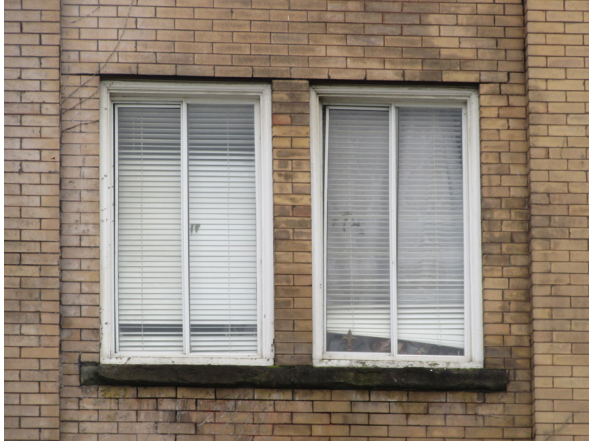
Original double assembly window openings on 3rd floor.

- Inspect for condition and complete inventory of north façade window frames.
- Salvage wood window frames of the north façade and evaluate if frames can be reused in the reconstructed façade or if they require replacement in-kind.

- Install new sashes to match original configuration (1-over-1) in original wood frames or new wood frames if condition does not permit reuse of original wood sashes.
- Prime and paint as required in appropriate colour, based on colour schedule devised by Heritage Consultant.

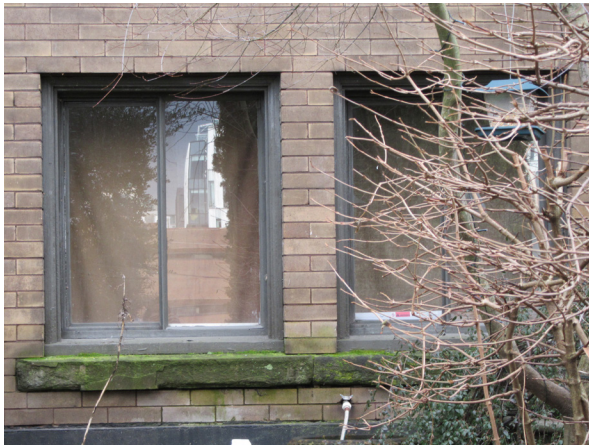
Original double assembly window openings on basement level with sandstone sill.

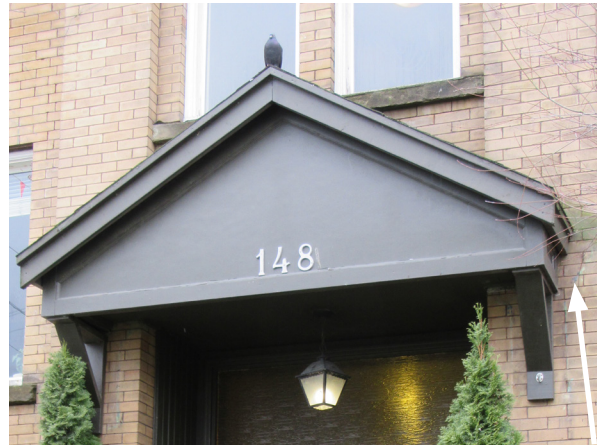
Wood gabled canopy over main entrance. Note outline (white arrow) of previous canopy is evident on the existing brick.

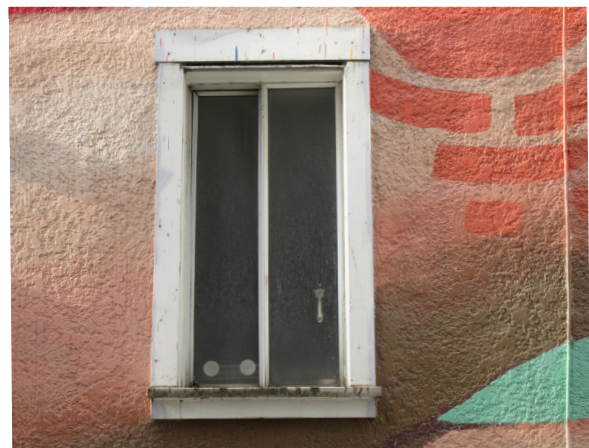
While the Donnacona Block features original window openings on all exterior walls, all the original sashes have been replaced. On the north façade, the original sashes have been replaced with metal inserts and the rear and side elevations currently have metal and vinyl inserts. The original wood frames are still intact in most openings. Archival photographs suggest the original wood sashes were hung sashes in a 1-over-1 configuration. A single skylight is present that provides light to the third floor hallway.

Existing window opening on east elevation, insert window installed.

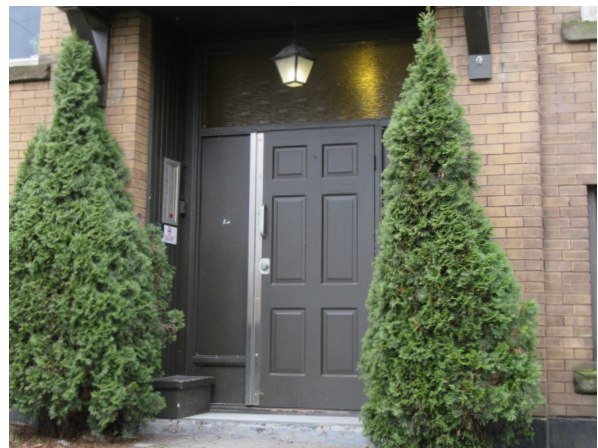
Main entrance on north elevation with intact sidelights and transom.

The north entry consists of a main door, nearly full height sidelights and a transom window. The transom glazing is not original and the sidelights have been covered over and painted; however, the wood frames appear to be original and in good condition. Historically appropriate glazing should be reinstated for both the sidelight and transom openings. The north door is not original and does not reflect the historic character of the building, and should be replaced with new wood door assembly that is historically appropriate.

- Salvage door frame, transom, and sidelights of north entry and assess for potential reinstallation at reconstructed north façade entry, if condition permits. If reuse is possible, repair as required. If salvage elements cannot be repaired, replace in-kind.
- Rehabilitate north entry through installation of new door which should be visually compatible with the historic character of the building and installation of glass in sidelights and transom.

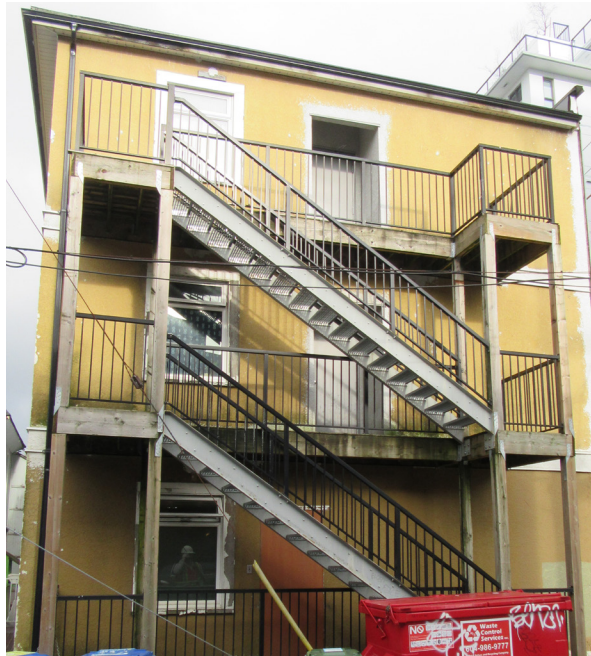
There are three doors that exit onto the fire escape on the rear elevation. The doors are not original. There is one door on the ground floor of the west elevation that exits onto a ramp down to the back lane. The door is new. Original openings for a door exiting onto the original balcony on the west elevation have been filled in.

Door openings onto fire escape on rear elevation.
