Conservation Plan

6825 West Boulevard, Vancouver, BC V6A 3E8

November 2020

6825 West Boulevard, Vancouver, BC

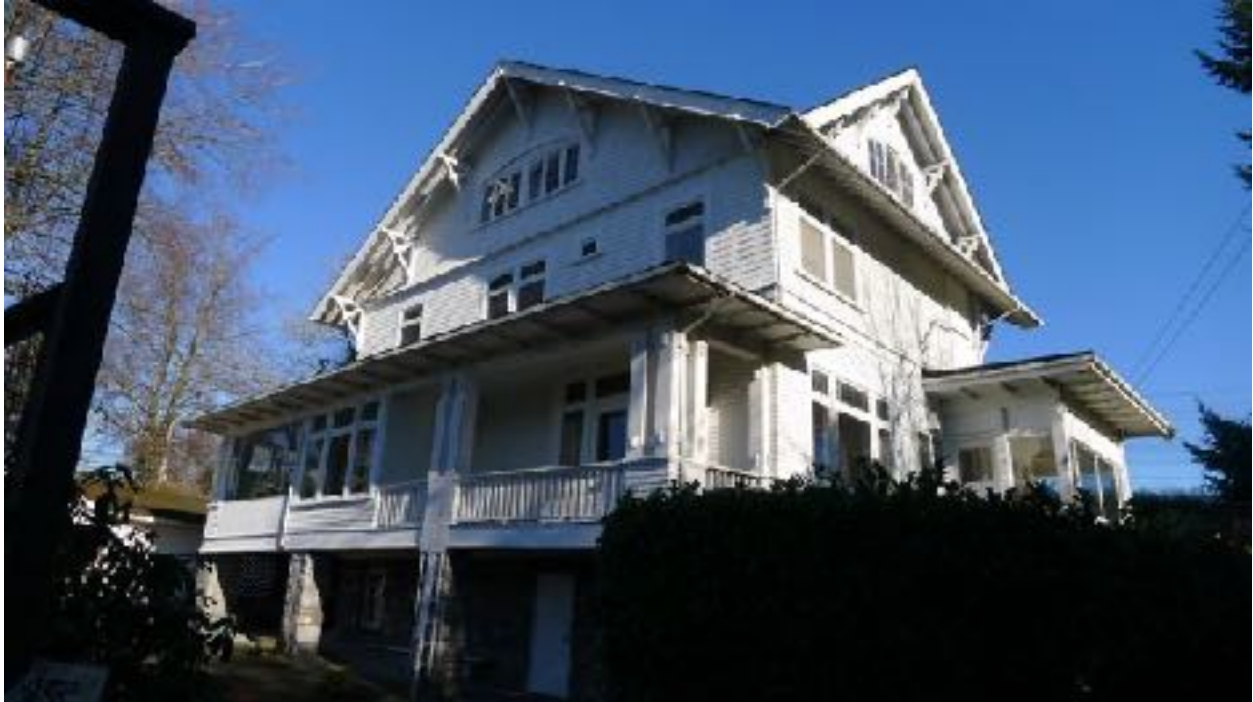
The house from the rear looking to the northeast showing the porch with its granite piers, the alterations with the expansion of a room into the porch cutting it in two. On the upper floors the two sleeping porches have been glassed in to provide additional living space.

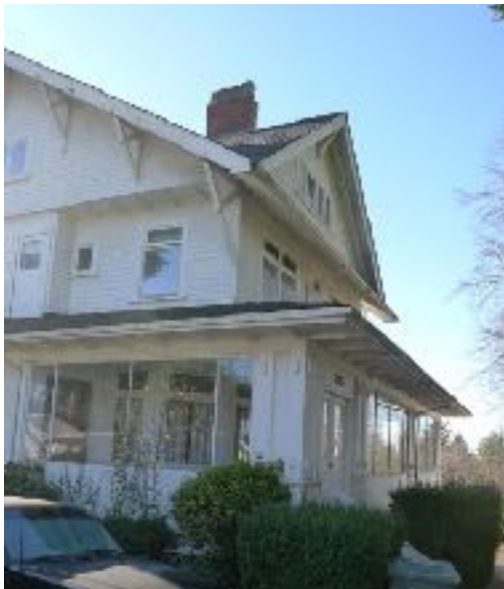
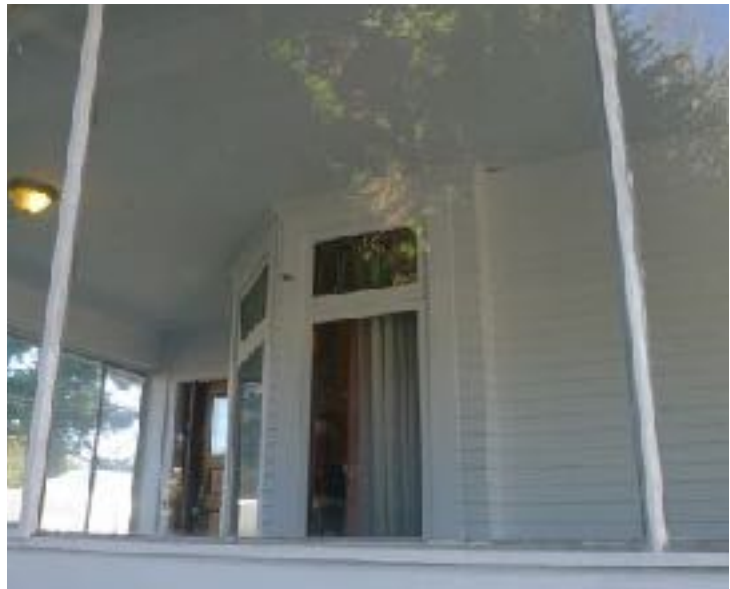
East and north side of the house showing the entrance off the porch and the bay window under the porch roof.

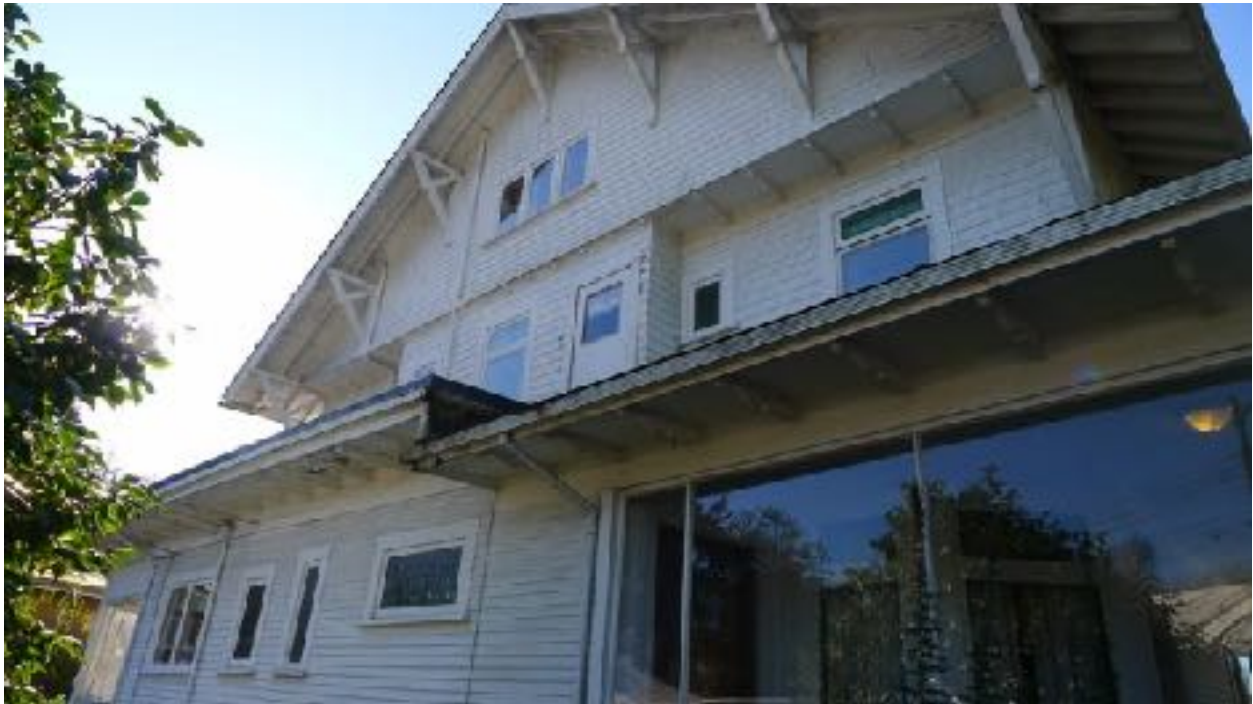
East side of the house showing the entrance and alterations to the facade

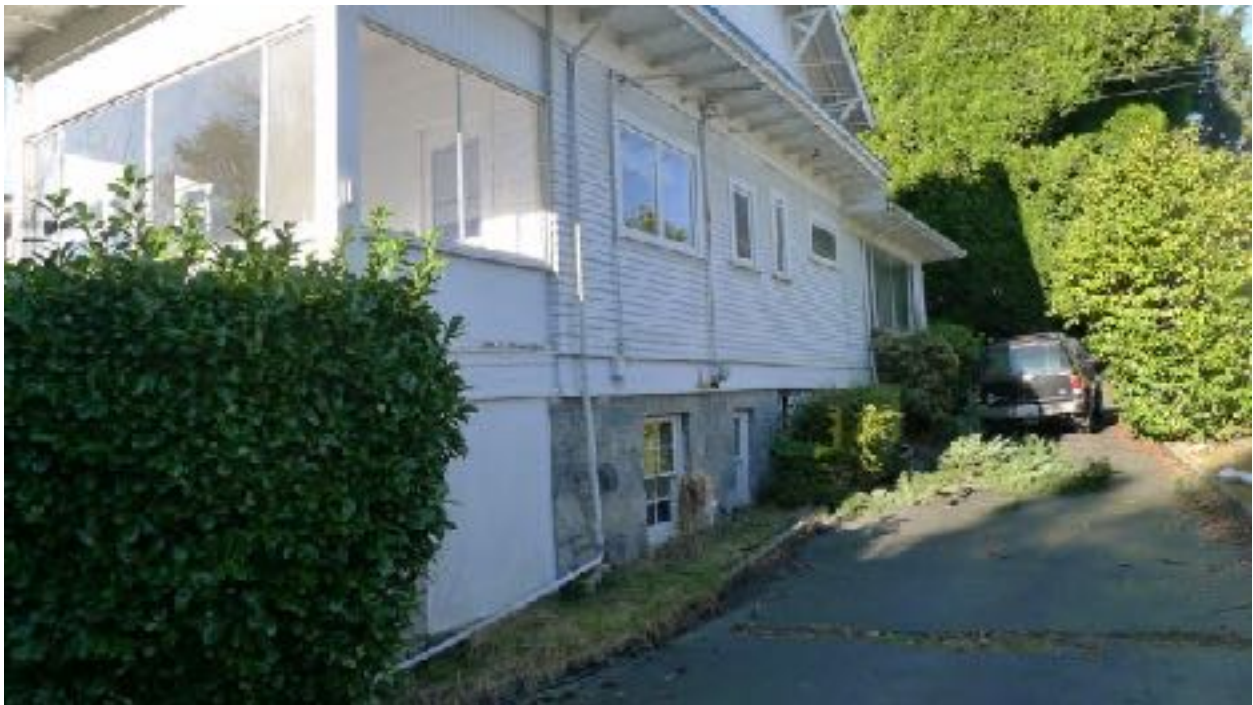
East side of the house looking from the kitchen porch showing the granite foundation

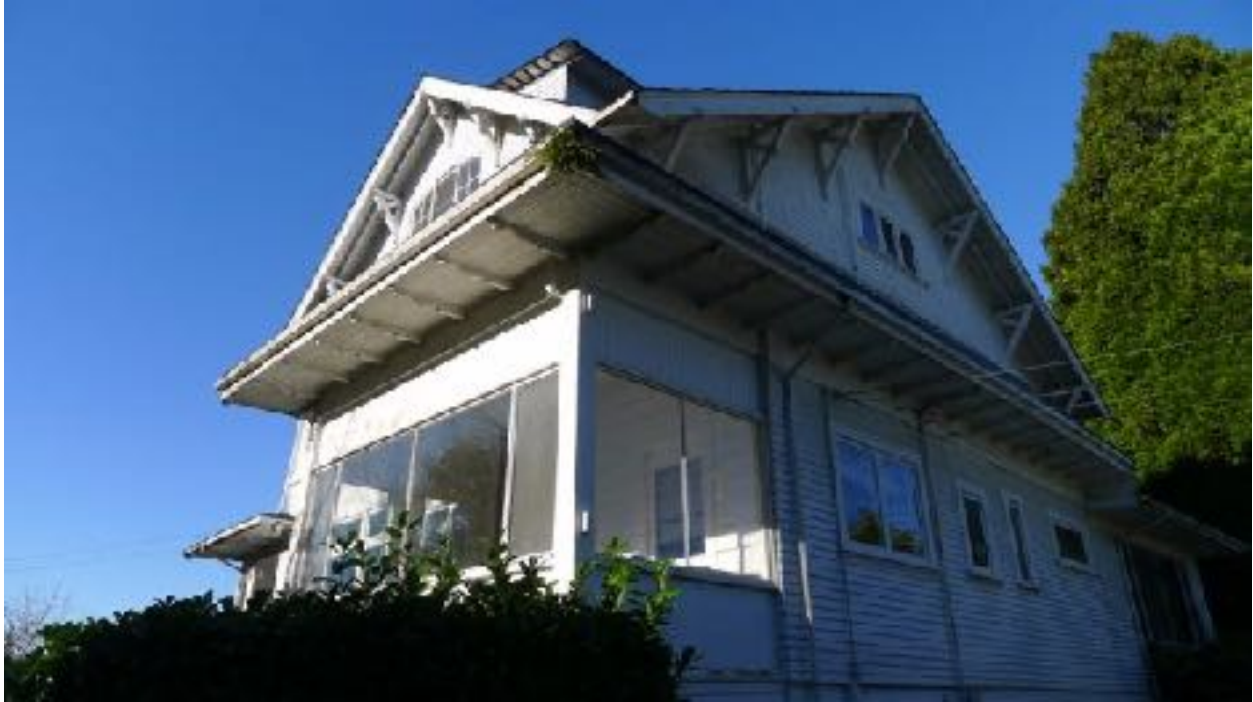
East and south side of the house with kitchen porch showing the addition of a dormer on the side gable.

A dormer has been added to the east side of the south facing gable, and a chimney on the south wall has been removed with a resulting patch. The west and south facing sleeping porches have been closed with the addition of windows. Two windows on the east side appear to be later additions.

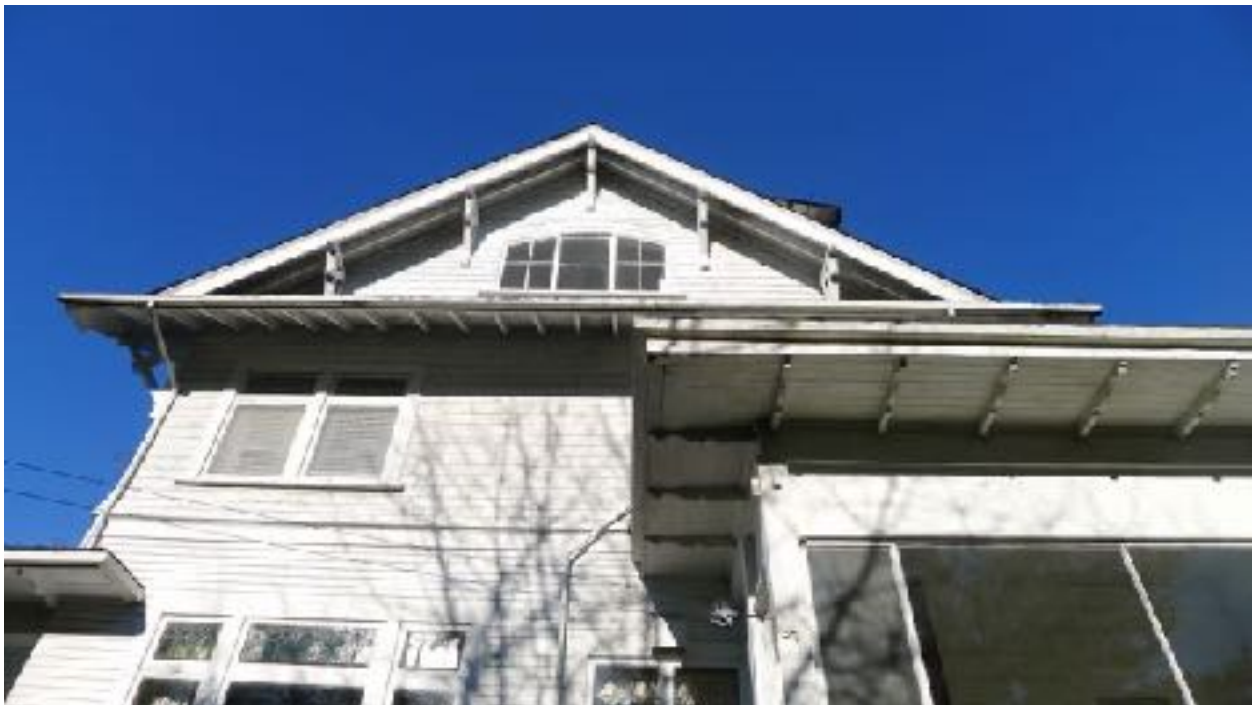
South side of the house with kitchen porch showing the closed in sleeping porch.

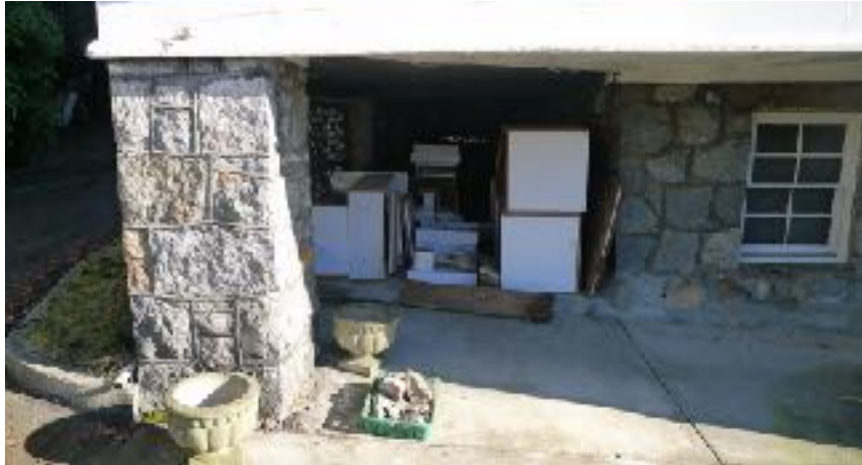
The stone piers and basement foundation showing the standing seam mortar joints

<p>Stonework</p>	<ul style="list-style-type: none"> • the basement and piers supporting the veranda are of coursed rubble 	<ul style="list-style-type: none"> • the stonework is in good condition overall • there are some visible repairs to the basement walls 	<p>Retention or material for reconstruction</p>	<ul style="list-style-type: none"> • the stonework is an important element of the house, care should be taken to retain the stone for reconstruction of the foundation and piers • care should be taken to match the mortar type and style of raised joints • it is recommended that a qualified masonry contractor over see the work
