**The report prepared by Glotman-Simpson for the City of Vancouver in 2012,
*Seismic Assessment and Upgrade Options in response to the Statement of Work
Outlined in the Request for Proposals PS11466.***

RE: Seismic Screening Review for Atira Women's Resource Society
101 East Cordova Street, Vancouver, BC

Read Jones Christoffersen Ltd. performed a seismic risk evaluation of Atira Women's Society located at 101 East Cordova Street, in Vancouver. This evaluation included a "rapid visual seismic screening", a review of drawings, and a walk-through site inspection. The "rapid visual seismic screening" was based on the second edition of the FEMA 154 Handbook, "Rapid Visual Screening of Buildings for Potential Seismic Hazards".

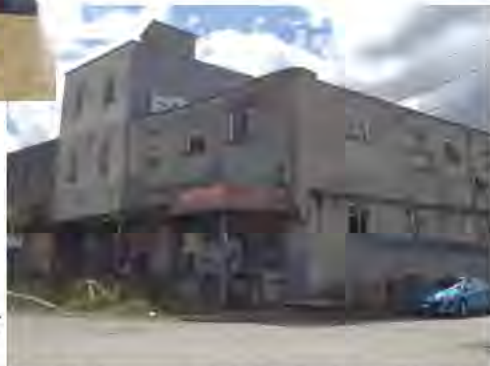
NORTH WEST ELEVATION

Drawings were not made available during the review. Structure appeared to be wood post and beam framing with wood framed exterior walls. Exterior stucco cladding is in poor condition and represents a potential fall hazard. Unreinforced brick chimney, and unbraced north canopy structure also represent potential fall hazards. Pounding is a potential hazard from adjacent building (on East side).

Based on our screening we recommend a detailed, quantitative assessment of the seismic force resisting elements. The review thus far has indicated potential concerns with respect to the adequacy of the base structure seismic force resisting system.

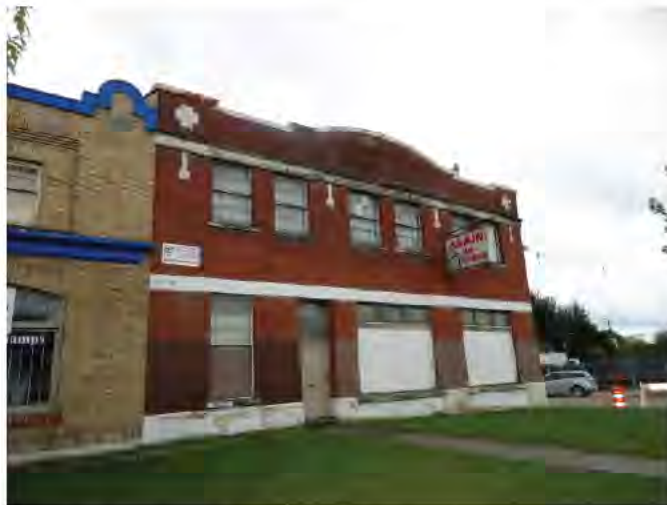
NORTH ELEVATION

Drawings were not made available during the review. Structure appeared to be wood post and beam interior framing with wood decking, and unreinforced masonry block walls. Concrete cornice and window sills are spalling and are potential fall hazards. Brick parapets and chimney are also potential fall hazards. Pounding is a potential hazard from adjacent building (on East side).

Based on our screening we recommend a detailed, quantitative assessment of the seismic force resisting elements. The review thus far has indicated potential concerns with respect to the adequacy of the base structure seismic force resisting system.

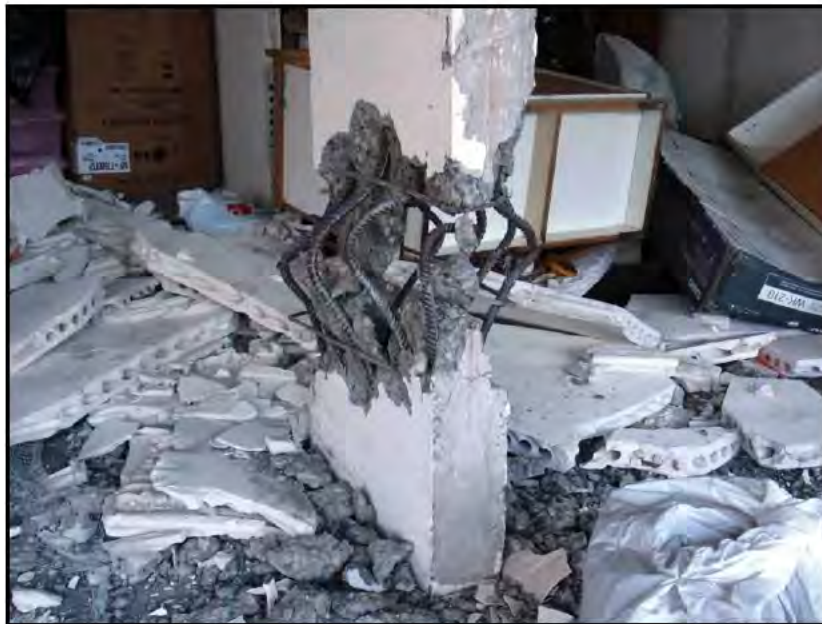
Figure 4.3 Results of poorly confined concrete and widely spaced column ties, resulting in column failure in a building in Chile 2010.

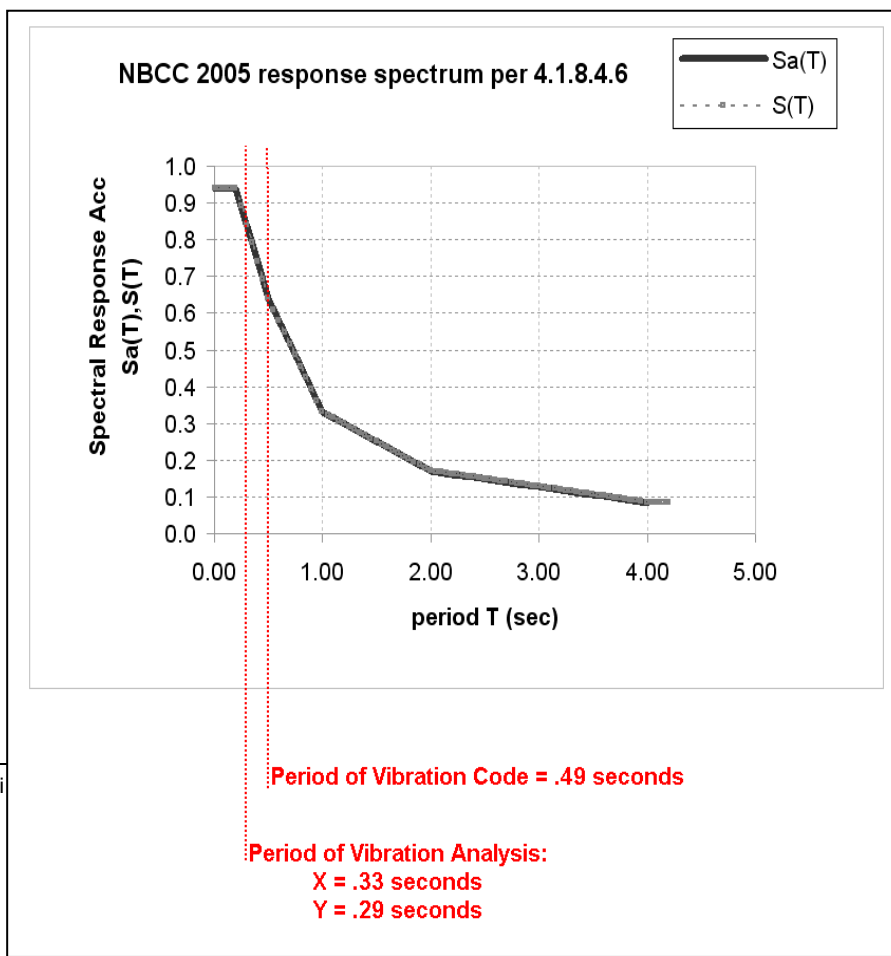
Figure 4.10 East Wing analysis of natural period of vibration indicates a very stiff building which will attract high seismic forces. The Code approximation for a building of this height and size would indicate a .49 second period whereas our more detailed analysis indicates .29 and .33 seconds in the two principle axis. While both these methods are approximate, they clearly indicate a stiff building scenario.
