File No. 04-1000-20-2016-233

Re: Request for Access to Records under the Freedom of Information and Protection of Privacy Act (the "Act")

Storm and Sewer Service records for 450 E 47th Ave Vancouver (other possible address is 451 E 48th Ave, 400 Block of E 48th Ave) for the private and city property regarding this property. I would like the records of all work completed including but not limited to camera scope, root cutting, auguring, drain cleaning. Reference number is 7849460.

Work Slip

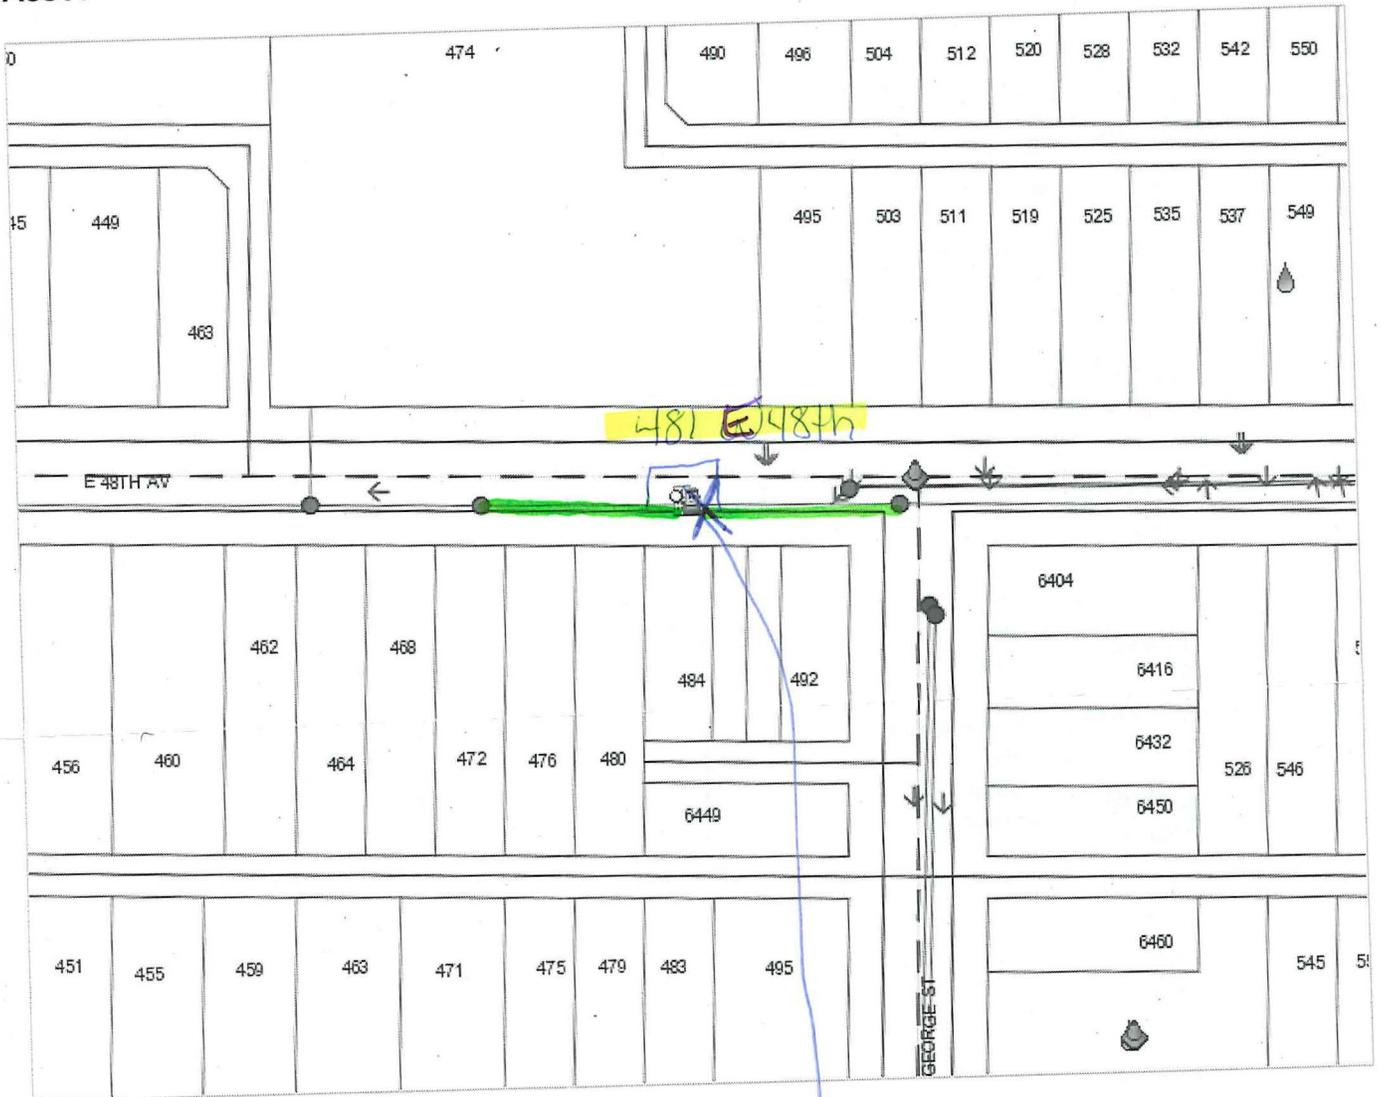
Safety & Asset Notes:						
PM Schedule	Last Completed Work Order					
Crew Comments						
Found Heavy Roots 2.4m East of Downstream M.H. Need a Sucker Track to Root cut main W/O EES753149 emailed to Dispatch <div style="text-align: right;">

*2.4m from
downstream
MH Heavy Roots*

SAP Charge #	Address & Location: 400 - 499 E 48TH AV (from EES751063 CCTV inspection found heavy roots 2.4m east of downstream m/h needs to be root cut (250 Comb))			Responsible		
EES753149				Sewer Operations		
Work Order #	Work Order Activity			Created Date		
753149	Maintenance(400 E 48 RC main)			Jun 11, 2016		
Group Project #	Problem	Sub Activity	Assigned To	Crew ID		
		SROOTCUT	ALBANO LUIS	28		
Work Order Comments:						
Reference #1				Billable?		
Reference #2				N		
Service Request #:						
Contact Name		Contact Phone	Contact Type			
Asset Type	Asset ID #	B.U.N	Status	Asset Area	Map # (Facet)	District
Main (C)	401780		IN_SERVICE	CBD08	Q21	5
Asset Details: C 250 Millimeter VC 60.66 Meters 4.81% [60.66 - 250 C VC 4.81% 1930]:						
Safety & Asset Notes:						
PM Schedule	Last Completed Work Order					
	Jun 07, 2016; 751063; Maintenance (400 E 48 CCTV Main)					
Crew Comments						
<p>Root cut Main 250 comb 60.66m. All ok!</p> <p style="text-align: right;">Job Completed

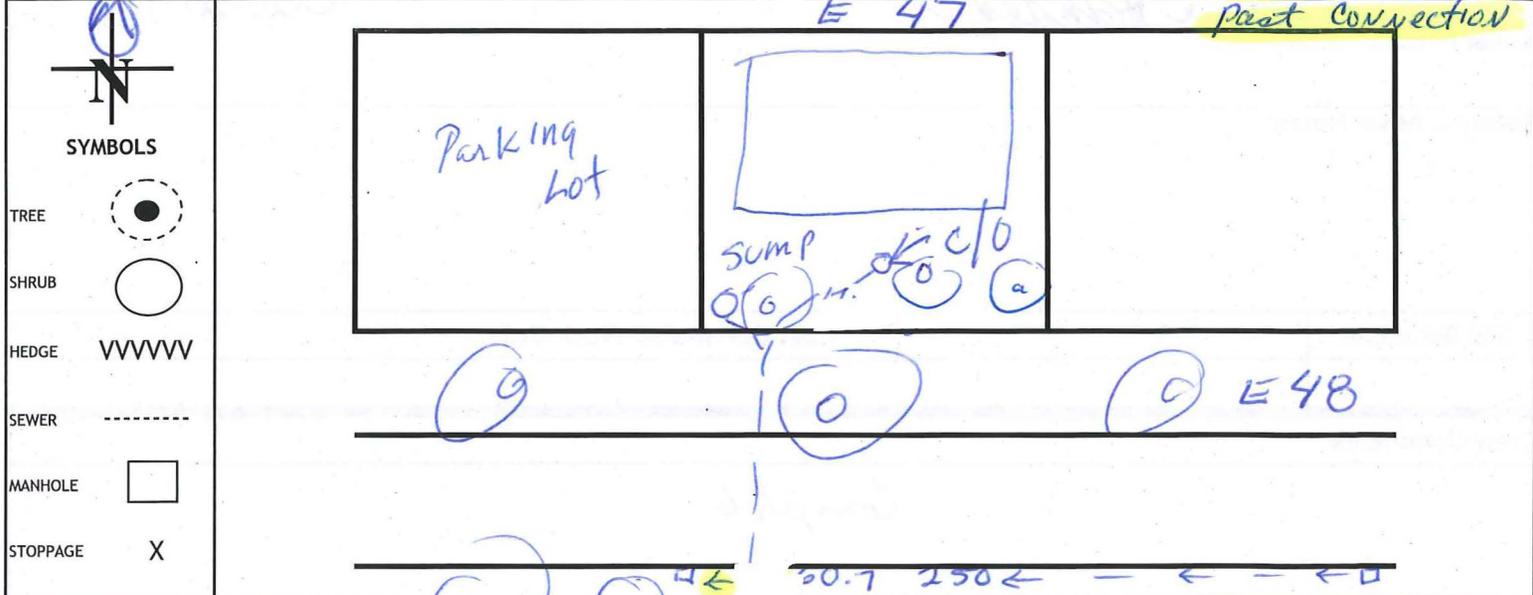
CONNECTION:	DEPTH AT PL: 0 M	PL IS 0 M FROM C/O	DEPTH AT MAIN: _____ M	WYE MEASUREMENTS:
PRIVATE SIDE RELAID: <input type="checkbox"/>	PL OFFSET: _____ M	N S E W of N S E W	DEPTH AT HOUSE: _____ M	_____ M
CITY SIDE RELAID: <input type="checkbox"/>				FROM DOWNSTREAM MH _____ M
COMMENTS: Complete was flowing				
Contractor was saying 3 floods recently with damage No visible problems abs - private side + PVC city side - tried to tv down sewer main couldn't reach 10m in main to man hole 74.4 we need to have camera crew to tv main from man hole 74.4 to East Past Connections may need to be root cut as a problem may exist				
SUPT COMMENTS: Created W/O 1235 751063 for CCTV - Report to T. Shaw				
				SUPT SIGNATURE:

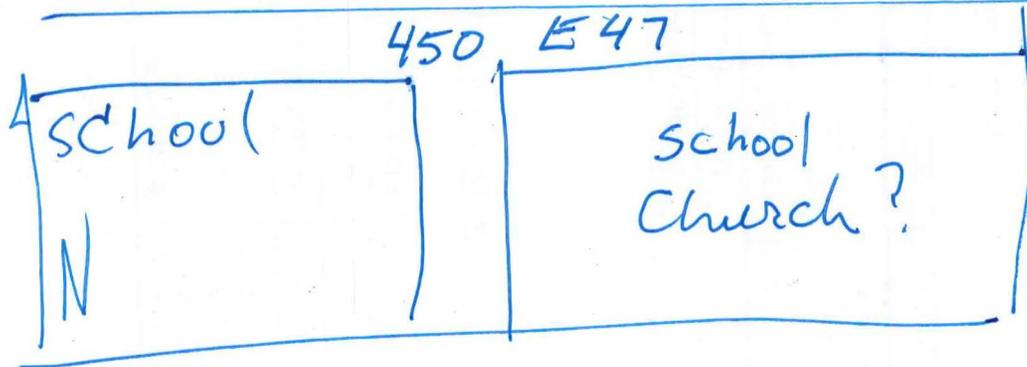
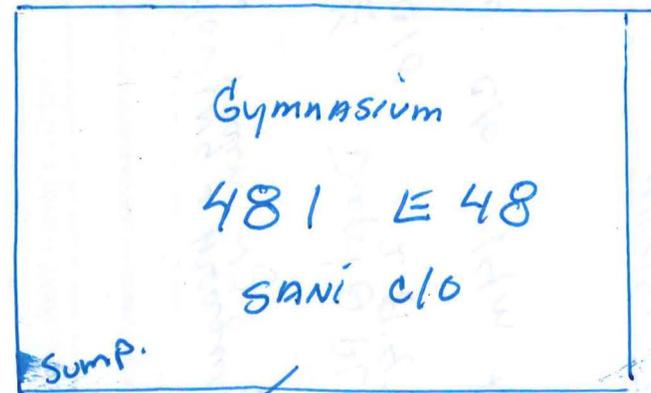
SAP Charge #	Address & Location: 450 E 47TH AV			Responsible		
EES755112	ST ANDREWS SCHOO (No Asset in Hansen - Crew to CCTV connection for condition of pipe and location of root infiltration. Work from o/s sump - connection goes to E 48th 250 Comb Main)			Sewer Operations		
Work Order #	Work Order Activity			Created Date		
755112	Maintenance(450 E 47 - SCCTV SVCLN)			Jun 15, 2016		
Group Project #	Problem	Sub Activity	Assigned To	Crew ID		
		SCCTV	ALBANO LUIS	S_Crew23		
Work Order Comments:						
<i>Please trace. for hansen.</i>						
Reference #1				Billable?		
Reference #2				N		
Service Request #:	R968810 (Sewage Backup/Flooding)					
Contact Name		Contact Phone	Contact Type			
McVeigh Mechanical		604-808-4218	Other			
Asset Type	Asset ID #	B.U.N	Status	Asset Area	Map # (Facet)	District
Asset Details:						
Safety & Asset Notes:						
PM Schedule	Last Completed Work Order					
Crew Comments						
<i>Depth @ Wye 2.74 .. flowing + measured to E48 from wye 6.5 Building Gymnasium</i> <i>Bm. 55 m 481 E 48</i> <i>PL offset 34.1 W of E</i> <i>PL 15 14 m from C/O</i> <i>Measurements from Sani C/O 14m to P/L</i> <i>Storm Sump is 10' Deep.</i> <i>Depth @ PL 2.84 sani</i>
