Records related to Murray Hotel at 1119 Hornby Street:

1. Structural report prepared by Structural Solutions, dated January 4, 2019; and
2. City of Vancouver Annual Inspection Report prepared on January 16, 2019 by Inspector Nick Liu.

Project No.: K1397

Re: Structural Review of 1119 Hornby St., Vancouver, BC

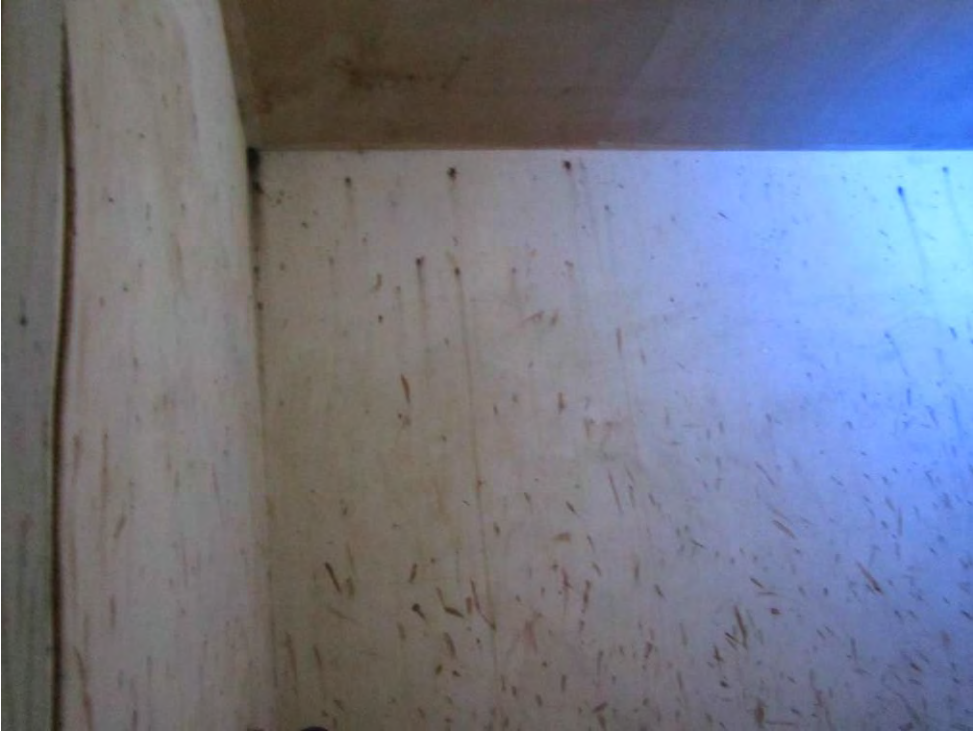
<p>Violation 30 Photo 35</p>

29. Room 107 - No self-closer - Section 15.1 (1) - Photo 33
30. Room 107 - Ceiling and walls exhibiting blood stains and filth - Section 21.10 (a) - Photo 34 & 35

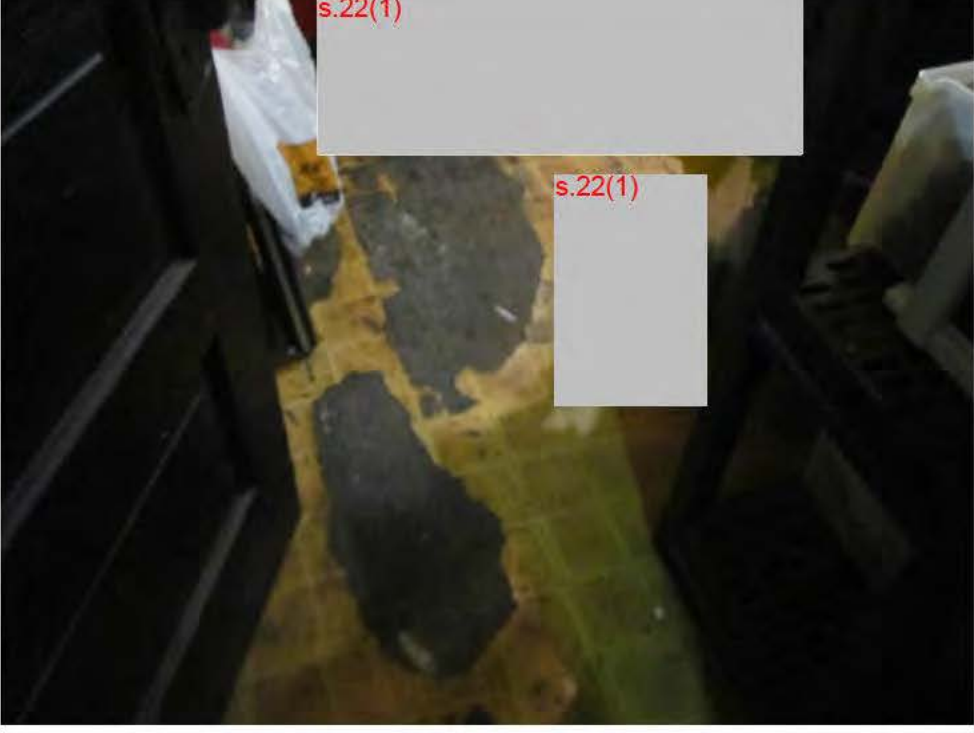
<p>Violation 41 Photo 46</p>
Photo	Description

40. Room 118 - Ceiling insufficiently repaired (Plywood patch) - Section 14.1 (2) - Photo 45
41. Room 118 - Vinyl flooring was peeled - 13.1 (1) - Photo 46

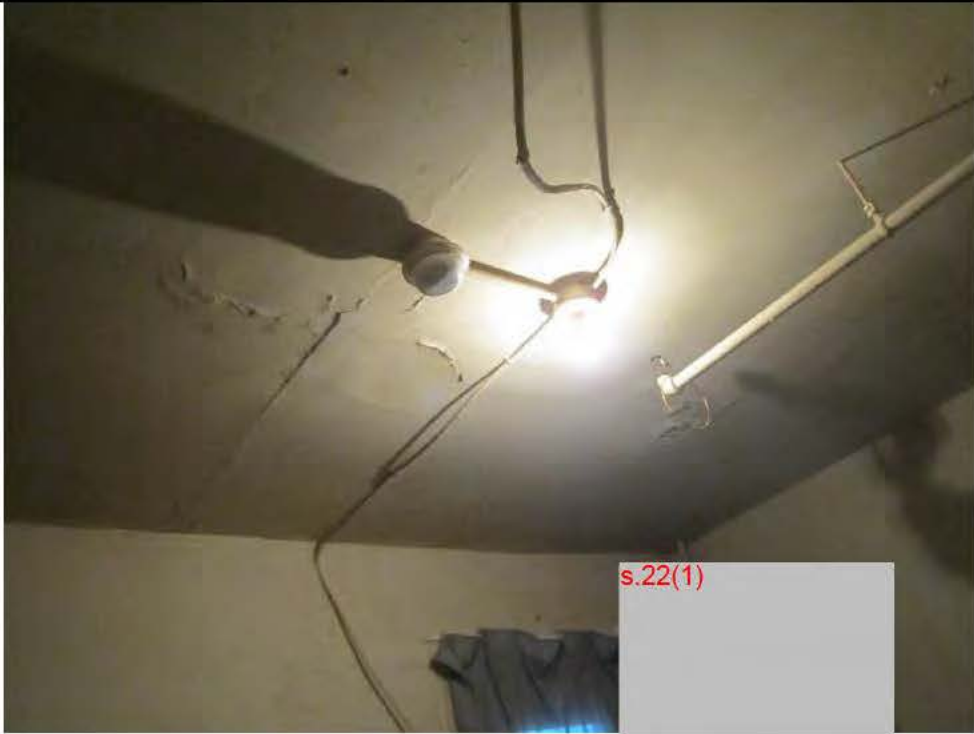
<p>Violation 44 Photo 49</p>

43. Room 122 - No self-closer - Section 15.1 (1) - Photo 48
44. Room 122 - Ceiling is cracked - Section 14.1 (2) - Photo 49
45. Room 122 - Ceiling insufficiently repaired (Plywood patchwork) - Section 14.1 (2) - Photo 50

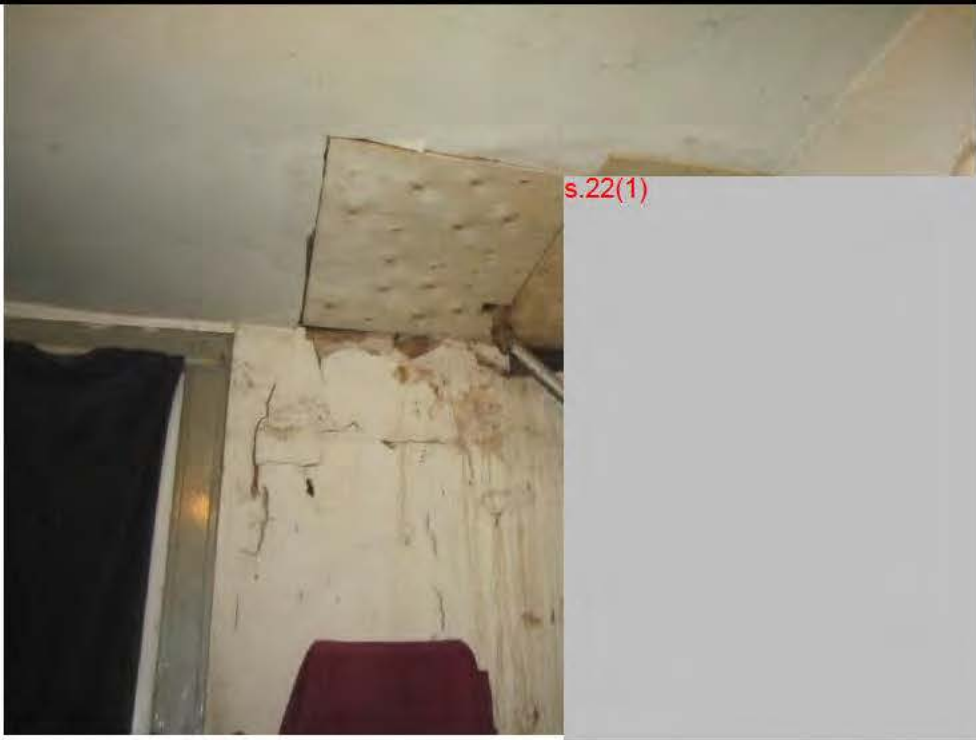
<p>Violation 46 & 47 Photo 51</p>

46. Room 123 - Ceiling insufficiently repaired (Plywood patchwork) - Section 14.1 (2) - Photo 51
47. Room 123 - Wall is cracked with dark stains - Section 14.1 (2) - Photo 51

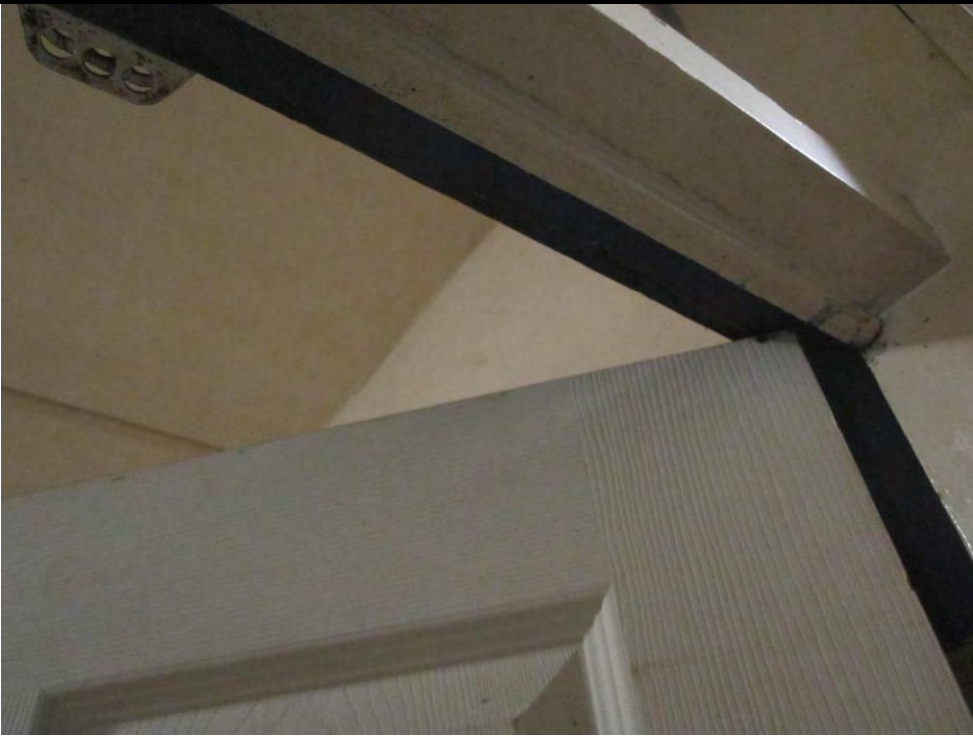
Violation 65 Photo 67

63. Room 210A - Ceiling tile missing - Section 21.10 (d) - Photo 65
64. Room 210A - No electrical outlet plate - 19.1 (b) - Photo 66
65. Room 212 - No self-closer - Section 15.1 (1) - Photo 67

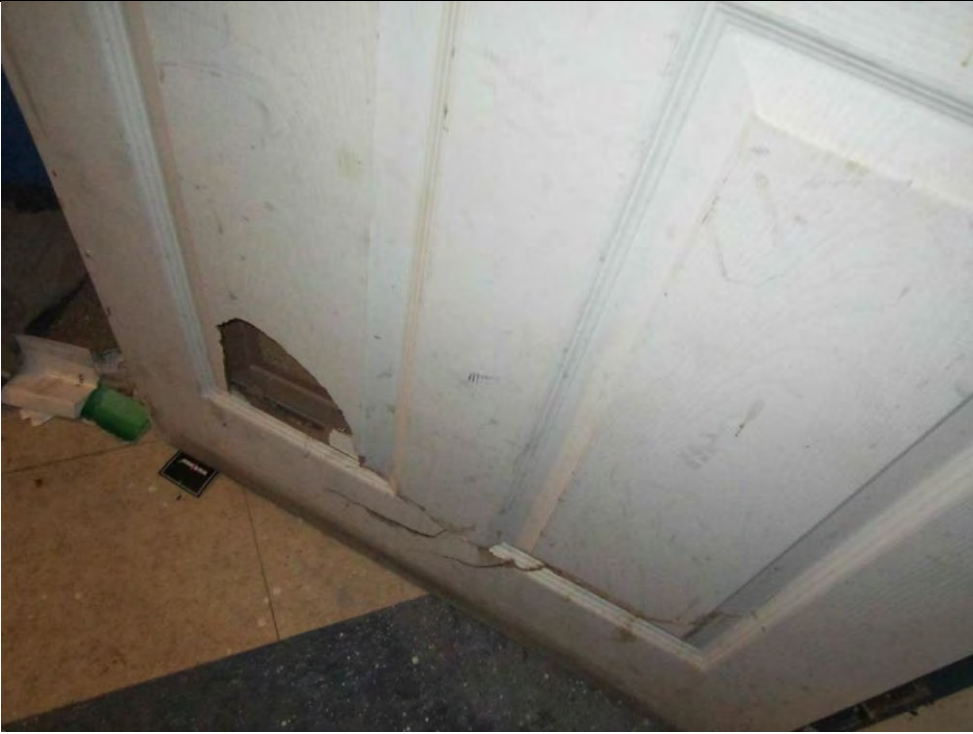
Violation 66 Photo 68
Photo	Description

66. Room 212 - Breach in the door approx. 6"x6" - Section 14.1 (2) - Photo 68
67. Room 212 - Sink in considerable deterioration exhibiting stains and filth - Section 21.10 (a) -

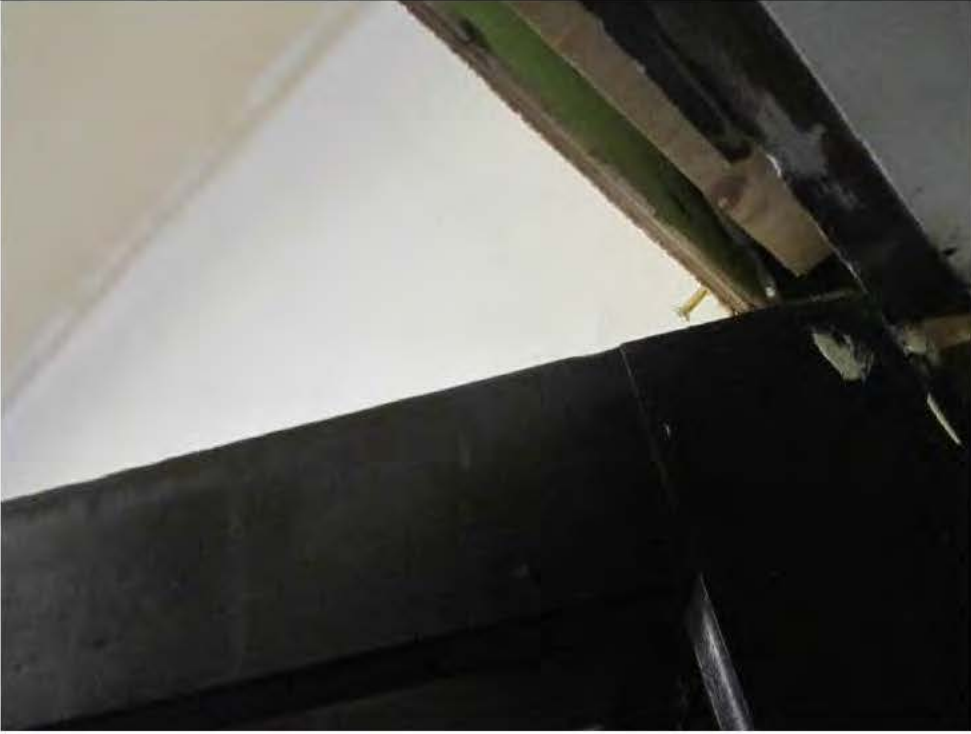
<p>Violation 71 Photo 73</p>

- 70. Room 214 - Plumbing leak under the sink - Section 21.10 (f) - Photo 72
- 71. Room 215 - No self-closer - Section 15.1 (1) - Photo 73
- 72. Room 215 - Floor missing several tiles - Section 13.1 (1) - Photo 74
