Re: **Request for Access to Records under the Freedom of Information and Protection of Privacy Act (the "Act")**

Record of maintenance of the water/sewer pipe on Hull Street (located under the street), from November 24, 2017 to March 7, 2019.

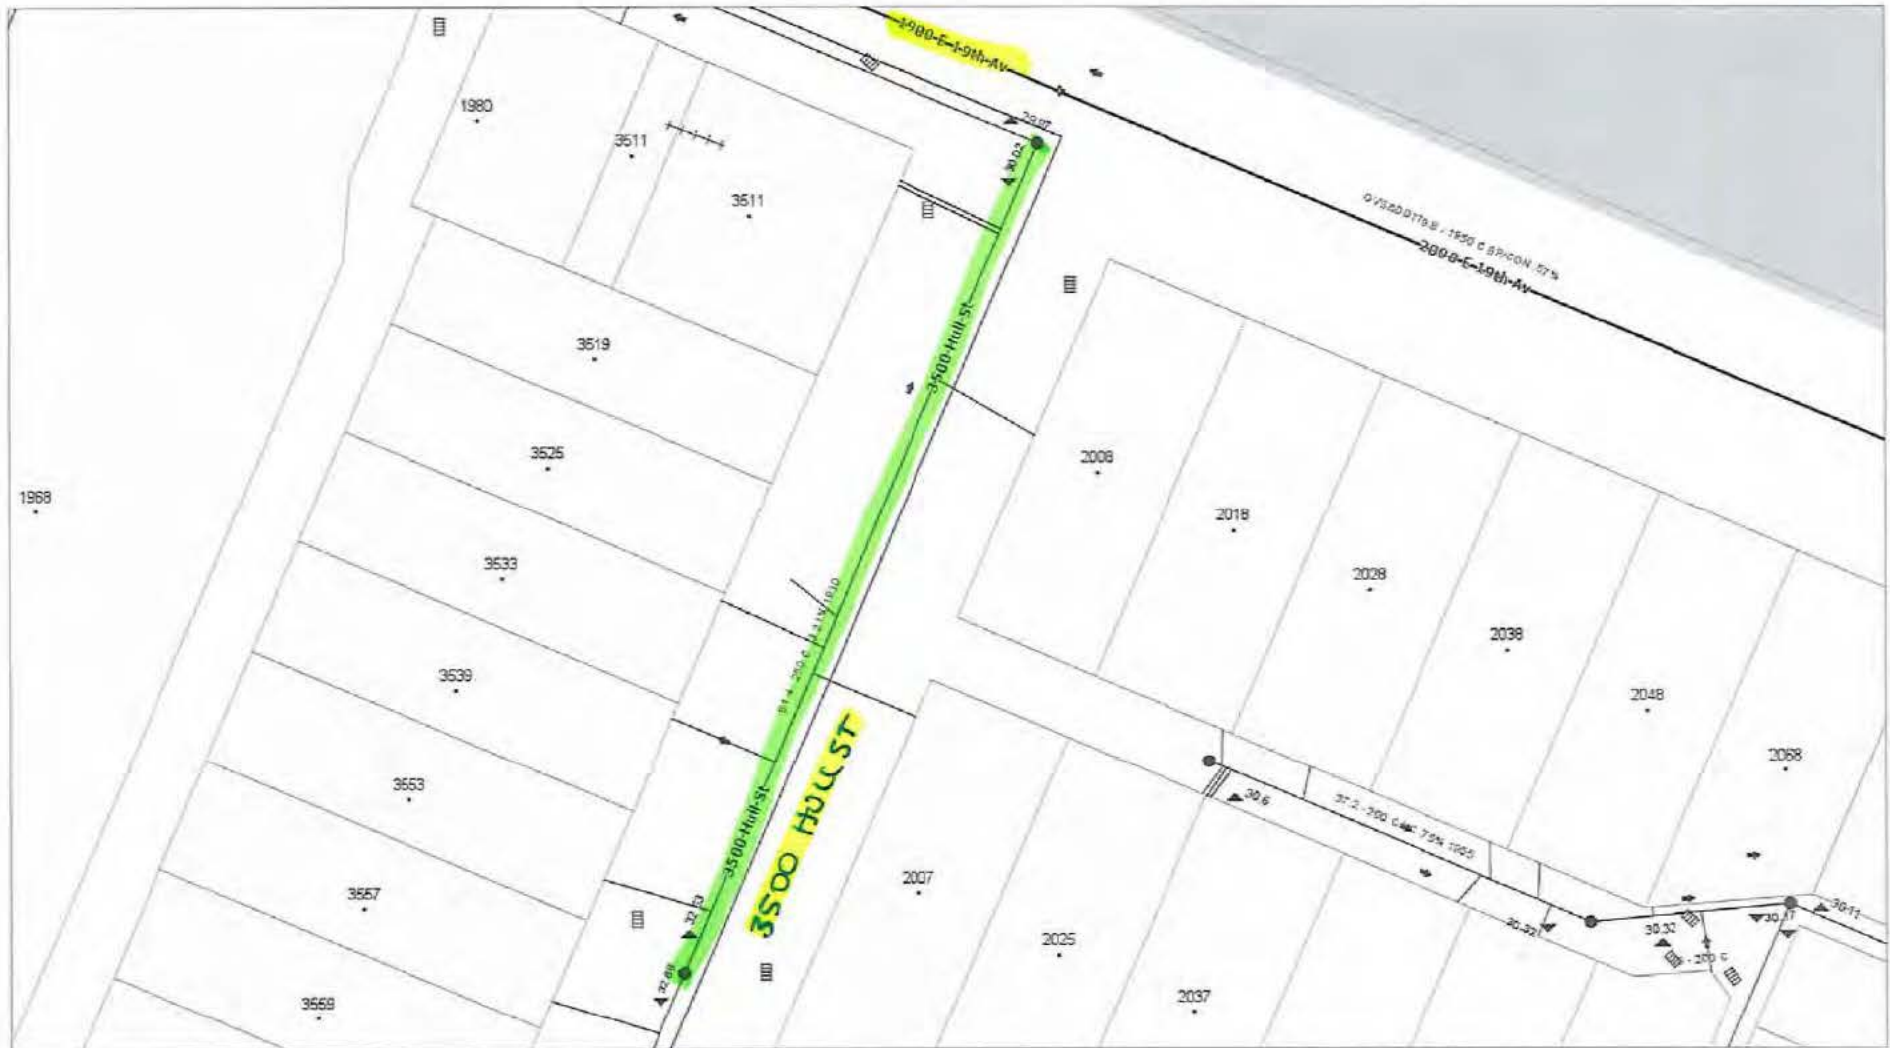
CCTV

81.83m 250mm →

6 MONTHS	25411	2017/11/24; 924407; Maintenance (3500 Blk of Hull St Plg Mn)				
Crew Comments						
CCTVed 200mm combined completed (Pic on back) <div style="text-align: right;">

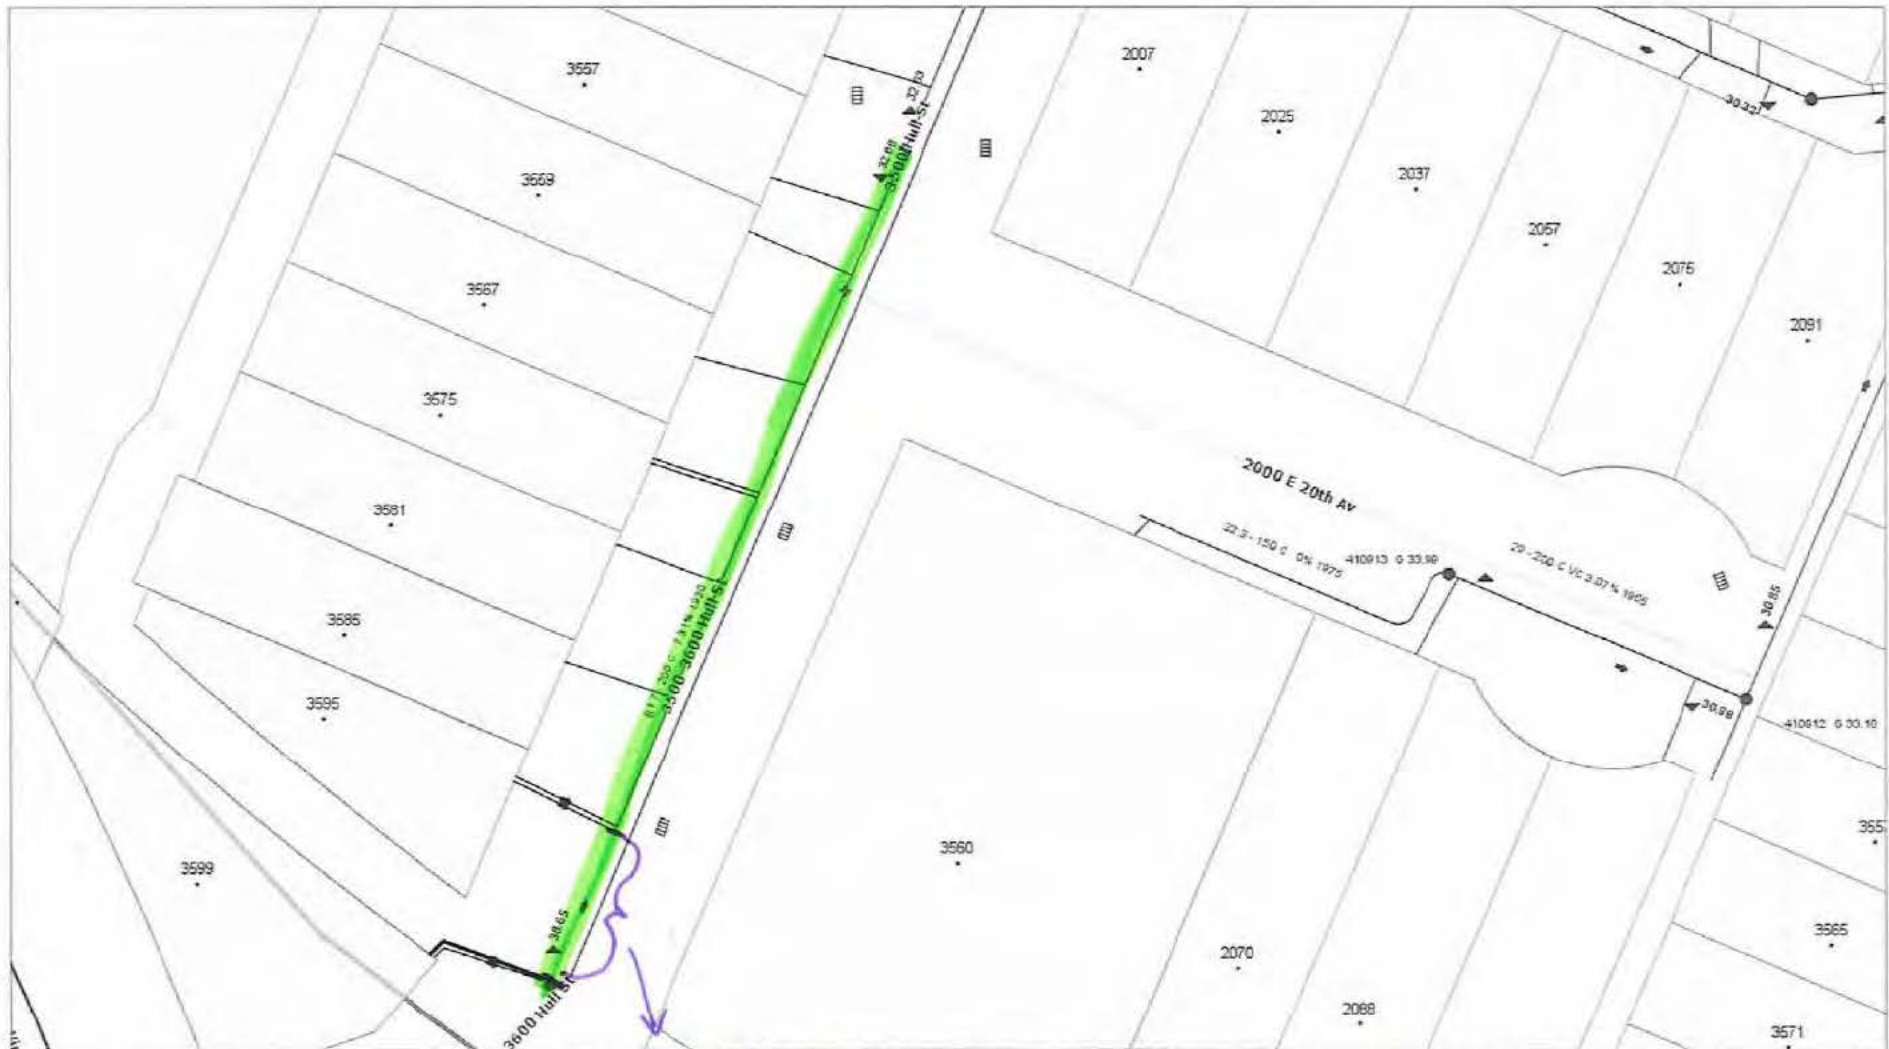
IN VANMAP THIS SECTION OF MAIN DOESN'T SHOW
HANSEN SHOWS SECTION E MH AT CONN FROM 3599 Hull
Please confirm which is correct.
