1000 Beach Ave, Vancouver, BC

Arborist Report | December 2018

Re: 1000 Beach, 988-1018 Beach Avenue, Vancouver
Tree Review

TP-2019-00001

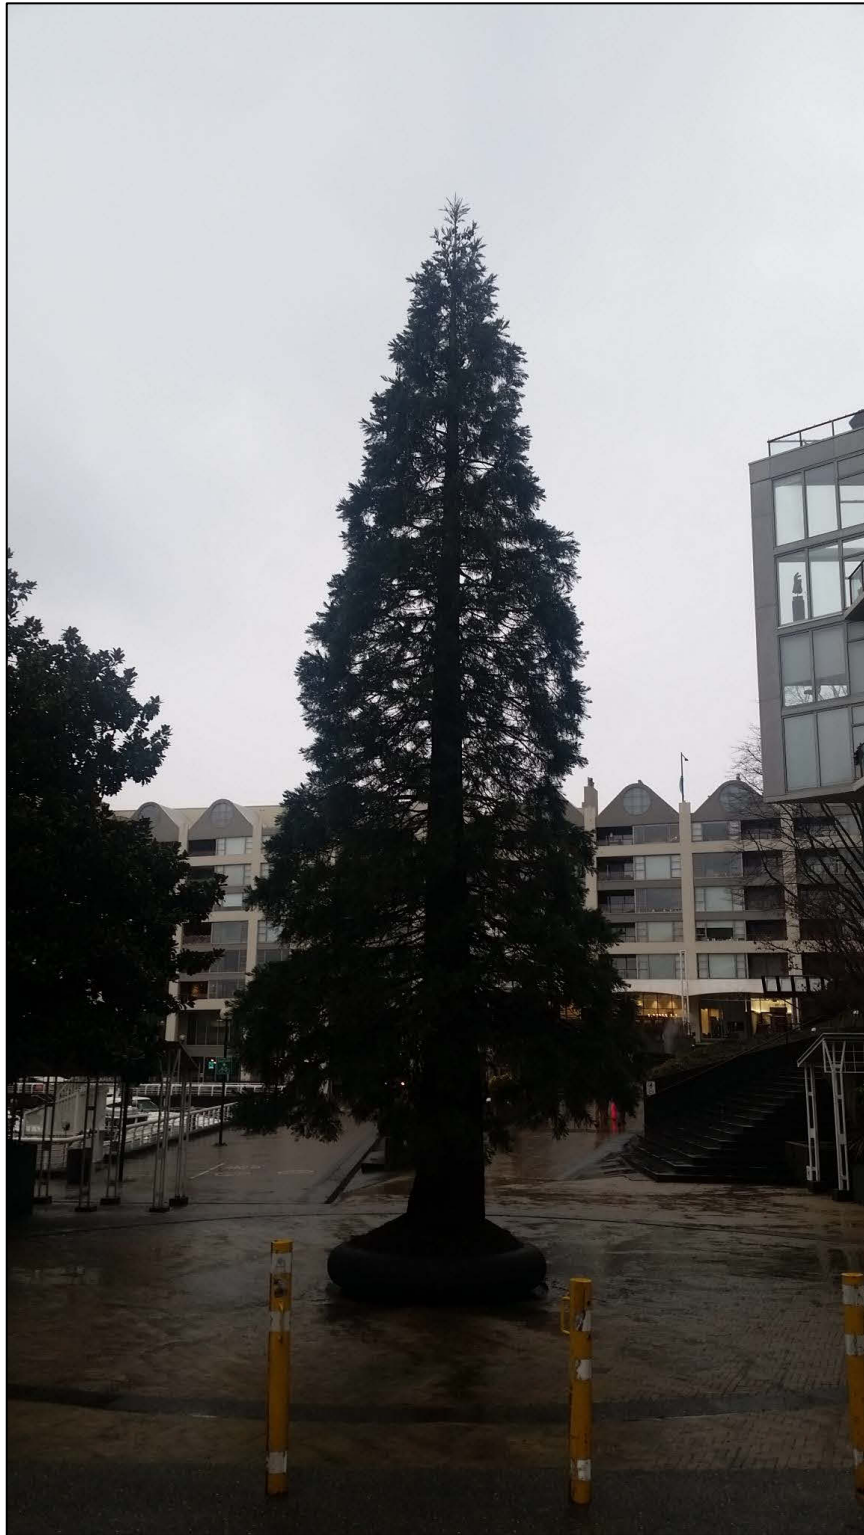
Observations: The tree is growing within a raised planter on top of a paved area. There is little room for further stem or root growth within the planter and there is evidence of roots having lifted the surrounding pavement. The tree has been implicated in damage to the roof of the parking structure which is directly beneath the tree.

The Giant Sequoia viewed from Seabreeze Walk.

Recommendation: Remove the tree before further property damage is caused.

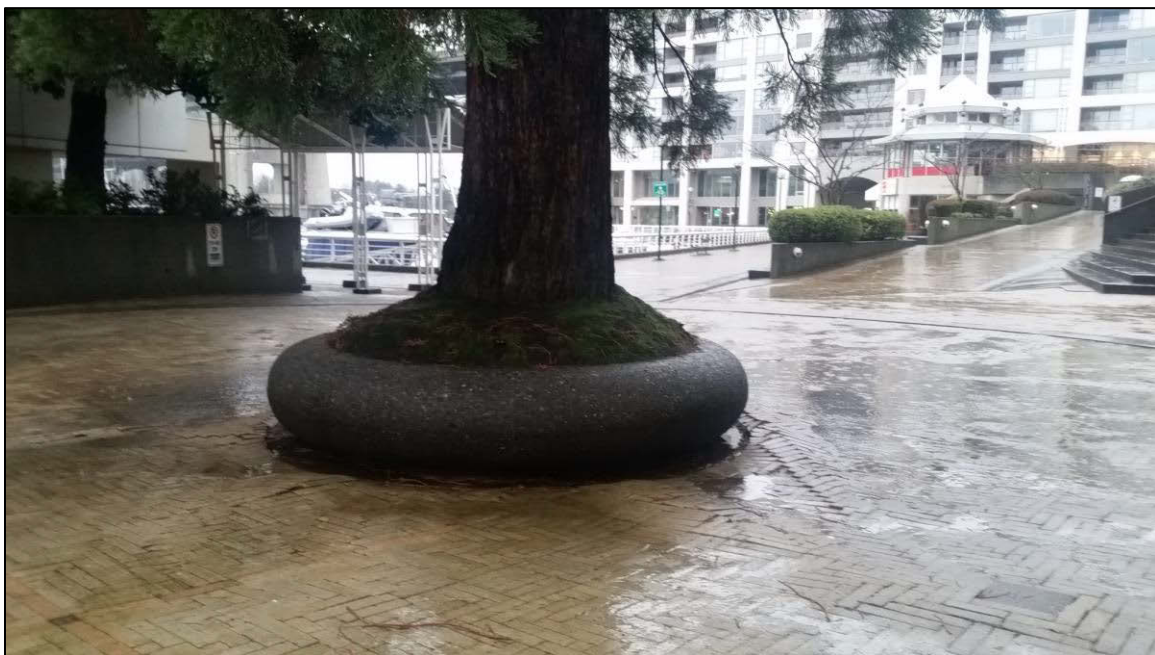
Discussion: The tree is poorly situated for its present size and future growth potential. Given the likely increase in size and root zone requirements over the coming years it is anticipated that future property damage will be caused. There are no pruning options that will control the size of the tree and/or its root growth.

The base of the tree showing the limited space within the planter and the root damage to the paved areas.

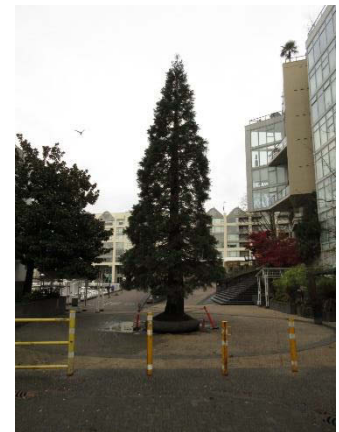
There is a large tree in a planter above the parking garage roof slab, which is located within an easement on the south end of the property (between 988 Beach Avenue and 990 Beach Avenue). This easement is part of a City of Vancouver cycling path.

Photo 1: Large tree in cycling path.

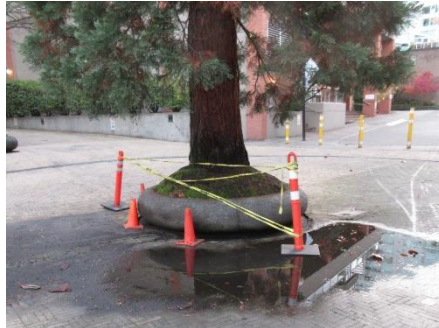
Further, the uneven pavers have caused poor surface drainage around the planter, resulting in large areas of ponding. Over the winter months, ponding water will freeze and create a slipping hazard for pedestrians and cyclists.

Photo 2: Ponding water around planter.

Based on our visual review, we recommend the tree be removed and any damage to the garage roof slab waterproofing be repaired. Once the tree is removed, the pavers should be reinstalled to produce an even surface.

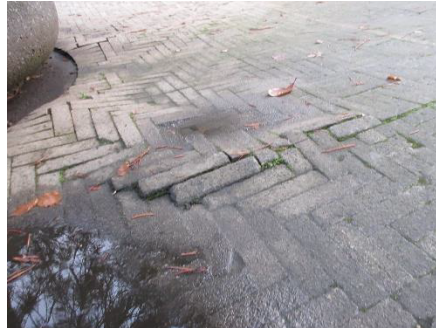
The tree appears to be oversized for the existing concrete planter. Tree roots have extended outside of the planter, lifting surrounding concrete pavers. The uneven paver surface created by the tree roots presents a tripping hazard for pedestrians and cyclists.

Photo 3: Uneven pavers around planter.

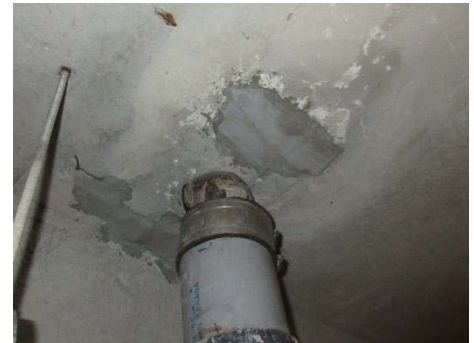
Below the tree, there is evidence of past leakage (i.e., efflorescence staining) through the garage roof slab. It appears that roots have caused damage to the waterproofing that is causing water leakage. Continued leakage will result in corrosion of the embedded reinforcing steel, concrete damage, and potential property damage or safety risk if spalled concrete falls on vehicles or pedestrians below. Reinforcing steel corrosion and further structural deterioration is particularly of concern at this location because ownership will need to use de-icing salts to manage the risk of falls around ponding areas (i.e., de-icing salts facilitate reinforcing corrosion). We recommend the garage roof slab waterproofing be repaired, which will require removal of the tree above.

Photo 4: Efflorescence and previous concrete repairs below the tree.
