Site Address:
1296 Wolfe Avenue, Vancouver, BC

HAZARDOUS MATERIALS ASSESSMENT

PRELIMINARY INVESTIGATION – ASBESTOS AND LEAD

MOULD ASSESSMENT

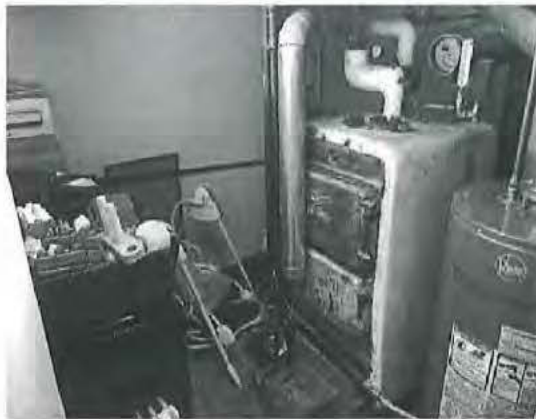
Two (2) boiler pipe insulation samples collected from the residence were found to contain Chrysotile asbestos. At the time of the inspection, the boiler pipe insulation and boiler jacket were in **poor condition with a high risk of disturbance**, posing a **high risk of exposure**. Boiler pipe and boiler jacket insulation produces **friable** dust upon disturbance. **This material is in poor condition and has subsequently contaminated contents of the mechanical/boiler room.**

Mechanical/Boiler Room - Overview

The asbestos-containing boiler pipe insulation and boiler jacket must be professionally repaired and encapsulated or abated and disposed of using the appropriate safe work procedures. Abatement of this material, as well as any contaminated contents requires **high risk work procedures** (dependant on the scope of work and procedures), and disposal specifications that comply with WorkSafeBC Regulations, the Environmental Management Act, and Hazardous Waste Regulation. Air monitoring is recommended.

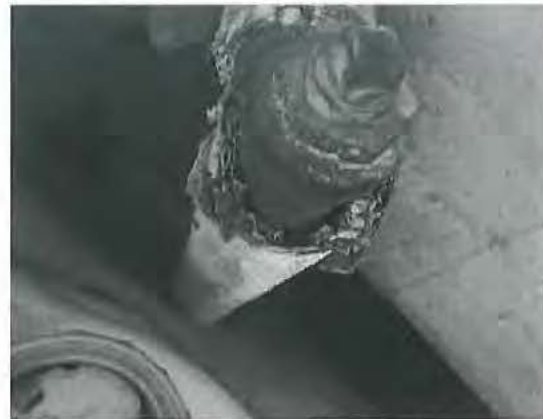
Mechanical/Boiler Room - Asbestos Pipe Insulation

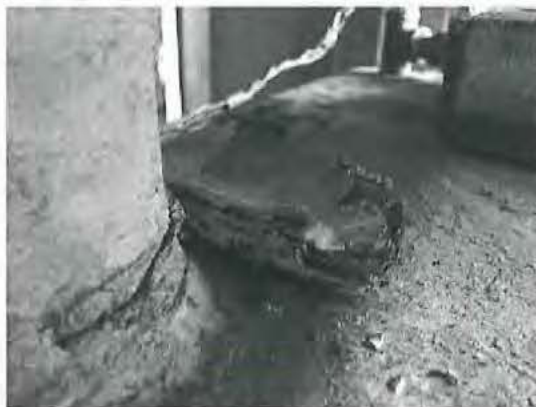
Mechanical/Boiler Room - Asbestos Pipe Insulation Debris

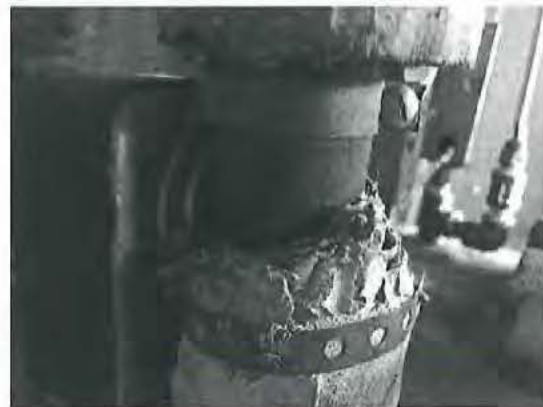
Mechanical/Boiler Room - Asbestos Pipe Insulation

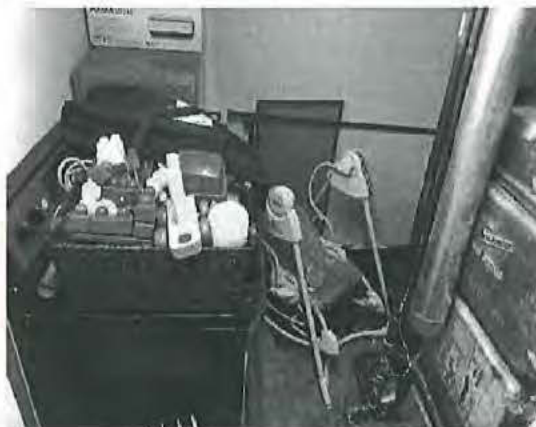
All boiler pipe and boiler jacket insulation throughout the residence must be presumed asbestos-containing. In the mechanical/boiler room, the following must be treated as asbestos-containing/contaminated:

- All dust and debris
- All remaining porous materials:
 - Kids toys and infant swing
 - Storage boxes
 - Portable Vacuum
 - Central Vacuum collection bin and filter

Mechanical/Boiler Room - Contaminated Contents

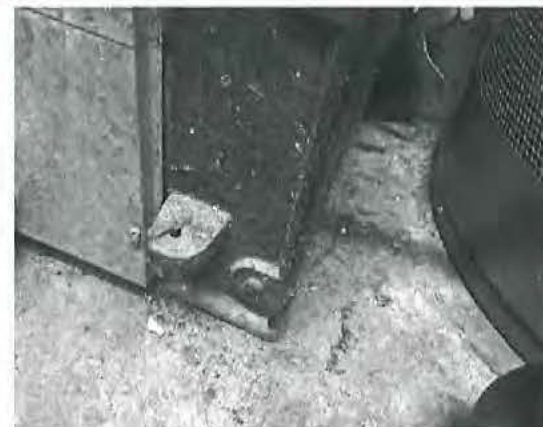
Mechanical/Boiler Room - Dust/Debris

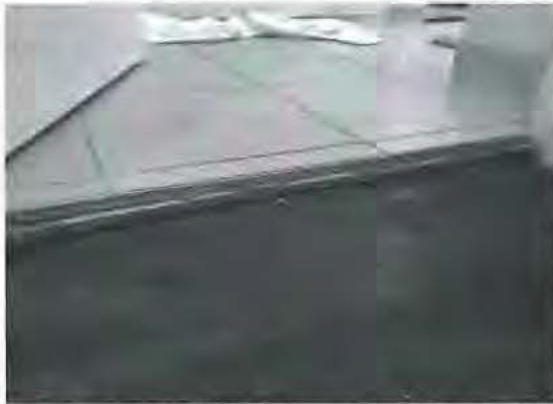
One (1) layer of vinyl floor tile in one (1) multi-layer vinyl flooring sample collected from the residence was found to contain Chrysotile asbestos. At the time of the inspection, the vinyl floor tile

was in **good condition** with a **low risk of disturbance**, posing a **low risk of exposure**. VFT is non-friable.

Upper Washroom – VFT Under Ceramic Tiles and Plywood

If this material will be removed, it must be abated and disposed of using the appropriate safe work procedures. Abatement of this material requires **moderate risk work procedures** and disposal specifications that comply with WorkSafeBC Regulations, the Environmental Management Act, and Hazardous Waste Regulation. Air monitoring is recommended.

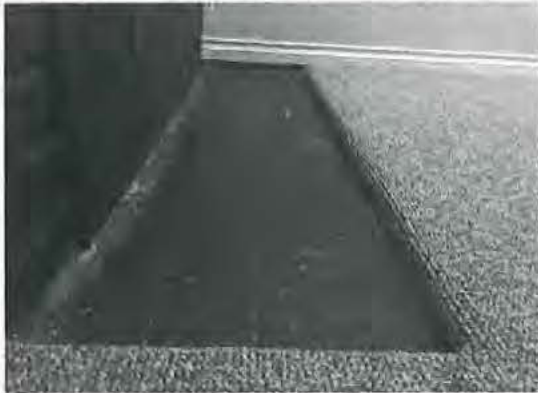
Paint	Lead Conc. (mg/kg)	Substrate	Location	Condition	Disturbance Risk	Exposure Risk
Black Multi-layer	9,570	Ceramic Tile	Lower West Bedroom Fireplace Hearth	Poor	High	High
White Multi-layer	97	Wood	Upper-Level Main Washroom Door	Good	Low	Low

Lower Level West Bedroom – Fireplace Hearth – Lead Paint

The paint on the lower west bedroom fireplace hearth is in **poor condition**. It must be abated and disposed of, or encapsulated, following lead safe work procedures that comply with WorkSafeBC Regulations, the Environmental Management Act, and the Hazardous Waste Regulation.

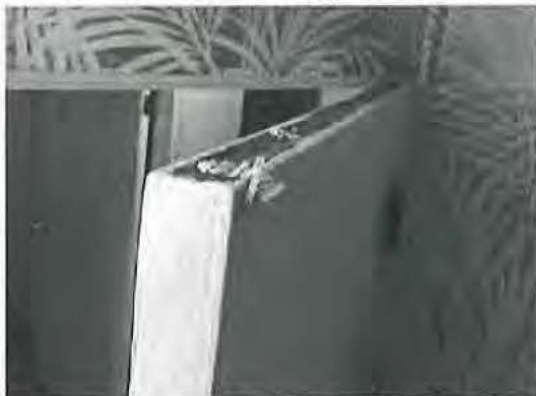
Upper-Level Main Washroom – Wood Door – Lead Paint

If the paint on the wood doors is to be disturbed, it must be abated and disposed of following lead safe work procedures that comply with WorkSafeBC Regulations, the Environmental Management Act, and the Hazardous Waste Regulation.

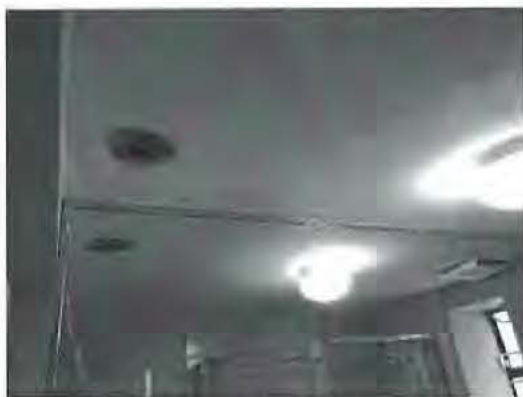
A visual assessment was conducted to identify the presence of mould on building materials within the residence. Mould was observed on the walls and ceilings for the upper washroom, as well as the ceiling of the lower washroom. **Please see recommendations 3.1.**

Lower Washroom - Mould on Drywall Ceiling

It is recommended that a professional restoration/abatement company be retained to remediate and remove all mould-impacted materials in the upper and lower washrooms. All affected materials must be removed and disposed of using appropriate remediation procedures and in accordance with WorkSafeBC and BC Ministry of Environment.

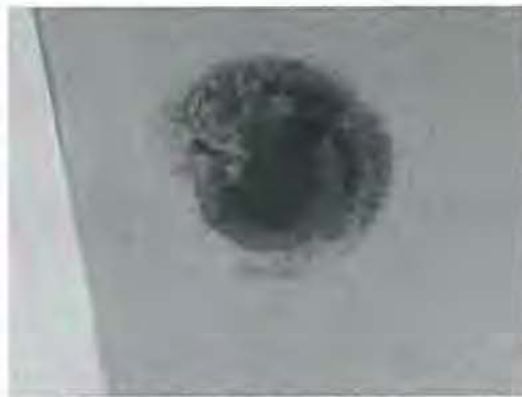
Lower Washroom - Mould on Drywall Ceiling

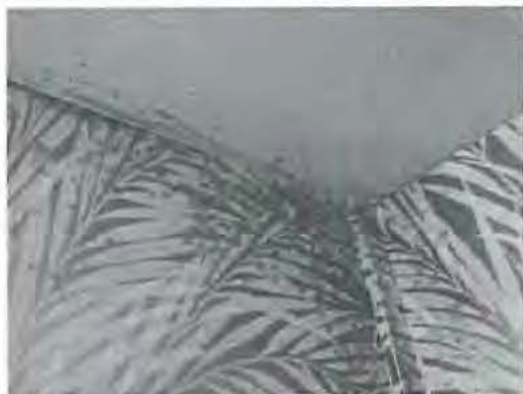
Upper Washroom - Mould on Drywall Ceiling and Wallpaper

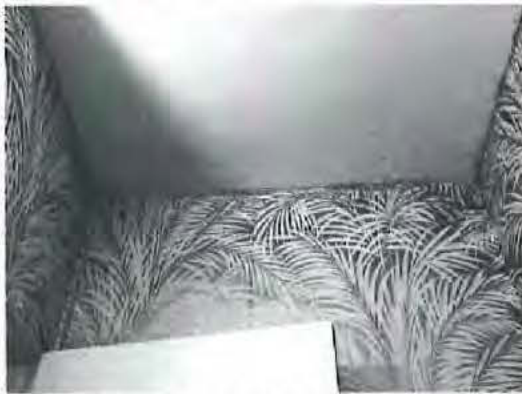
Upper Washroom - Mould on Drywall Ceiling and Wallpaper

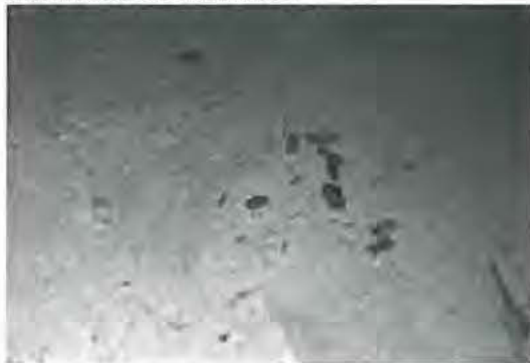
Rodent droppings were observed in the attic space and a strong smell of rodent urine was present in the lower level mechanical room. **Please see recommendations 3.2.**

Attic – Rodent Droppings

It is recommended that a professional restoration/abatement company be retained to remediate and remove all rodent dropping impacted materials in the attic space and mechanical/boiler room. All affected materials must be removed and disposed of using appropriate remediation procedures and in accordance with WorkSafeBC and BC Ministry of Environment.

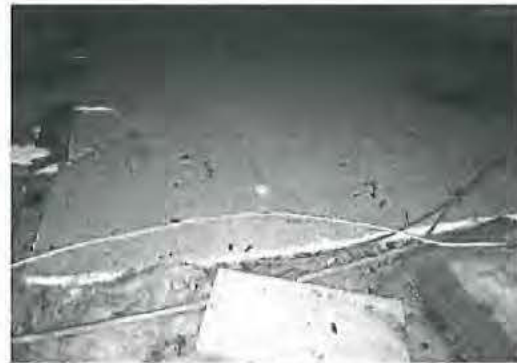
Attic – Rodent Droppings and tripped rodent trap
