RE: Request for Access to Records under the Freedom of Information and Protection of Privacy Act (the "Act")

1. **Records of inspections of 439 Powell Street, between January 1, 2011 and March 31, 2015, including annual SRO inspections, and inspections related to enforcement actions or structural integrity;**

1. what caused the brick veneer on the east elevation of the building located at 439 Powell Street to separate and fall into the building located at 451 Powell Street on or around July 24th, 2013; and,
2. what is the condition of the brick veneer and wood frame exterior wall on the west elevation of 439 Powell Street.

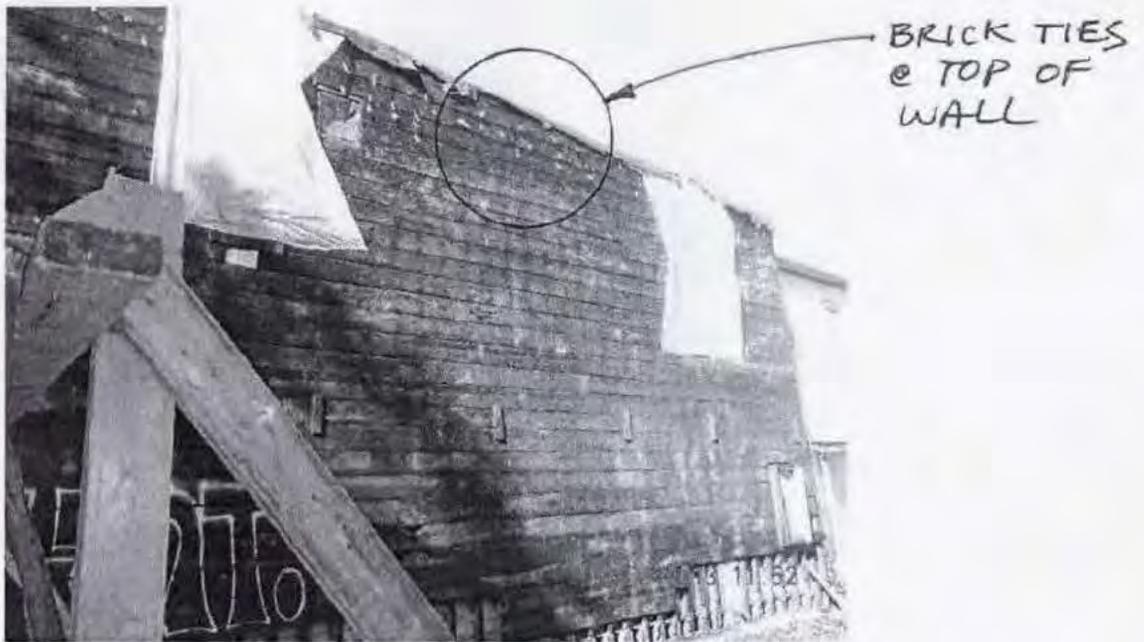
The more recently installed metal brick ties at the top of the wall are a significantly stronger brick veneer connection detail compared to the remainder of the brick veneer which was connected to the wall with nails from the wood siding cast into the brick veneer mortar joints. At some point, the nails supporting the brick veneer were pulled out of the mortar joints and the brick veneer became unsupported over a certain height. The shear weight of the section of brick veneer above this unsupported height of brick veneer caused the unsupported brick veneer to buckle outward and towards the south building located at 451 Powell Street. Once the brick veneer buckled outward, there was no support for the brick veneer above so the veneer collapsed into the south building located at 451 Powell Street.

Figure 6: Brick Ties for Anchoring Brick Veneer to East Wall of 439 Powell Street, Vancouver

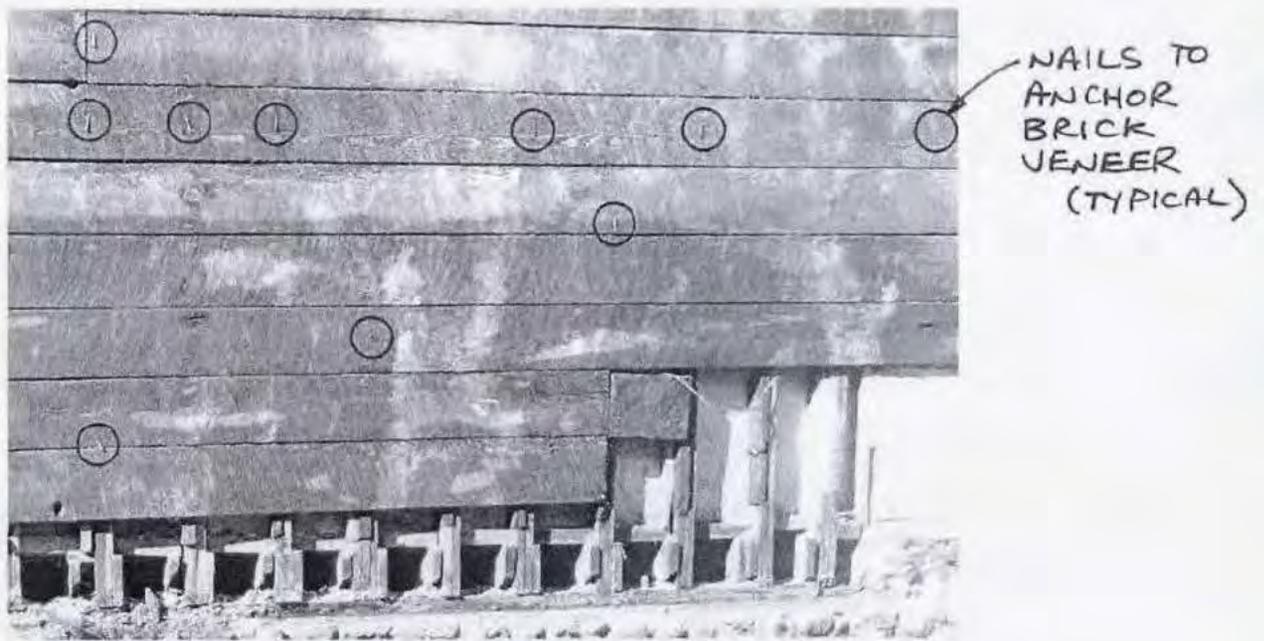
I believe that as the wood frame wall dropped due to wood rot, the wall transferred this downward movement and resulting force to the brick veneer through the nails and bricks ties fastened to the wood siding. The brick veneer resisted the downward movement and resultant force from the wood frame wall because the brick veneer was supported on the stone and mortar foundation wall.

Figure 7: Nails for Anchoring Brick Veneer to East Wall of 439 Powell Street, Vancouver

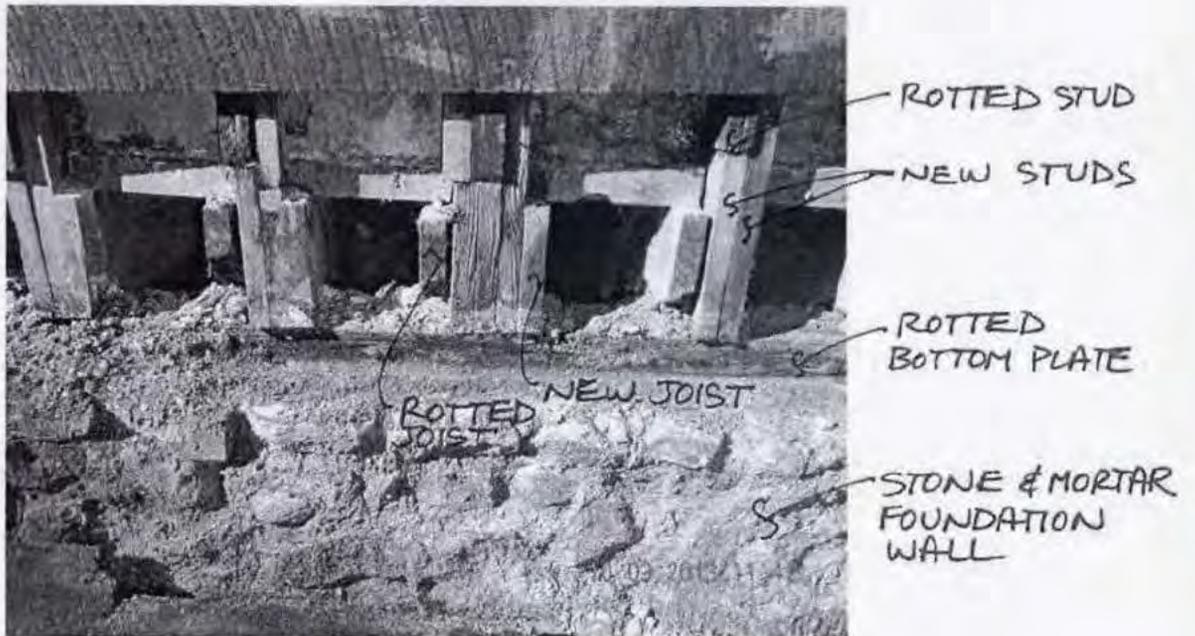
In my opinion, the east wood frame wall of the south building located at 439 Powell Street has sustained significant structural damage over a long period of time from wood rot that has been caused by water ingress. It appears that water has penetrated the brick veneer on the east elevation of the south building from either wind-driven rain through the brick veneer or by failure of the cap flashing at the top of the wall. Water has been running down the wall studs and horizontal siding behind the brick veneer and stopping at the bottom wall plate below the main floor level. At this point, the water has been rotting the bottom plate, the wood floor joists and the wall studs.

Figure 8: Base of East Wall of 439 Powell Street, Vancouver

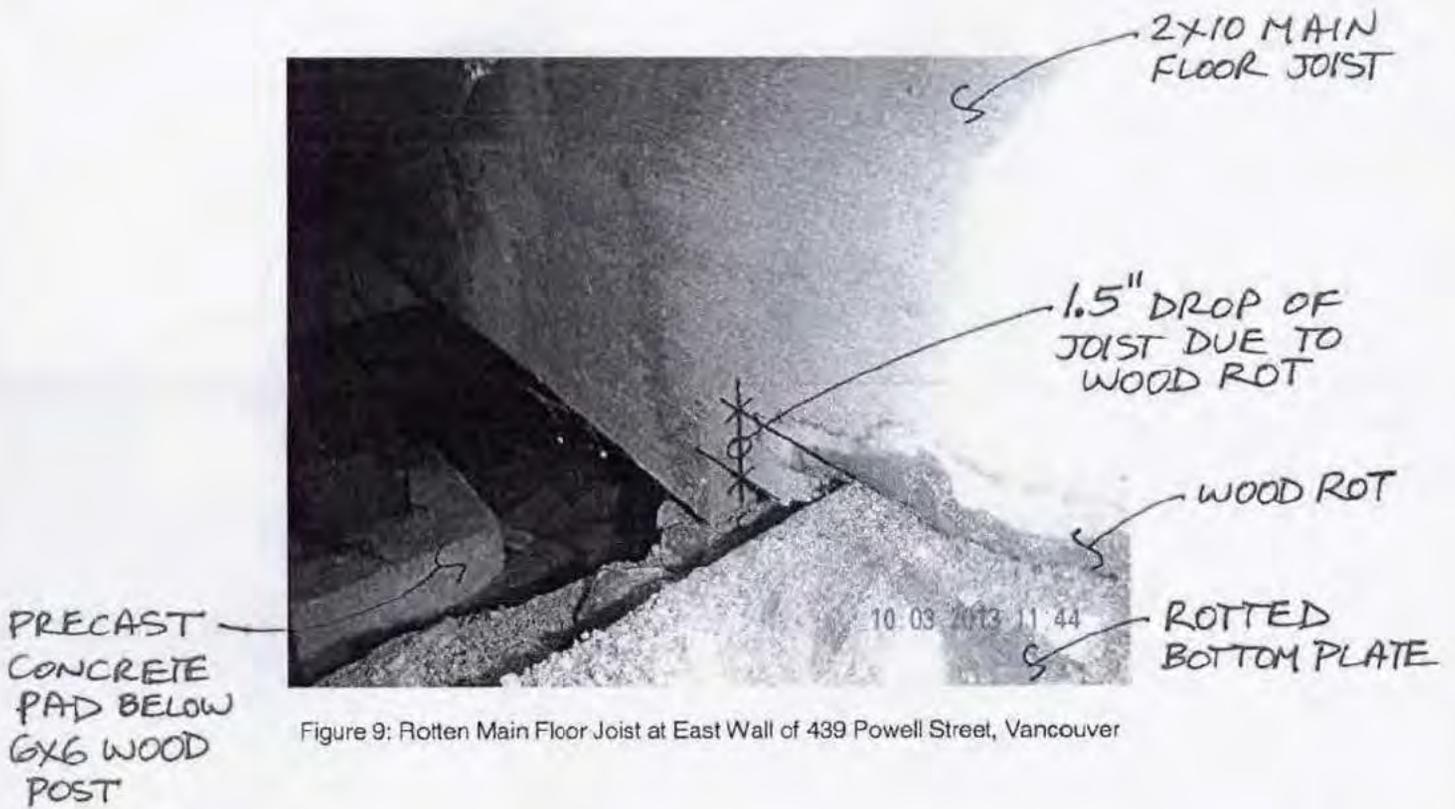
It appears that at some point in the past, the bottom section of the rotten wall studs of the south building had been replaced with new stud sections 'sistered' onto the existing studs and new main floor joists had been installed adjacent to the existing rotten floor joists (see Figure 8). The existing main floor wood joists had dropped as much as 1.5 inches relative to the wall plate due to the wood rot (see Figure 9). The wall bottom plate appeared to be a 3x6 wood plate and a car key was easily pushed horizontally the full depth into the wood at several locations over the entire length of the wood plate (see Figure 10). It was also clear to the naked eye that the rotten wood bottom plate had been compressed by the load applied by the wall studs.

Figure 9: Rotten Main Floor Joist at East Wall of 439 Powell Street, Vancouver

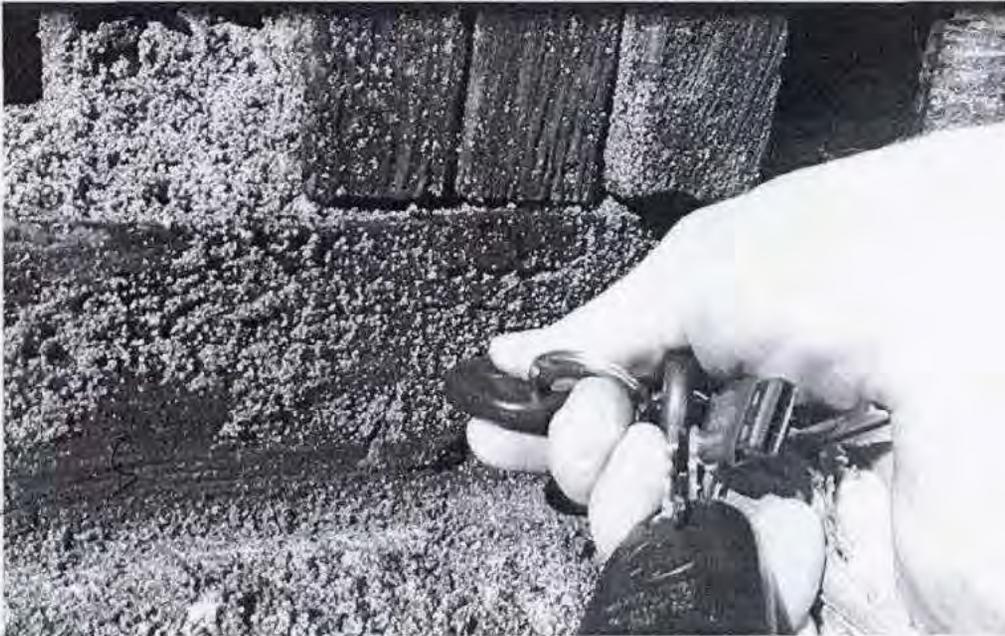
In my opinion, the failure of the brick veneer failure on the east elevation of the south building located at 439 Powell Street was caused by wood rot of the wood frame wall behind the brick veneer. The brick veneer was supported on the stone and mortar foundation wall and attached with nails and brick ties to the wood frame wall behind. As has been shown, the wall studs, main floor joists and wood bottom plate below the main floor level have been rotting for some time and the main floor structure had dropped as much as 1.5 inches.

ROTTED
BOTTOM
PLATE

Figure 10: Key Fully Inserted into Wood Plate of East Wall of 439 Powell Street, Vancouver

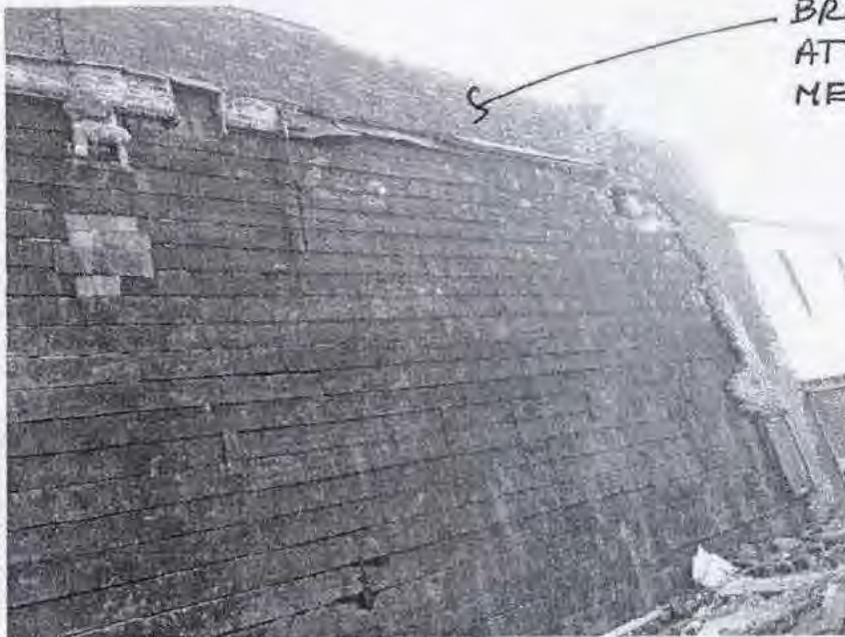
BRICK VENEER
ATTACHED WITH
METAL TIES

Figure 11: Brick Veneer Intact on East Elevation of 439 Powell Street, Vancouver

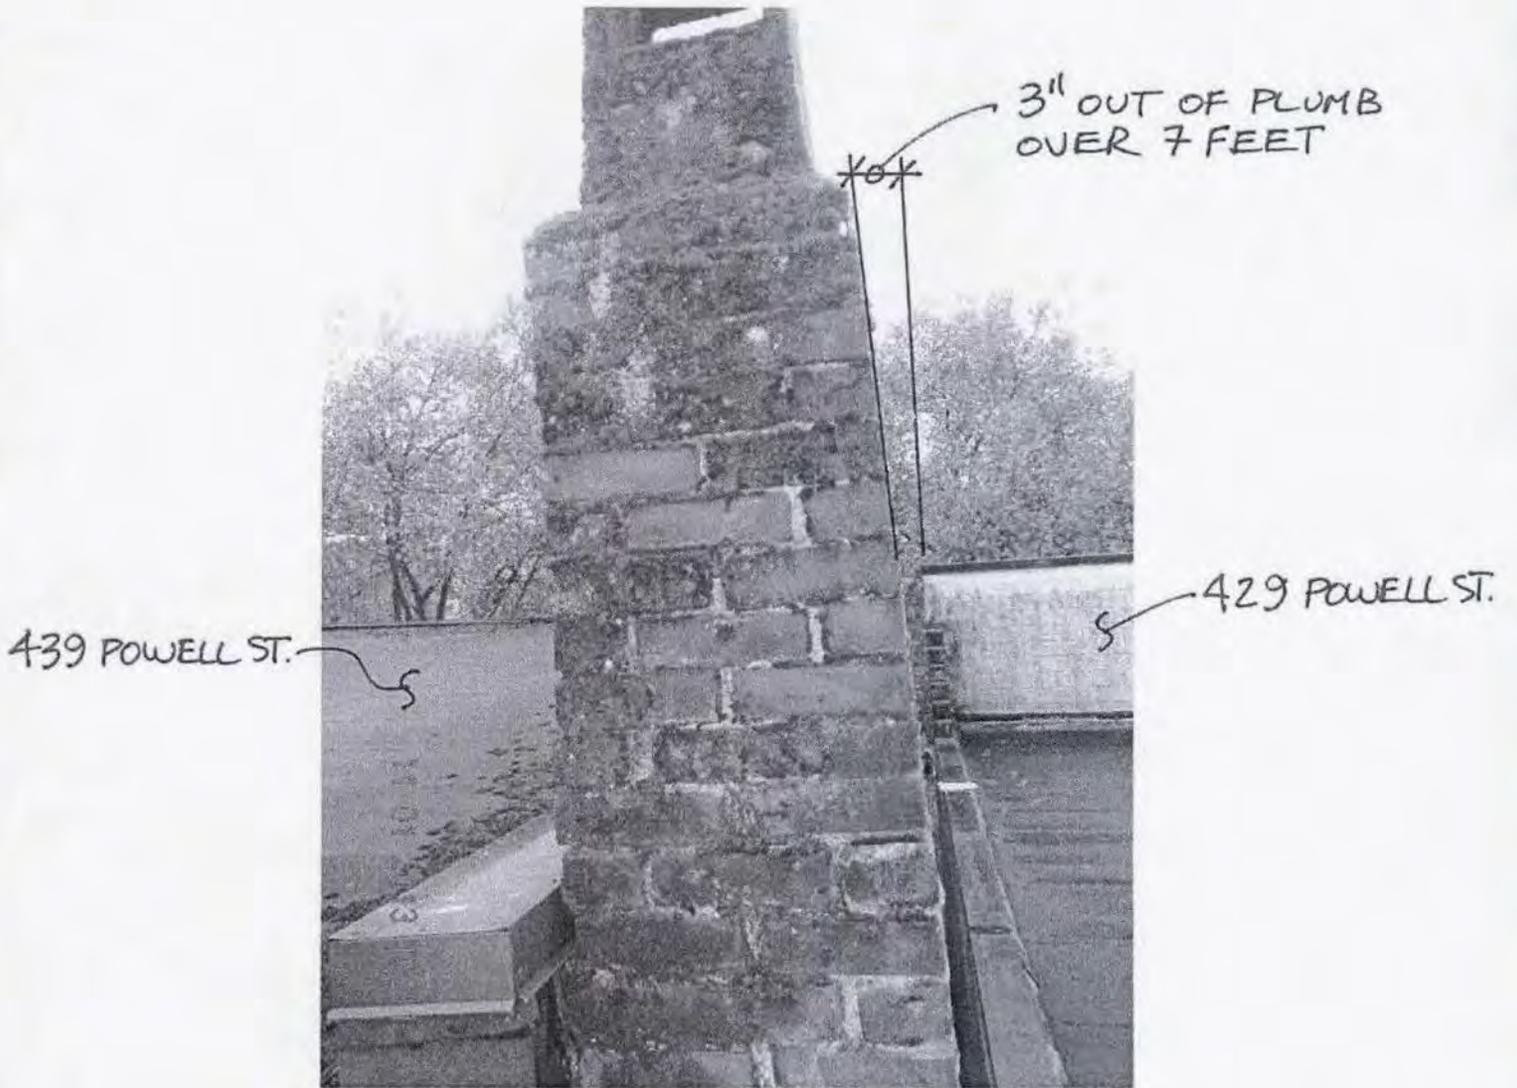
Figure 12: Chimney Out of Plumb on West Elevation of 439 Powell Street, Vancouver

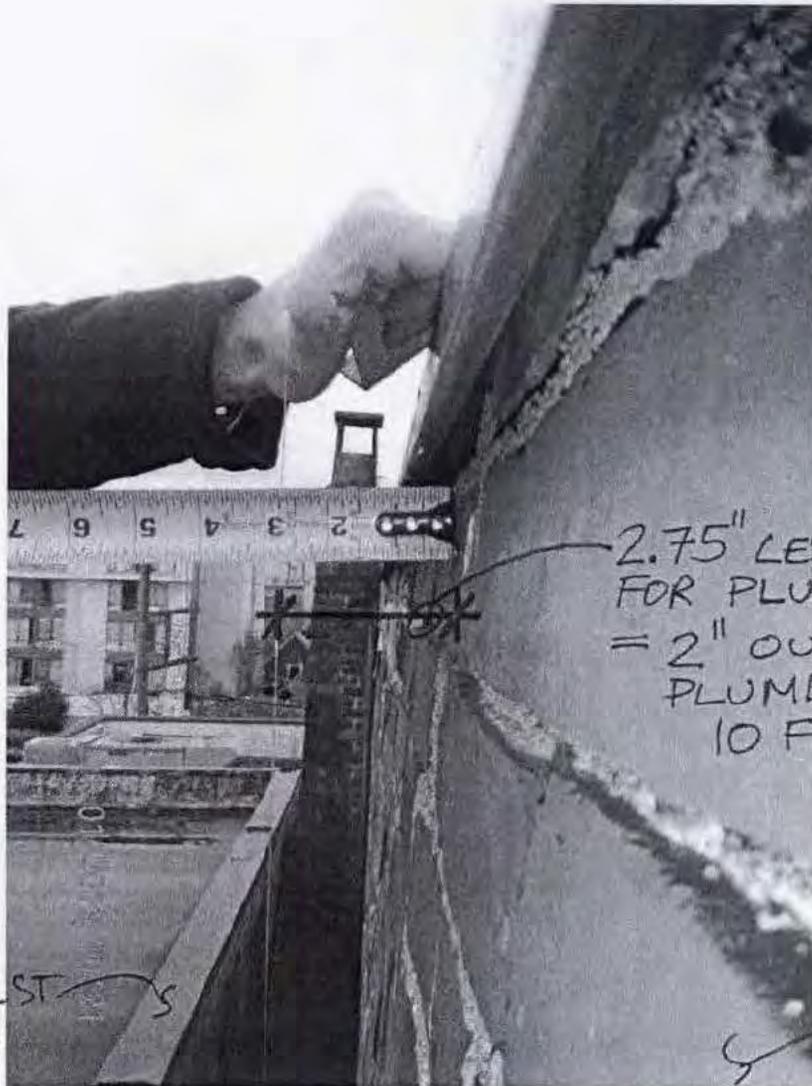
I revisited the site again on November 1st, 2013 with a plumb-bob to review the condition of the brick veneer on the west elevation of the south building located at 439 Powell Street. By using the plumb-bob I was able to determine that the brick chimney on the west elevation was out of plumb by approximately 3 inches over 7 feet (see Figure 12) and I confirmed that sections of the brick veneer on the west elevation were out of plumb by as much as 2 inches over 10 feet (see Figure 13). In my opinion, the original brick veneer would have been constructed in a plumb or near plumb condition and that these out of plumb measurements are significant and are a strong indication of damage to the west wood frame wall from wood rot.

9. sections of the brick veneer at the top of the west elevation of the south building of 439 Powell Street are bowing outward as much as 2" over 10 feet which is significant and a strong indication of damage to the west wood frame wall from wood rot caused by water ingress;

Figure 13: Brick Veneer Out of Plumb on West Elevation of 439 Powell Street, Vancouver

15. to mitigate the risk of a failure and collapse at any time of the entire brick veneer on the west elevation of the south building located at 439 Powell Street, the entire brick veneer should be completely

- removed piece by piece starting from the top of the wall by a competent general contractor under the supervision of a structural engineer familiar with the demolition of this type of brick veneer construction;
16. based on the damage from wood rot that was seen in the east wood frame load bearing wall of the south building located at 439 Powell Street, the damage from wood rot in the west wood frame load bearing wall of the building will be the same or worse than the damage noted in the east wall of the building; and,
 17. due to the difficulty of repairing the east and west wood frame load bearing walls and foundations of the south building located at 439 Powell Street to satisfy the current Vancouver Building By-law, the best course of action may be to demolish the entire building.

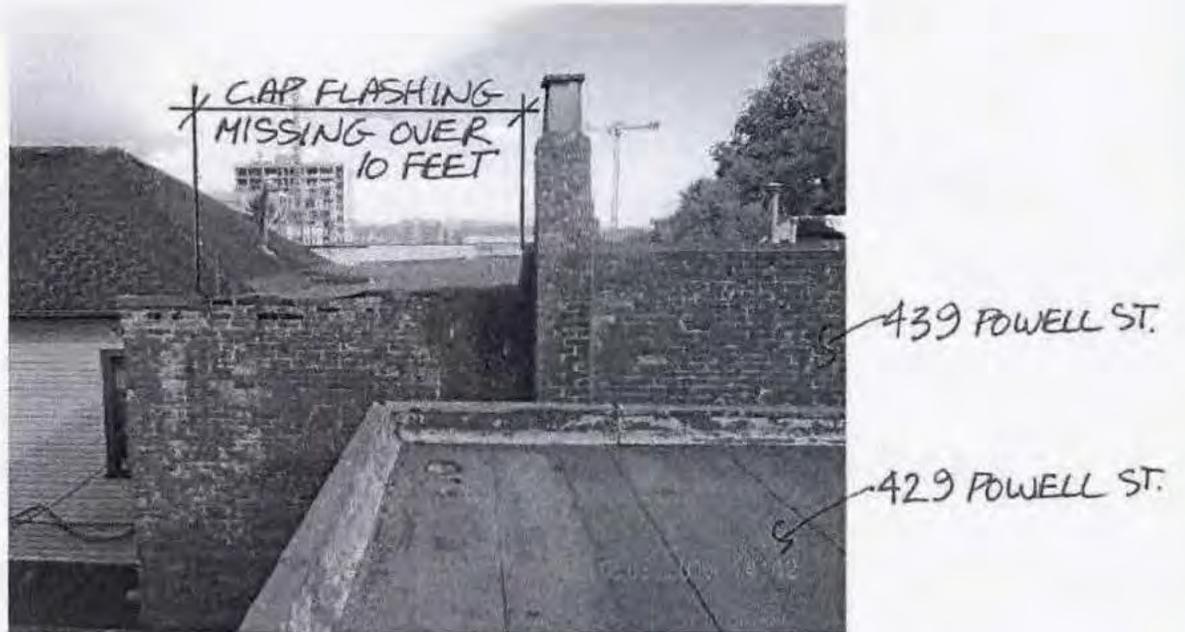
1. an approximately 10 foot long section of metal cap flashing was missing from the top of the wall on the west elevation at the north end of the building (see Figure 14);
2. pieces of brick veneer were entirely missing at several locations on the west elevation (see Figures 15 and 16);
3. mortar in the brick veneer on the west and north elevations at the north-west corner of the building was in very poor condition and in need of re-pointing (see Figure 16);

Figure 14: Cap Flashing Missing on West Elevation of 439 Powell Street, Vancouver

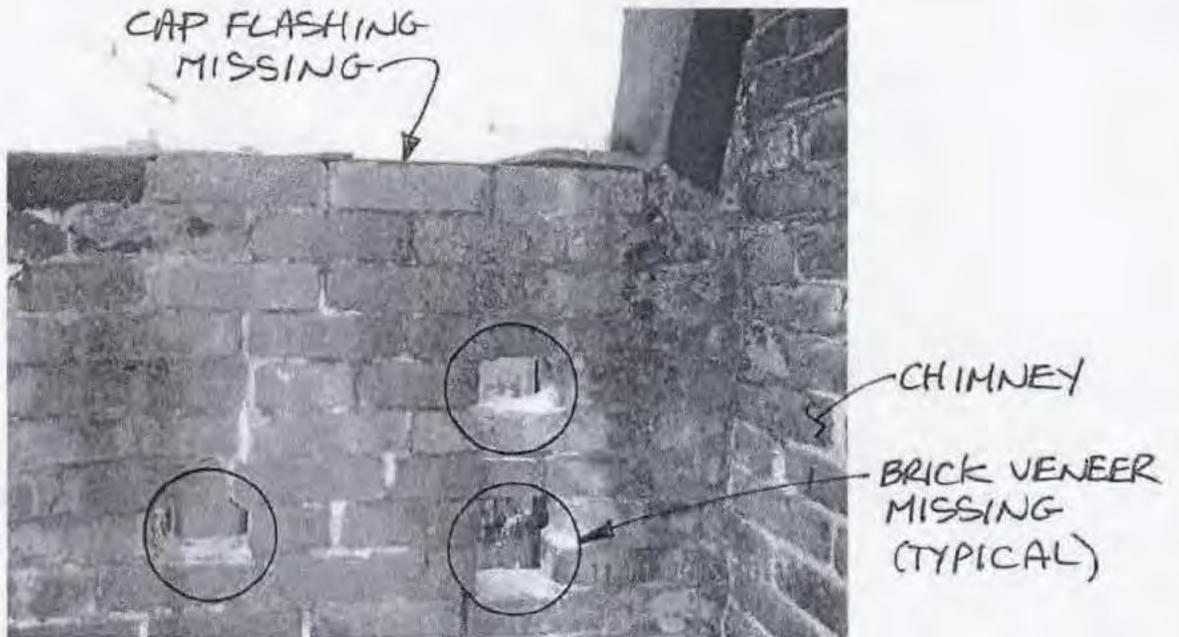
Figure 15: Pieces of Brick Veneer Missing on West Elevation of 439 Powell Street, Vancouver

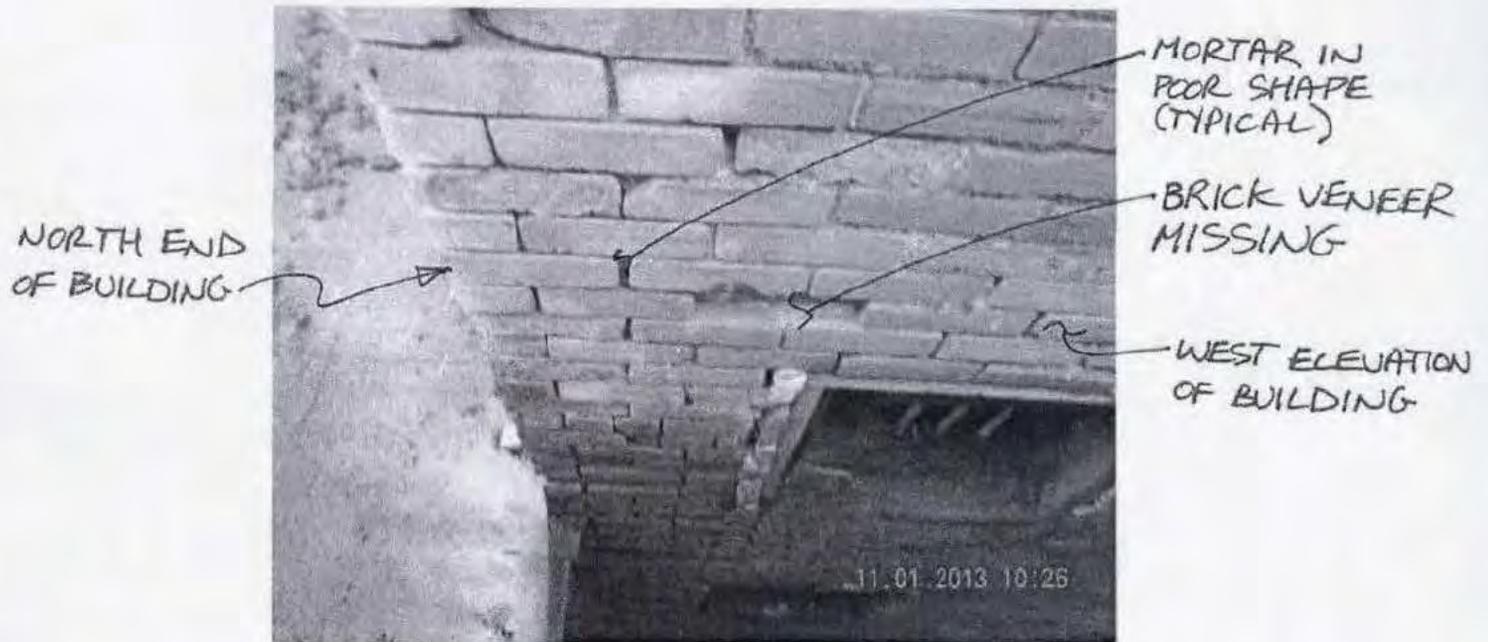
Figure 16: Mortar in Poor Shape at N-W Corner of 439 Powell Street, Vancouver

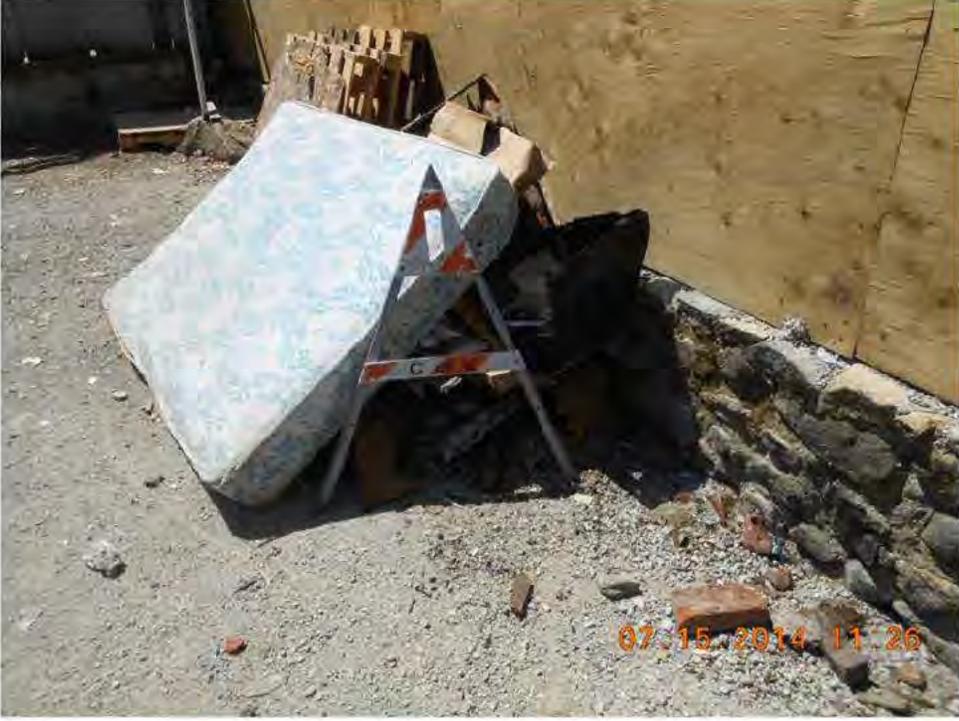
<p>Discarded items piled in the southwest portion of this property.</p>

Under Section 6 of the Untidy Premises By-law, as owner of the property, you are **ORDERED TO** remove this accumulation of rubbish and discarded materials on or before **AUGUST 5, 2014** and to thereafter maintain the site in a tidy condition.
