RE: Arborist Report for City of Vancouver Street Activities Department - For property located at Champlain Heights Trails Vancouver, BC

Due to concerns regarding the condition of trees within the Champlain Heights Trails network an assessment was requested. A start-up site meeting was conducted on December 22, 2020, and Parks Board Staff were present; the scope of the assessment was discussed, and their input and direction was provided. These trails were inspected on January 7, 8 and 13, 2021. One hundred and sixty-two trees were assessed; they have been numbered 1 - 162 for the purpose of this report. Forty-one photographs, and a copy of the Champlain Heights Trail map have been included as part of this report. An aerial images have been copied and included from Vanmap to identify the areas that were assessed, and the approximate locations of the trees. City property lines for the trail system is not defined on-site; therefore, in some instances tree ownership will need to be verified by the City.

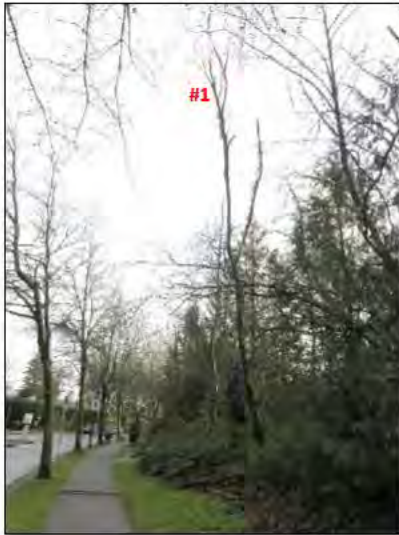
Tree #1

TREE #	SPECIES	DBH (cm)	Height (ft.)	LOCATION	DISTANCE (From P.O.C)	CONDITION	OBSERVATIONS	RECOMMENDATIONS	PRIORITY
1	Birch	25	30	Red Alder Trail*	3.6m S of sidewalk on Blake St.	Declining	In severe decline. Lean and asymmetrical canopy to the north over sidewalk. Dead top, extensive branch dieback and fungal activity.	REMOVE	1
2	Alder	100 (44+41+15)	30	Red Alder Trail*	5.5m E of walkway & 9m S of sidewalk	Fair	Three stems at base. Top of central stem dead. Bark is cracked and sloughing.	Remove dead top & monitor	2
3	Vine Maple	22 (10+6+6)	15	Red Alder Trail*	2.4m W of walkway & 10m N of lamp #472	Fair	Multiple stems. Stems over walkway removed and stubs remain.	Remove stubs	3
4	Birch	24	30	Red Alder Trail*	2m E of walkway & 29m S of sidewalk on Blake St.	Declining	Slight lean east of stem towards building. Dead top, branch dieback and limb shed.	REMOVE	1
5	Big leaf maple	80 (52+28)	60	Red Alder Trail*	5m W of walkway & 7m W of lamp #572	Fair/Poor	Originally had five stems; three stems removed. Large dead wood. Callusing wounds, decay, and fungal activity.	REMOVE	1

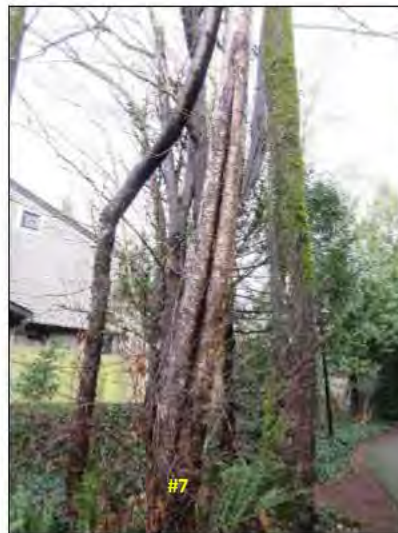
Tree #7

6 Tag# 293	Alder	59	40	Red Alder Trail*	1m E of walkway & 15m S of lamp #772	Fair	Branch dieback. Callusing wound on north side of stem commencing at 4.5ft to 8ft. Canker and fungal activity present.	MONITOR	2
7	Birch	36	40	Red Alder Trail*	1.2m W of walkway & 10m S of lamp #872	Dead	Callusing wound with decay on south side of stem commencing at 2ft to 4ft. Fungal activity present.	REMOVE	1
8	Big leaf maple	56 (30+6)	35	Red Alder Trail*	1m W of walkway & 8m S of lamp #872	Declining	Two stems at base; bark inclusion. Branch dieback. Wound north stem at 4ft to 10ft.	REMOVE	1
9 Tag# 027	Bitter cherry	23	35	Red Alder Trail*	8.1m E of walkway & 3m south lamp #872	Dead	Pathway to residential building 8ft from the south side of stem.	Confirm Ownership & REMOVE	1
10	Birch	70 (30+20+20)	35	Red Alder Trail*	3.9m E of walkway & 3m N of lamp #972	Declining	Multiple stems; several stems removed. Dead top, deadwood and limb shed. Targets; residential building, walkway, and occupants.	Confirm Ownership & REMOVE	1

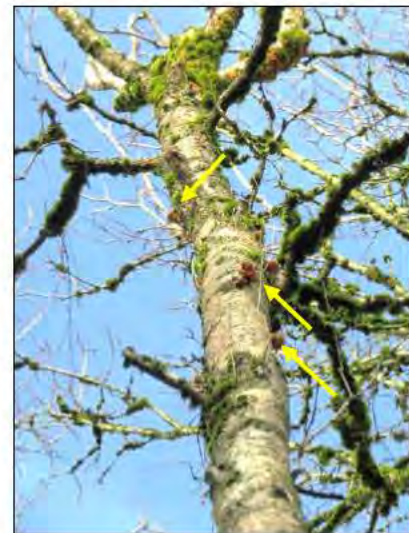
Tree #7 – Fungal activity

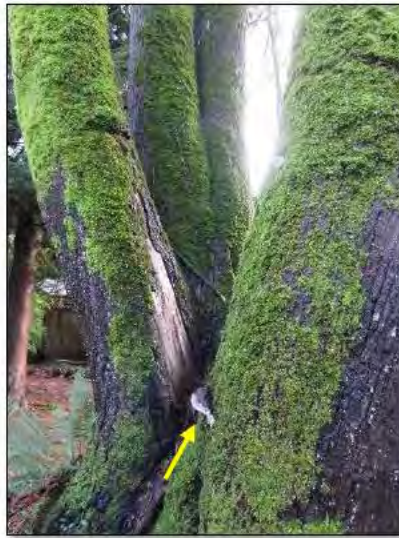
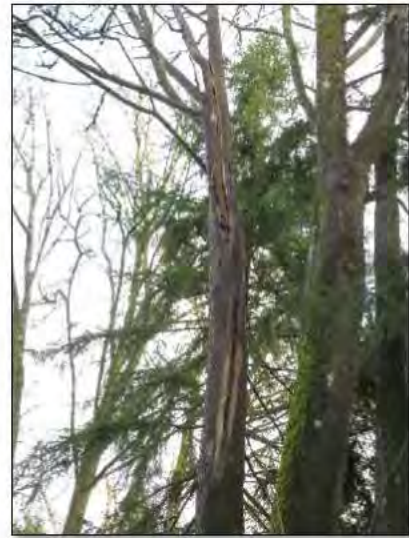
Tree #12 (Tag 073)

11	Alder	22	20	Red Alder Trail*	3.6m W of walkway & across from lamp #972	Dead	Top failed. Bark cracked and sloughing. Fungal activity present. Targets; pathway to residential area and walkway.	REMOVE	1
12 Tag# 073	Big leaf maple	16	50	Red Alder Trail*	5.4m E of walkway & 10m N of lamp #1072	Fair/Poor	Four stems commencing at base. Dieback and limb shed. Callusing wounds with decay. Fungal fruiting bodies observed. Chain slightly embedded around stem.	REMOVE	1
13 Tag# 033	Alder	85 (43+42)	50	Red Alder Trail*	5.6m E of walkway & 10.5m S of lamp #972	Fair	Two stems at base. Topped; wound has not callused over, and the bark is cracked and sloughing. Pruning wounds have not callused over and decay is present. Targets; residential building, walkway, and occupants.	Confirm ownership & MONITOR	2
14	Hemlock	39	35	Red Alder Trail*	1m E of walkway & 5m N of amp #1072	Fair/Poor	Lean and asymmetrical canopy to the southwest. Bark cracked and sloughing. Branch dieback and canker.	Confirm ownership & MONITOR	2

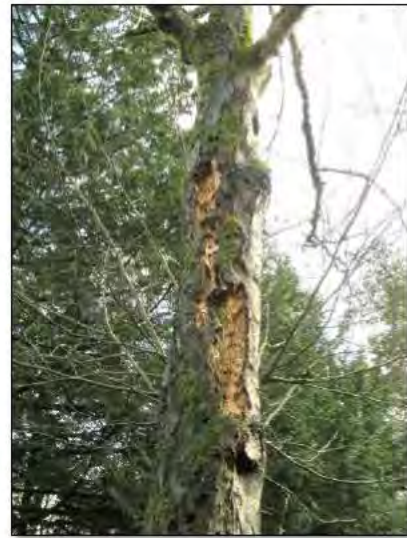
Tree #21 (Tag 406)

20	Big leaf maple	56 (40+16)	40	Red Alder Trail*	1.8m SW of walkway & 13m W of lamp #385	Fair/poor	Two stems at base; callusing wound at union to 8ft. Dead top and branch dieback.	REMOVE	1
21 Tag# 006	Alder	48	30	Red Alder Trail*	2.4m SW of walkway & 7m E of lamp #385	Poor	Corrected lean to southeast. Extensive large deadwood and limb shed. Evidence of bird activity; significant boring.	REMOVE	1
22	Alder	48	30	Red Alder Trail*	2.1m SW of walkway & 2m W of lamp #385	Fair/Poor	Corrected lean to the northwest. Central leader reduced in height; wound not callused, decay and fungal activity are present. Limb failure east side at 15ft.	MONITOR	2
23	Big leaf maple	32	20	Birch Trail*	2.4m N of walkway & 16m E of lamp #385	Declining	Canopy asymmetrical to the southwest. Dead top, large deadwood and limb shed. Wound west side of stem at base to 12ft and east side at base to 4ft.	REMOVE	1
24	Big leaf maple	44	35	Birch Trail*	3.9m N of walkway & 6m E of lamp #585	Poor	Appear to have several stems at one point. Corrected lean and asymmetrical canopy to the south. Dead wood. Fungal activity at base on northwest side.	REMOVE	1

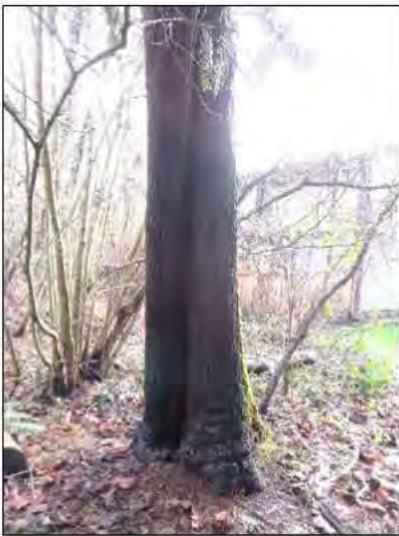
Tree #25 (Tag 299)

TREE #	SPECIES	DBH (cm)	Height (ft.)	LOCATION	DISTANCE (From P.O.C)	CONDITION	OBSERVATIONS	RECOMMENDATIONS	PRIORITY
25 Tag# 299	Big leaf maple	57	40	Birch Trail*	8.8m S of walkway & 4m E of lamp #785	Declining	Corrected lean and asymmetrical canopy. Dead top, deadwood. Column of decay west side at base to 10ft. Bark sloughing. Fungal activity observed. Targets; pathway to residential building and occupants.	Confirm ownership & REMOVE	1
26	Alder	21	25	Birch Trail*	5.4m S of walkway & 2m E of lamp #585	Declining	Dead top and branch dieback. Bark sloughing and canker. Targets; path to residential buildings and occupants.	Confirm ownership & REMOVE	1
27	Alder	39	30	Birch Trail*	6.6m S of walkway & 6m W of lamp #585	Declining	Central stem failed, decay and fungal activity at failure site. Deadwood and limb shed. Canker. Targets; path to residential buildings and occupants.	Confirm ownership & REMOVE	1

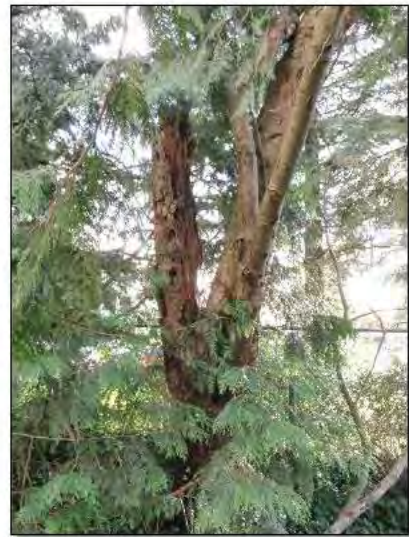
Tree #44

44	Alder	27	35	Orange Dogwood Trail*	2.7m S of walkway & 11m E of Champlain Cres.	Poor	Corrected lean and asymmetrical canopy to the west. Branch dieback. Bark cracked and sloughing. It has canker. Targets; City sidewalk, bench, walkway, and occupants.	REMOVE	1
45	Alder	30	35	Orange Dogwood Trail*	1.2 S of walkway & 16m E of Champlain Cres.	Poor	Corrected lean to the northwest. Branch dieback. It has extensive canker. Targets; bench, walkway, and occupants.	REMOVE	1
46	Alder	28	20	Orange Dogwood Trail*	3m S of walkway & 2.5m W of lamp #384	Declining	Lean to the northwest. Branch dieback. It has canker. Ivy on stem.	REMOVE	1
47	Alder	38	30	Orange Dogwood Trail*	1m S of walkway & 14m W of lamp #484	Dead	Lean to the south. Dead top and deadwood. Bark sloughing and sapsucker damage.	REMOVE	1
48	Alder	30	30	Red Alder Trail*	3.3m E of walkway & 10m N of lamp #277	Dead	Lean to the northwest over walkway.	REMOVE	1

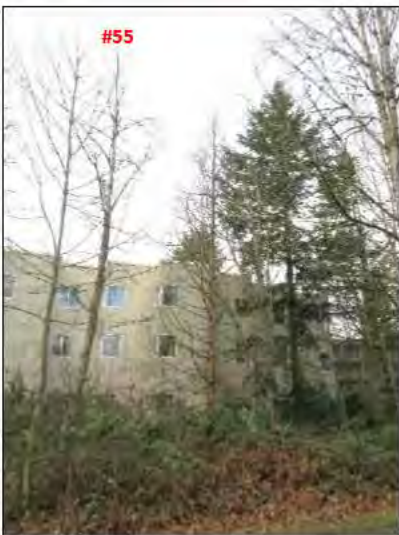
Tree #55

55	Alder	32	25	Red Alder Trail*	6.6m W of walkway & 12m S of lamp #178	Dead	Top shed and deadwood. Fungal activity is present. Targets; residential building and occupants.	Confirm ownership & REMOVE	1
56	Alder	26	25	Red Alder Trail*	3m NW of walkway & 2.5m S of lamp #278	Dead	Originally two stems at base. North stem removed; remaining stem is dead, and the bark is sloughing. Fungal activity observed at base.	REMOVE	1
57	Alder	19	25	Red Alder Trail*	2.4m N of walkway & 6m W of lamp #484	Dead	Lean to the south side. Bark sloughing.	REMOVE	1
58	Alder	19	25	Fir Trail*	2.1m N of walkway & 7.5m W of lamp #484	Dead	Lean to the south.	REMOVE	1
59	Alder	99 (38+33+28)	40	Fir Trail*	9.7m S of walkway & 6m E of lamp #184	Fair/Poor	Three stems at base. Branch dieback. Wound on central stem. Evidence of bird activity and it has canker.	Remove central stem	2
60	Alder	36	40	Fir Trail*	8.4m S of walkway & 3m E of lamp #284	Declining	Originally two stems at base. Lean to the north. Dead top. Column of decay south side at 8ft to 20ft. Extensive canker.	REMOVE	1

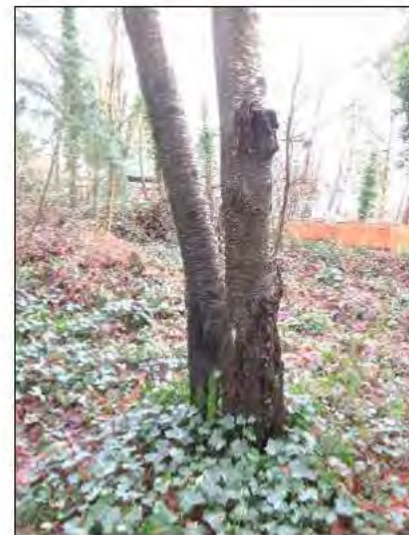
Tree #62

61	Cottonwood	22	20	Red Alder Trail*	1.2m E of walkway & 9.5m N of lamp #179	Dead	Corrected lean to the west over walkway. Dead top and branch dieback. Evidence of bird activity.	REMOVE	1
62	Bitter Cherry	55 (2+26)	30	Red Alder Trail*	2.1m E of walkway & 2.5m N of lamp #379	Poor	Two stems at base. West stem failed at 15ft; decay and fungal activity at failure site. Lean and asymmetrical canopy to the northwest. It has extensive canker and fungal activity at the base.	REMOVE	1
63	Alder	36	40	Red Alder Trail*	3m W of walkway & 7m S of lamp #579	Declining	Significant corrected lean to the northwest. Bark cracked and sloughing at 20ft – 40ft. Targets; basketball court, walkway, and occupants.	REMOVE	1
64	Big leaf maple	47	40	Red Alder Trail*	5.4m E of walkway & 11m S of lamp #579	Dead	Bark has sloughed.	REMOVE	1
65	Black Locust	24	20	Red Alder Trail*	4.2m W of walkway & 14m S of lamp #979	Poor	Significant lean and asymmetrical canopy to the west side; tension roots exposed east of stem. Branch dieback. Fungal activity at base. Targets; playground and occupants.	REMOVE	1

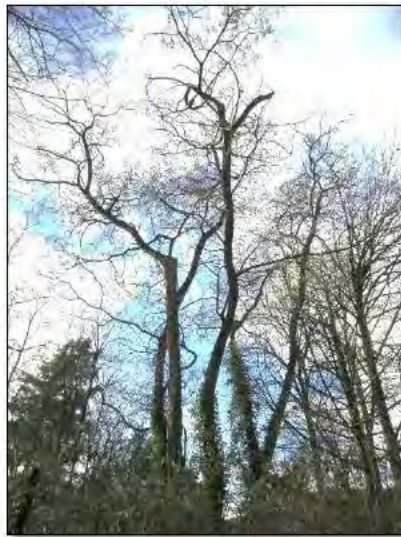
Tree #75

75	Black locust	144 (58/56/30)	45	Red Alder Trail*	7.5m SW of walkway & 7m SW of lamp #1382	Fair	Four stems at base. Deadwood; previously pruned. Multiple seams. Column of decay on west side at base to 10ft.	Remove deadwood	2

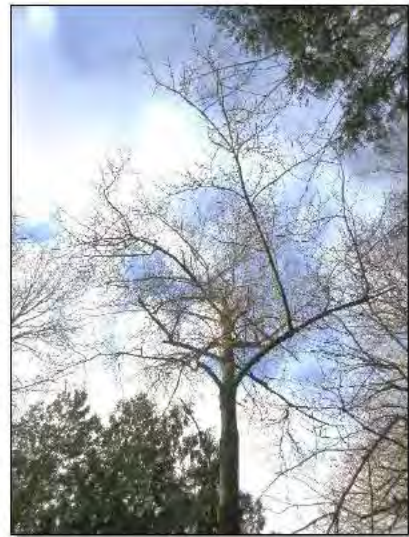
Tree #76

TREE #	SPECIES	DBH (cm)	Height (ft.)	LOCATION	DISTANCE (From P.O.C)	CONDITION	OBSERVATIONS	RECOMMENDATIONS	PRIORITY
76	Cottonwood	64	70	Red Alder Trail*	3m SW of walkway & 9m SE of lamp #1182	Fair	Significant limb shed. Wounds have not callused over; decay and fungal activity are present.	Remove deadwood and hangers. Aerial inspection requested.	2
77	Alder	50	50	Red Alder Trail*	1.8m SW of walkway & SW of lamp #882	Poor	Significant corrected lean and asymmetrical canopy to the northeast. Deadwood and sloughing bark. It has canker and fungal activity was observed.	REMOVE	1
78	Big leaf maple	51	50	Red Alder Trail*	1m SW of walkway & 4m NW of lamp #882	Declining	Lean to the northeast. Extensive deadwood and sloughing bark. Fungal activity at base.	REMOVE	1
79	Alder	50	20	Red Alder Trail*	1.8m SW of walkway & 1.5m SE of lamp #682	Dead	Tall dead stem.	REMOVE	1
80	Alder	30	30	Red Alder Trail*	2.4m S of walkway & 5m E of lamp #582	Declining	Lean to the southeast. Branch dieback. Canker and fungal activity observed.	REMOVE	1

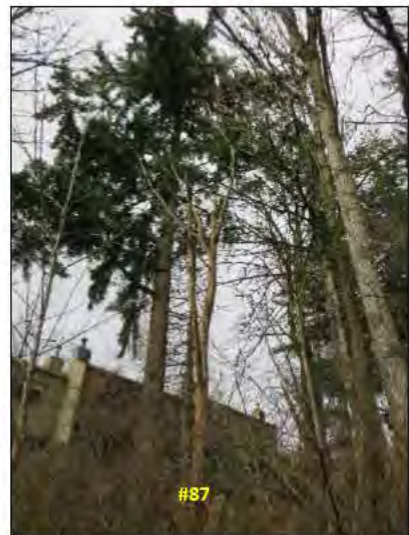
Tree #87

87	Big leaf maple	27	20	Grey Gum Trail*	4.8m N of walkway & 9m NE of lamp #1879	Dead	Bark cracked and sloughing.	REMOVE	1
88	Big leaf maple	32	35	Sunrise Trail*	2.4m S of sidewalk on Champlain Cres.	Declining	Lean to the north over sidewalk. Significant deadwood. Large cavity of decay on north side at base to 3ft.	REMOVE	1
89	Big leaf maple	36	35	Sunrise Trail*	2.4m S of sidewalk on Champlain Cres.	Fair	Corrected lean to the northwest. Deadwood. Wound on north side at base.	Remove deadwood & MONITOR	2
90	Alder	38	30	Sunrise Trail*	3.3m S of sidewalk on Champlain Cres.	Declining	Lean to the south. Deadwood and canker.	REMOVE	1
91	Alder	33	25	Sunrise Trail*	7.2m N of walkway & 21m SW of sidewalk on Champlain Cres.	Dead	Bark sloughing.	REMOVE	1
92	Alder	14	12	Sunrise Trail*	1m N of walkway & 20m SW of sidewalk on Champlain Cres.	Dead	Bark sloughing.	REMOVE	1
93	Alder	22	25	Sunrise Trail*	1m S of walkway & 3m E of lamp #483	Dead	Bark sloughing.	REMOVE	1

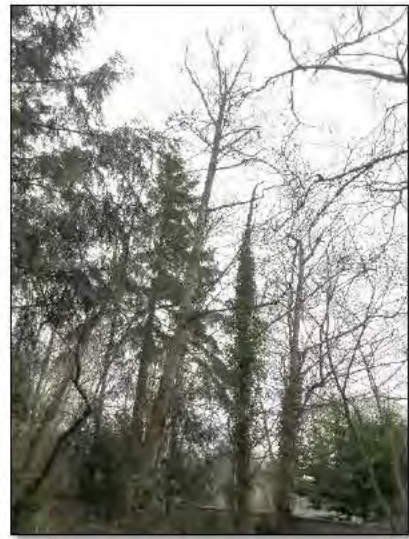
Trees #100 – 103

101	Alder	32	25	Sunrise Trail*	10m S of walkway & 14m E of lamp #283	Poor	Deadwood and canker.	Confirm ownership & REMOVE	1

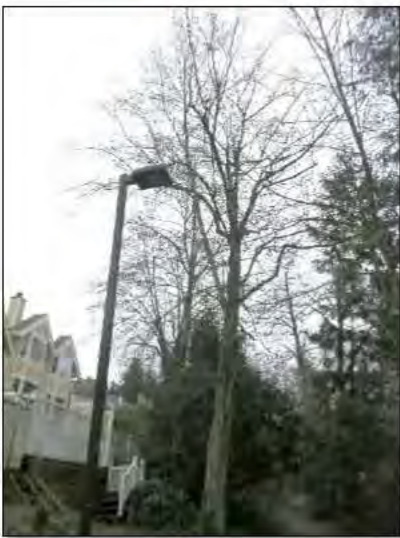
Tree #107

107	Alder	62	50	Sunrise Trail*	1m N of walkway & 8m E of lamp #183	Fair	Deadwood. Pruning wound west side at 15ft; decay and sloughing bark.	Remove deadwood & inspect old pruning wound	2
108	Alder	19	15	Sunrise Trail*	2.1m W of walkway & N of lamp #23	Dead	Lean to the southeast. Top failed. Bark cracked and sloughing.	REMOVE	1
109	Alder	55	60	Sunrise Trail*	6.3m W of walkway & 9m N of lamp #23	Poor	Significant corrected lean and asymmetrical canopy to the northeast. Branch dieback and canker. Wound with decay southwest side at 2ft to 6ft.	Confirm ownership & REMOVE	1
110	Alder	41	60	Sunrise Trail*	5.7m W of walkway & 5.5m N of lamp #23	Poor	Corrected lean to the northeast and asymmetrical canopy to the east. Branch dieback and canker.	Confirm ownership & REMOVE	1
111	Alder	42	60	Sunrise Trail*	3.6m W of walkway & W of lamp #23	Poor	Corrected lean to the south. Branch dieback and canker.	Confirm ownership & REMOVE	1

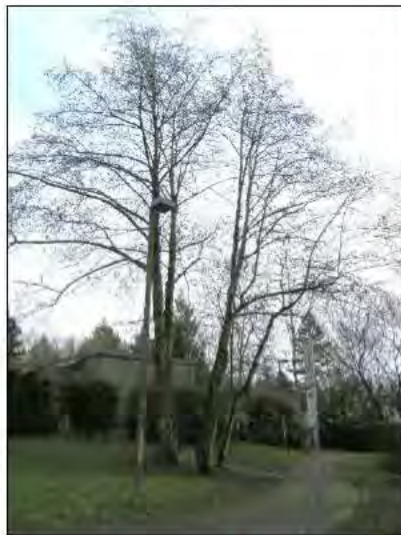
Tree #145 & #146

145	Alder	32	25	Grey Gum Trail*	2.4m E of walkway & 9.5m N of lamp #878	Poor	Lean and asymmetrical canopy to the southeast. Branch dieback and canker.	REMOVE	1
146	Alder	18 est.	25	Sunrise Trail*	8m NW of sidewalk on Matheson Cres.	Dead	Leaning on adjacent tree to the south. Blackberry surrounding base. Targets; City sidewalk, Matheson Cres., vehicles and pedestrians.	REMOVE	1
147	Alder	26	30	Sunrise Trail*	10m NW of sidewalk on Matheson Cres.	Dead	Bark sloughing.	Confirm ownership & REMOVE	1
148	Alder	23	35	Sunrise Trail* 30ft	10m NW of sidewalk on Matheson Cres.	Dead	Bark sloughing. On slope. Targets; City sidewalk, Matheson Cres., vehicles and pedestrians.	Confirm ownership & REMOVE	1
149	Alder	23 est.	35	Sunrise Trail*	10m NW of sidewalk on Matheson Cres.	Dead	Bark sloughing. On slope. Targets; City sidewalk, Matheson Cres., vehicles and pedestrians.	Confirm ownership & REMOVE	1
150	Big leaf maple	35 est.	35	Red Alder Trail*	5.4m W of walkway & 6m S of lamp #1479	Fair/Poor	Canopy asymmetrical to the east. Deadwood and evidence of bird activity.	Remove upper stem above boring holes & leave wildlife snag	3

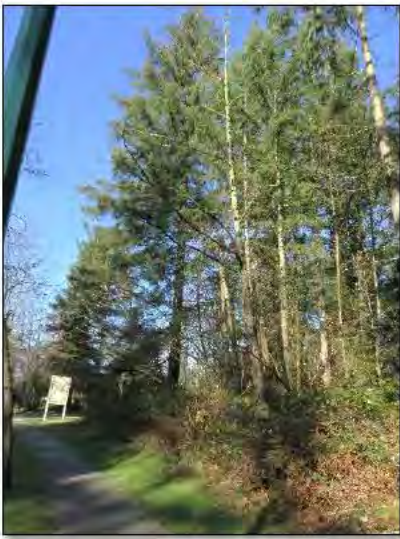
Trees #159 & 160

160	Alder	30 est. (15+15)	25	Black Cottonwood Trail*	5m NE of sidewalk on Champlain Cres. & 26m SE of sidewalk on Blake St.	Dead	Two stems at 2ft; top of both stems has shed. Bark sloughing. Fungal activity observed. North of lamp standard #275 that is adjacent to Champlain Cres.	REMOVE	1
161	Alder	55	35	Orange Dogwood Trail*	10m E of sidewalk on Champlain Cres.	Declining	Two stems at 6ft. East stem dead; top has shed. Decay south side at 3.5ft. Evidence of bird activity and fungal fruiting bodies observed.	REMOVE	1
162	Alder	24	20	Sunrise Trail*	7.2m S of walkway & 26m SW of sidewalk on Champlain Cres.	Declining	Originally two stems at base. Bark sloughing.	REMOVE	1
