Arborist Report for Development Permit Application (DP-2021-00545) at 2120 West 10th Avenue. Date Range: June 1, 2021 to August 24, 2021.

TREE MANAGEMENT REPORT: **FOR PROPOSED DEVELOPMENT**

Site Address: **2120 West 10th Avenue, Vancouver**Project: **Application for Proposed Rezoning Development**

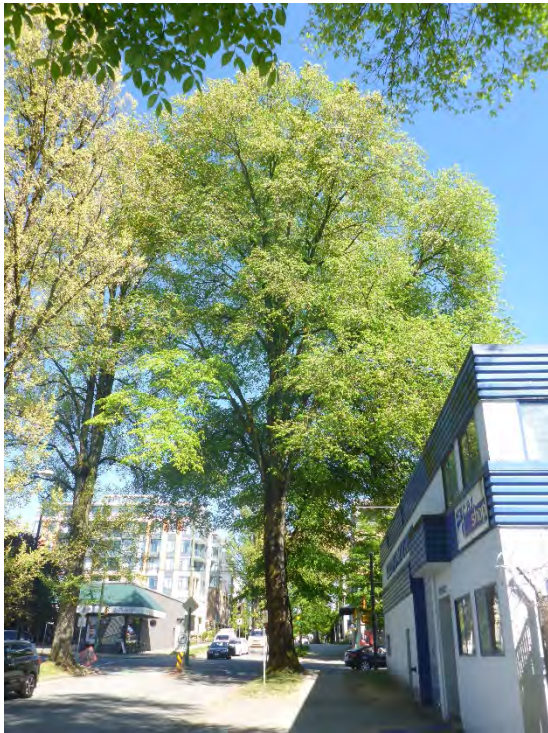
Tree #C02

TRAQ Ratings:	Likelihood of Failure:	Likelihood of Impact:	Failure and Impact:	Consequences:	Risk Rating:
TREE C02	Probable	High	Likely	Severe	<u>High</u>

- Tree Tag/ID: C02
This tree will likely be made high-risk due to the demolition and removal of the existing building foundation directly adjacent to the trunk.
Since this is a project related removal request, the removal and replacement costs are expected to be the responsibility of the developer.

- Tree Tag/ID: C02
See TRAQ details above.
Since this is a pre-existing condition, the removal of this tree should be the sole responsibility of the Park Board. Considering the reported results of a Level 3 assessment by Park Board staff, and their requirement to retain and protect this tree, we recommend the following measures:
 - Re-assess the tree, particularly a Level 3 assessment of the roots that may be exposed within the subject development site at the time of demolition (of the existing building), as well as to assess structural roots closer toward the tree where possible, to determine the structural condition of its root system (to the extent possible while limiting the assessment to non-destructive methods for the city hardscape).
 - Undertake further coordination with the Park Board in updating the tree risk assessment.

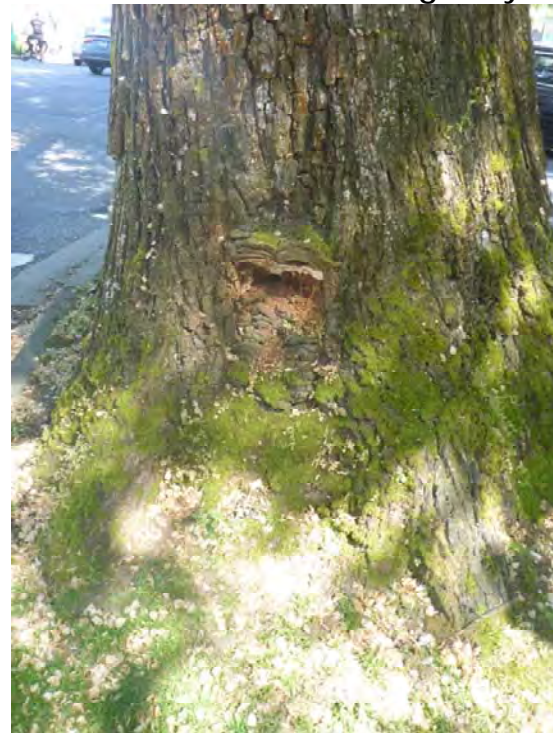
Tree #C02 Ganoderma fruiting body

The subject tree is large Elm that is with striking of several targets should it fail. *Ganoderma applanatum* fruiting body is visible at the trees base, with additional large wounds near the lower stem which is the main factor when considering the likelihood of failure. *Ganoderma applanatum* fungus decays lignin, cellulose and hemicellulose resulting in severe loss of wood strength. The decay occurs in the sapwood and heartwood of the lower trunk and sometimes large roots that are close to the base.

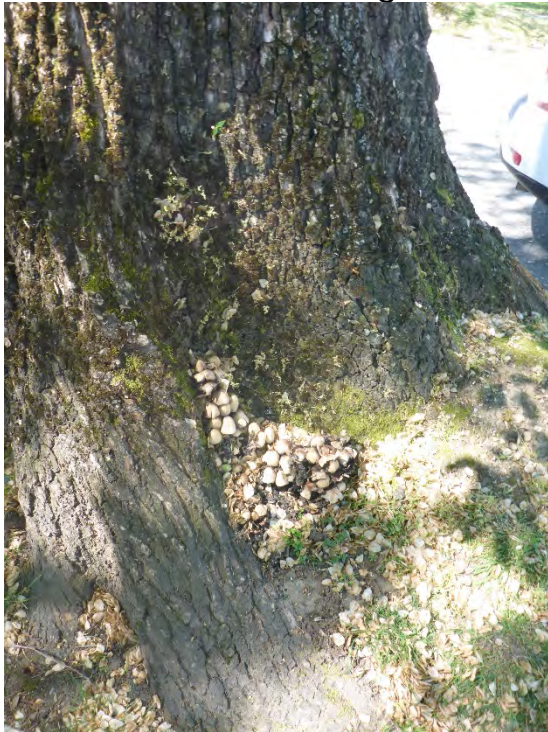
Tree #C02 Armillaria Fruiting bodies

Although a secondary pathogen was not seen on the tree at the time of assessment, it is understood that an *Armillaria* spp. root rot was found on the tree by other professionals. This finding would corroborate with the description above of the tree being somewhat close to the last stage of decay where a secondary pathogen begins to establish.

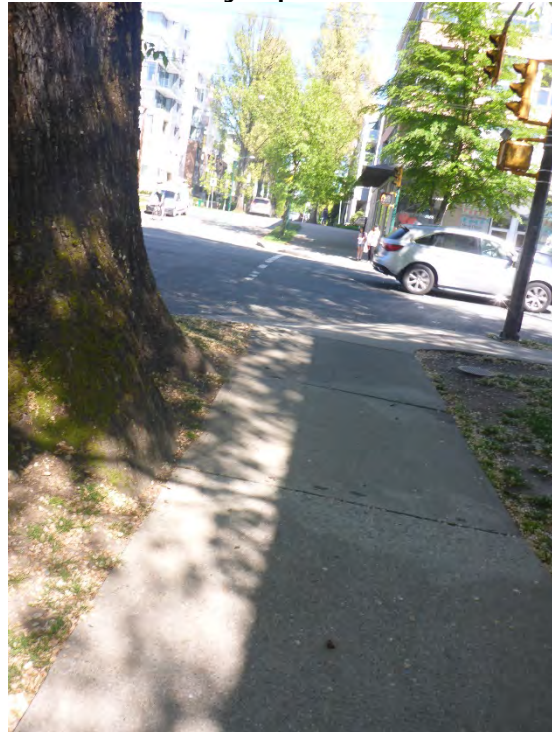
Tree #c02 Newly replaced sidewalk

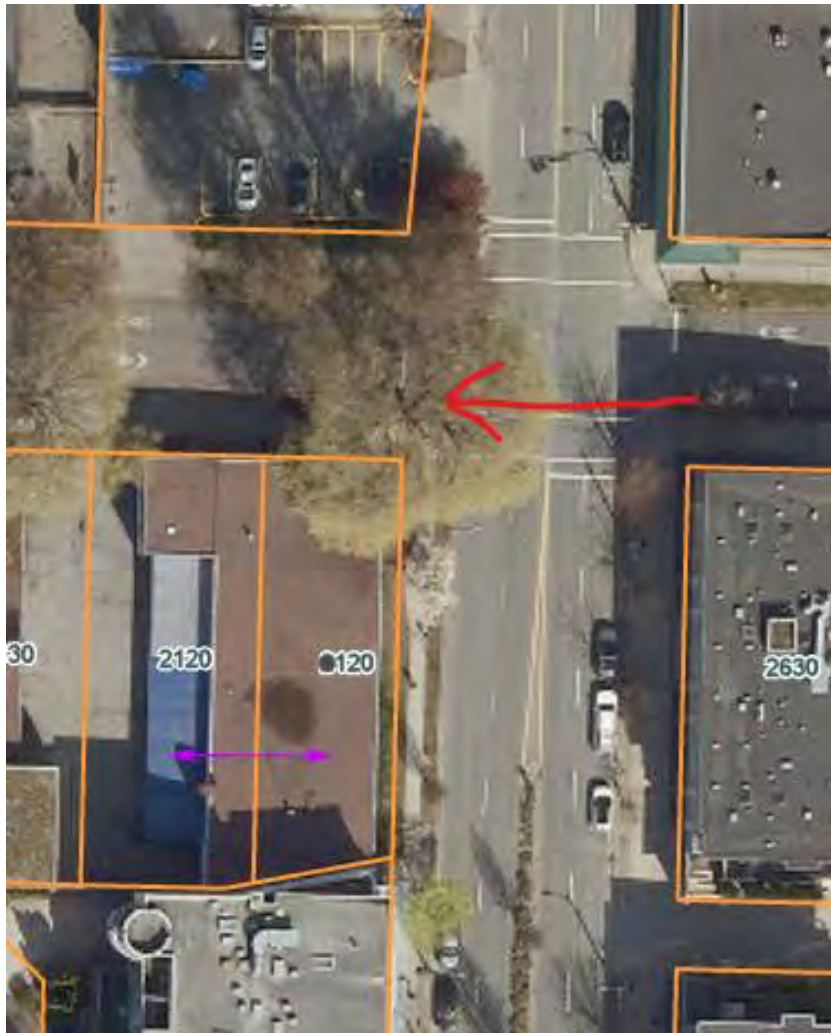
Figure 1. The subject tree in context of the surrounding landscape and infrastructure.

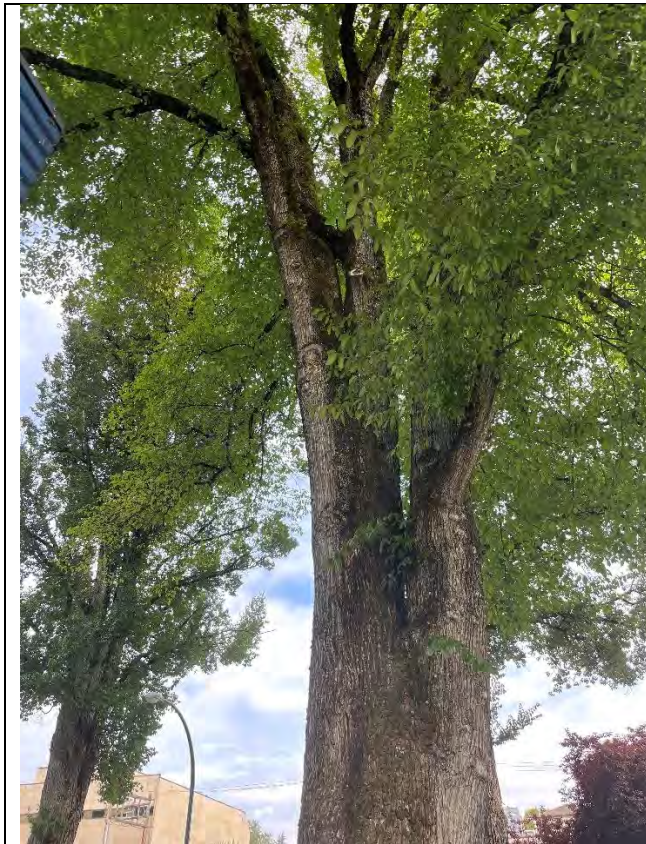
Photo 1. Looking up into the crown of the tree from its south side.

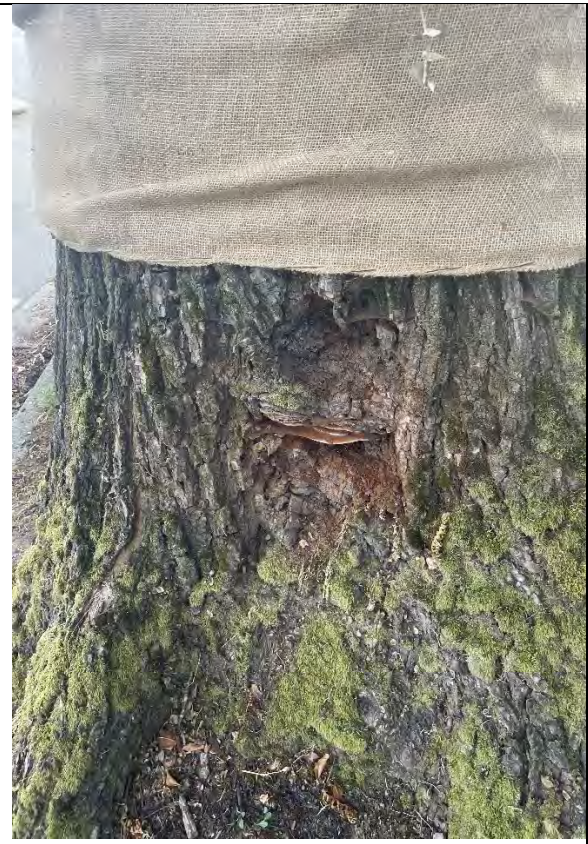
apply⁴". The subject elm has a decay cavity situated at the western edge and a fruiting body indicating a heart-rot decay on the southern side. This shows that the column of decay is not centrally located and therefore the strength loss calculation would make the determination of wood strength difficult to accurately determine. This puts the onus on the City to determine what the acceptable risk threshold is for a significant tree in the City.

Photo 2. Looking at the conk found on the west side of the tree.

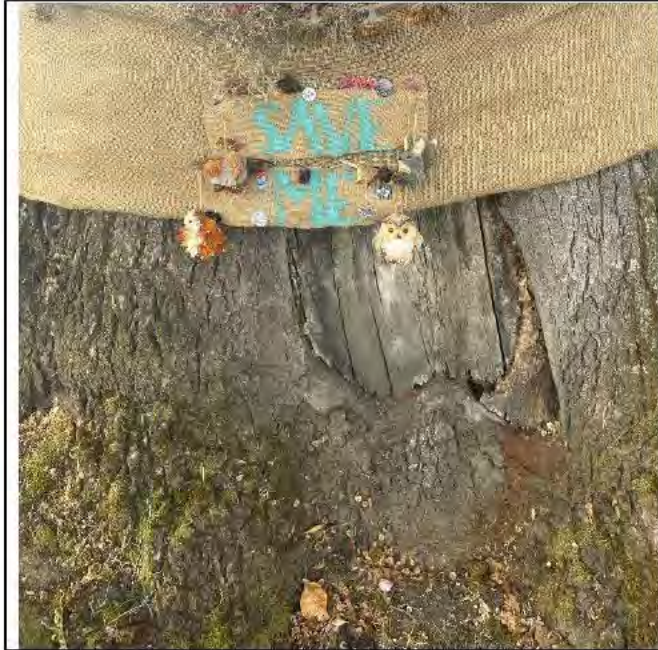
Photo 3. Looking at the wound on the north side where there is a cavity in behind the surface wood.

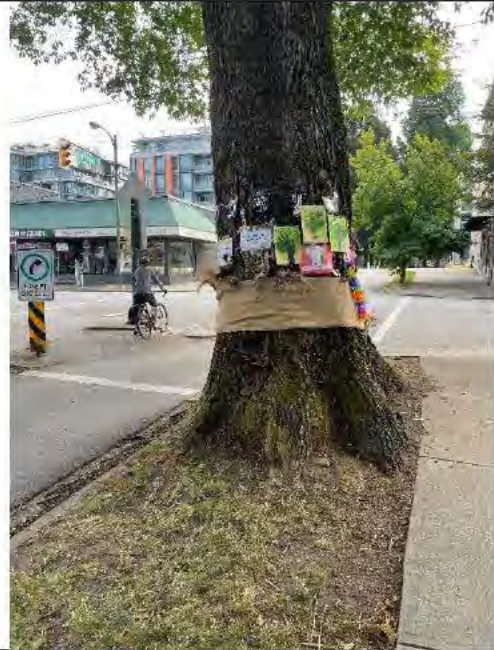
Photo 4. Looking east at the tree.
