HAZARDOUS MATERIALS SURVEY

**Sir David Livingstone Elementary School
Vancouver, BC**

**Vancouver School Board
Planning & Facilities
1580 West Broadway
Vancouver, BC
V6J 5K8**

**ACM ENVIRONMENTAL CORPORATION
#217 - 2323 Quebec Street
Vancouver, BC
V5T 4S7
604-873-8599**

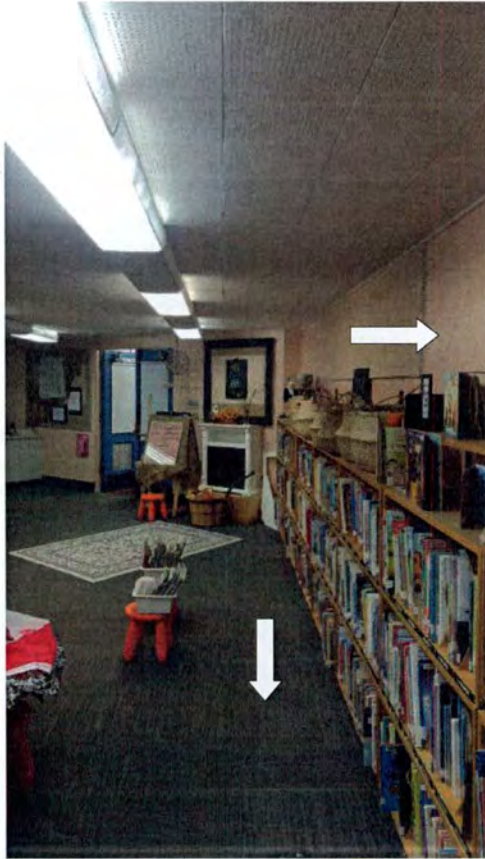
Very limited amounts of drywall were observed during the survey. Of all the drywall materials observed, representative sampling of the materials was conducted. Asbestos containing drywall taping compounds (1-5% Chrysotile asbestos) were found in various areas of the school. The locations of the asbestos containing drywall taping compounds do not indicate any pattern that would allow the materials to be distinguished from the non-asbestos containing drywall materials found within the school.

Therefore, all drywall materials found within the school are considered asbestos containing.

Asbestos Containing Drywall and Vinyl Floor Tiles (under carpet) in Library

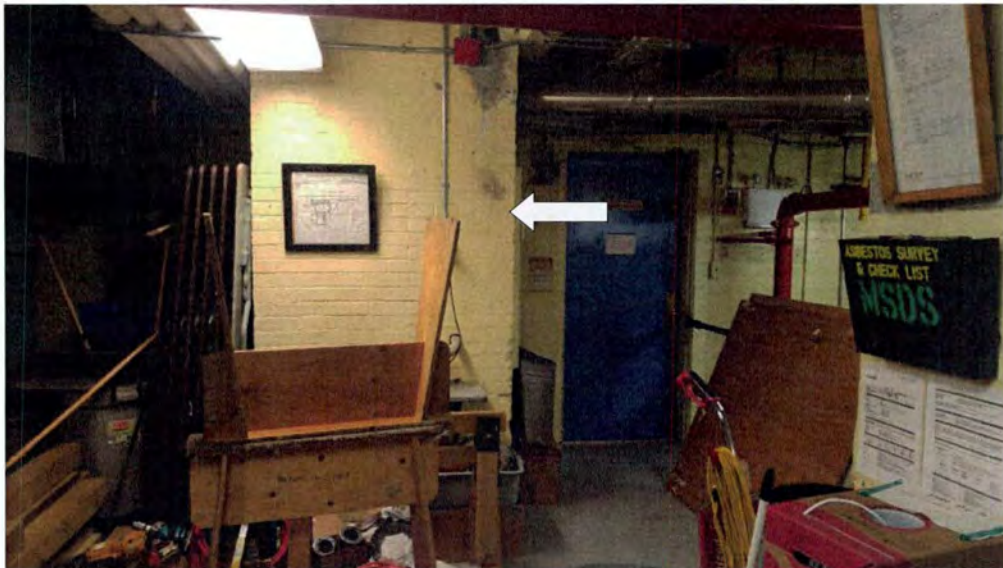
A concrete skim coat was observed on the interior perimeter walls and chimney within the boiler room of the building. Two samples of the concrete coating were collected during this survey and both were found to contain 1-5% Chrysotile asbestos.

Boiler Room with Asbestos Containing Concrete Skim Coat on Walls & Chimney

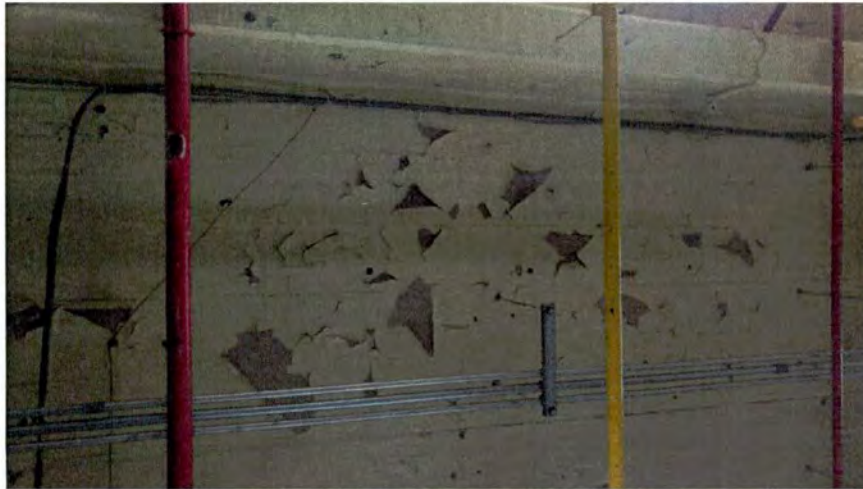
The lead containing materials existing within the school consist of paints/coatings, and lead containing products, such as ceramic tiles and vent pipes. All lead containing materials were found to be in generally good condition, with only some areas showing signs of deterioration (e.g. flaking paints on some walls and ceilings, etc.).

The Canadian Hazardous Products Act (CHPA) considers paints with lead levels above 90 mg/kg or 0.009% to be lead containing. WorkSafeBC requires risk assessments for lead exposure for any work that may impact lead containing paints/coatings, even for lead levels below 90 mg/kg if the materials are to be welded, cut, drilled, grinded, or sanded. **Due to the overwhelmingly high number of samples above 90 mg/kg, all paints throughout the Main School Building and the Daycare "B" Building are considered to be lead containing.**

Peeling Lead Paint on Boiler Room Ceiling

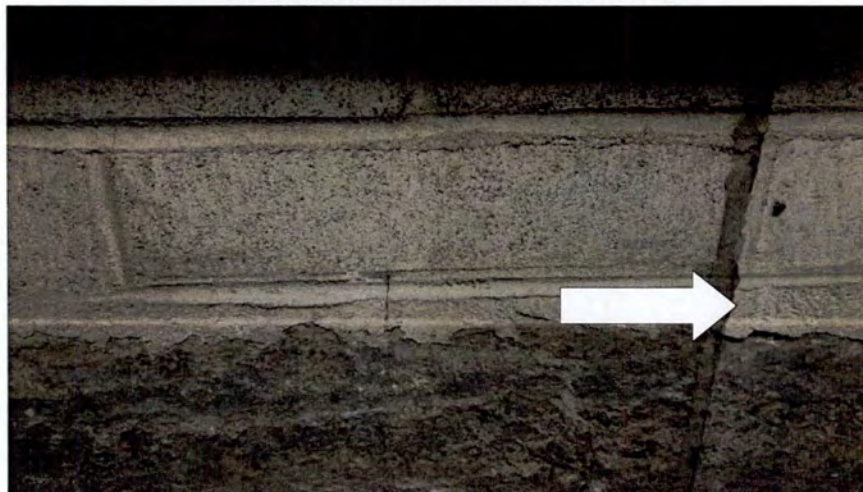
Almost all duct mastic materials throughout the building were observed to be a newer non-asbestos containing grey or white material. However, some original Asbestos containing silver/gold duct mastic materials (1-5% Chrysotile asbestos) were observed in Fan Room 024 (residual mastic left on concrete walls) as well as in Fan Room 010 (one square duct riser beside entrance door. No other asbestos containing duct mastics were observed on any other visible ducting during the survey.

All silver and/or gold duct mastic found within the school is considered asbestos containing.

Residual Asbestos Containing Duct Mastic on Wall in Fan Room 024

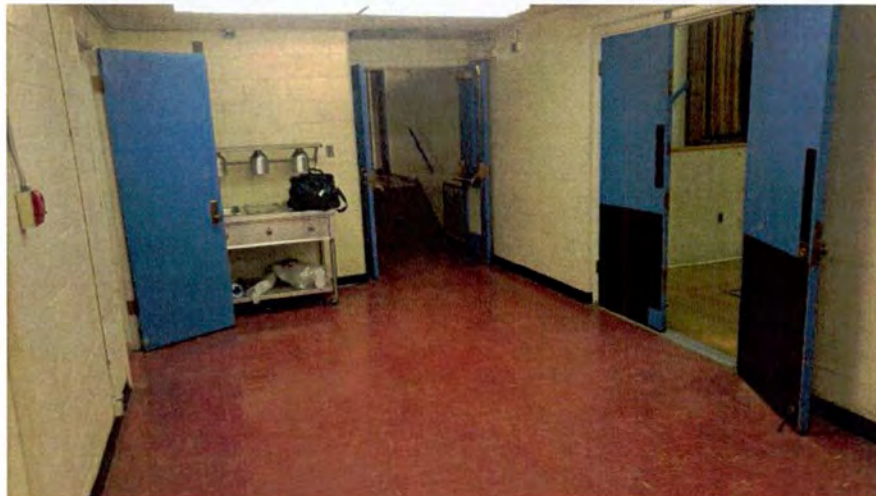
Various vinyl floor tiles were observed to exist within the buildings surveyed. A sample of each pattern/type of vinyl floor tile observed was collected. All 9" vinyl floor tiles within the building and the 12" cream vinyl floor tiles within Storage Room 014 were found to be asbestos containing. No asbestos was detected in any of the underlying mastic adhesive materials. Based on the sampling, asbestos containing vinyl floor tiles (1-5% Chrysotile asbestos) were identified in the following areas:

Corridor 023 – 9" Asbestos Red Vinyl Floor Tiles

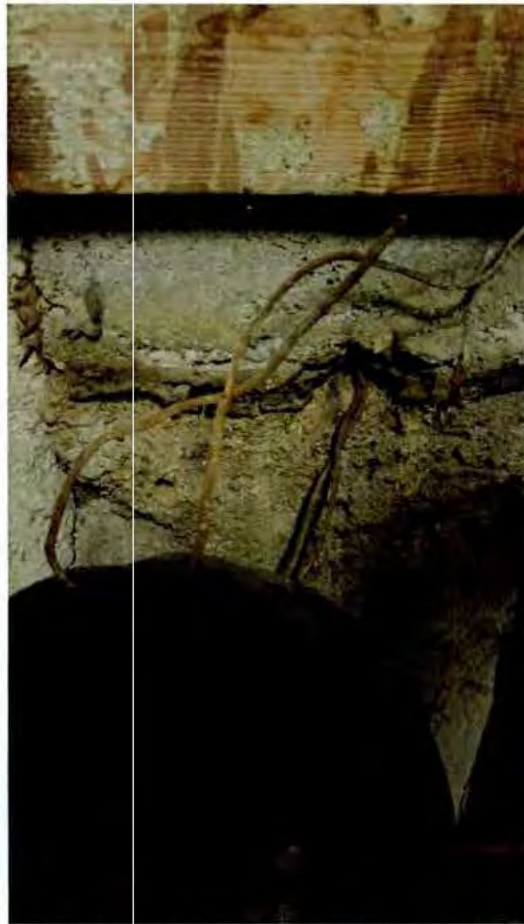
A square opening in the west wall of Fan Room 024 was observed to be filled with a soft brown cementitious material. One sample of the material was collected during this survey and found to contain 1-5% Chrysotile asbestos.

Although no further materials of this type were observed in the building, there is a possibility more of the same materials may exist in concealed areas. Any soft brown cementitious wall fill materials encountered within the building must be treated as asbestos containing.

Asbestos Containing Wall Fill Material in Fan Room 024

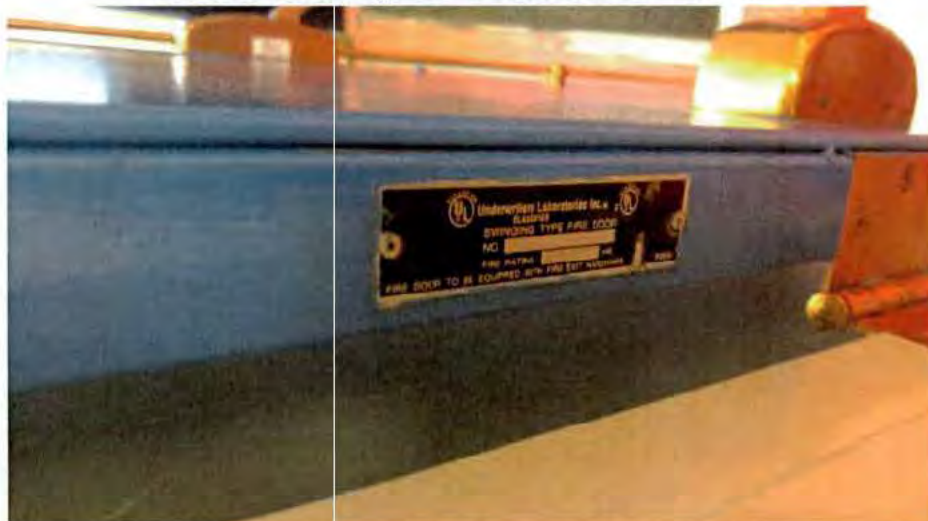
Assumed Asbestos Containing Fire Door Label

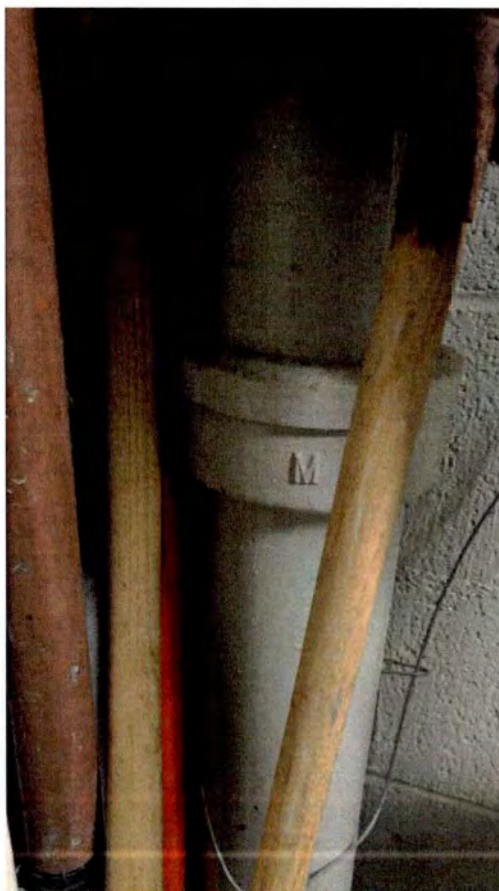
Assumed Asbestos Containing Bells & Spigots on Drain Lines

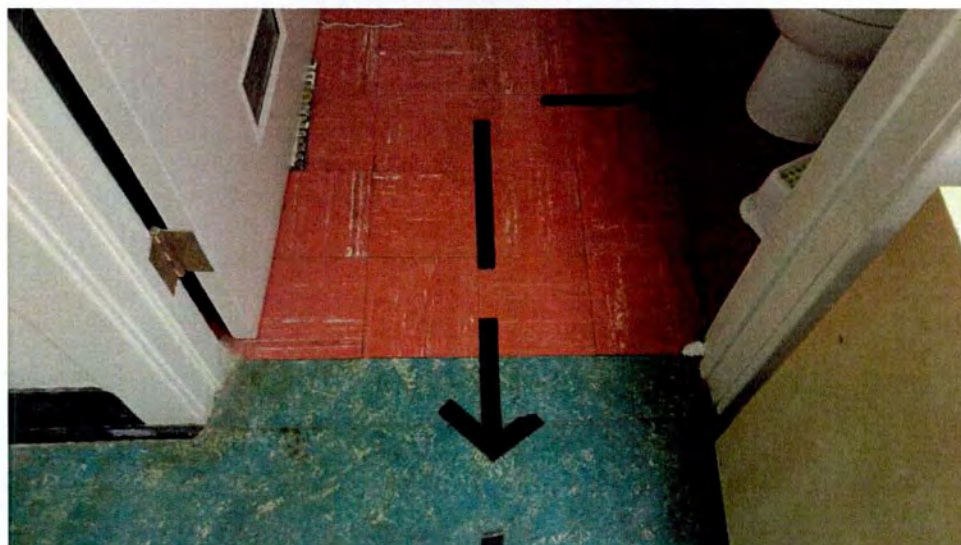
Asbestos Containing Red 9" Vinyl Floor Tiles in Daycare Building Washroom
