File No.: 04-1000-20-2021-531 - Phased Release 1 of 2

## **TREE MANAGEMENT REPORT:** **FOR PROPOSED DEVELOPMENT**

Report Date: **July 4, 2018**

Site Address: **2120 West 10<sup>th</sup> Avenue, Vancouver**

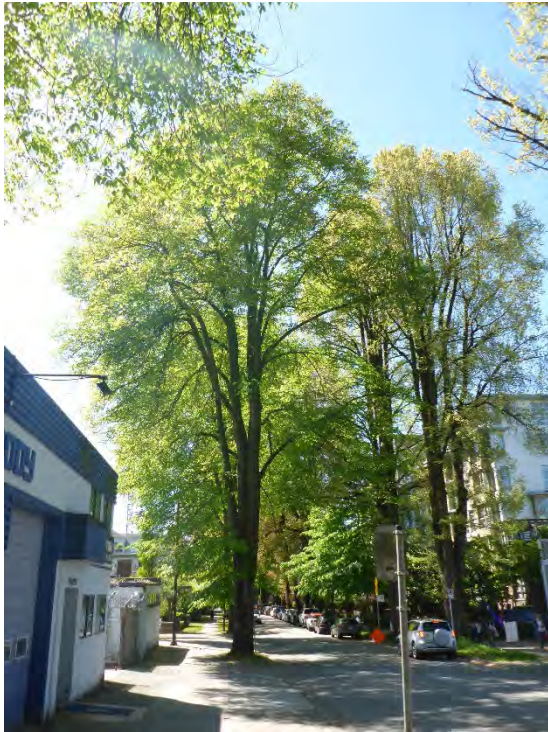
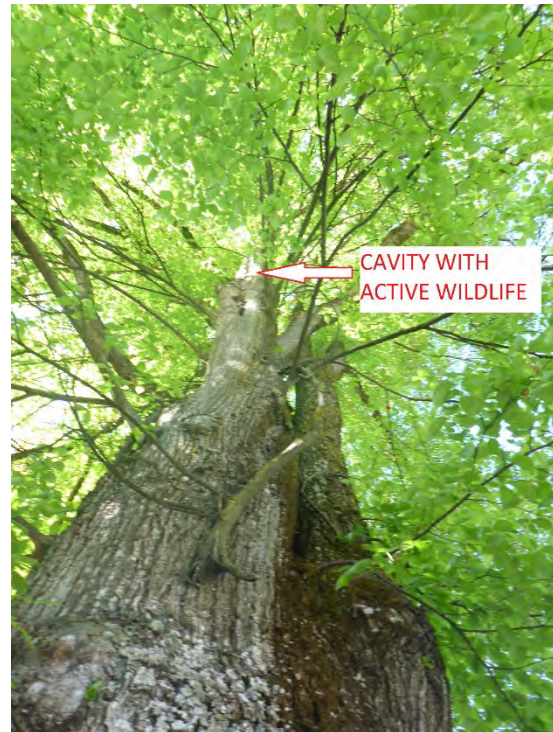
Tree #C01

Tag/ID	# of Trees	Loc	Common name, (Botanical)	Dbh	Ht	Spr	Suitability	Contribution	Priority	Assessment Findings	Action	Rationale	CPZ	RPZ
C01	1	City	Scotch elm (Ulmus glabra)	107	35	8.0	C	H	N/A	<ul style="list-style-type: none"> <li>• Cavity observed on the westernmost scaffold actively used by squirrels</li> <li>• Safe retention of this tree includes end weight reduction of the westernmost scaffold branch, and proactive pruning to reduce the crown spread to 4-5m on the west side of the tree. The overall scope of pruning is well within tolerances and it will not impact the health, stability, nor aesthetics of the tree.</li> <li>• Protect rots to the edge of the existing building near PL.</li> </ul>	Protect		9.0 N 5.0 S	see dwg

- Prune Tree Tag/ID's: C01 and C02  
The crown of this tree overhangs slightly into the subject site. Mitigation of this condition appears feasible within tolerable scopes of pruning with adherence of ANSI A300 standards. The proposed pruning should be directed by the project arborist from this office. Note that all pruning to street trees will require approval from the city arborist at the Parks Board and it will be performed by the Park Board crews at the developer's cost.

2. Pruning - Tree C01 and C02:  
This tree requires pruning as recommended by the project arborist to mitigate aerial building clearance. All tree work is to be carried out under the direction of the project arborist from this office and by the Vancouver Park Board crews. The scope of pruning is within ANSI standards (A300).

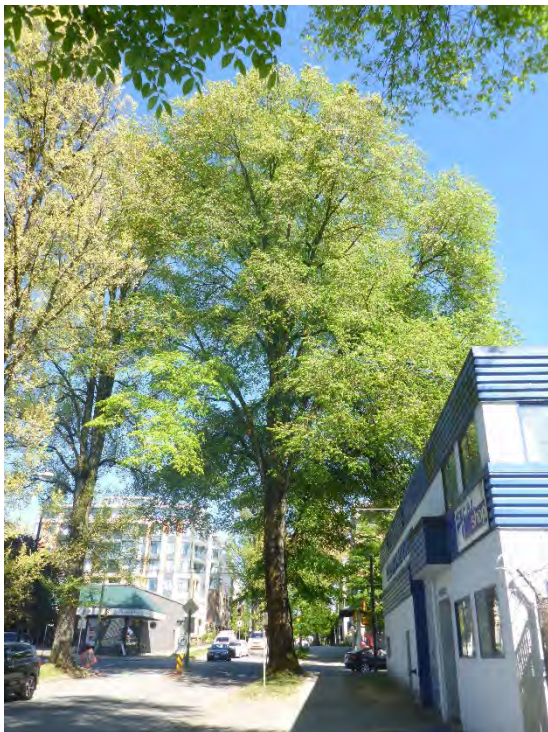
Tree #C02

- 1 tree on this site is deemed to have significant structural defects that warranted assessment by TRAQ methods, considering a 3 year term related to decay within the main bole and the very likely circumstance that the buttress roots have also been structurally impaired by decay fungal disease.

- Tree C02 was assessed to Level 2 Basic Visual Assessment standards.
- Level 3 testing is deemed to not be required to determine severity of defects.
- The target includes Pedestrians, cyclists, cars, and buildings deemed to have frequent and constant occupancies in the current land use, and to have frequent and constant occupancies during the construction phase with high likelihood that tree failure(s) will impact people. The consequences for the failure will be severe.

TRAQ Ratings:	Likelihood of Failure:	Likelihood of Impact:	Failure and Impact:	Consequences:	Risk Rating:
<b>TREE C02</b>	<b>Probable</b>	<b>High</b>	<b>Likely</b>	<b>Severe</b>	<b><u>High</u></b>

- Root and trunk rot diseases (i.e. Armillaria and Ganoderma) fruiting bodies observed at the base of trunk and on ground adjacent to the base of the tree.
- Sounding revealed the presence of internal decay in the buttress roots and within the lower bole.
- Historical trunk injury observed on the north side of the trunk resulting in a large open wound. Internal trunk decay behind the injury was detected by sounding.
- Failure of this tree is probable in any direction via either stem failure or root failure and target ratings are constant.
- Due to the severity of the defects, pruning is not an applicable treatment for mitigation and removal is strongly recommended.
- This tree is **HIGH-RISK** (see TRAQ findings in accompanying report).
- Park Board will be notified by this office for their consideration and action.

- Tree Tag/ID: C02  
This tree will likely be made high-risk due to the demolition and removal of the existing building foundation directly adjacent to the trunk.  
Since this is a project related removal request, the removal and replacement costs are expected to be the responsibility of the developer.

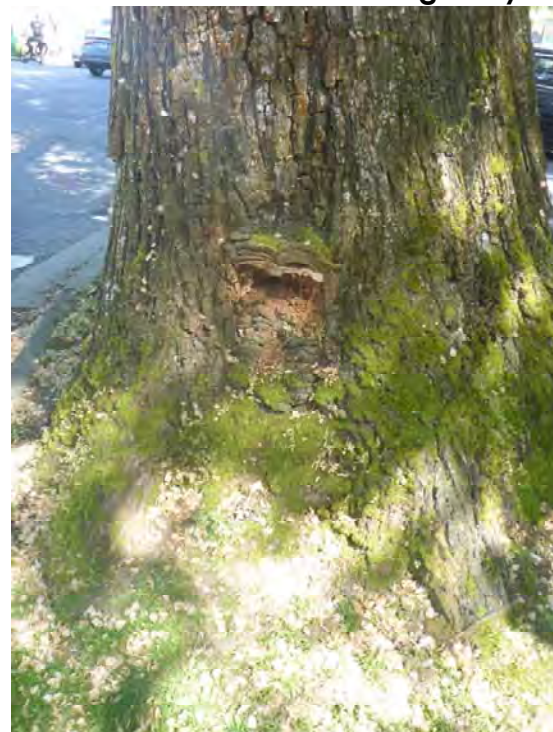
Tree #C02 Ganoderma fruiting body

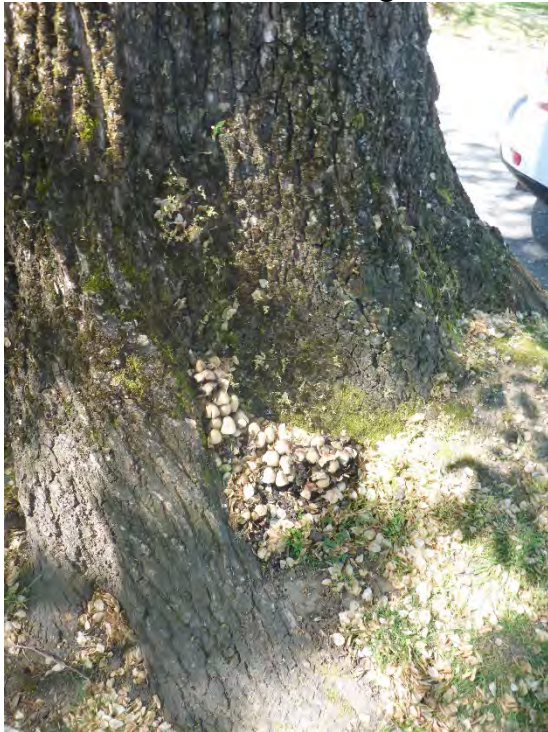
Tree #C02 Armillaria Fruiting bodies

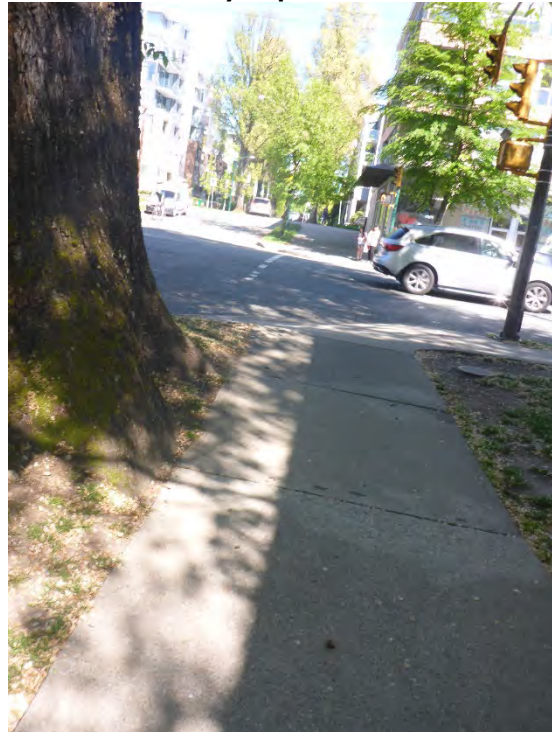
Tree #c02 Newly replaced sidewalk

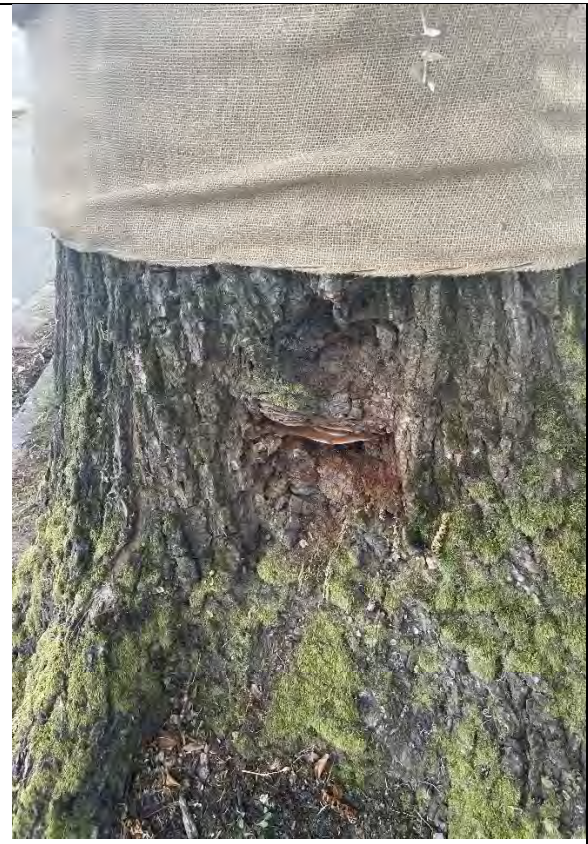
apply<sup>4</sup>". The subject elm has a decay cavity situated at the western edge and a fruiting body indicating a heart-rot decay on the southern side. This shows that the column of decay is not centrally located and therefore the strength loss calculation would make the determination of wood strength difficult to accurately determine. This puts the onus on the City to determine what the acceptable risk threshold is for a significant tree in the City.

Photo 2. Looking at the conk found on the west side of the tree.

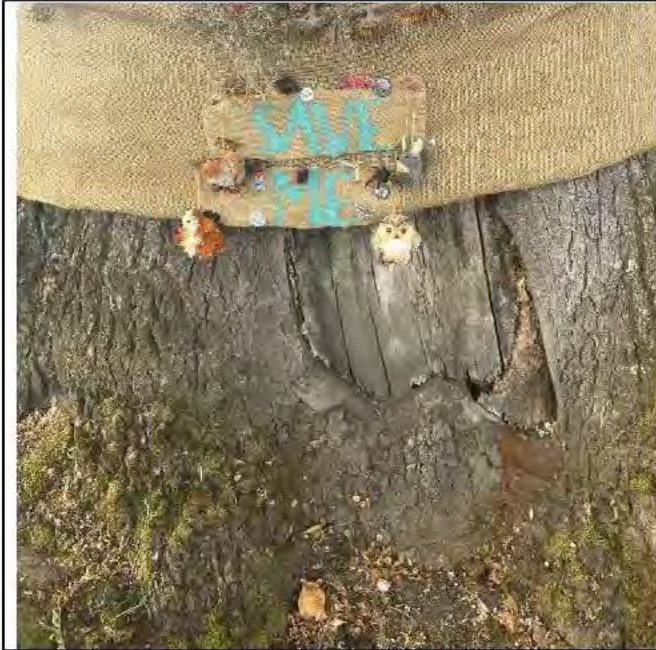
Photo 3. Looking at the wound on the north side where there is a cavity in behind the surface wood.

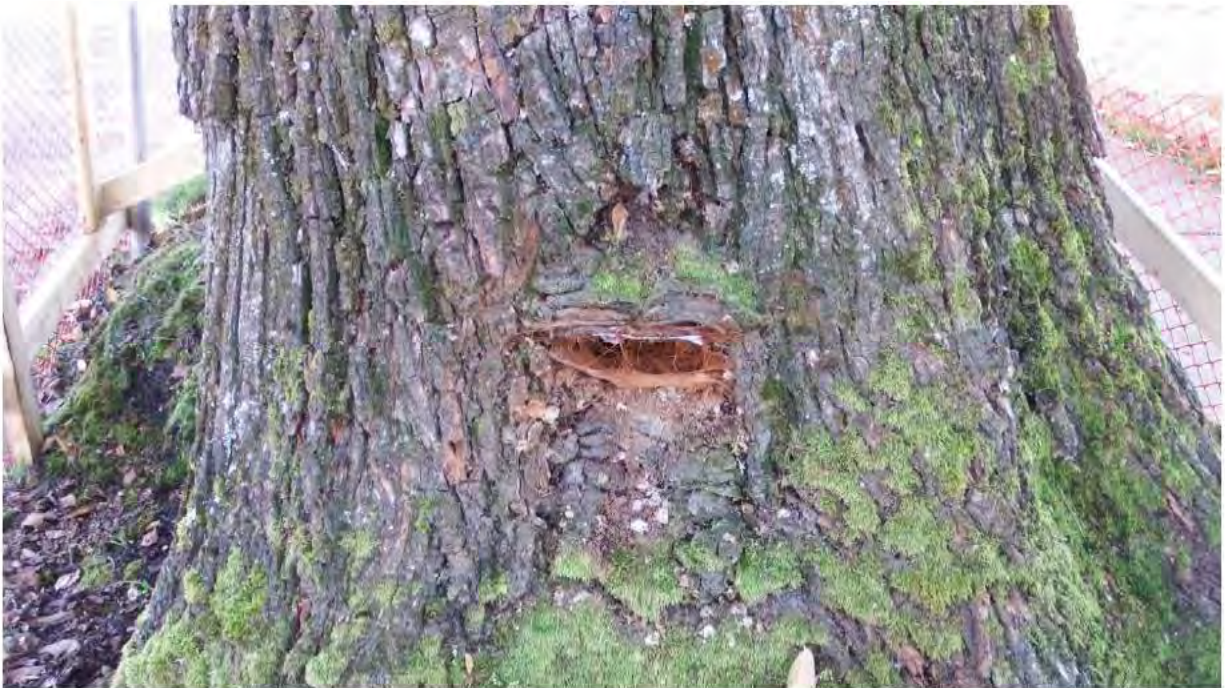
Figure 5 - Ganoderma Conk Visible of West Side of Tree

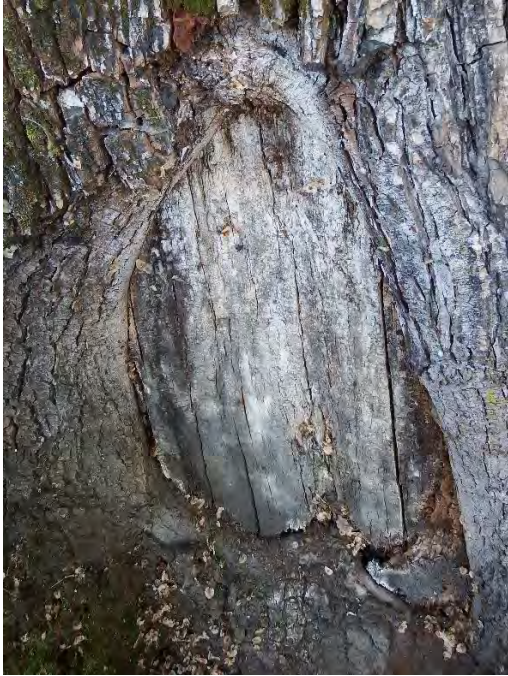
*Figure 6 - Wound on North Side of Trunk Near Base*

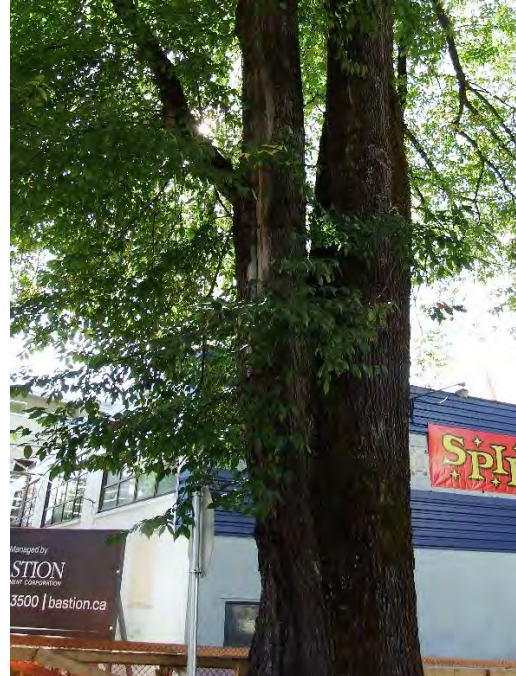
*Figure 7 - Wounded Stem on East Side over Arbutus Street*

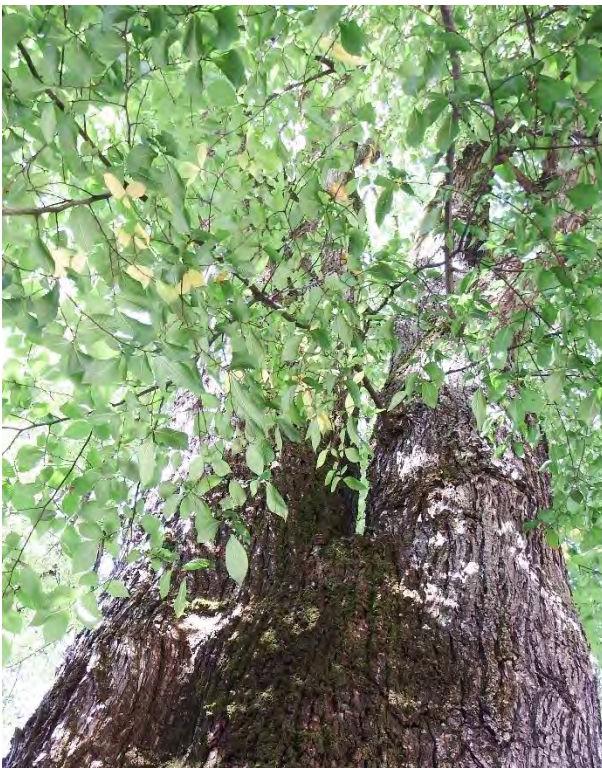
*Figure 8 - Codominant Union*

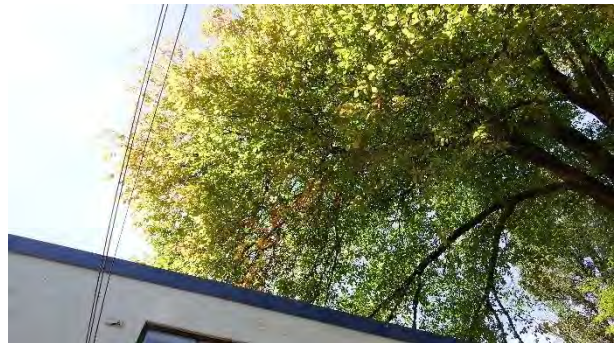
*Figure 9 - Overextended Branches over 2120 W10th Ave.*

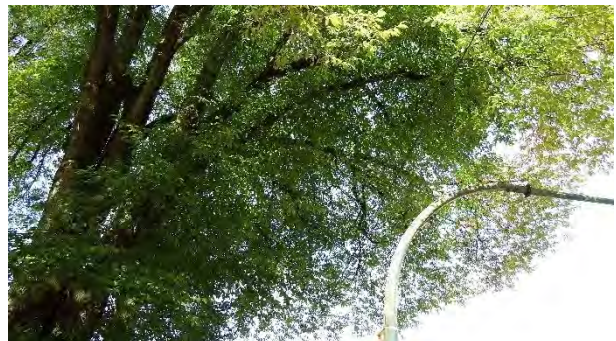
*Figure 10 - Overextended Branches over Arbutus Street*

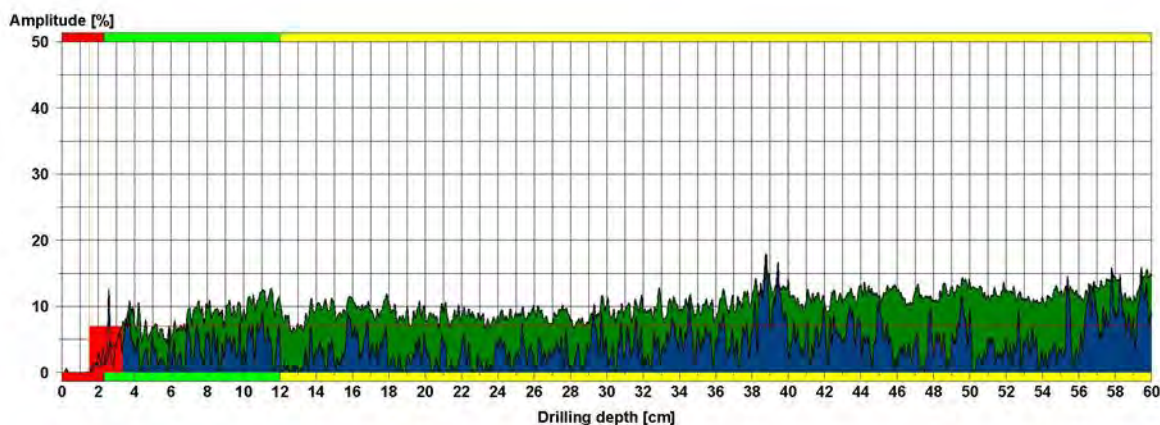
Figure 13 - Resistograph Test 1 Results

This test showed a thin layer of bark followed by an atypical resistance profile for the species. Both the rotational and feed resistance were low. The profile showed likely signs of incipient decay and advanced white rot throughout.

From	0.0 cm	to	2.3 cm	:	Bark
From	2.3 cm	to	12.0 cm	:	Poor Quality Wood
From	12.0 cm	to	60.0 cm	:	White rot
From	0.0 cm	to	0.0 cm	:	
From	0.0 cm	to	0.0 cm	:	
From	0.0 cm	to	0.0 cm	:

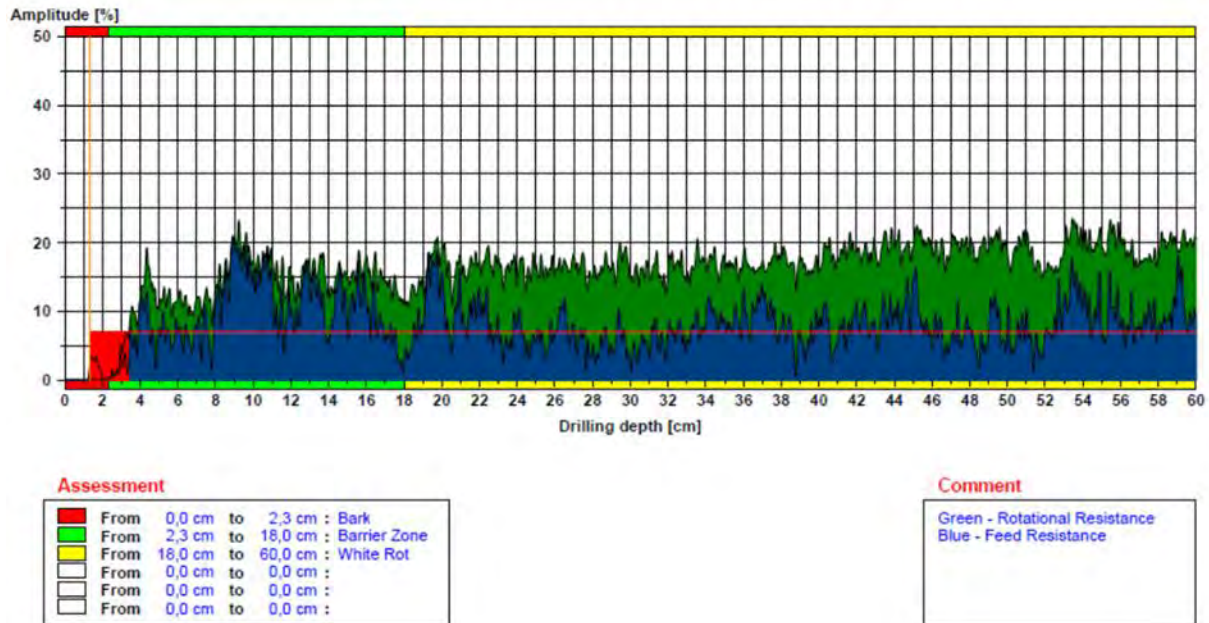
Figure 15 - Resistograph® Test 2 Results

This test showed a lower resistance than typical for the species. 20cm of sound wood was measured, and decay throughout the remaining of the profile. This measurement was taken opposite to conk and 70cm higher. It suggests the decay is progressing out of the root collar and into the basal area of the tree.

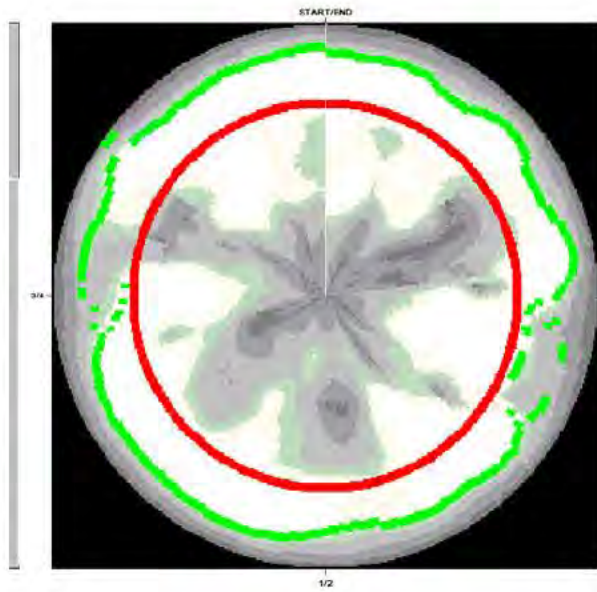
Figure 16 - Envelope Display - Tree Radar® Readout @ 2.1 m

Figure 16 is a readout showing areas of diffused wavelengths from the TRU®. The areas of concern are these diffused wavelengths that are the grey, and green areas within the red circle. These areas suggest alterations of wood density content. The area near the 3/4 mark denotes the area with the large scar from trunk damage.

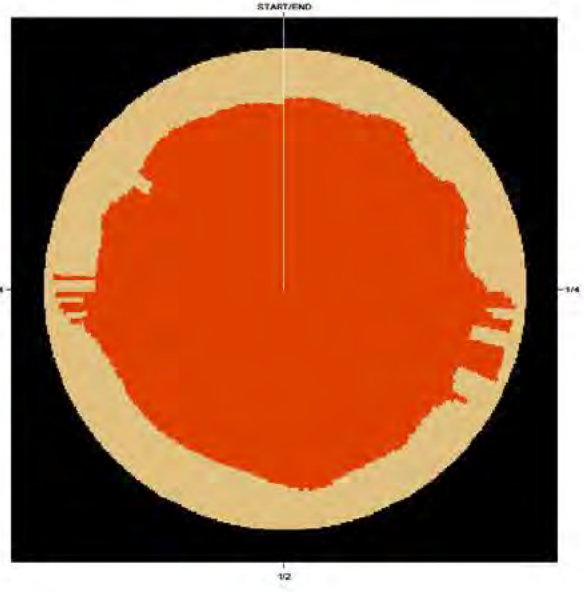
Figure 17 - Smoothed Display - Tree Radar® Readout @ 2.1 m

Figure 17 The orange area indicates changes in wavelength reflection, refraction, or diffusion. It is possible the change indicated by the orange area is heart wood.

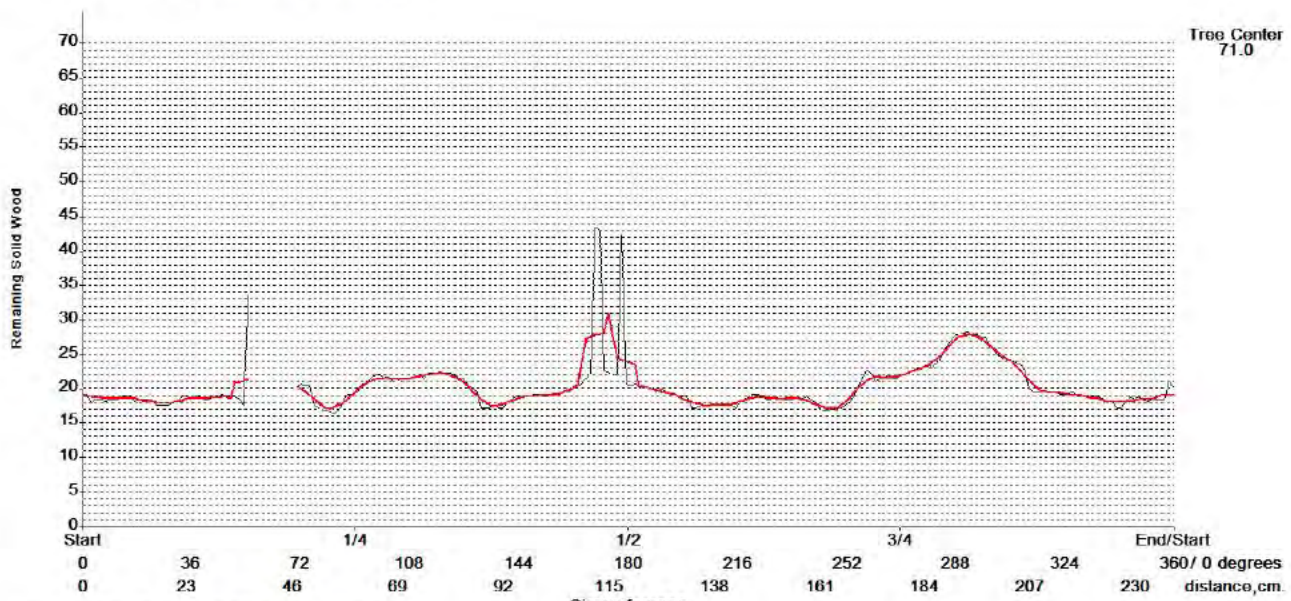
Figure 18 - Graph of TRU Data at 2.1m

This graph is an estimation of remaining sound wood based on the results from TRU® reading at 2.1 m. It suggests the sound wood is approximately 20 cm thick.

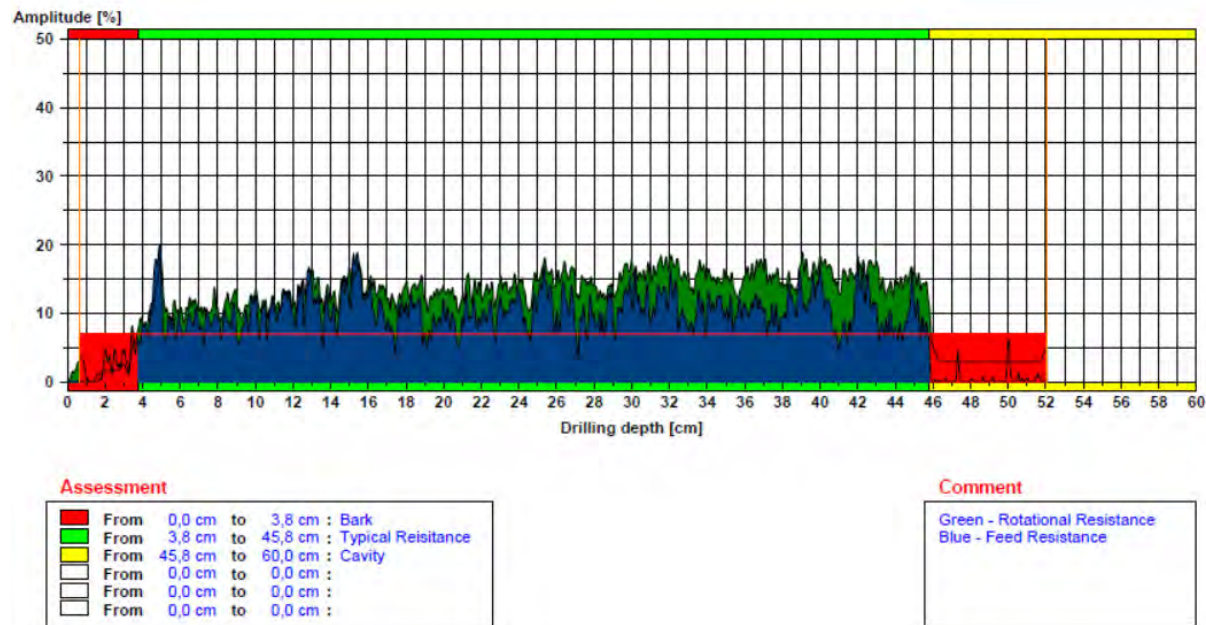
Figure 20 - Resistograph® Test 3 Results

The test was taken in a large buttress with substantial reaction wood to explore the presence of soundwood columns. It showed stronger rotational and feed resistance as compared to the other profiles. The wood was structurally sound up to 46 cm, where a cavity was found.

This is an indicator that the decay is moving outwards and upwards from the observed conk on the west side of the tree.

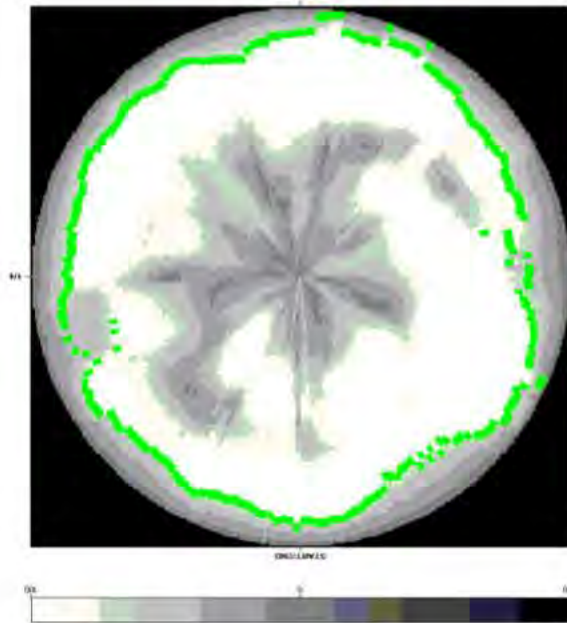
Figure 22 is a TRU® image showing areas increased wavelength diffusion. The areas of concern are these diffused wavelengths that are the grey. These areas also correspond with known decay indicators, such as the cavity and konk.

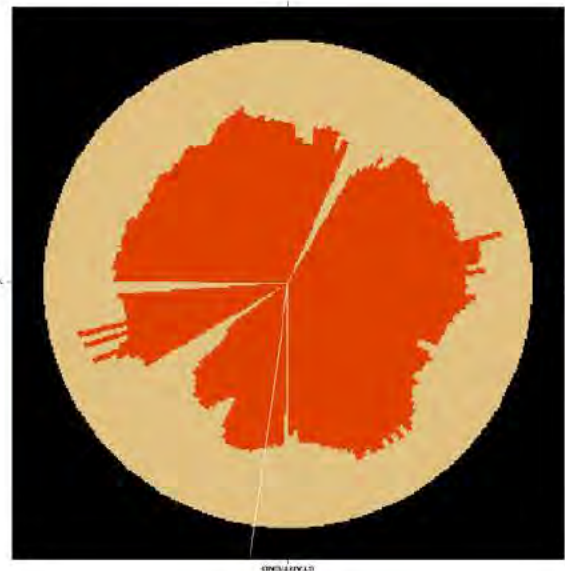
Figure 23 The orange area indicates changes in wavelength reflection, refraction, or diffusion. These areas correspond closely to the data gathered from the Resistograph tests.

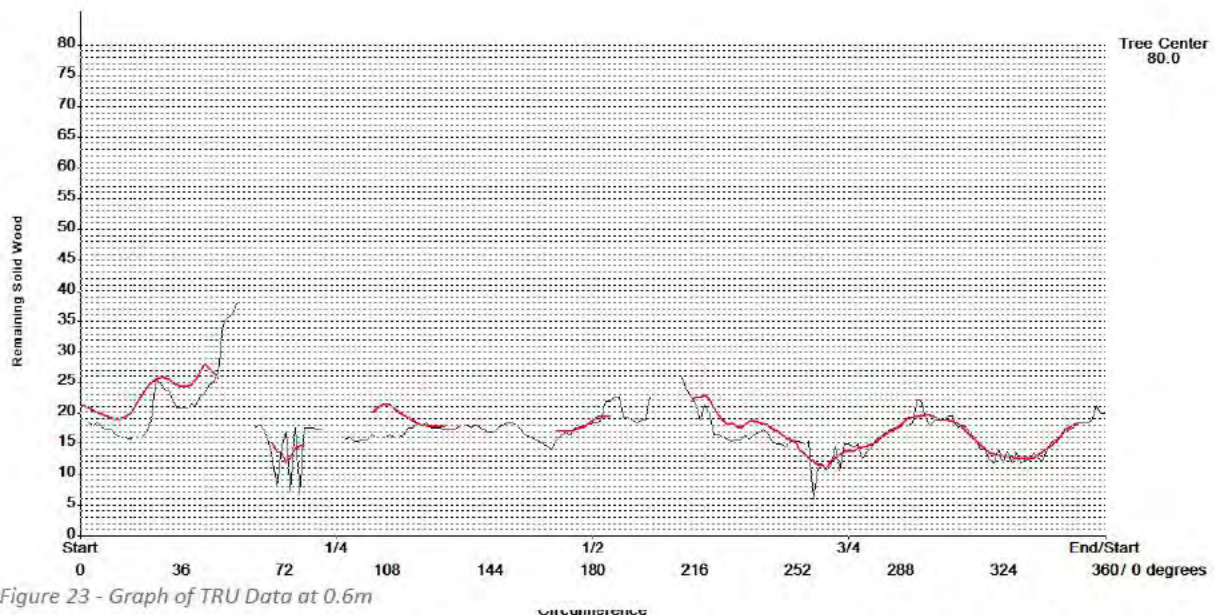
Figure 23 - Graph of TRU Data at 0.6m

This graph represents the estimated remaining sound wood based on the TRU® data. The remaining sound wood averages 15 - 20 cm and is approximately 35 cm in its highest area. The areas of extremely low shell wall correspond with the visibly damaged areas and the area nearest the konk. The area nearing the  $\frac{3}{4}$  mark is associated with the wound near the base on the north side of the tree.

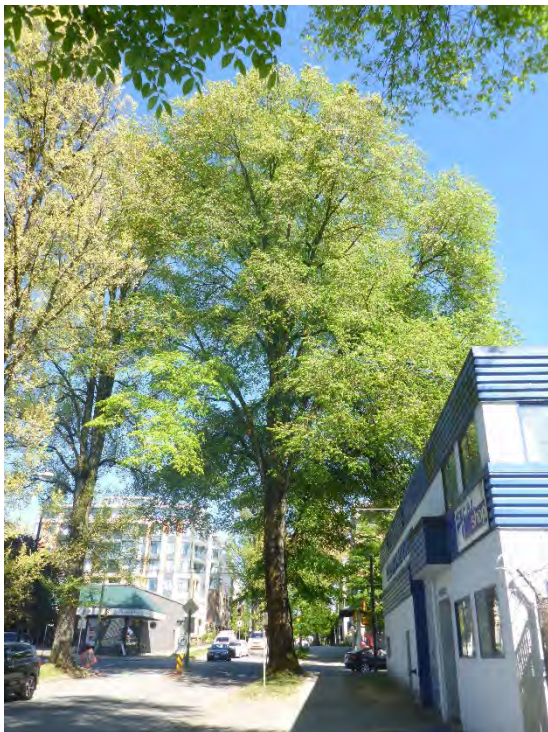
Tree #C02

Tag/ID	# of Trees	Loc	Common name, ( <i>Botanical</i> )	Dbh	Ht	Spr	Suitability	Contribution	Priority	Assessment Findings	Action	Rationale	CPZ	RPZ
C02	1	City	English elm ( <i>Ulmus procera</i> )	134	35	10.0	U	H	N/A	<ul style="list-style-type: none"> <li>• Sidewalk recently replaced adjacent to the tree so root impacts are expected to have been incurred.</li> <li>• Root and trunk rot diseases (i.e. Armillaria and Ganoderma) fruiting bodies observed at the base of trunk and on ground adjacent to the base of the tree.</li> <li>• Sounding revealed the presence of internal decay in the buttress roots and within the lower bole.</li> <li>• Historical trunk injury observed on the north side of the trunk resulting in a large open wound. Internal trunk decay behind the injury was detected by sounding.</li> <li>• Failure of this tree is probable in any direction via either stem failure or root failure and target ratings are constant.</li> <li>• Due to the severity of the defects, pruning is not an applicable treatment for mitigation and removal is strongly recommended.</li> <li>• This tree is <b>HIGH-RISK</b> (see TRAQ findings in accompanying report).</li> <li>• Park Board will be notified by this office for their consideration and action.</li> </ul>	Refer for Removal	High Risk Tree	11.0

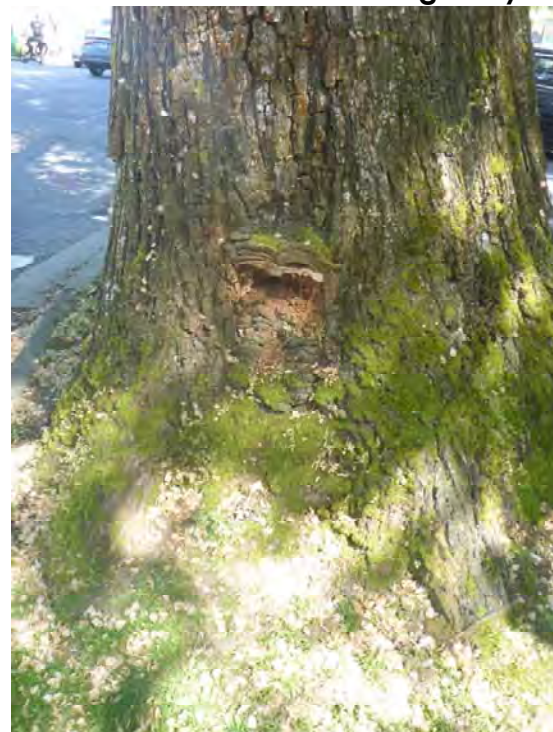
Tree #C02 Ganoderma fruiting body

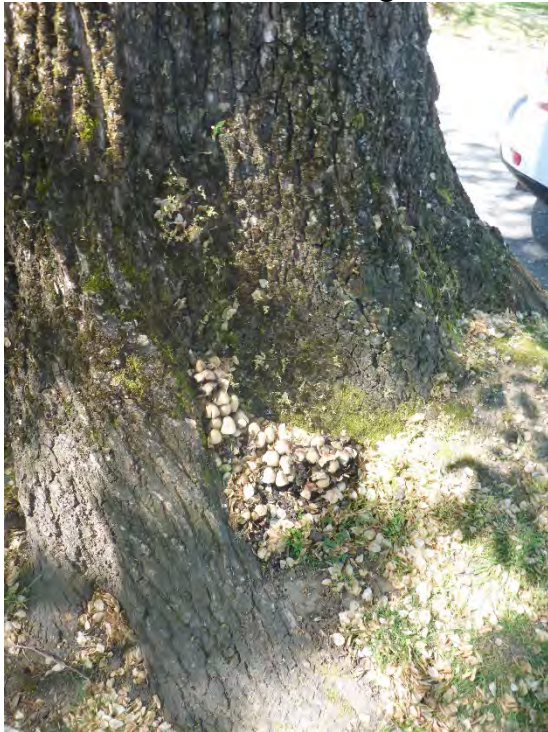
Tree #C02 Armillaria Fruiting bodies

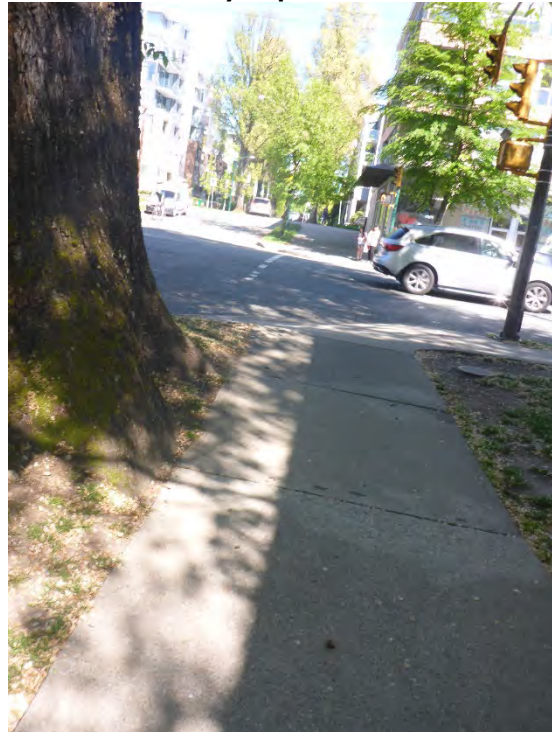
Tree #c02 Newly replaced sidewalk
