Arborist Report

File #:	19-072.1
Date:	07 September 2021 Updated November 1, 2021
Weather:	Sunny
Client:	Blackfish Homes
Telephone:	604-649-4667
Email:	rob@blackfishhomes.ca
Site Address:	3375 West 12th Avenue, Vancouver, British Columbia V6R 2M8

This letter is to detail findings from a post construction site assessment regarding a retained tree on the neighbour's property. Burley Boys Tree Service Ltd. had been retained to be called to site to monitor construction activity near the critical root zones (CRZ's) of the retained trees for the duration of the project and to ensure that all works for the development project have been completed in accordance with the Arborist Report(s), File #19-017 (19-017.1) dated 11 February 2019.

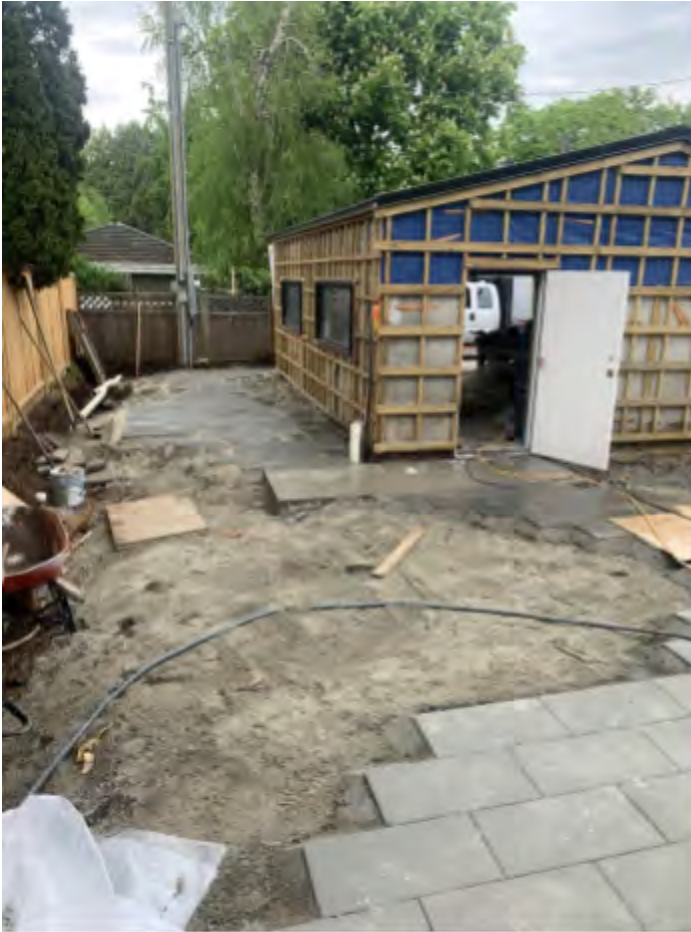
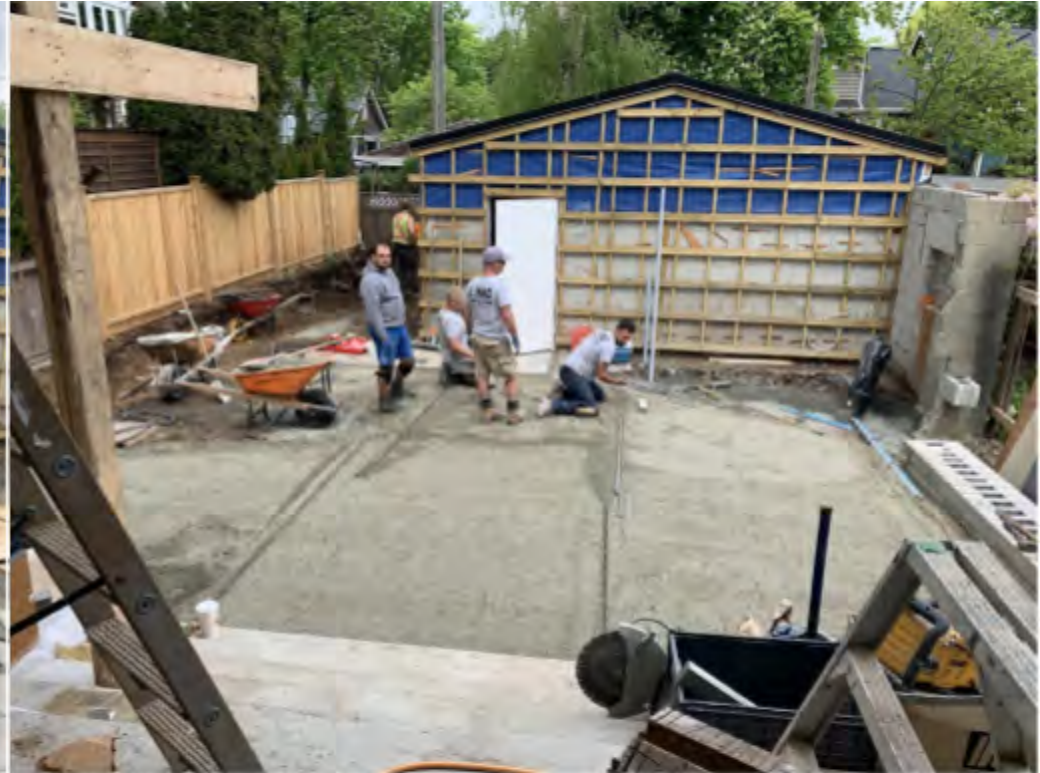
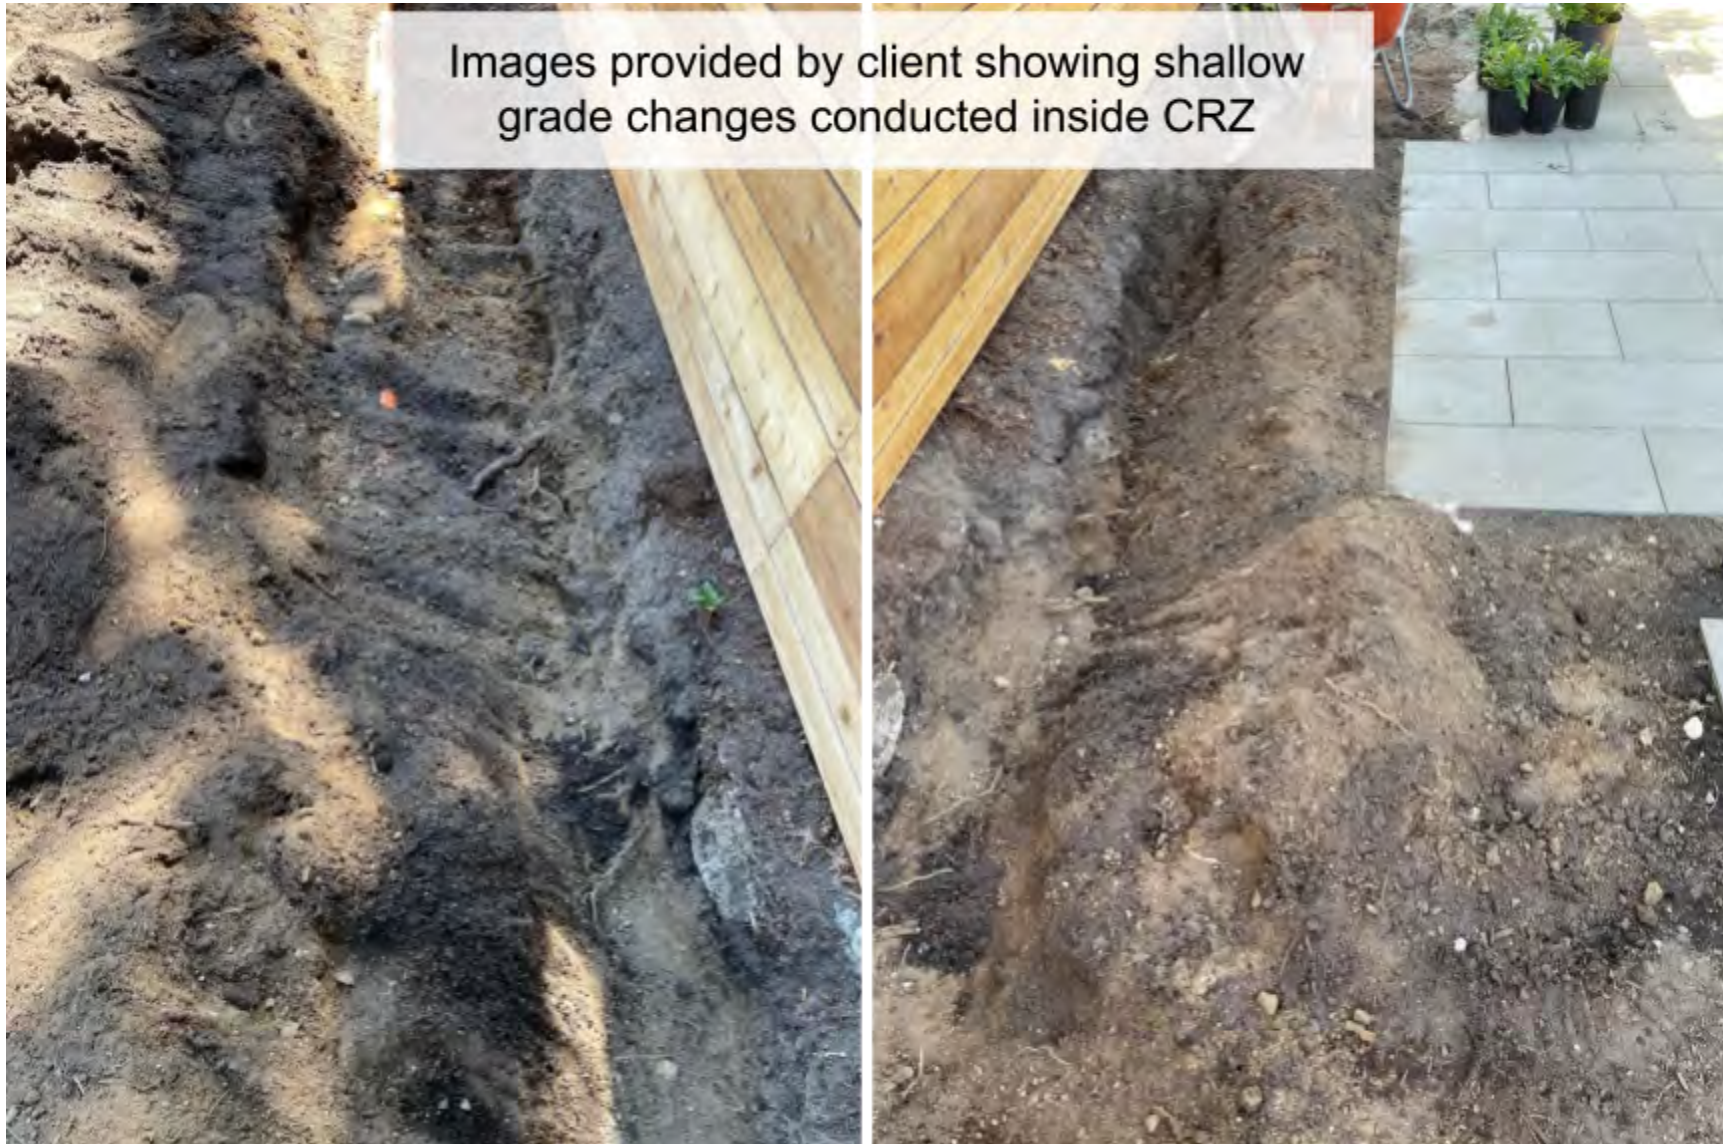
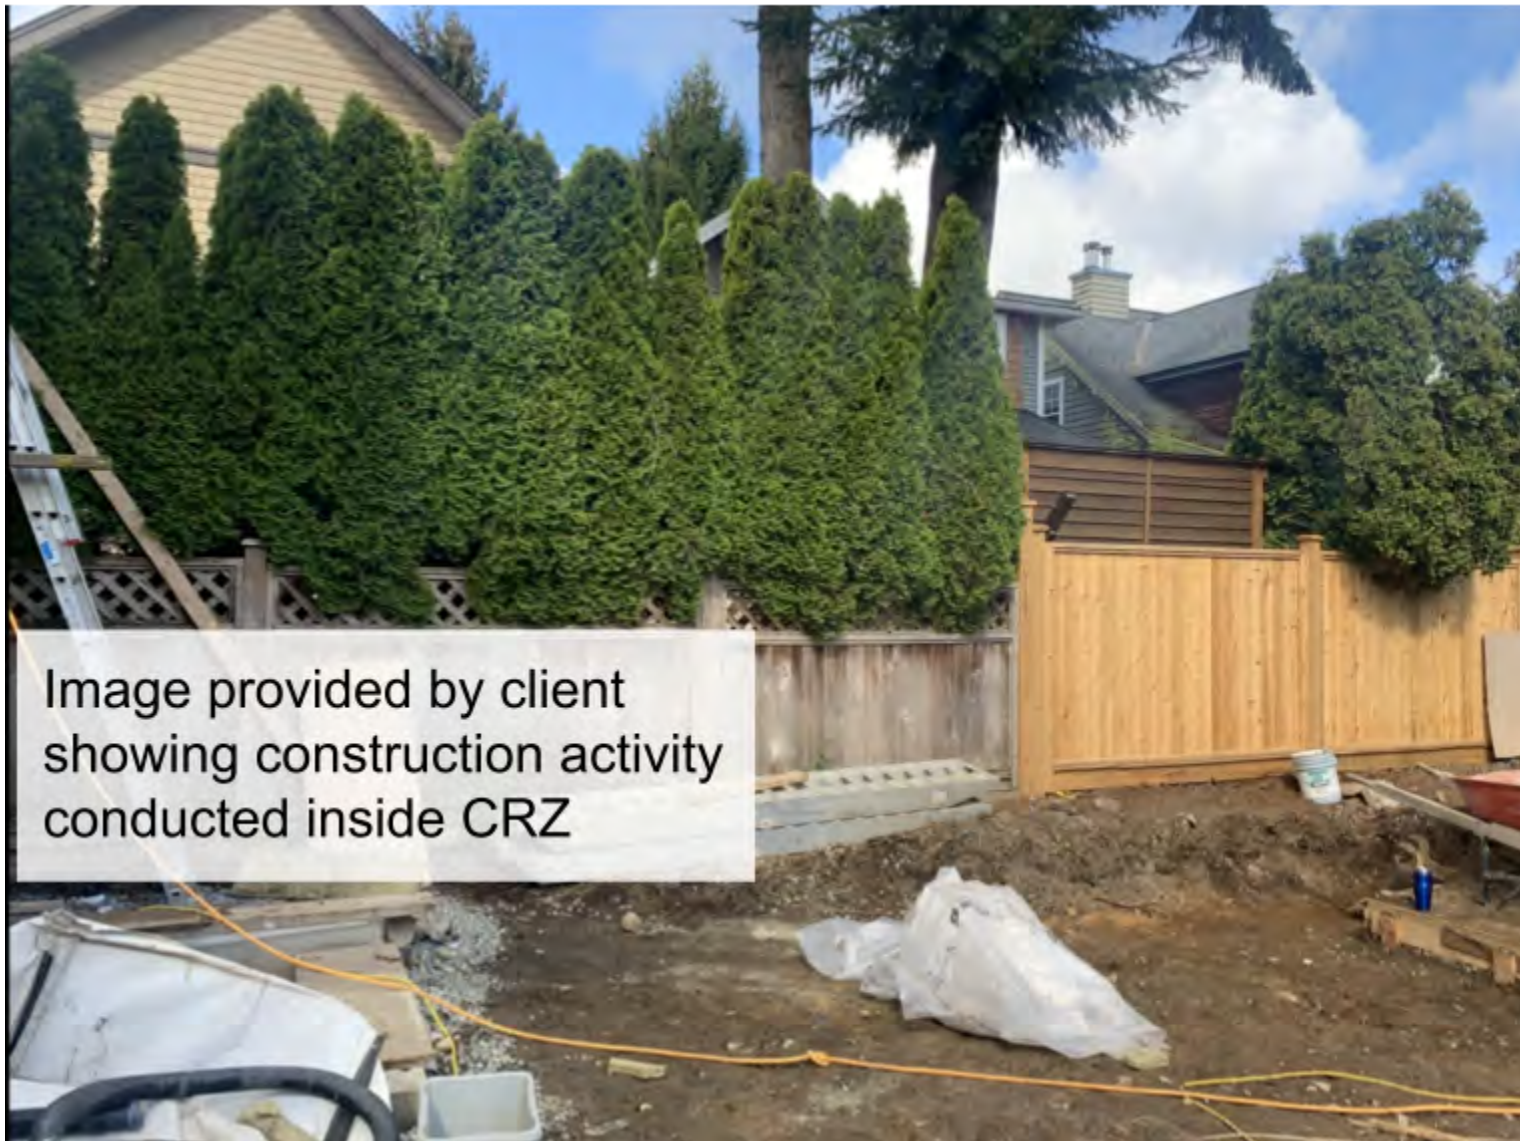
The tree appears to be unaffected as a result of this construction. The previous grade has been restored. As can be seen in the provided images, only small fibrous roots were impacted by the shallow excavations. Small landscape plants were installed along the inside of the property line, and the new fence was installed at the same location as the previously existing fence. A small row of black bamboo hedging was installed and a semi-porous paver walkway with a small lawn area was installed.

The construction activity has affected less than 25% of the tree's CRZ and the area is permeable. In my experience managing tree retention through construction, Douglas fir trees are generally very resilient to such excavations; in well drained soils with little to no bedrock they are some of the deepest rooted trees in the area.

There is no evidence or suspicion that any of the tree's large, structural roots were damaged or severed during construction. no adverse effects are expected to the health or condition of this tree. This tree is deemed to present moderate risk. This is within an acceptable threshold. Retention is recommended.

Images provided by client showing construction activity conducted inside CRZ

As a beneficial option, Tree #6's CRZ should be considered to be aerated, vertically mulched & deep root fertilized by a Certified Arborist, this will alleviate any soil compaction that may have occurred and to help the tree re-generate the small fibrous roots that were lost during the shallow excavations. **This work has been completed.**

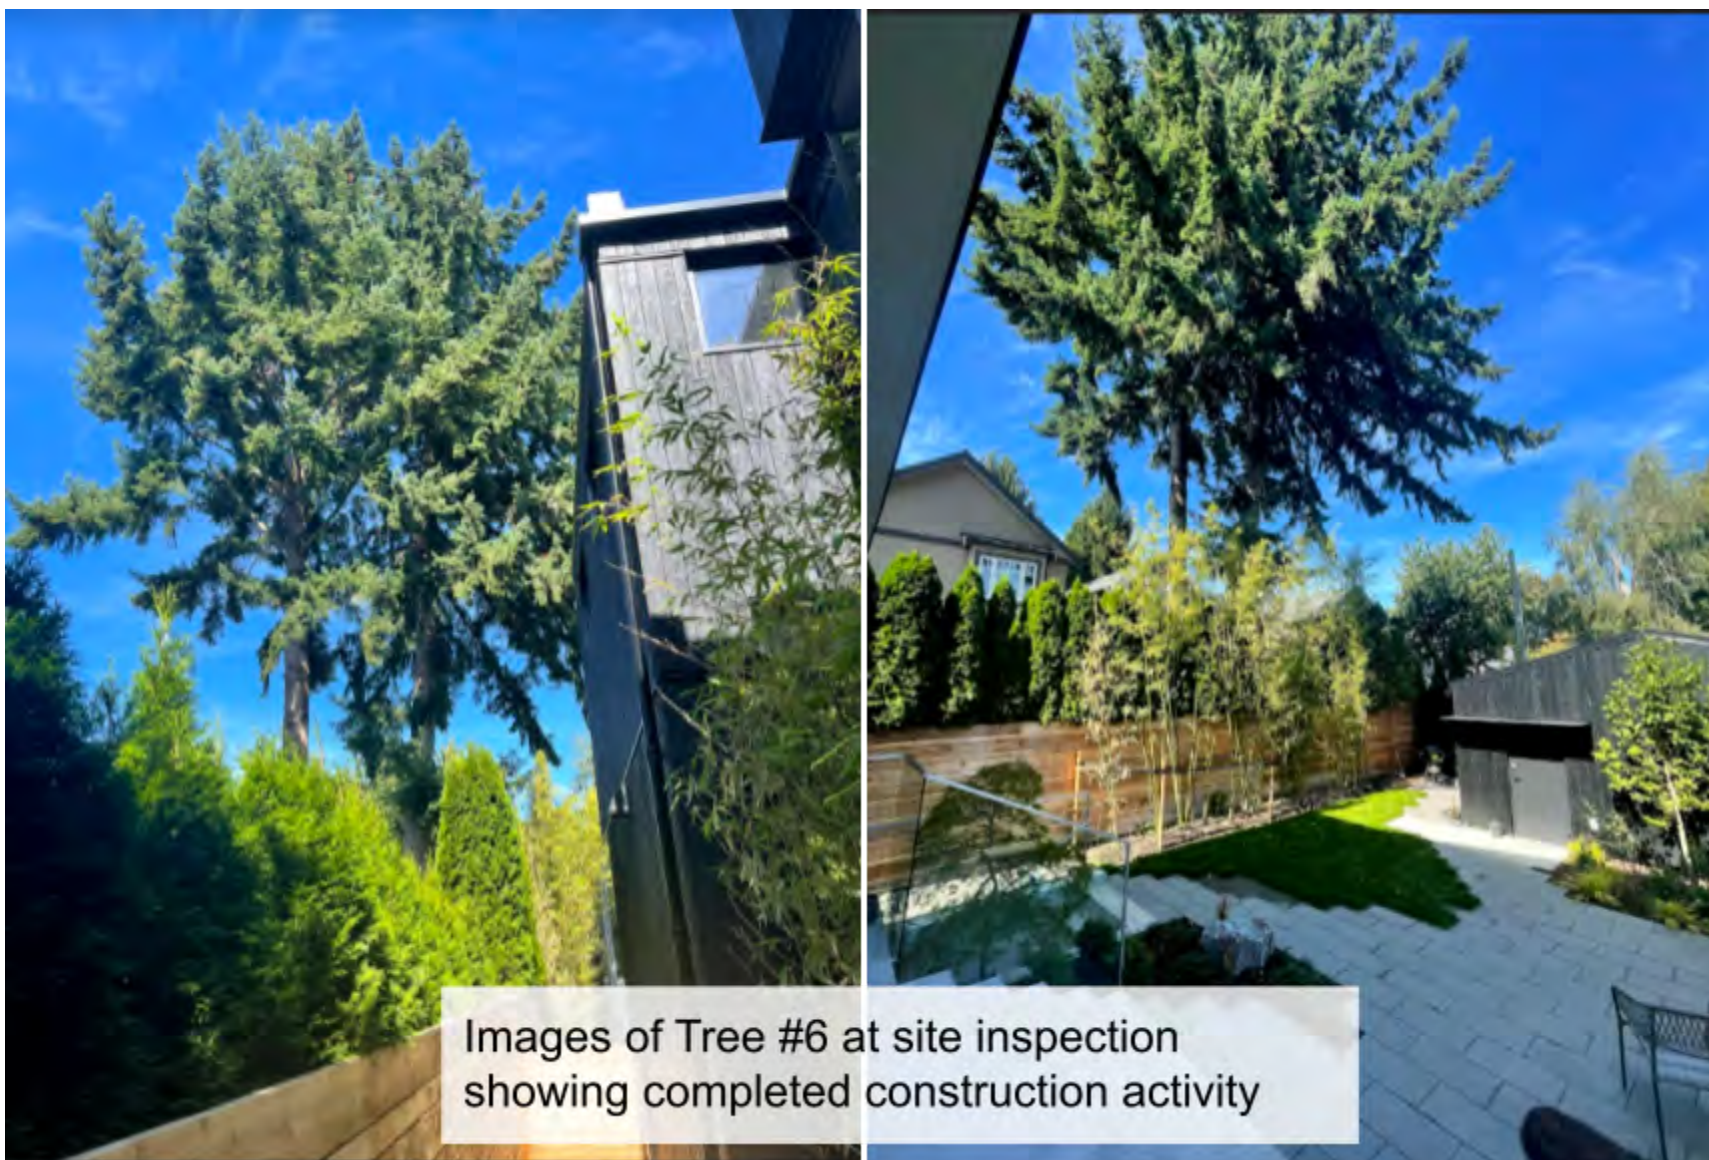
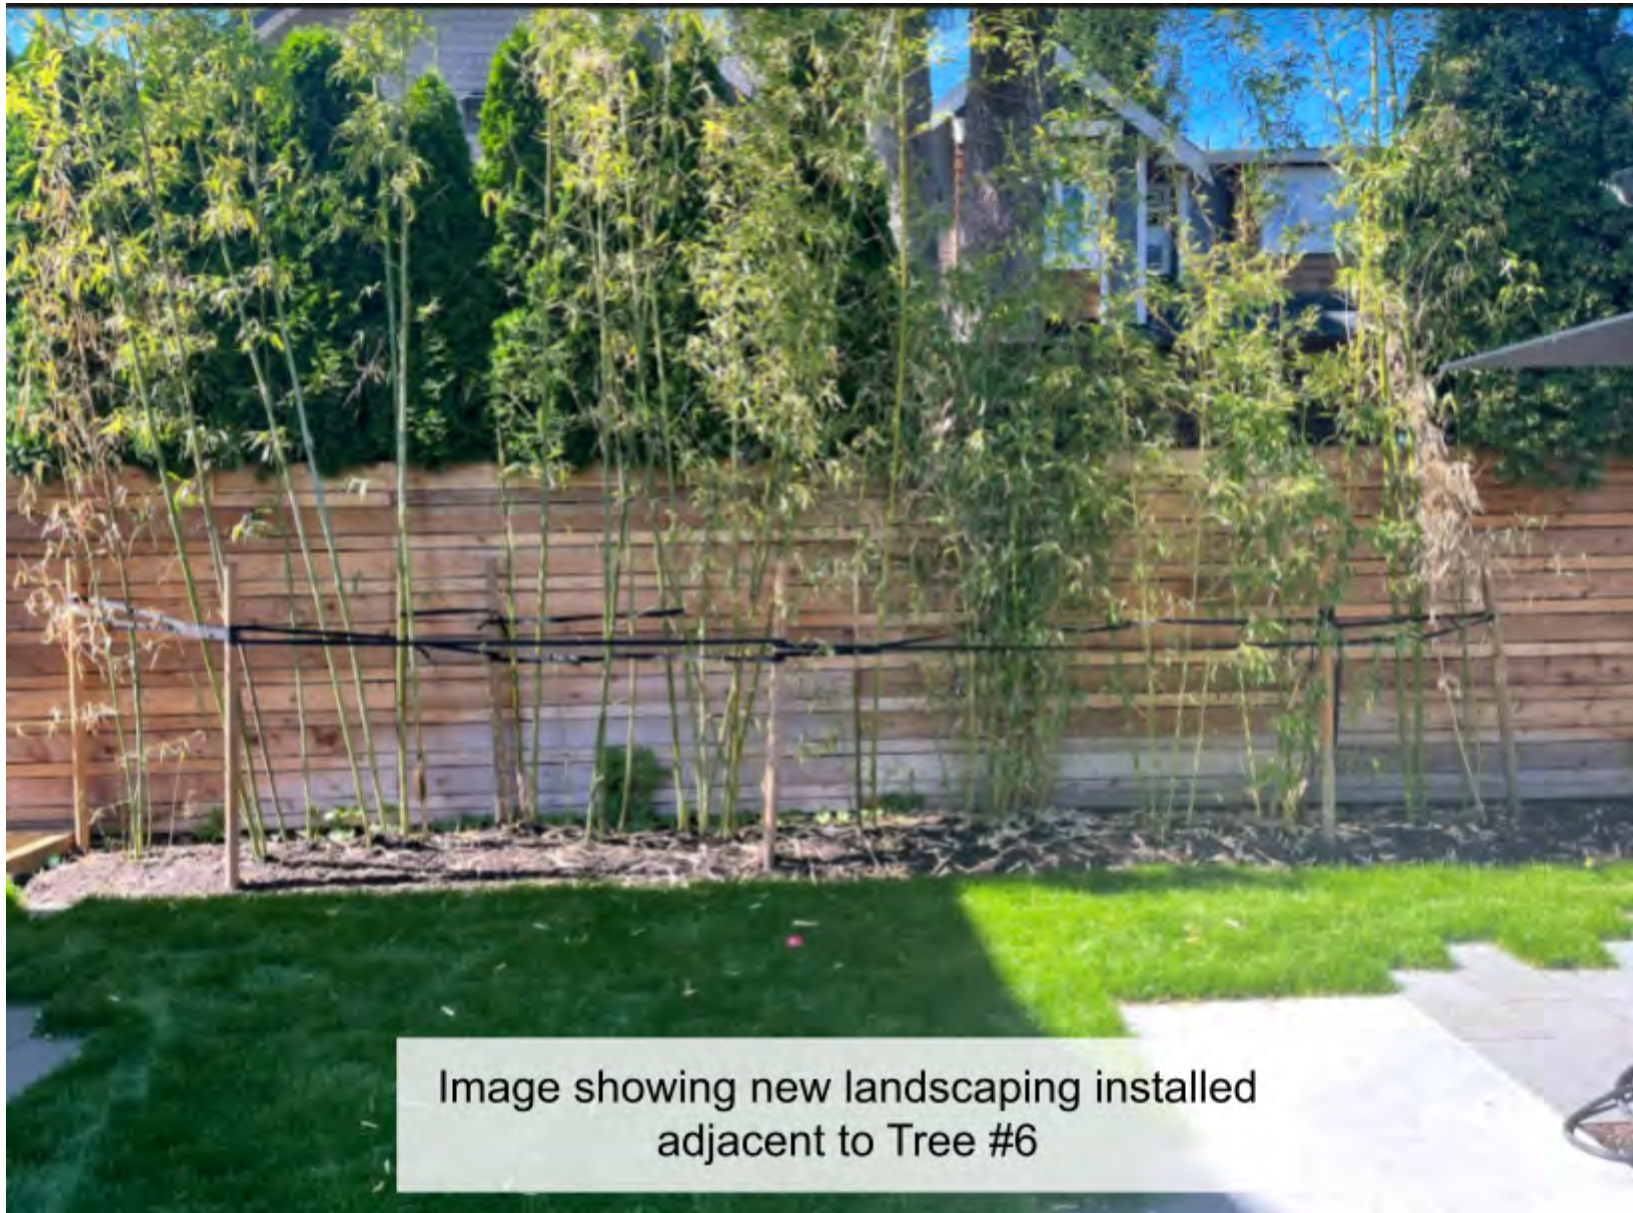
There is no concern that the newly planted small landscape plants will prohibit the tree's ability to re-grow small, fibrous roots.

Image showing new landscaping installed adjacent to Tree #6
