GEOTECHNICAL COMMENTS ON CAUSES AND FACTORS CONTRIBUTING TO COLLAPSE OF WEST EXCAVATION SHORING

Proposed Development
138 East 8th Avenue
Vancouver, BC

Our File: 120-4694

March 31, 2020

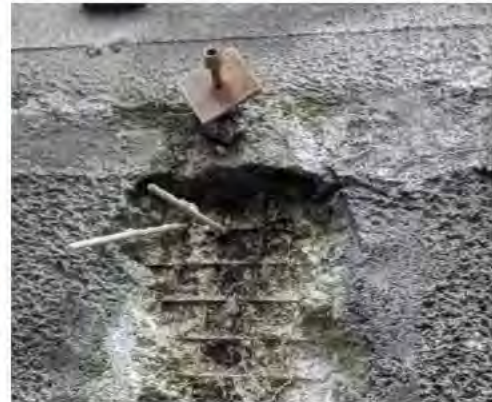
Photo 1: Anchor with loose plate and nut, efflorescence present - January 30, 2020

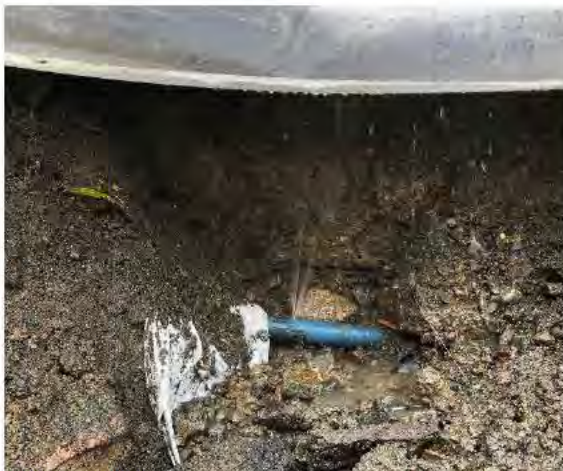
- Two photographs (Photo 2 and Photo 3) taken March 25, 2019 indicate a location where the water connection leading to the CNH building was leaking. This location appears to be near the north portion of the West Elevation (and near the future location of concentrated seepage). It is east of the documented location of this connection per City information. [We understand from discussions with Marco Sakamoto of Prima West on March 18, 2020, that this leak was repaired by a plumber using a rubber clamp.]

Photo 2: Water connection leak – March 25, 2019

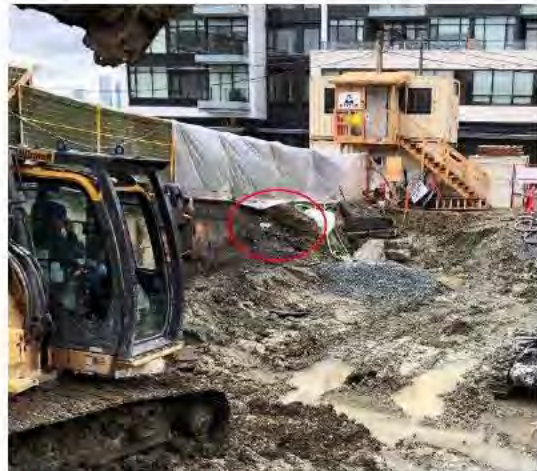
Photo 3: Inferred location of water connection leak March 25, 2019

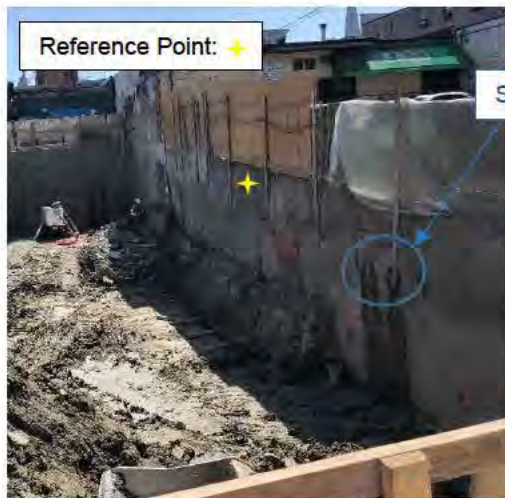
- There is a location approximately 30 feet south of the north end of the West Elevation near the first row of anchors where concentrated seepage out of the shoring face is evident, even on dry days, as early as May 1, 2019. We note that the above-noted repair of the CNH water service is near this seepage zone, as is the catch basin located in the parking lot of 141 East Broadway, approximately west of this seepage zone. With the passage of time, seepage at this elevation became progressively more extensive in a southward direction (Photos 4A, 4B and 5). Note that a reference point is used to indicate the same location in all the aforementioned photos.

Photo 4A: West Elevation seepage - May 1, 2019

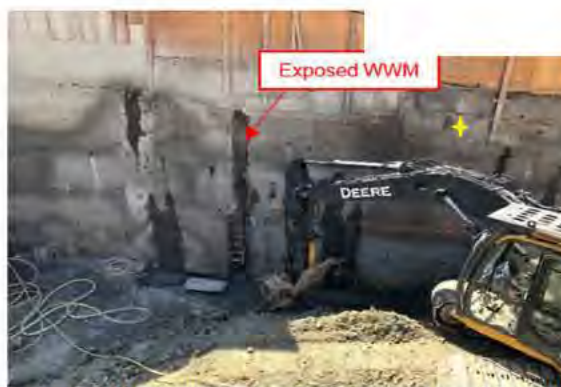
Photo 5: West Elevation Seepage - May 23, 2019

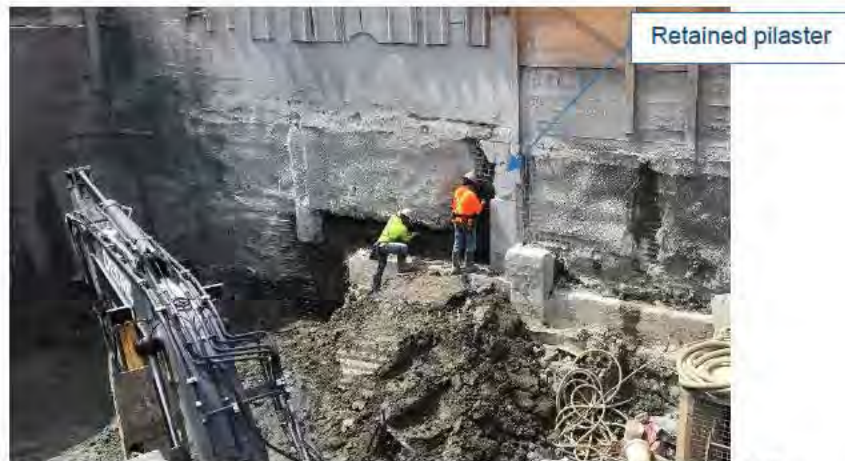
- Photographs indicate that underpinning installation did not follow the 3-day sequence specified in the GeoPacific drawings. Most notably, on May 9, 2019 it is estimated that approximately 60% of the subgrade supporting underpinning beneath the east wall of the CNH building fronting the Development Site was removed (rather than 33%). [It is inferred that the first lift of underpinning acted as a beam supported at its north end on the pilaster remnant. Pre-failure cracking of the CNH building walls could have been expected to result from this and subsequent load redistribution.]

Photo 6: 3-day panel excavation sequence not followed, May 9, 2019

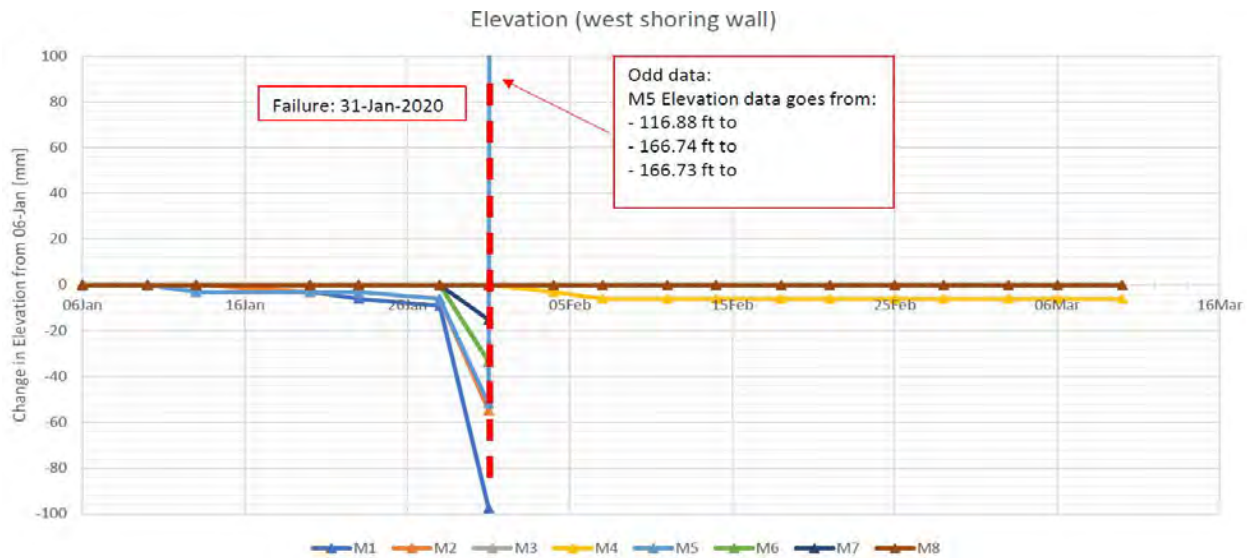
Figure 1: Survey monitoring data for West Elevation ('new') monitoring points

The above plot indicates a trend of increasing movement between January 6 and January 28, with January 28 movements exceeding the threshold where they might be considered to be within typical survey error. Rapid deterioration is evident between January 28 and the final, pre-failure measurements on January 31, 2020. The movement trends shown on these plots is consistent with qualitative observations of the progressively worsening cracking on the west shotcrete shoring wall and the subsidence and cracking in the asphalt immediately to the west.

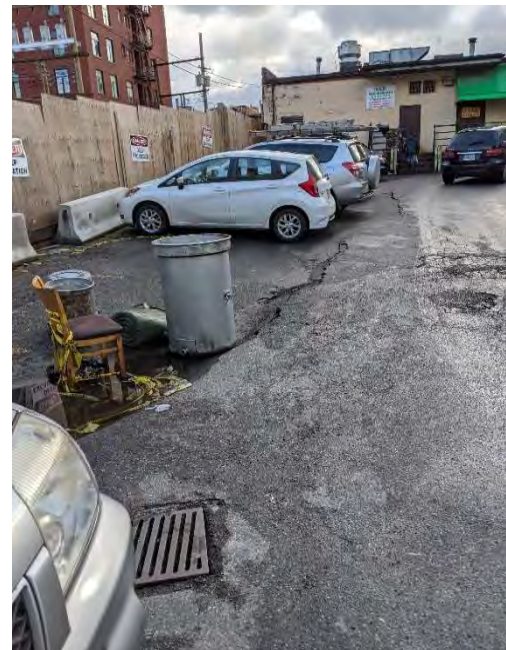
Photo 7: Parking lot cracking, January 28, 2020 (from Prima West)

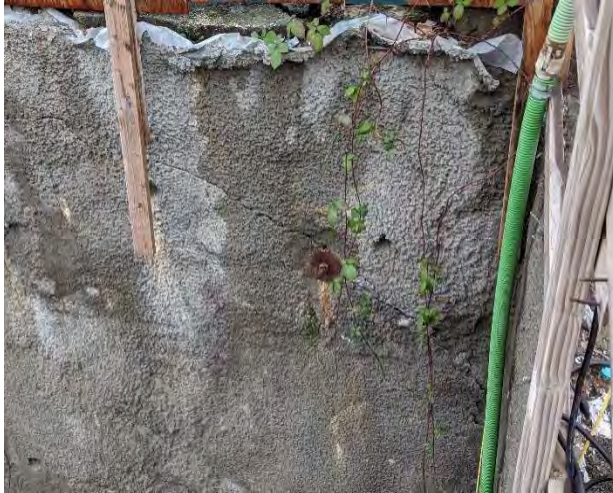
Photo 8: Cracking in the West Elevation, north end (Prima West, Jan. 27, 2020)

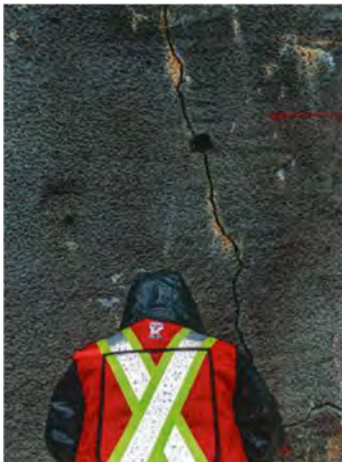
Photo 9: Expanded cracks in the West Elevation (GeoPacific, January 31, 2020)

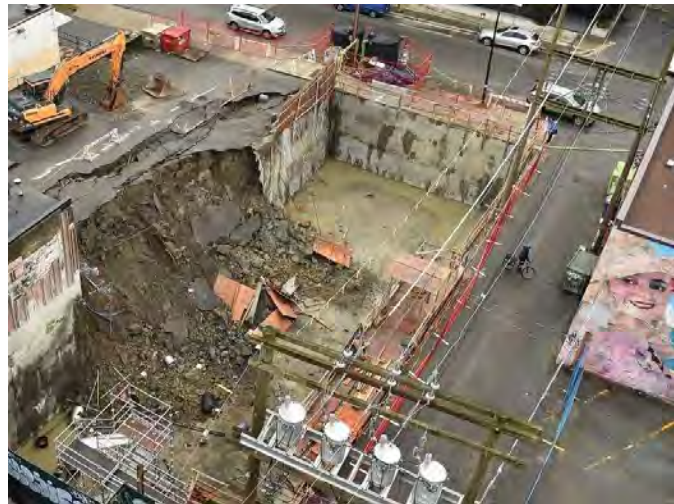
Photo 10: Aerial view of shoring failure (Vancouver is Awesome, February 4, 2020)

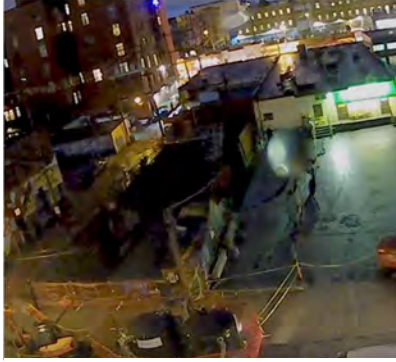
Photos 11 to 13 show the pattern of failure as indicated in the above referenced video. It is noted that the failure initiated in the north-south centre of the West Elevation shoring wall immediately adjacent to and encompassing the CNH parking lot (i.e. Section A). An splash of standing water at the base of the excavation can be seen being as a result of impact by collapsing material.

Photo 11: Failure initiated

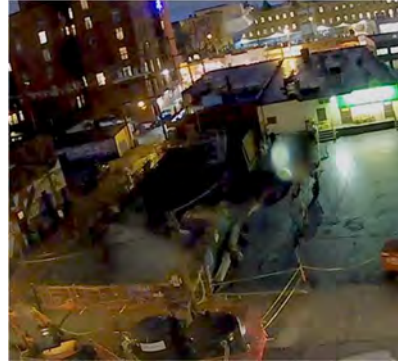
Photo 12: Material collapses

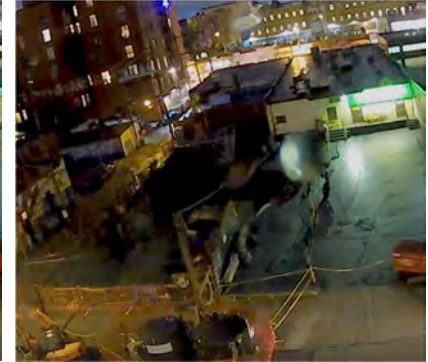
Photo 13: Material retained by existing basement wall collapses, 40 seconds after failure initiation

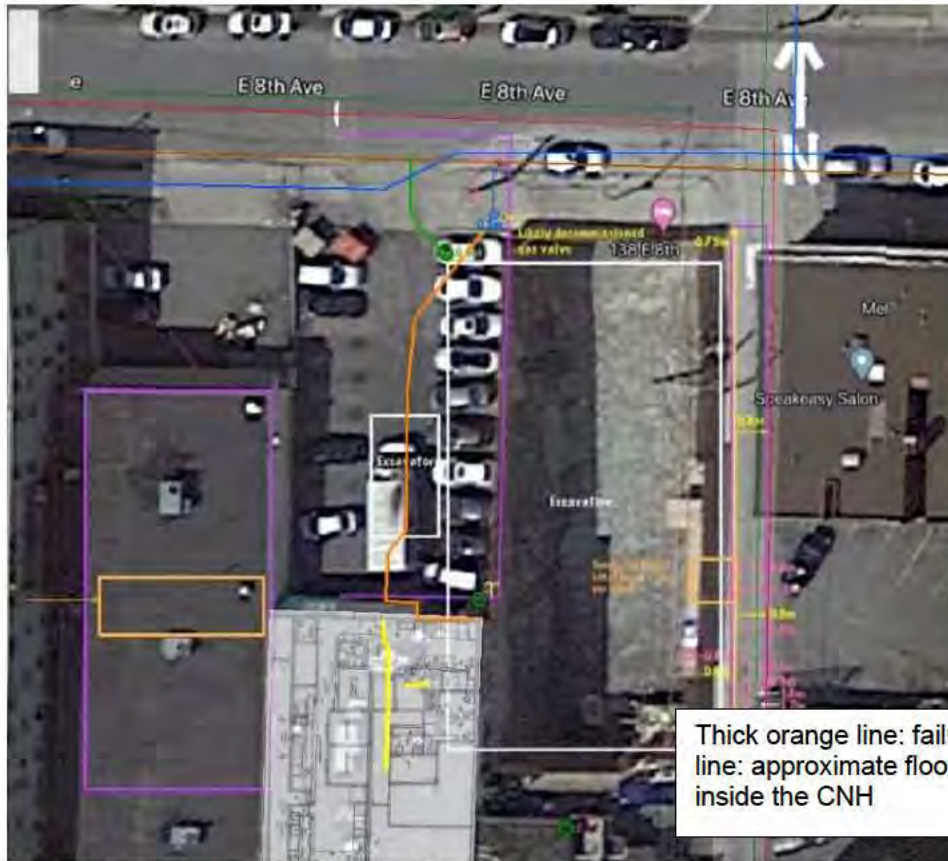
Thick orange line: failure scarp, Thick yellow line: approximate floor slab crack location inside the CNH

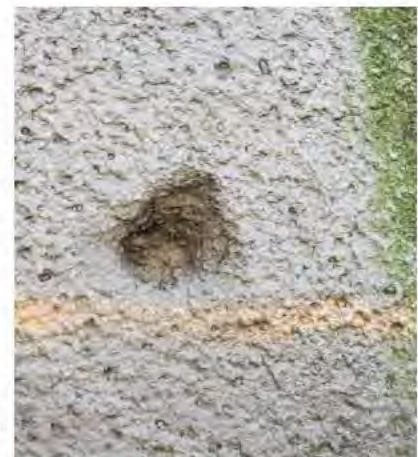
- Nine of 18 weep holes investigated along the East Elevation were not functional. Of the nine weep holes that were deemed to be functional, three showed signs of active seepage.
- one of 12 weep holes investigated along the South Elevation was found to be functional. It was noted that comparatively significant levels of seepage were observed to be occurring through four of the anchors along the South Elevation wall.

Photo 14: Example of non-functional 'weep hole', South Elevation

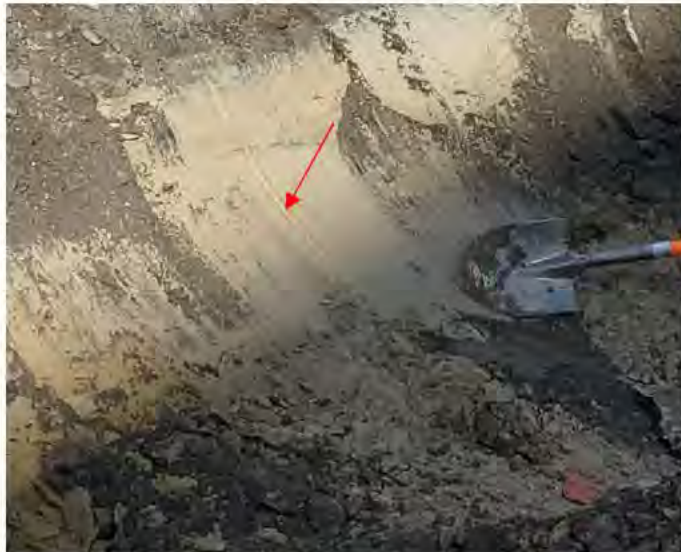
Photo 15: Vertical discontinuities in Capilano Deposits

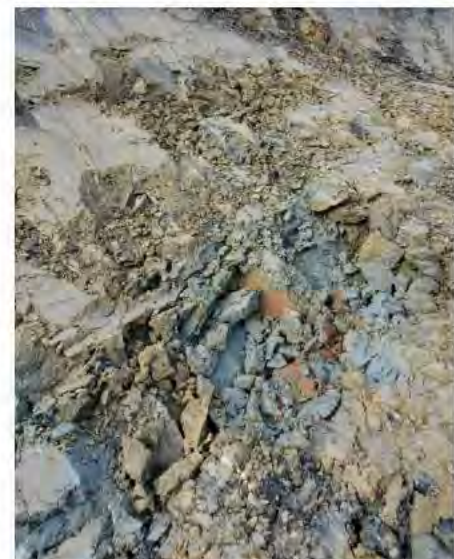
Photo 16: Oxidized sub-vertical discontinuity in Vashon Deposits

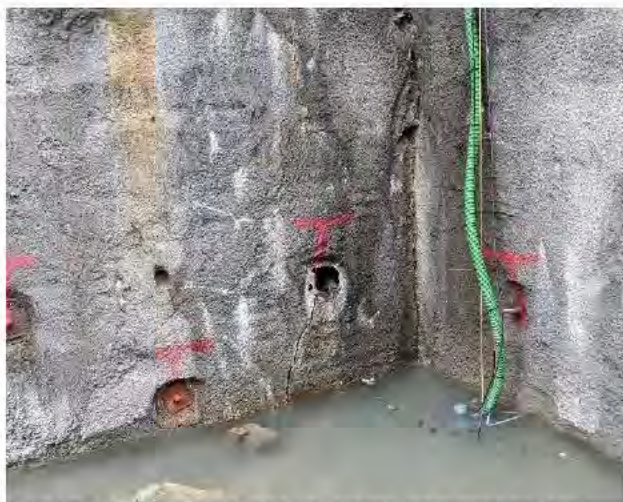
Based on the available pre-failure photographs, it appears that the failure scarp initiated 'in section' at a location 14.5 feet west of the property line shared between 138 East 8th Avenue and 141 East Broadway. This is at the front of the bond zone of the (top row of) soil anchors as indicated in Figure 4 above, and west of the west edge of the utility trench(es) associated with the water and gas connections to the CNH building. The photographs, taken at about the same time, show the bottom row(s) of anchors 'punching through' the shotcrete (Photo 17) and the concurrent condition of the CNH parking lot to the west of the punched anchors (Photo 18), are evidence that a failure has initiated.

Photo 17: Punched anchors/cracking along West Elevation shoring wall, January 30, 2020

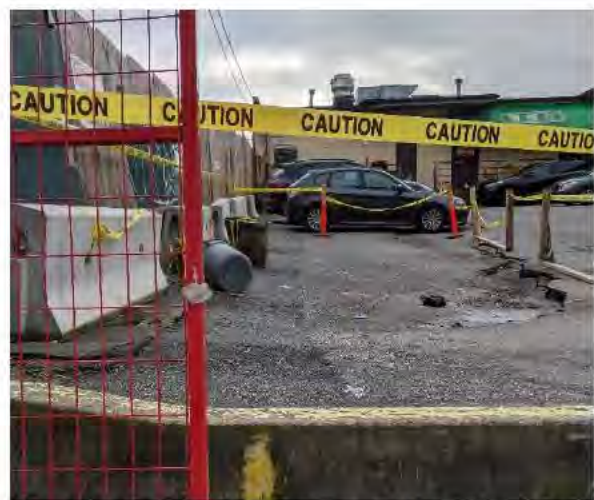
Photo 18: Subsidence of the CNH parking lot, January 30, 2020, January 30, 2020

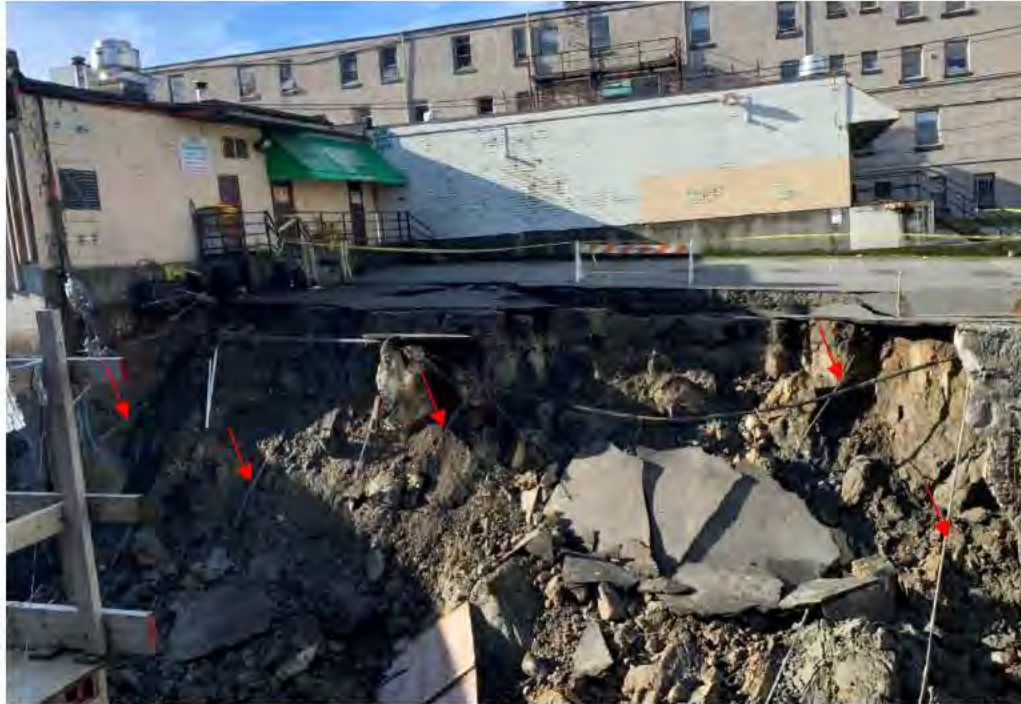
Based on photographs taken immediately post-failure, the ultimate failure scarp extended to 6.0 metres west of the shared property line and, although it encompassed soil occupied by anchors, post failure, the upper anchor(s) remained secured to their bond zones.

Photo 21: Post failure, visible anchors remain secured

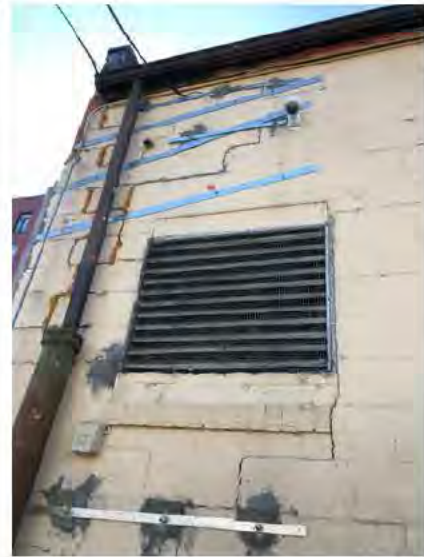
Photo 4

East corner of north wall with existing steel strapping anchored to masonry wall. We understand that the steel straps were in place prior to the subject failure.

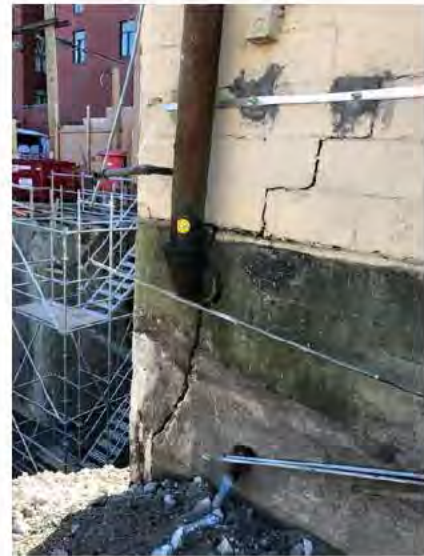
Photo 5

Bottom portion of east corner of north wall with visible foundation cracks extending into the masonry wall above. (Cracks in this portion have been recorded and close ups can be found from Photo 24 to Photo 28)

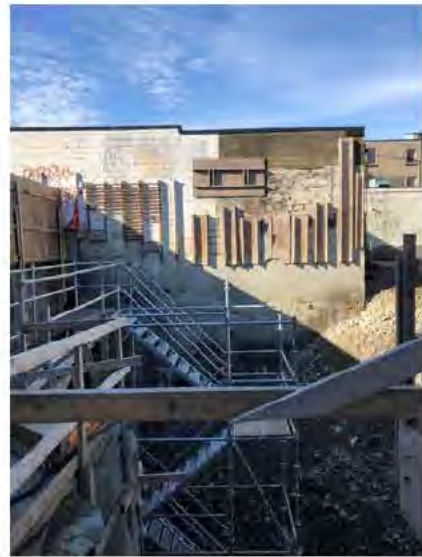
Photo 6

Full view of the east wall of the building adjacent to the excavation. We understand that the wooden temporary wall support was placed prior to the subject failure.

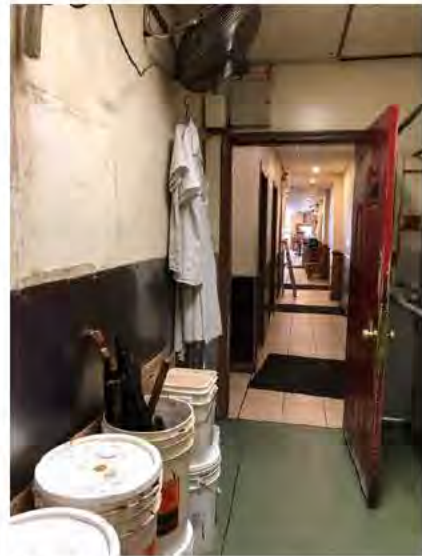
Photo 7

Looking south through the north south corridor with the slab on grade cracks visible at the bottom of photo extending into the tiles. (Tile crack measurement is shown on Photo 12)

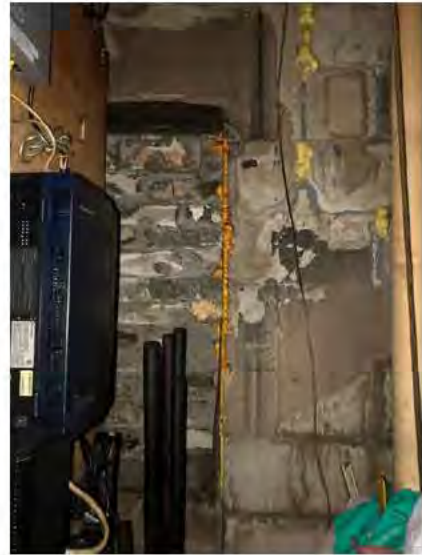
Photo 10

Service room at the northeast corner with masonry walls cracks visible from the inside.

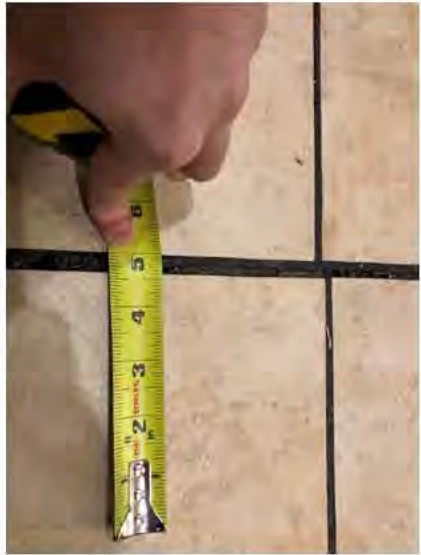
Photo 12

Corridor tiles shifted and opened up to a width of 3/8" inches (compared to regular tile gap of 1/8" inches).

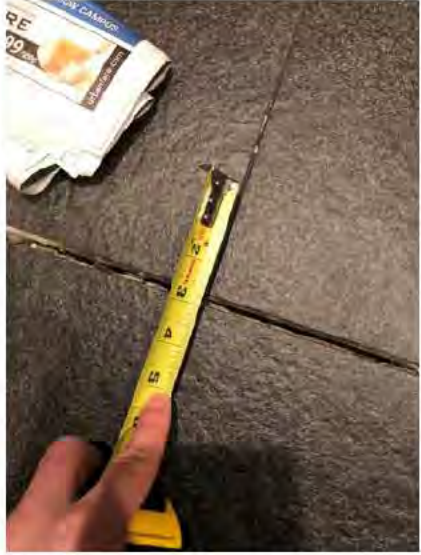
Photo 13

Tile gaps opening up inside the male washroom up to 5/16" inches (line of crack is in the east-west direction).

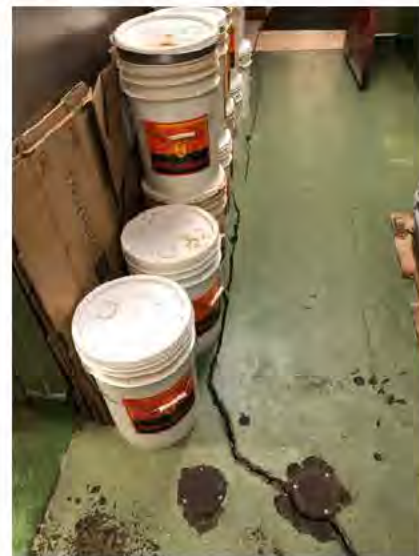
Photo 14

Major cracks in the slab on grade observed in the north center of the building have initiated previously, as caulking appeared to be in place at these locations. Caulking/sealant was observed along some cracks, indicating that some cracks are not recent; however stretched material across the width of the cracks indicates that movement occurred after installation of the caulking/sealant. (Cracks in this portion have been recorded and close ups can be found from Photo 16 to Photo 22)

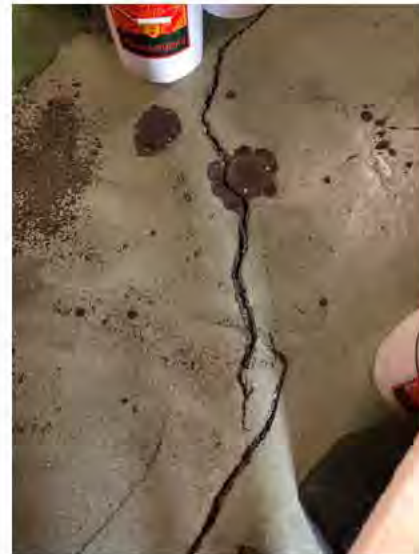
Photo 15

Another view of the major cracks in the slab on grade observed in the north center of the building. (Cracks in this portion have been recorded and close ups can be found from Photo 16 to Photo 22)

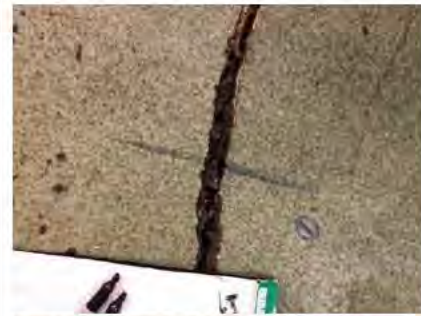
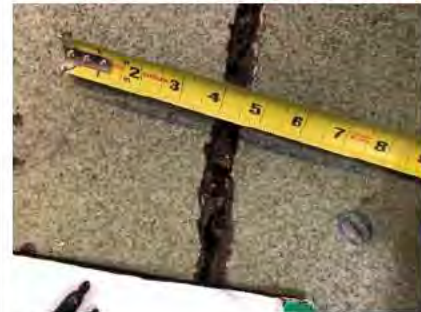
Photo 16

North center slab on grade crack at location labeled "1" with 1/2" of width.

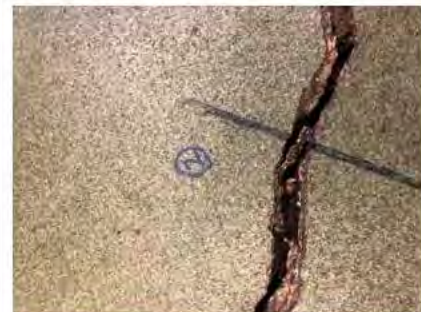
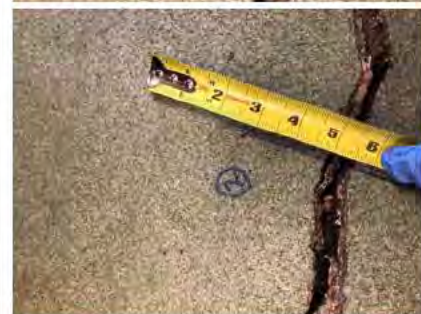
Photo 17

North center slab on grade crack at Location labeled "2" with 5/8" of width.

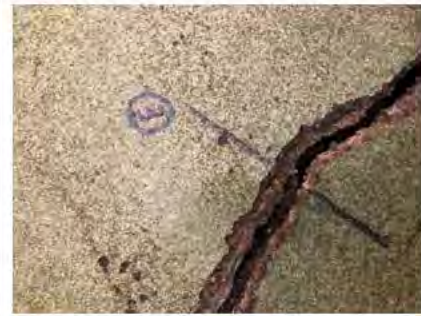
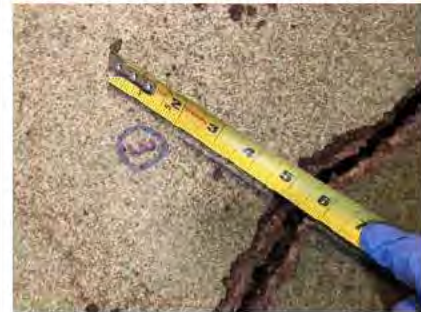
Photo 18

North center slab on grade crack at location labeled "3" with 1 3/16" of width.

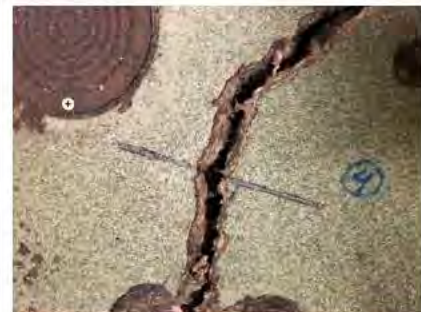
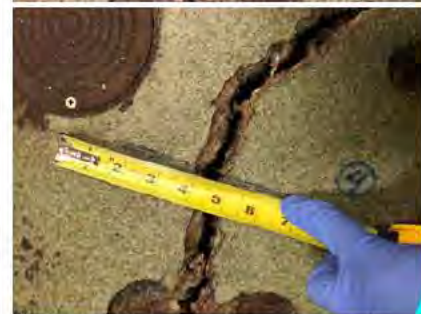
Photo 19

North center slab on grade crack at location labeled "4" with 7/8" of width.

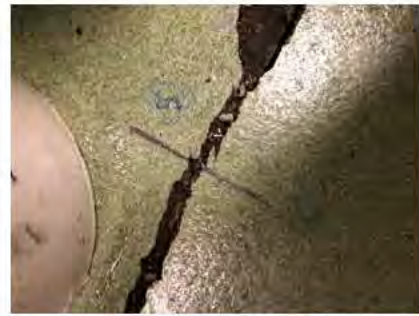
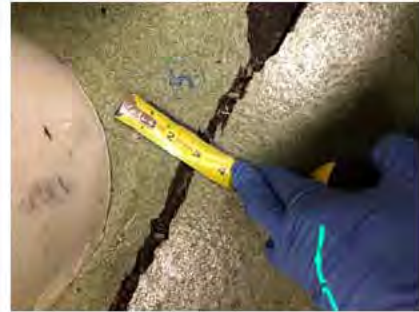
Photo 20

North center slab on grade crack at location labeled "5" with 1/2" of width.

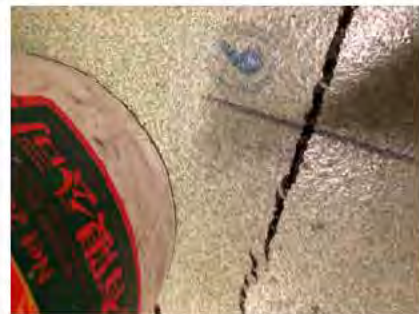
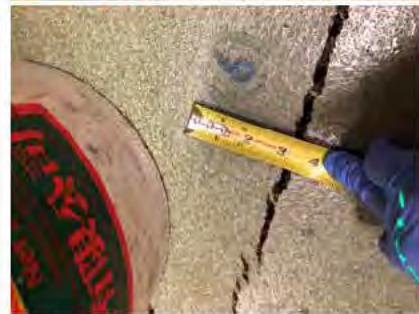
Photo 21

North center slab on grade crack at location labeled "6" with 5/16" of width.

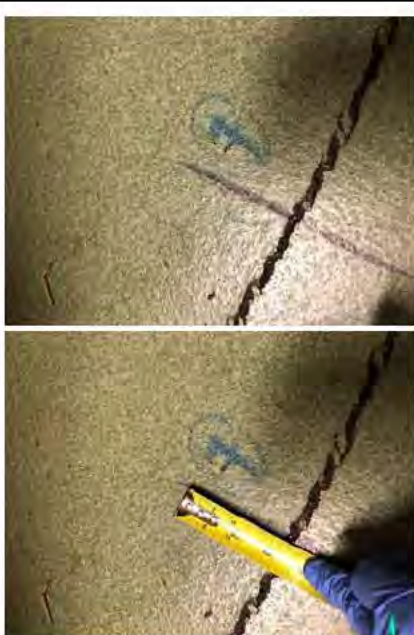
TABLE A1 – GENERAL OBSERVATIONS	
<p>North center slab on grade crack at Location labeled "7" with 5/16" of width.</p>

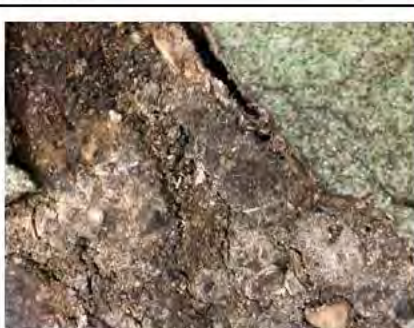
<p>Photo 23</p>

<p>Photo 22</p>
<p>Close up of the slab on grade crack with membrane detached and concrete exposed.</p>

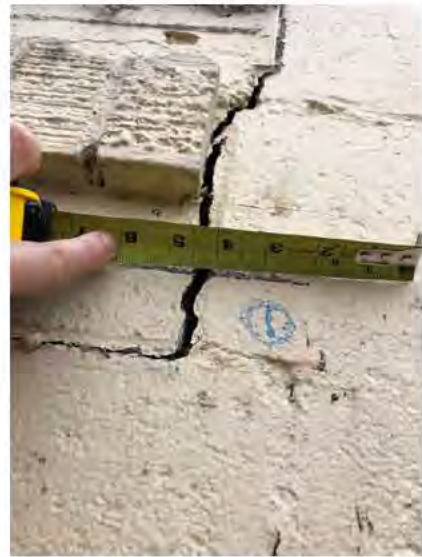
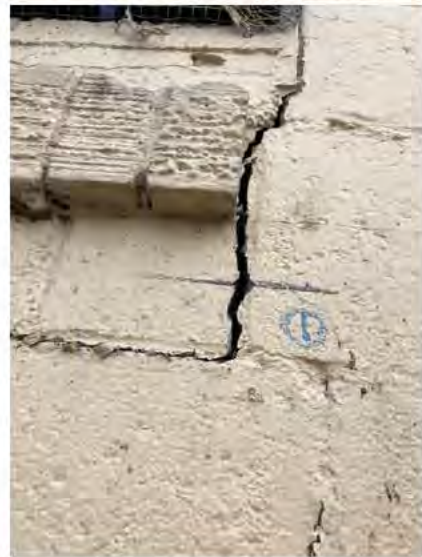
Photo 24

East of north masonry wall, mortar joint crack at location labeled "1" with ½" of width.

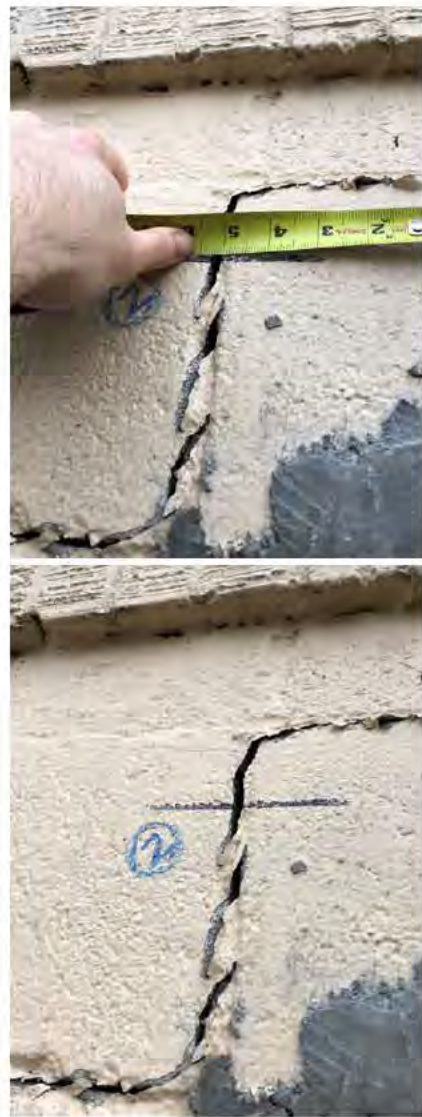
Photo 25

East of north masonry wall; mortar joint crack at location labeled "2" with 1/4" of width.

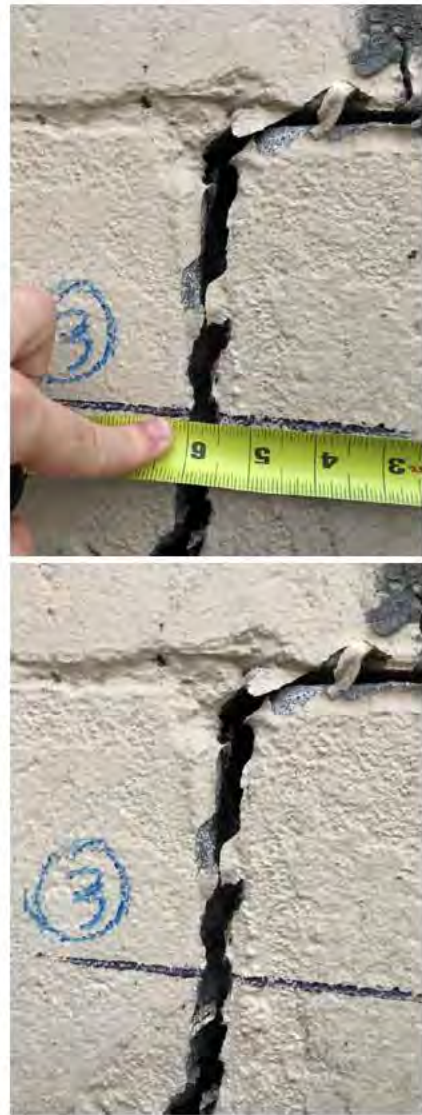
Photo 26

East of north masonry wall; mortar joint crack at location labeled "3" with ½" of width.

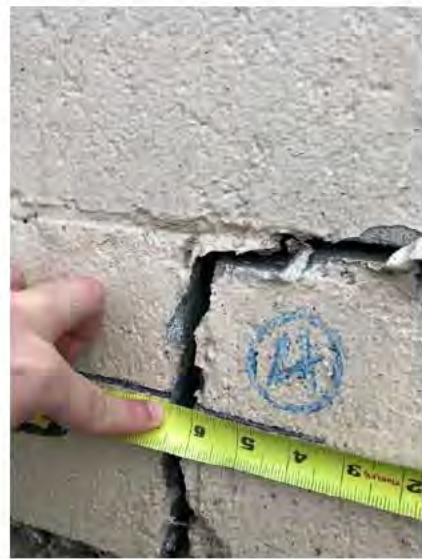
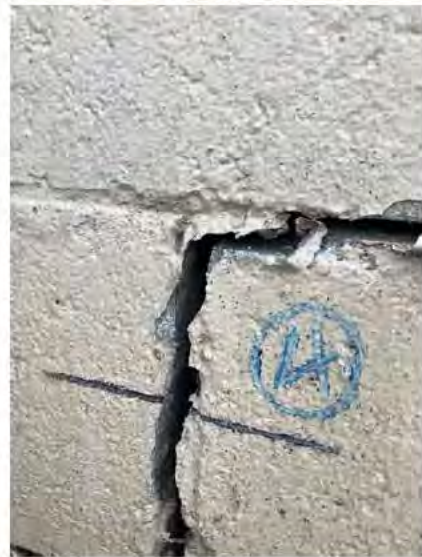
Photo 27

East of north masonry wall; mortar joint crack at location labeled "4" with ½" of width.

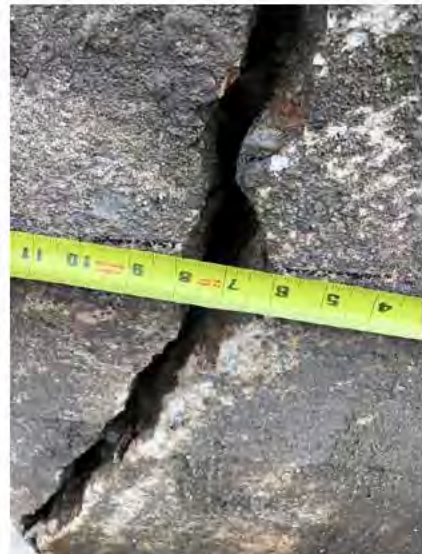
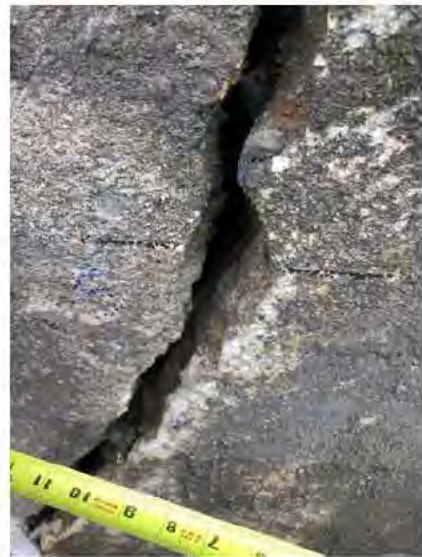
Photo 28

East of north masonry wall; Foundation crack at location labeled "5" with 1 7/8" of width.

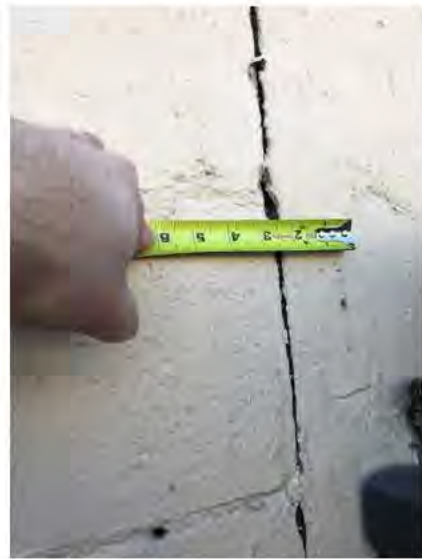
Photo 29

Masonry wall joint crack at north wall center with a width of ¼ inches.

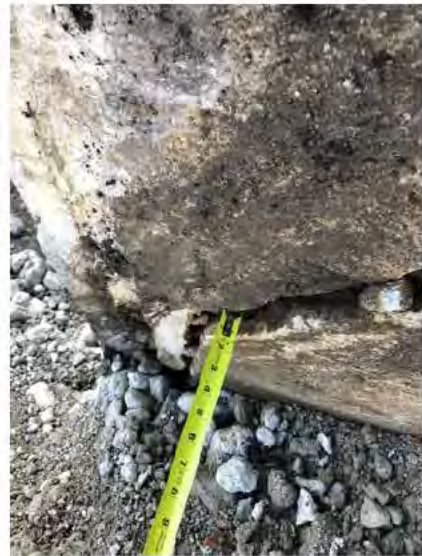
Photo 30

Foundation wall crack at northeast corner with out of plane crack of about 1 ¼ inches.
