ENVIRONMENTAL REVIEW AT EVERETT CROWLEY PARK

(FORMER KERR STREET LANDFILL)

October 22, 2014

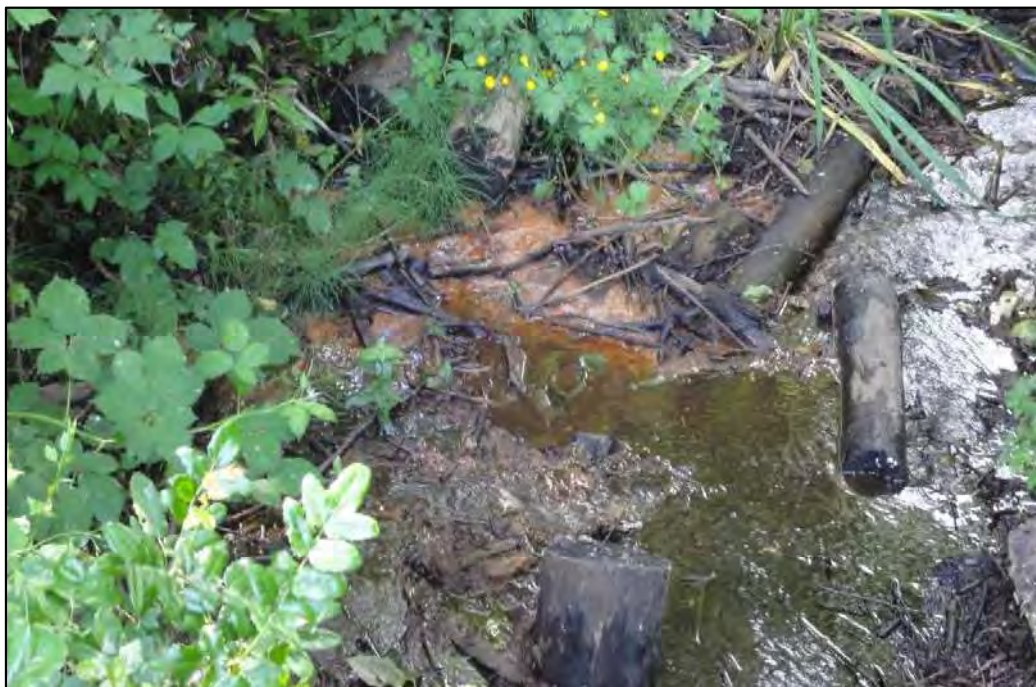
- At the discharge point from Avalon pond, minor iron staining was observed along the creek bank (photograph 9)
- Approximately 170 m downstream of Avalon pond, the creek was inspected and landfill garbage (concrete, old tubing, refuse) was visible along the exposed face of the western creek bank. No garbage

PHOTO 9: Close-up of iron staining immediately downstream of foot bridge at discharge point from Avalon pond. (June 12, 2014)

- perimeter of Avalon Pond at observation point on west side
- discharge point from Avalon pond
- two stations along Kinross Creek, preferably in the area of noted 'garbage' and prior to discharge to the storm catchment
- stagnant water pond between Marine Drive and Marine Way in Kinross Ravine Park.

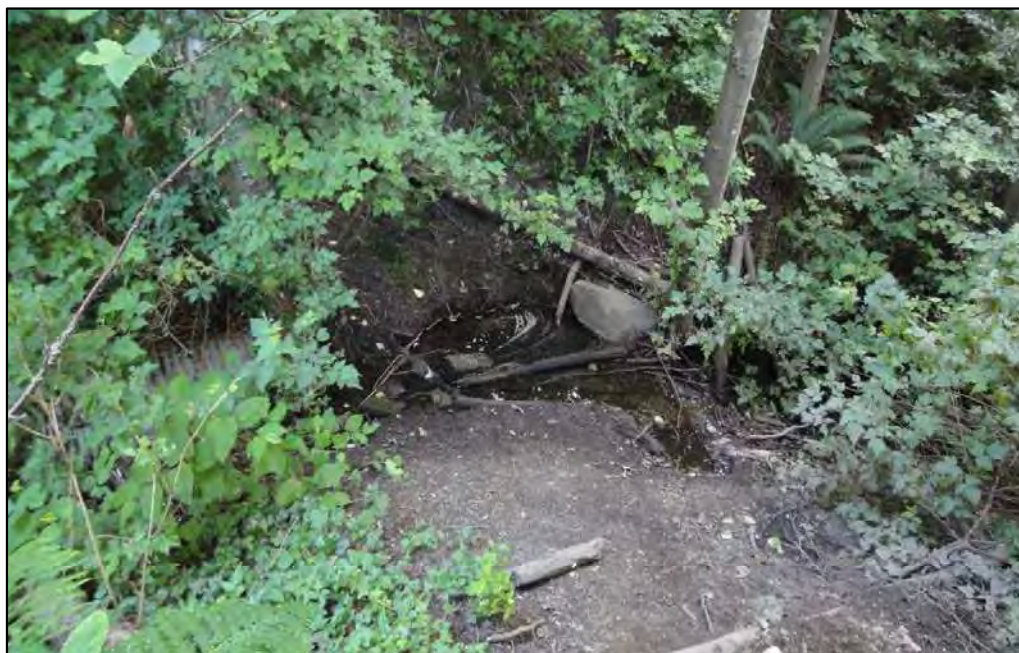
was visible on the eastern bank. No visible iron staining was observed (photographs 10-13) on either the east or west bank.

PHOTO 10: New Kinross Creek bank about 100 m north of bridge looking down ravine to creek and culvert within creek. (June 12, 2014)

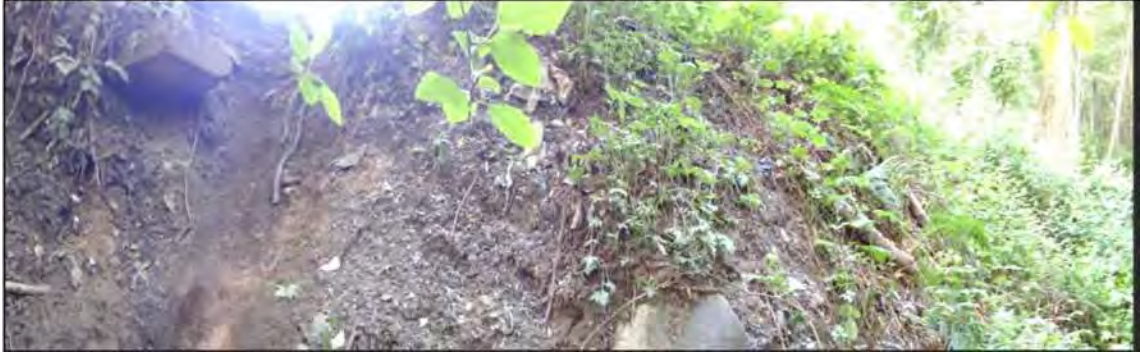
PHOTO 11: Panorama of New Kinross Creek bank about 100 m north of bridge. Exposed debris observed in creek bank (concrete, rubber, glass, shoe, garden hose etc). (June 12, 2014)

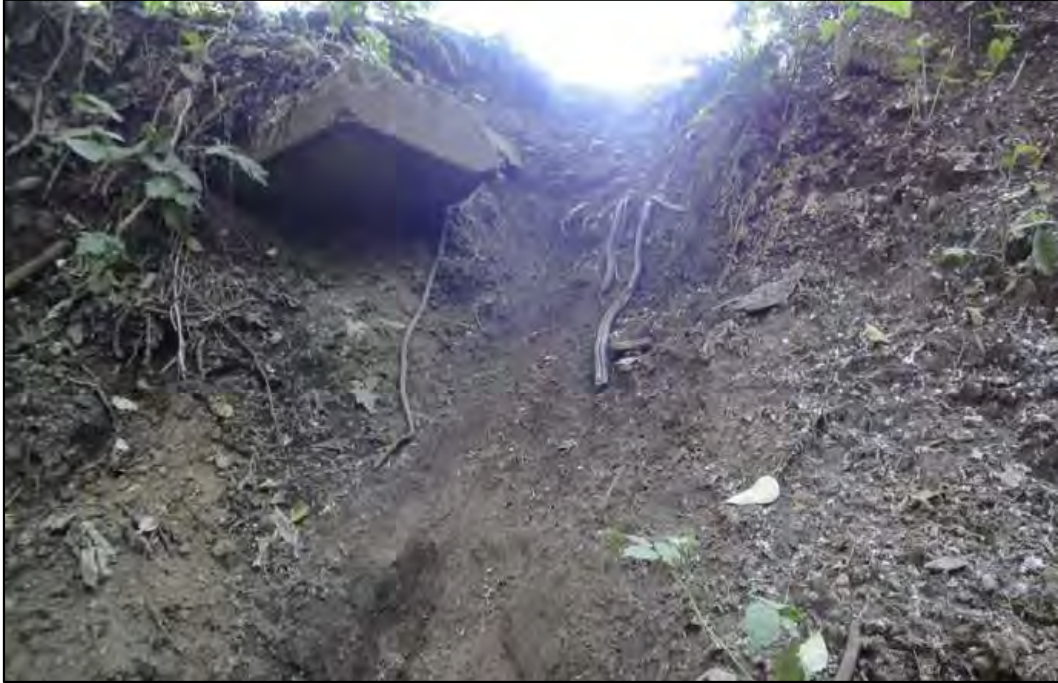
PHOTO 12: Close-up of debris of Photo 11 creek area. (June 12, 2014)

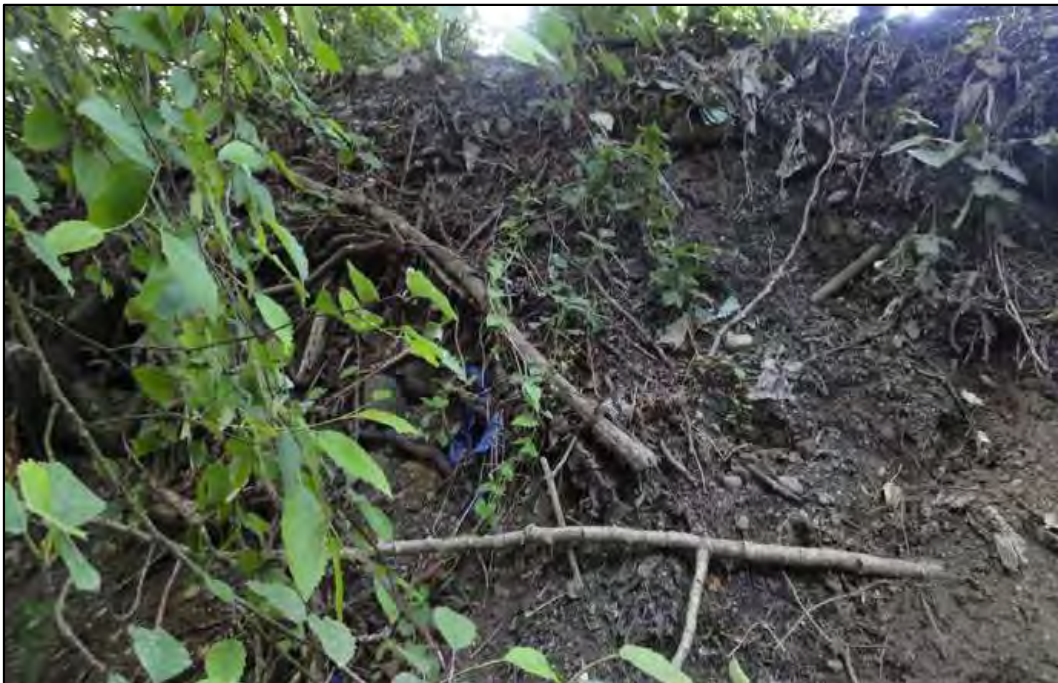
PHOTO 13: Close-up of debris Photo 11 creek area. (June 12, 2014)

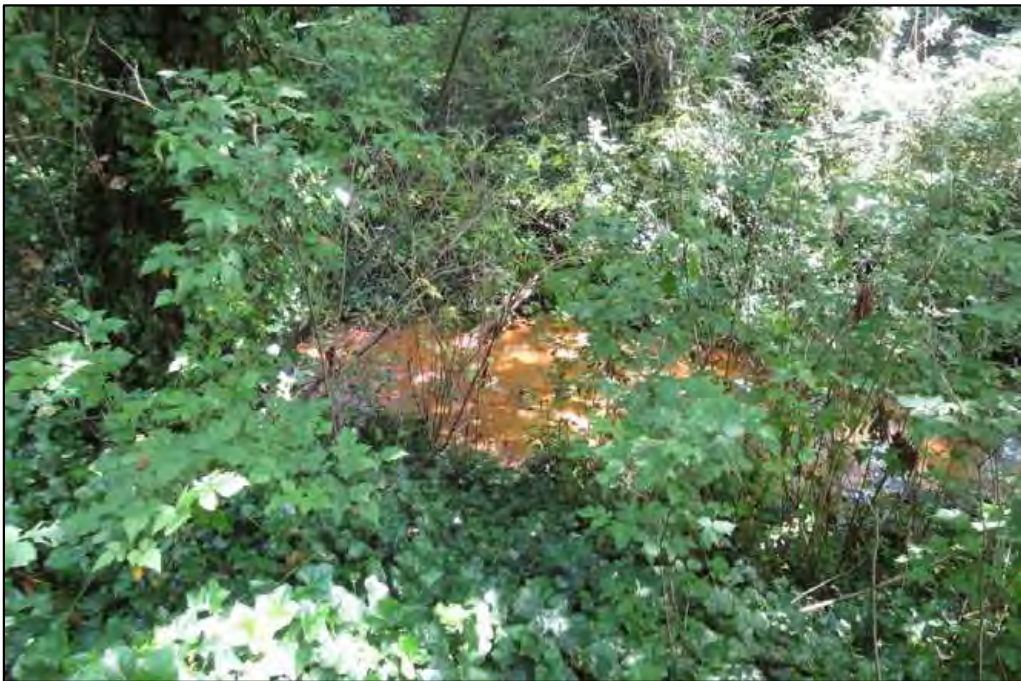
- Downstream of Marine Drive, within the Park, there is standing stagnant surface water with significant iron staining and biofilm accumulation across its width; approximately 3 m maximum. The source of the water is suspected to be discharge from the former Kinross Creek [Photographs 15-17 and 39, 40] and/or possible leaking from the adjacent sanitary sewer system.

PHOTO 15: Iron staining in stagnant ponding area between Marine Dr. and Marine Way (Kinross Ravine Park). (June 12, 2014)

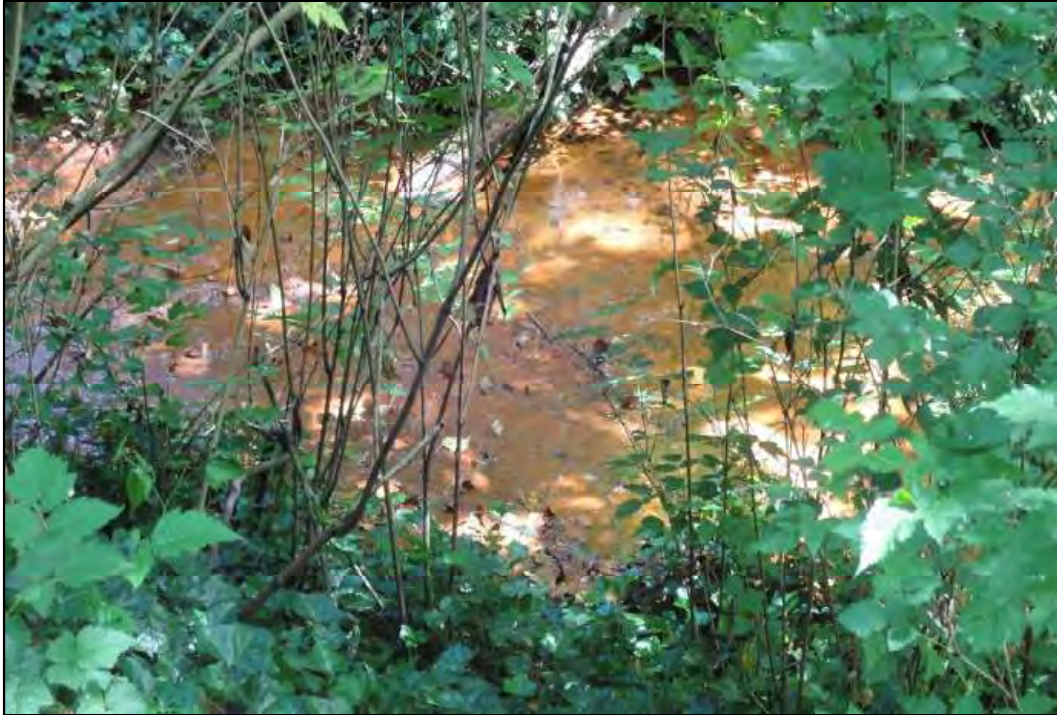
PHOTO 16: Close-up of iron staining in Kinross Ravine Park. (June 12, 2014)

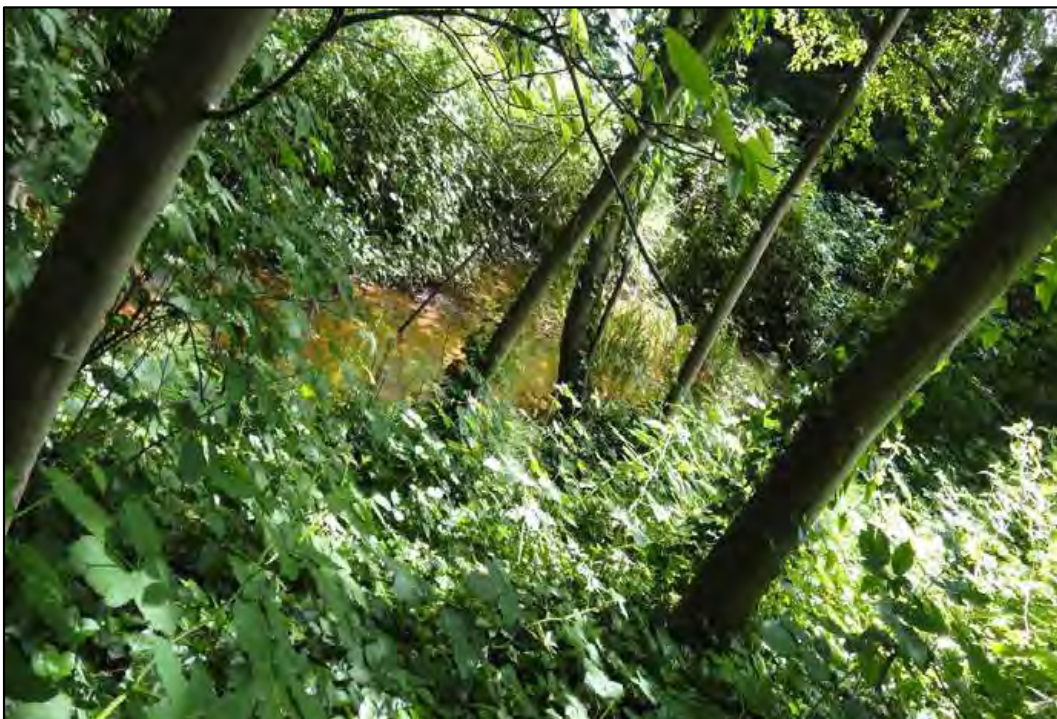
PHOTO 17: Iron staining in stagnant ponding area east side of Kinross Ravine Park. (June 12, 2014)

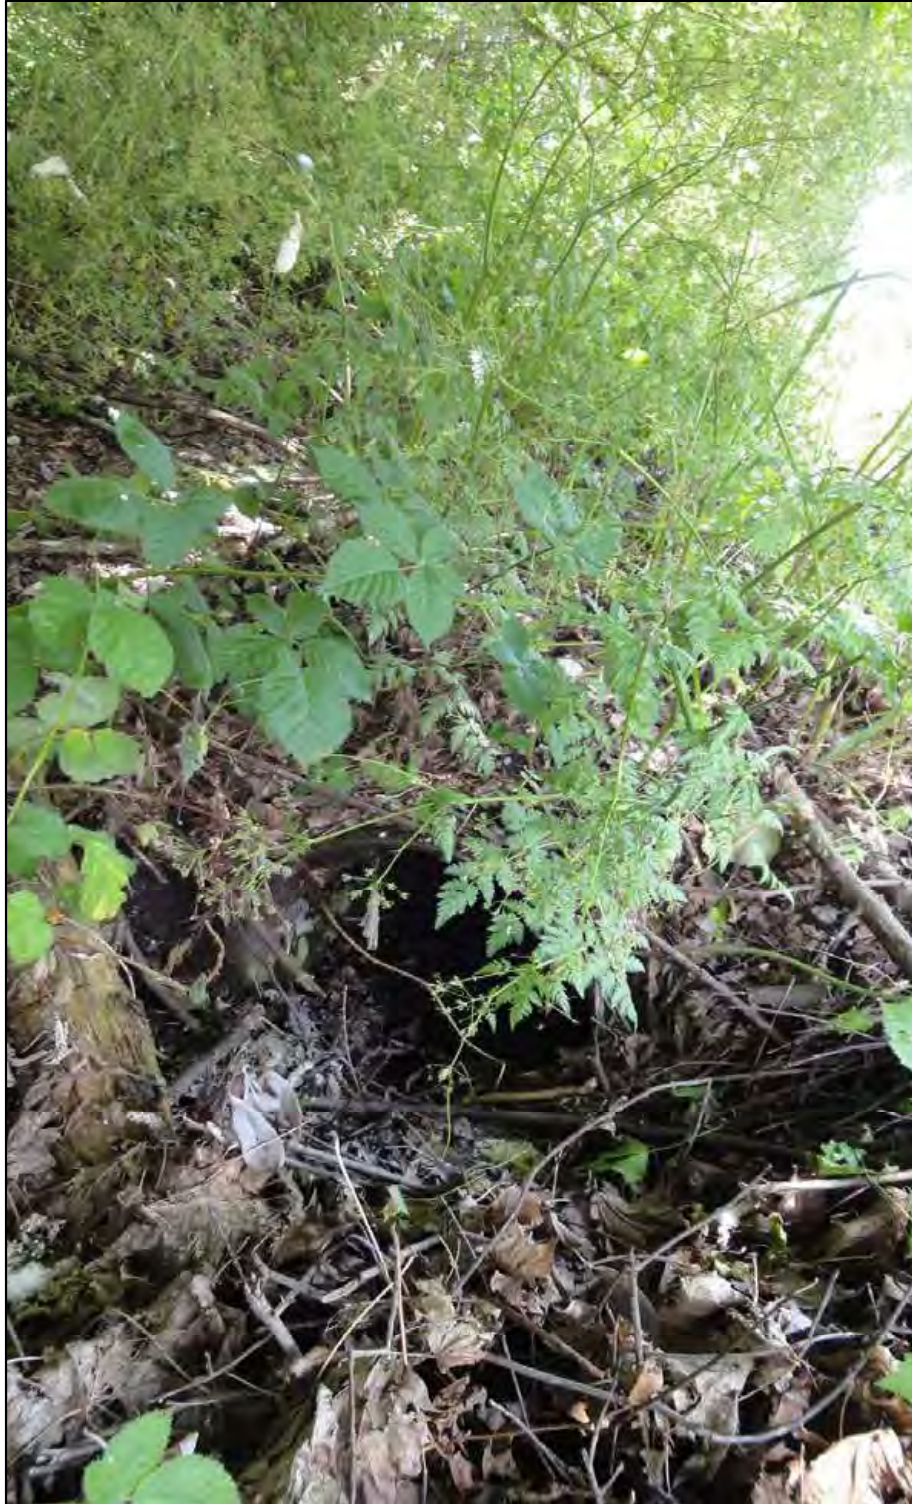
A: - a 2 m length of steel culvert (poor condition) was observed with stagnant water.

PHOTO 18: Observed culvert (approx. 15 ft long) partially covered in unofficial swale area (Seep A). Observed wetness and limited standing water around it. No iron staining observed. (June 12, 2014)

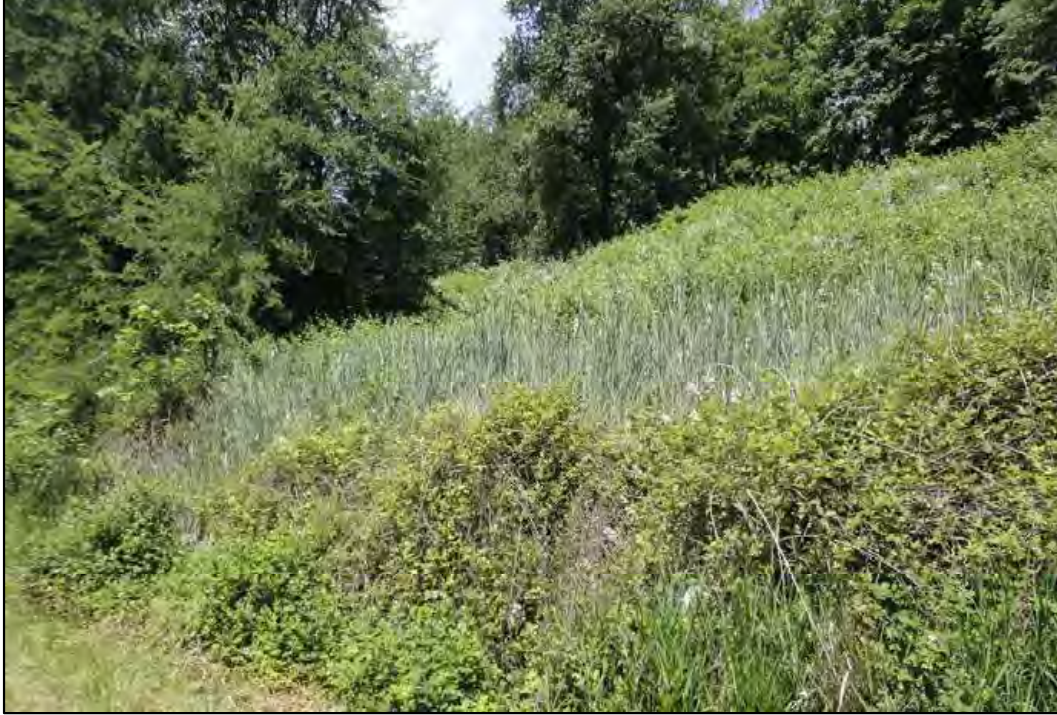
B: - an area of cattails and swale was observed east of former Kinross Creek Ravine.

PHOTO 19: Cattails observed along Marine Drive in a discharge seep area from slope. (June 12, 2014)

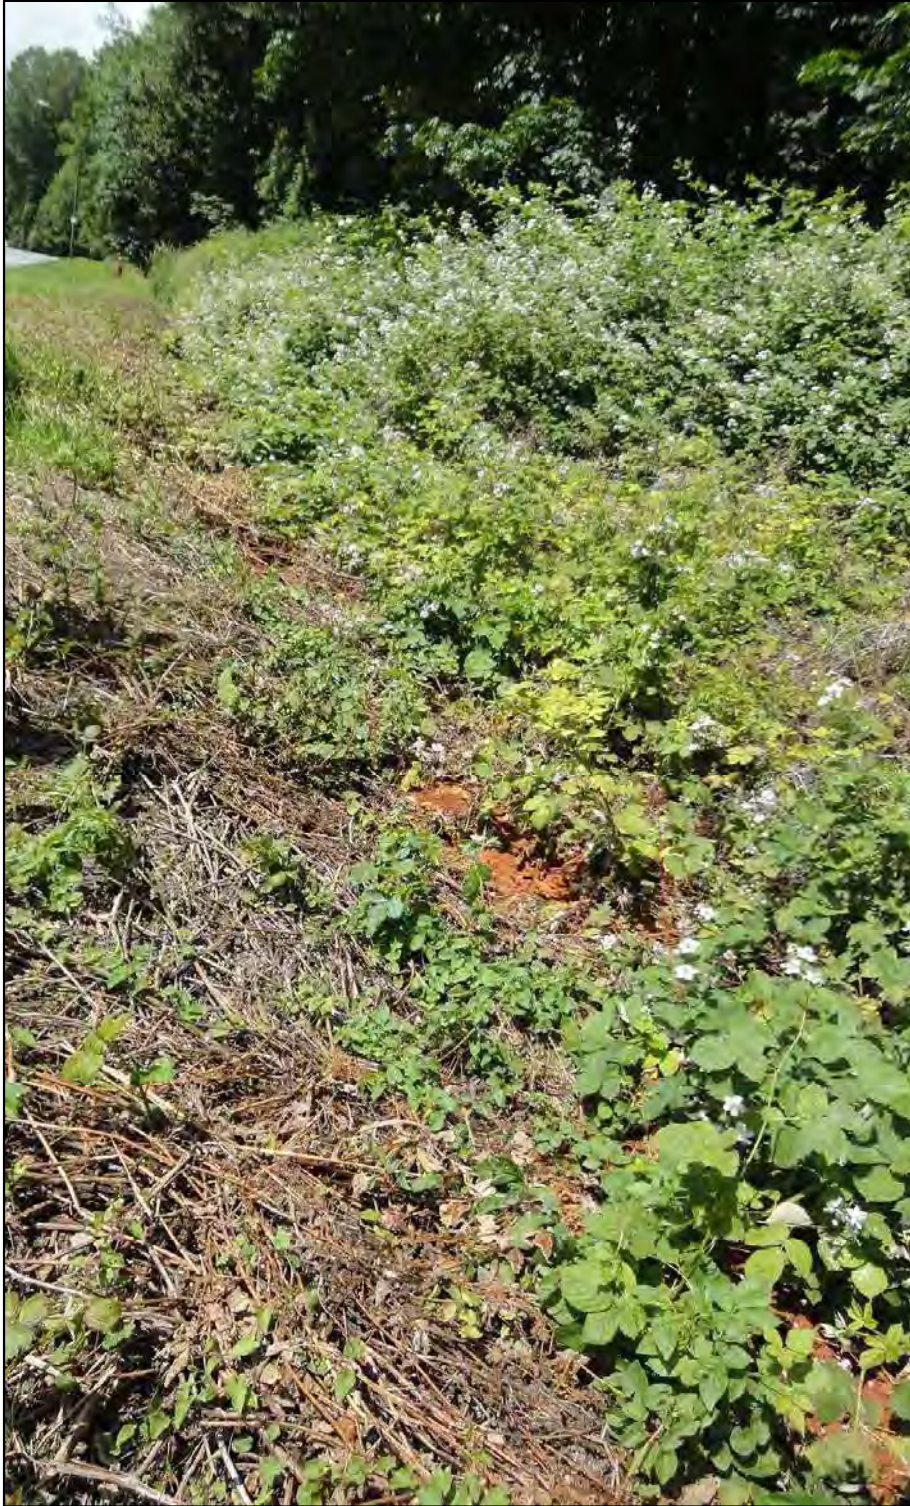
Seeps B to E were rust coloured indicating iron precipitate, typically common of leachate impacts.

PHOTO 20: Visible iron staining (Seep B) along Marine drive in small swale at toe of slope.
(June 12, 2014)

It is recommended to install seep sample ports at all seep locations (four) identified along Marine Drive and the one identified on Matheson Crescent.

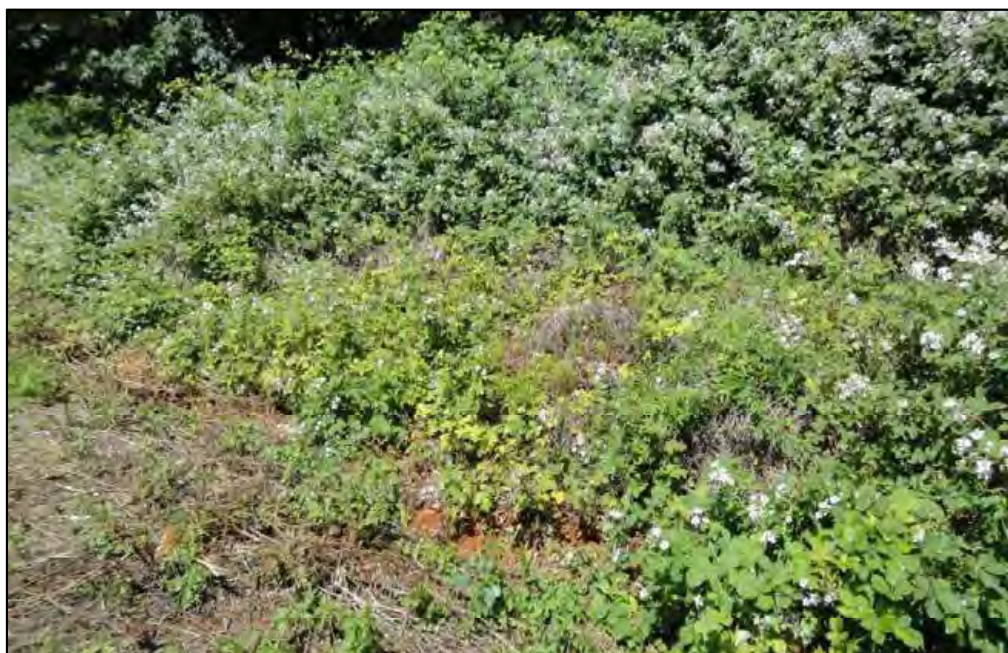
C: - swale area was observed adjacent to bus stop within area of former Kinross Creek Ravine.

PHOTO 21: Iron staining adjacent to bus stop from seeps (Seep C) along base of slope, along Marine drive. (June 12, 2014)

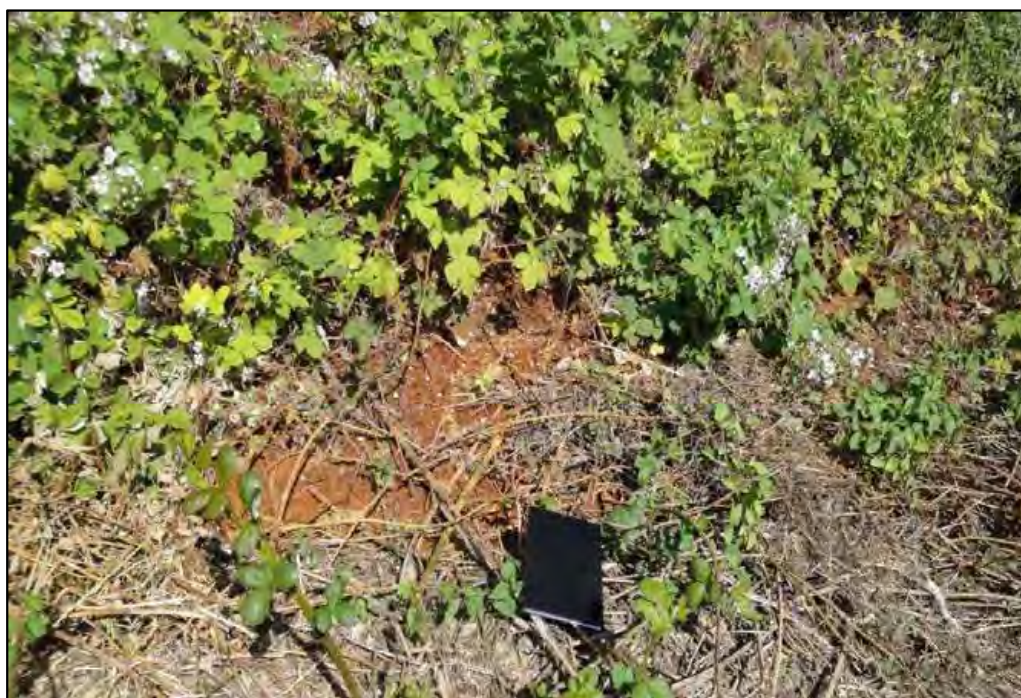
PHOTO 22: Close-up of iron staining Seep C. (June 12, 2014)

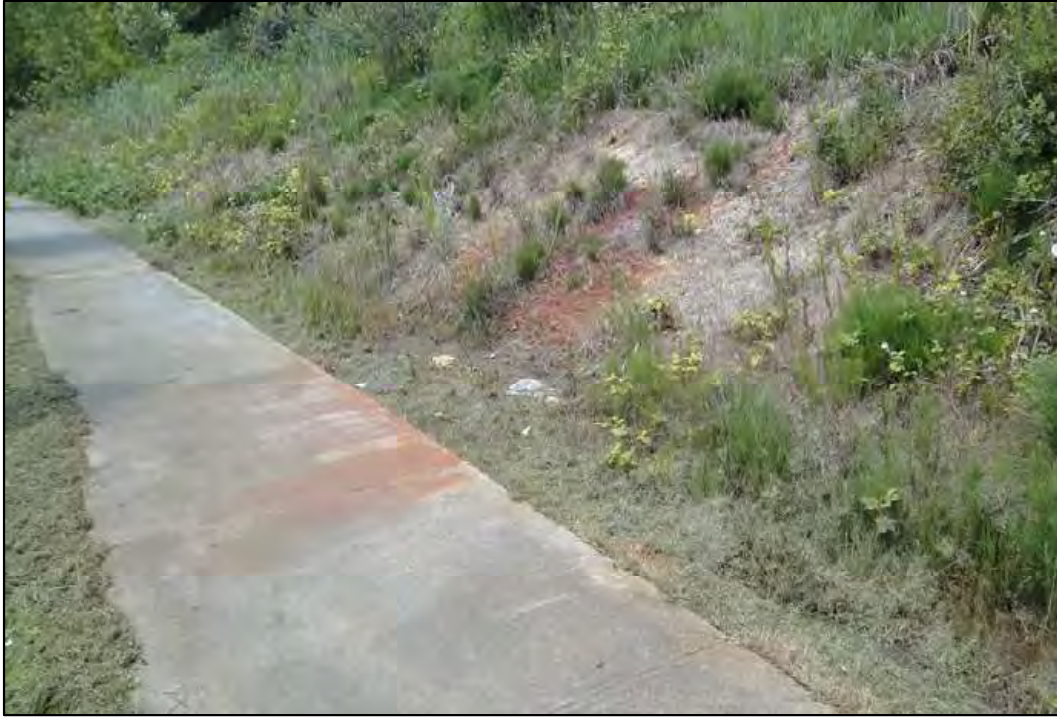
D: - an area of approximately 50 m in length adjacent to sidewalk on the north side of Marine Drive was observed including what appears to be an interception drain based on gravel at surface and a number of catch basins.

Additionally, the interception drain that was installed along Marine Drive would require re-evaluation due to the observed discharge of seeps onto the sidewalk area, despite the presence of the drain. Confirmation of the discharge of this drainage system would also need to be confirmed. There was an observed catch basin that the system was discharging too; it is unknown if this discharges into a combined sanitary/storm sewer system. The quality of the effluent discharge would need to be confirmed.

PHOTO 23: Iron staining in seep area (Seep D) along Marine Dr. onto sidewalk. (June 12, 2014)

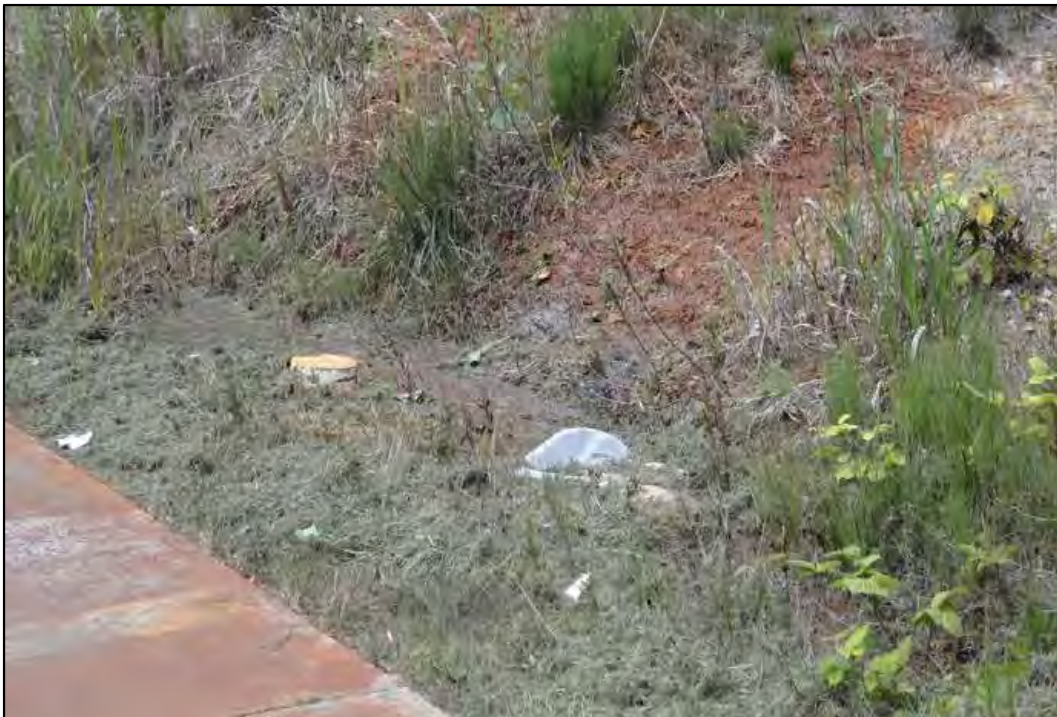
PHOTO 24: Close-up of iron staining (Seep D) and one of 2 x 6" diameter capped PVC piping. (June 12, 2014)

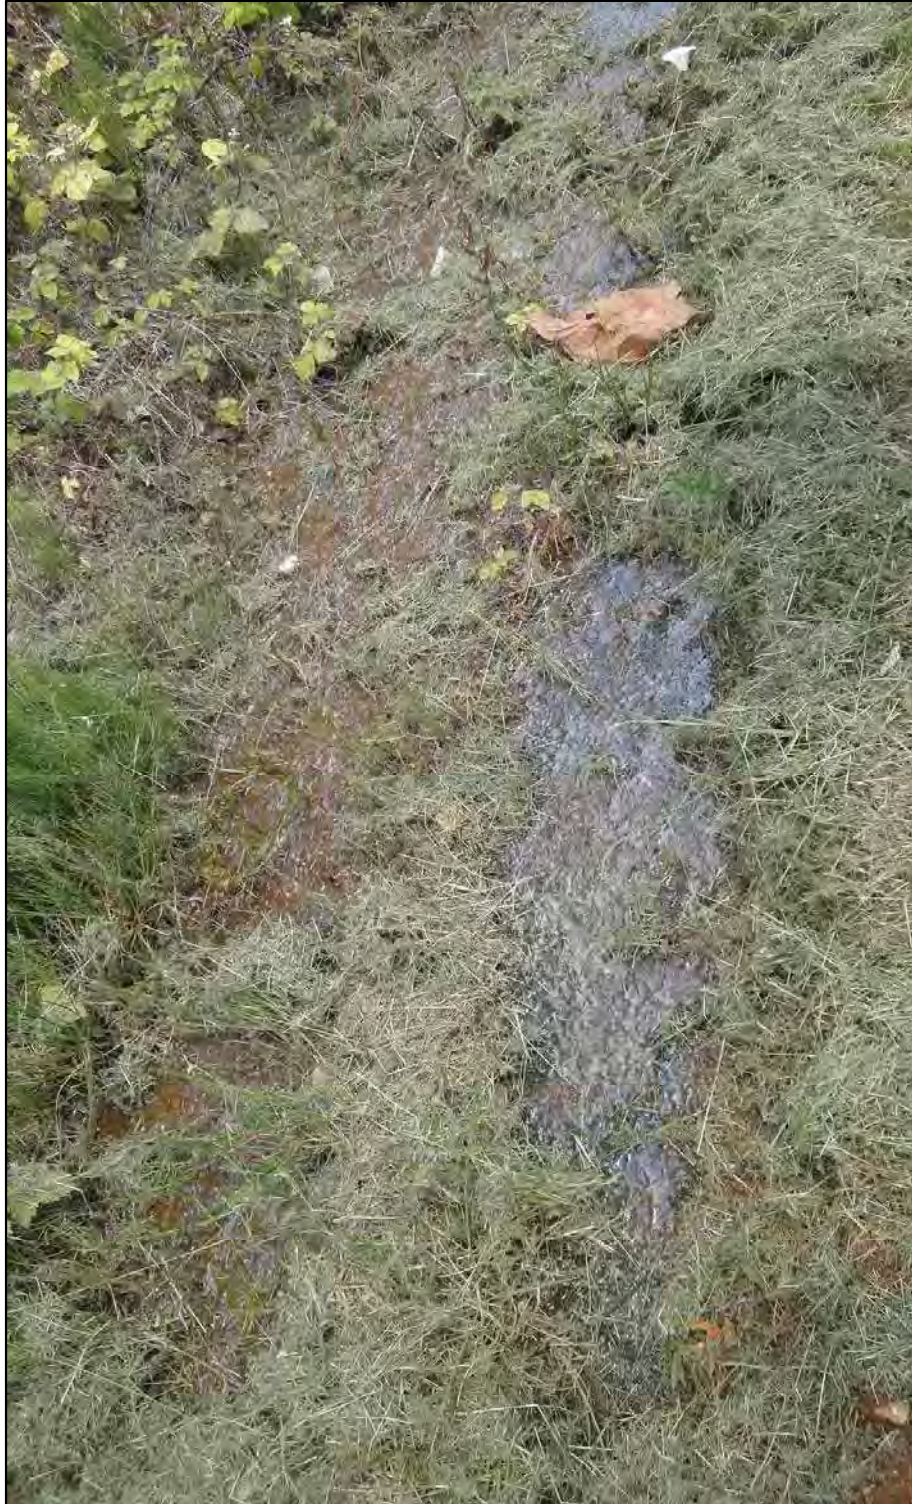
PHOTO 25: Iron staining (Seep D) along Marine Dr. (June 12, 2014)

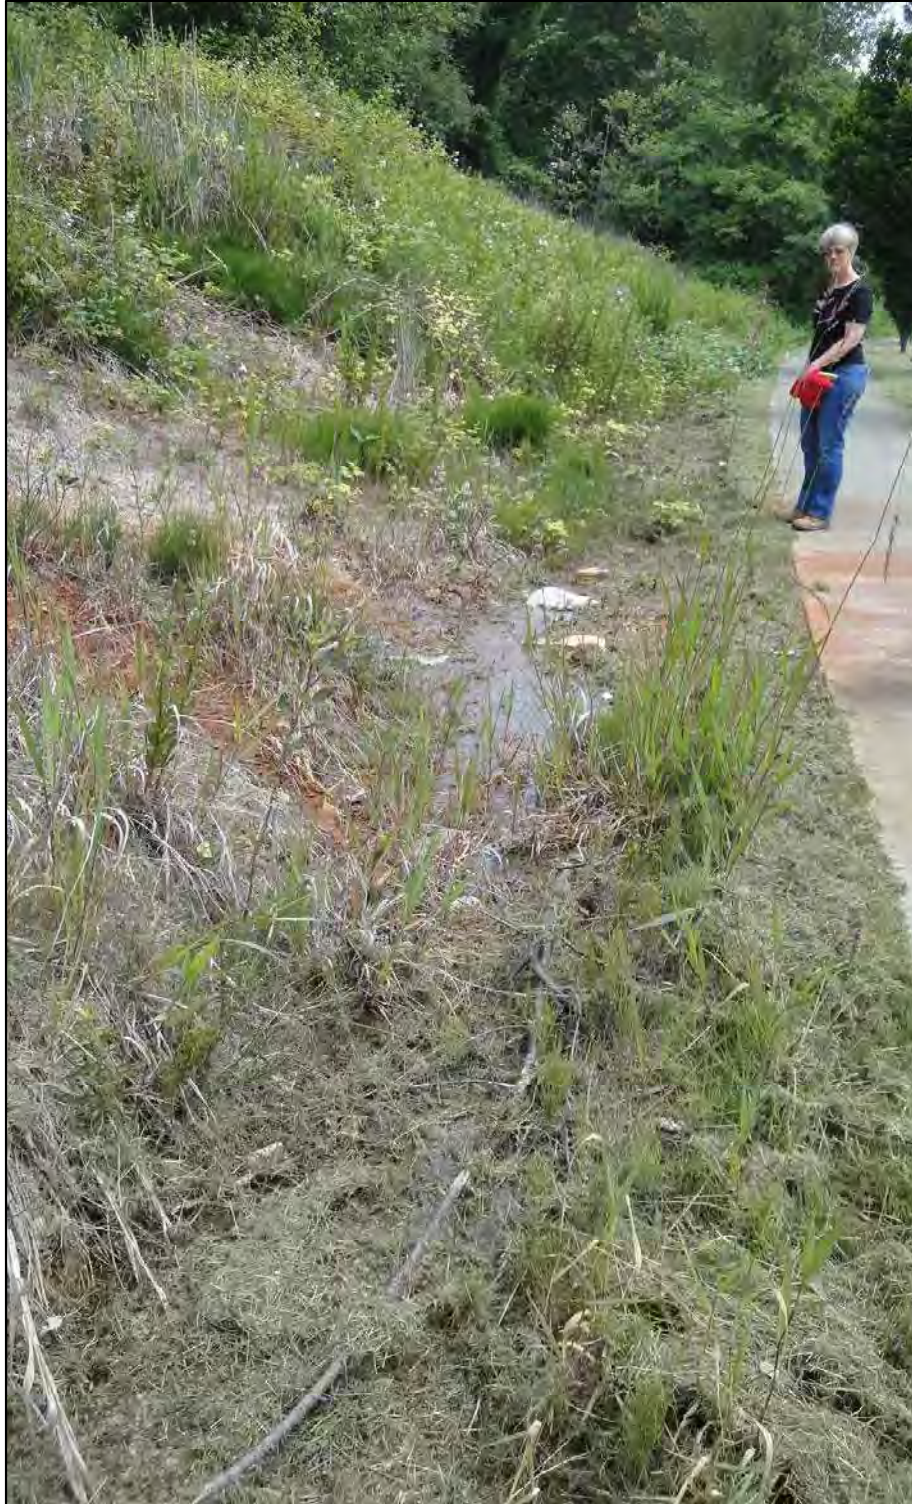
PHOTO 26: Iron staining (Seep D) along Marine Dr. onto sidewalk. (June 12, 2014)

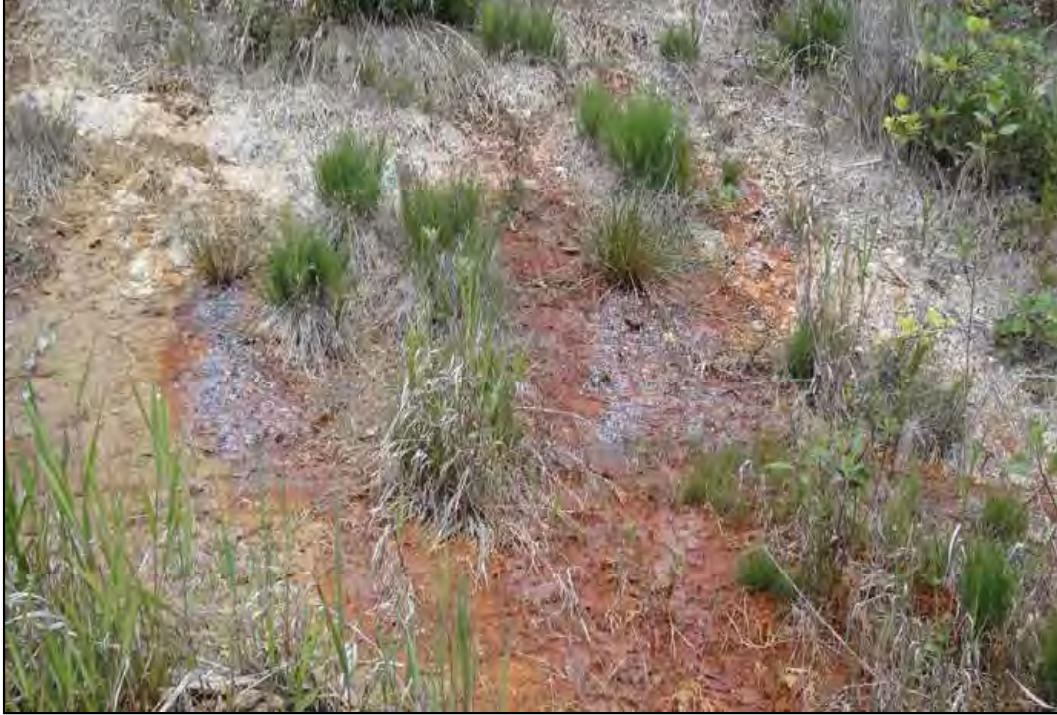
PHOTO 27: Close-up of iron staining (Seep D), further up hill. (June 12, 2014)

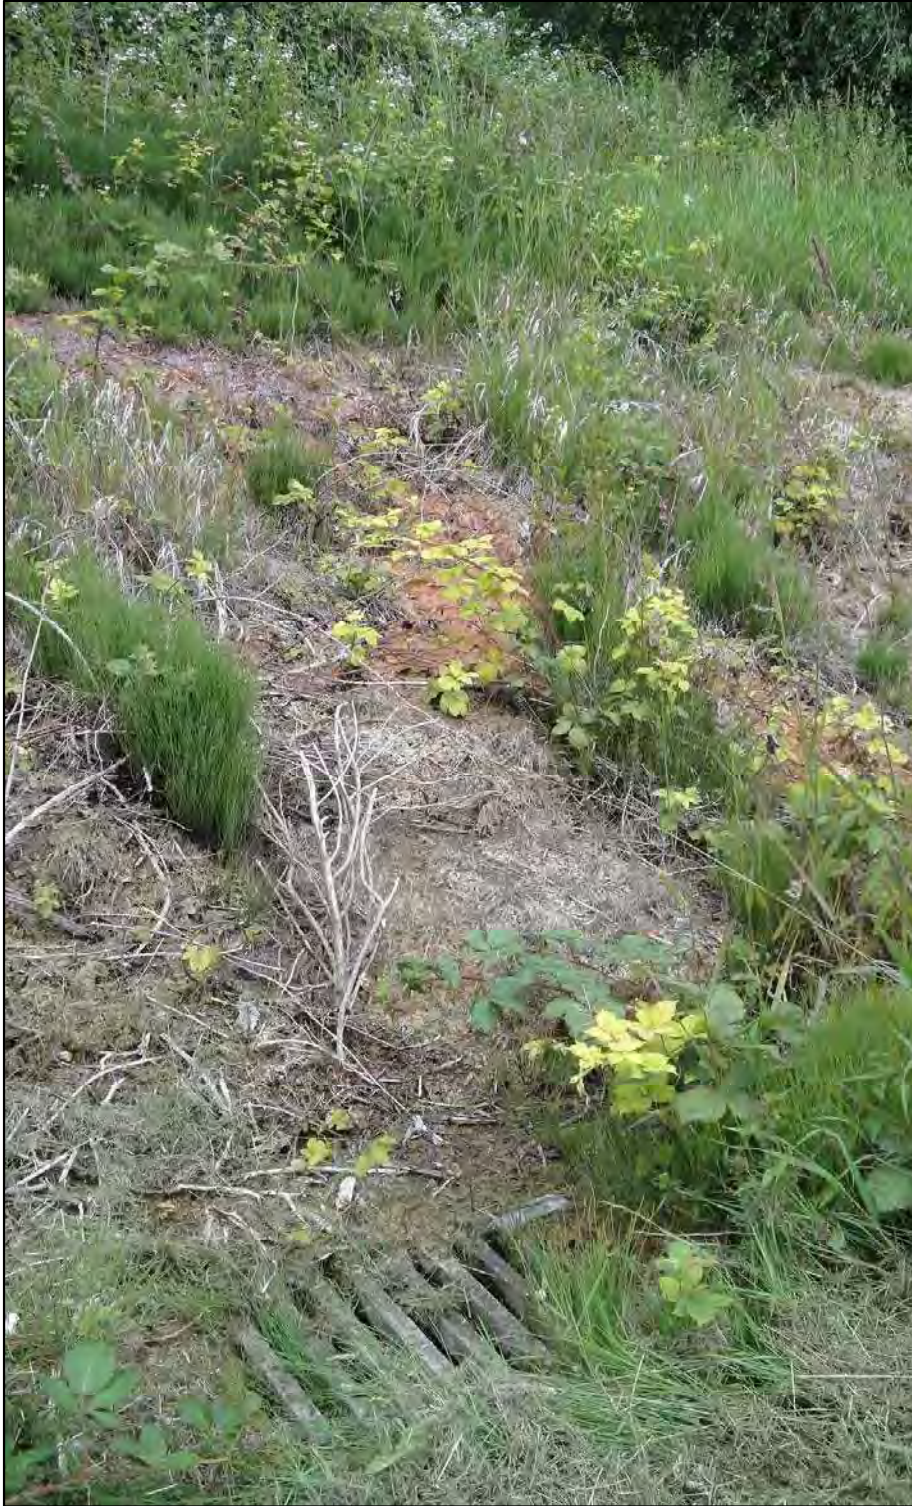
PHOTO 28: Storm sewer catch basin adjacent to iron staining of Seep D. (June 12, 2014)

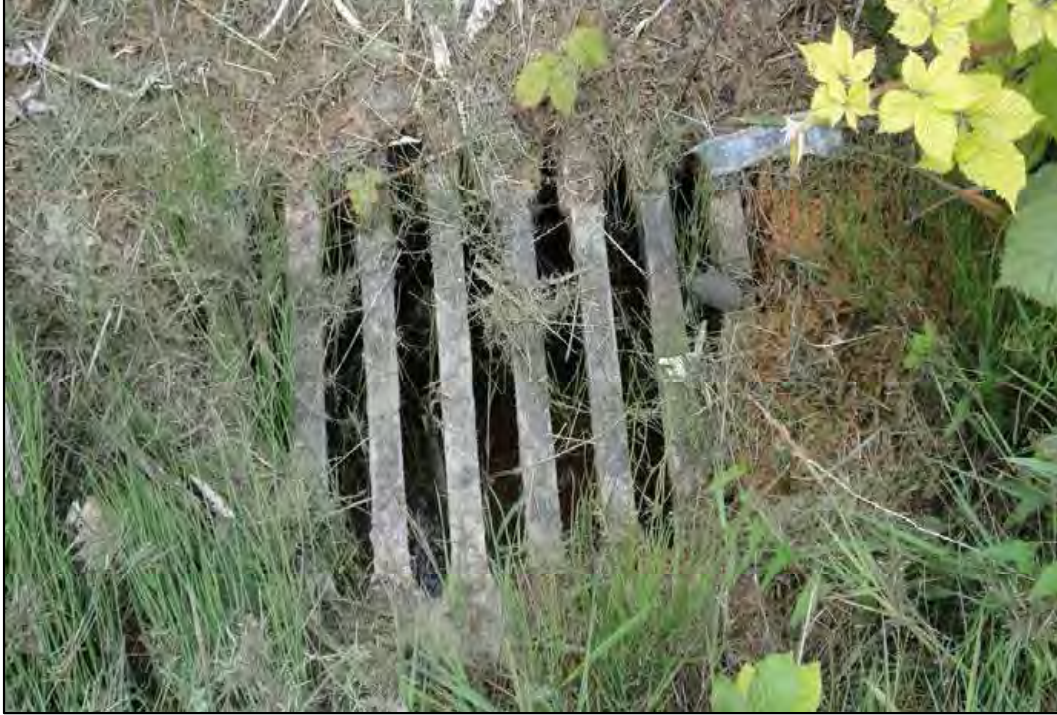
PHOTO 29: Close-up of storm sewer catch basin adjacent to iron staining of Seep D - observed staining discharging into the catch basin and observed within. (June 12, 2014)

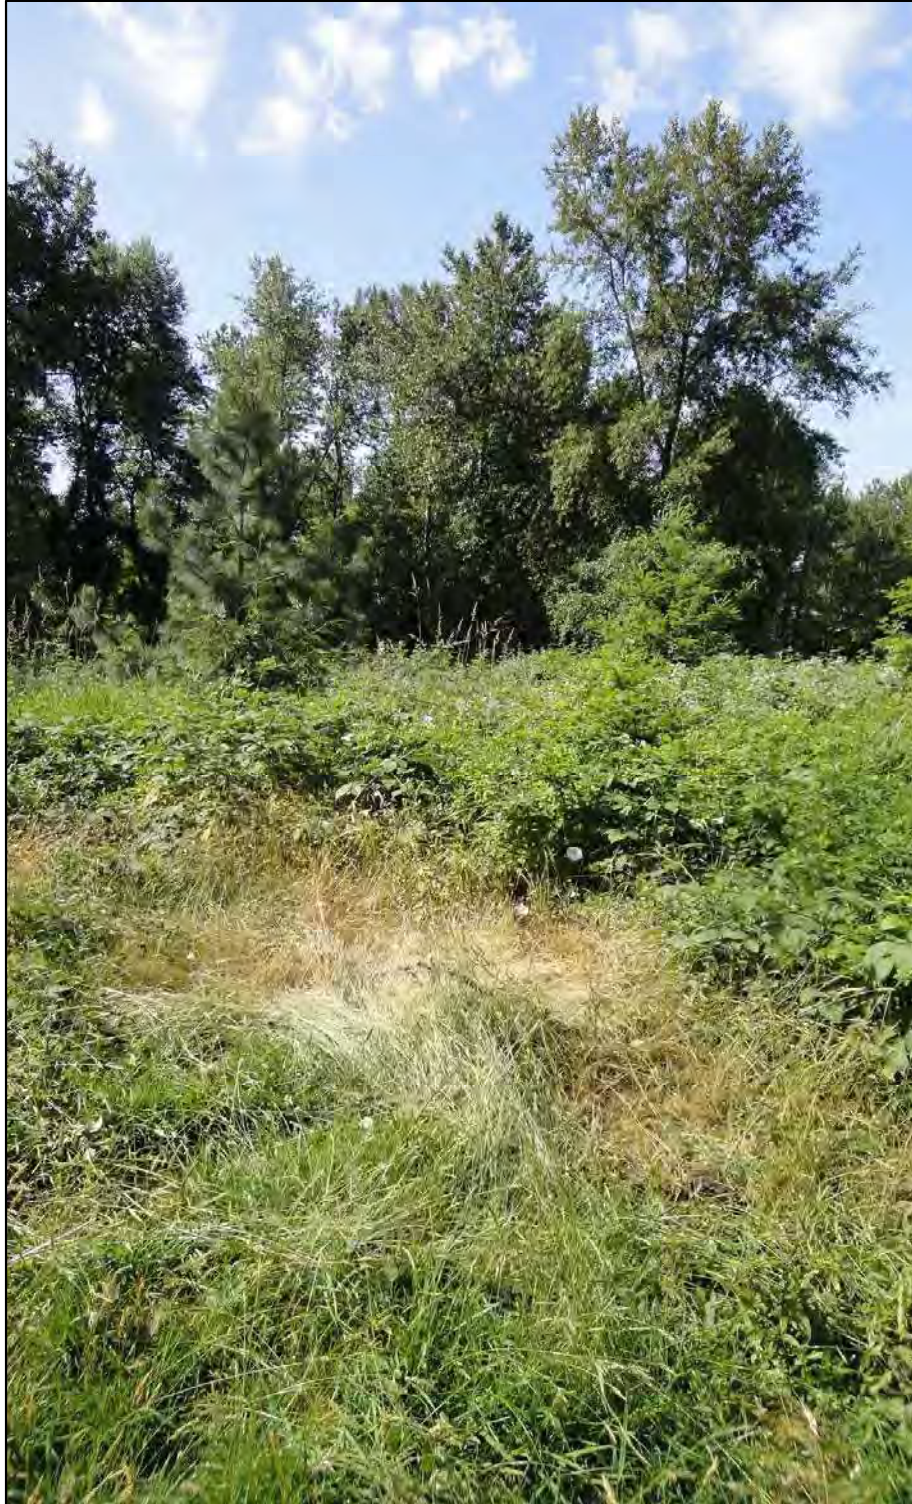
- observed pockets of stressed (dry) grass (Photographs 30 and 32);
- observed dead tree (noticed by SynergyAspen to have been replaced during a second site visit on June 20, 2014) [Photograph 32]; and
- two larger re-vegetated areas by City personnel and/or Crowley Park volunteer association. The re-vegetated areas were specifically targeted as poor growing areas due to a "hot spot" in park, due to landfill gas venting. The two areas were re-vegetated with evergreen trees, shrubs and bark mulch was at ground surface. The areas were delineated by wood logs at the perimeter [Photographs 31 and 33].

PHOTO 30: Suspect heat venting area (note observed patch of dry grass). (June 12, 2014)

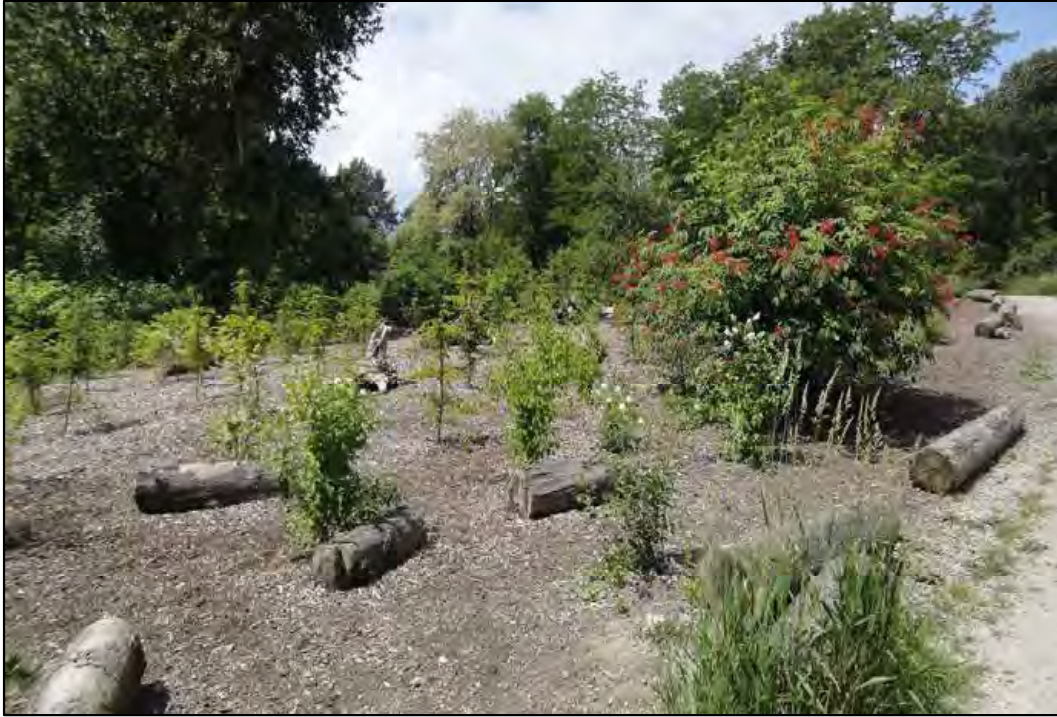
PHOTO 31: 2nd re-vegetation area. (June 12, 2014)

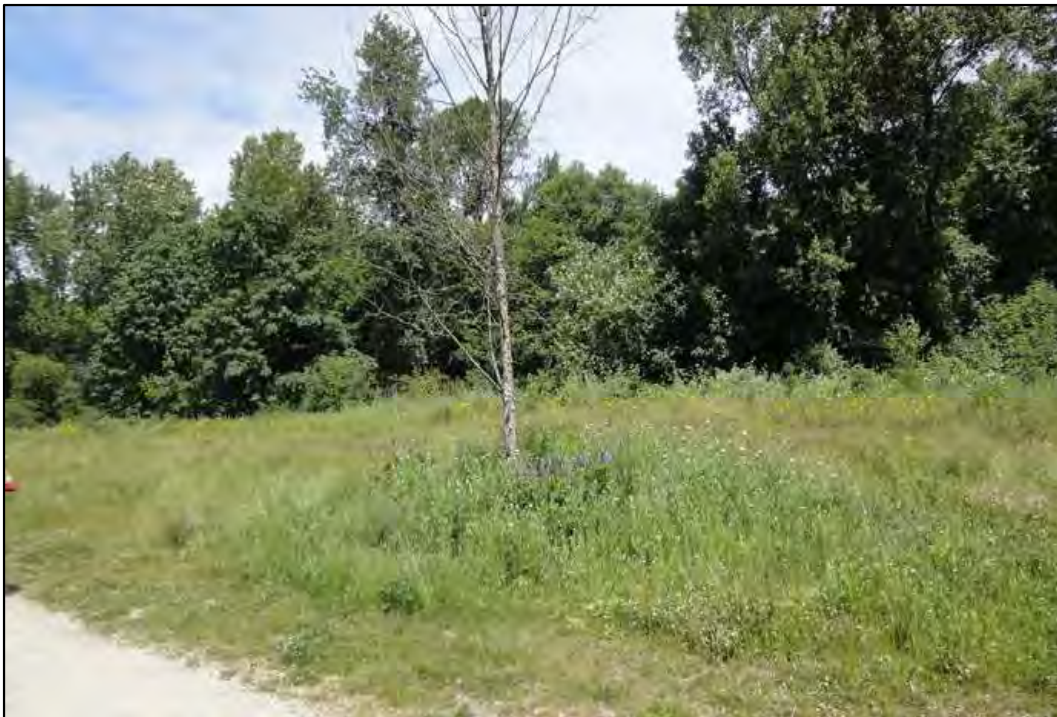
PHOTO 32: Across from 2nd re-vegetation area, to the north. Observed dead tree and only grass vegetation, no other trees. (June 12, 2014)
