ENVIRONMENTAL REVIEW AT EVERETT CROWLEY PARK

(FORMER KERR STREET LANDFILL)

October 22, 2014

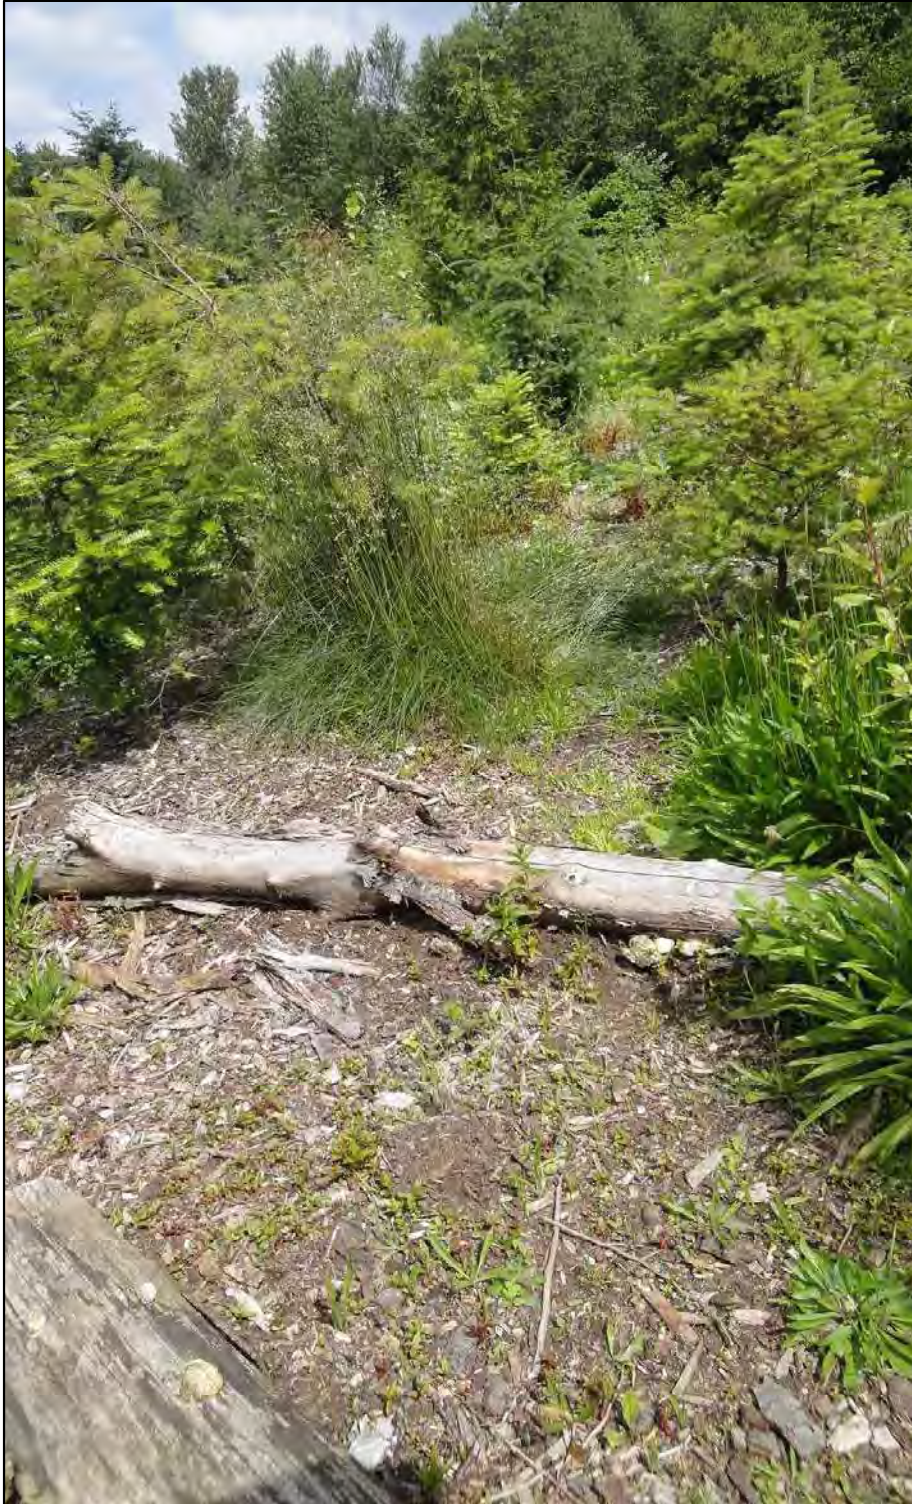
- observed pockets of stressed (dry) grass (Photographs 30 and 32);
- observed dead tree (noticed by SynergyAspen to have been replaced during a second site visit on June 20, 2014) [Photograph 32]; and
- two larger re-vegetated areas by City personnel and/or Crowley Park volunteer association. The re-vegetated areas were specifically targeted as poor growing areas due to a "hot spot" in park, due to landfill gas venting. The two areas were re-vegetated with evergreen trees, shrubs and bark mulch was at ground surface. The areas were delineated by wood logs at the perimeter [Photographs 31 and 33].

PHOTO 33: Stunted vegetation in suspect heat vent area (in a rehabilitation area) (June 12, 2014)

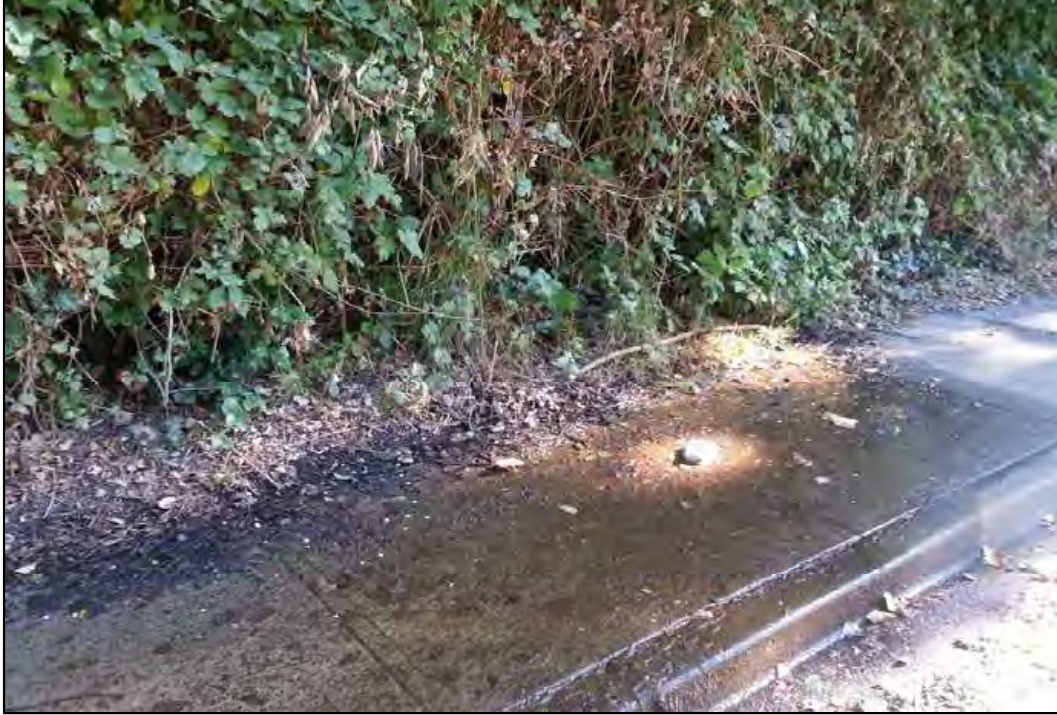
E: - A seep was noted on Matheson Crescent (Photographs 34 and 35) in close proximity to where New Kinross Creek discharges into a storm catchment drain (Photograph 36) and then likely into the City storm sewer system.

PHOTO 34: Seep onto sidewalk on Matheson Avenue. (June 30, 2014)

It is recommended to install seep sample ports at all seep locations (four) identified along Marine Drive and the one identified on Matheson Crescent.

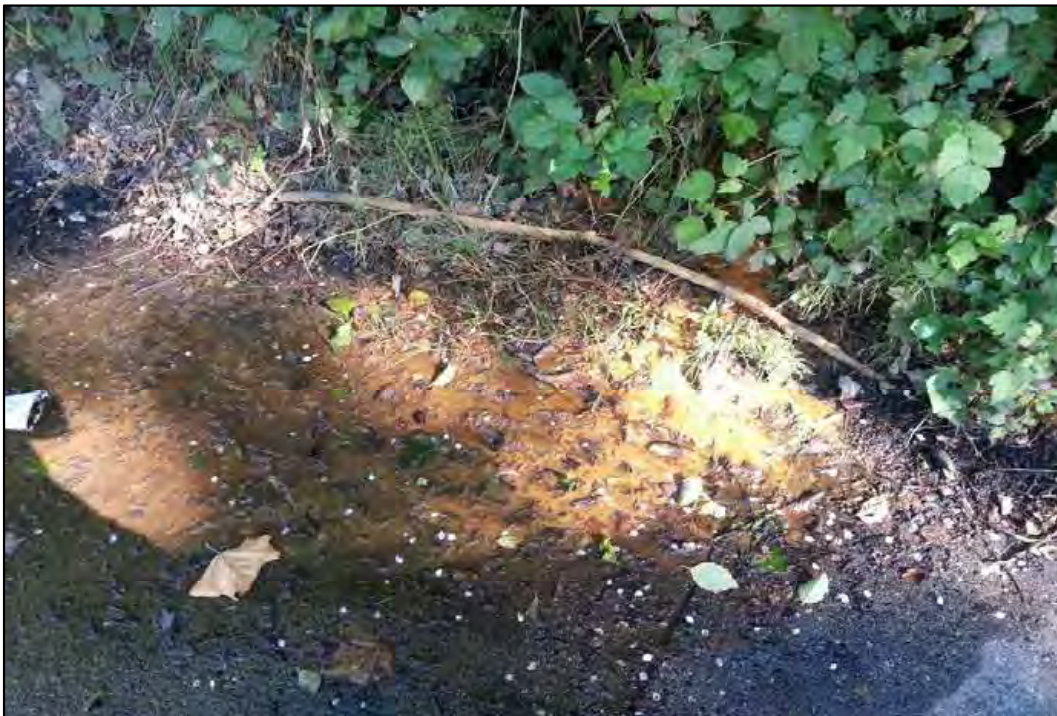
PHOTO 35: Seep onto sidewalk on Matheson Avenue (Close-up) (June 30, 2014)

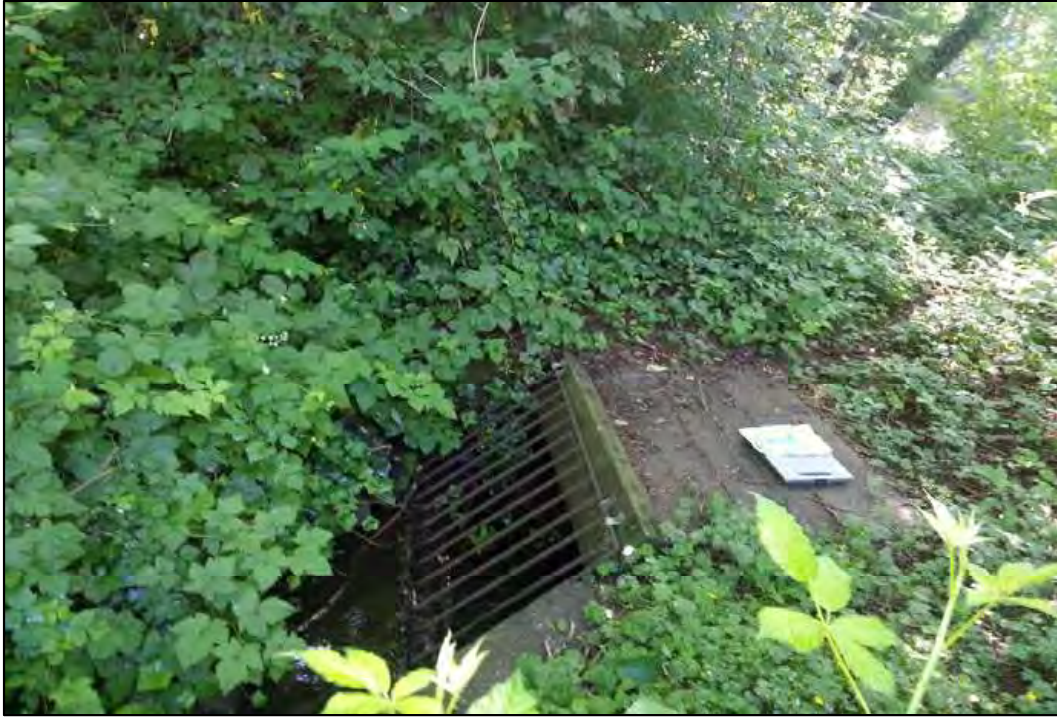
PHOTO 36: Storm drain for outfall from New Kinross Creek. (June 30, 2014)

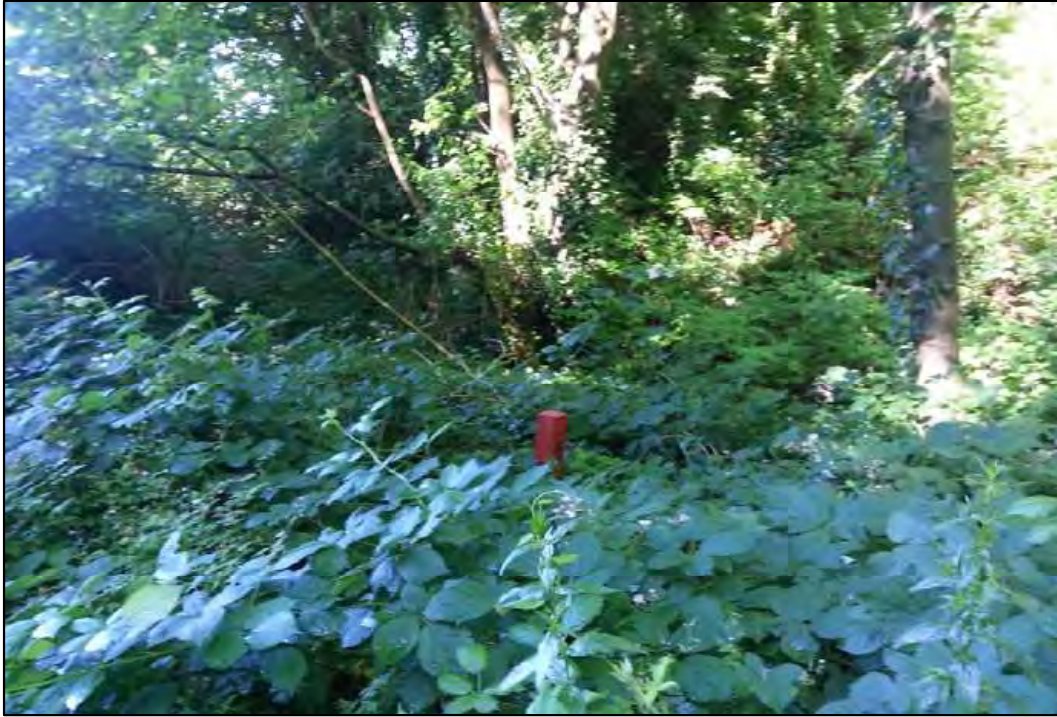
The monitoring well that was documented (observed and photographed) in the recent report prepared by Morrison Hershfield was located by SynergyAspen during a site visit conducted on June 30, 2014. However, the condition of the monitoring well could not be ascertained as the protective monument box was secured. The location of the monitoring well is presented on Drawing VAN6044-14-002 and in Photograph 38.

PHOTO 38: Monitoring well in SW portion of Kinross Ravine Park. (June 30, 2014)

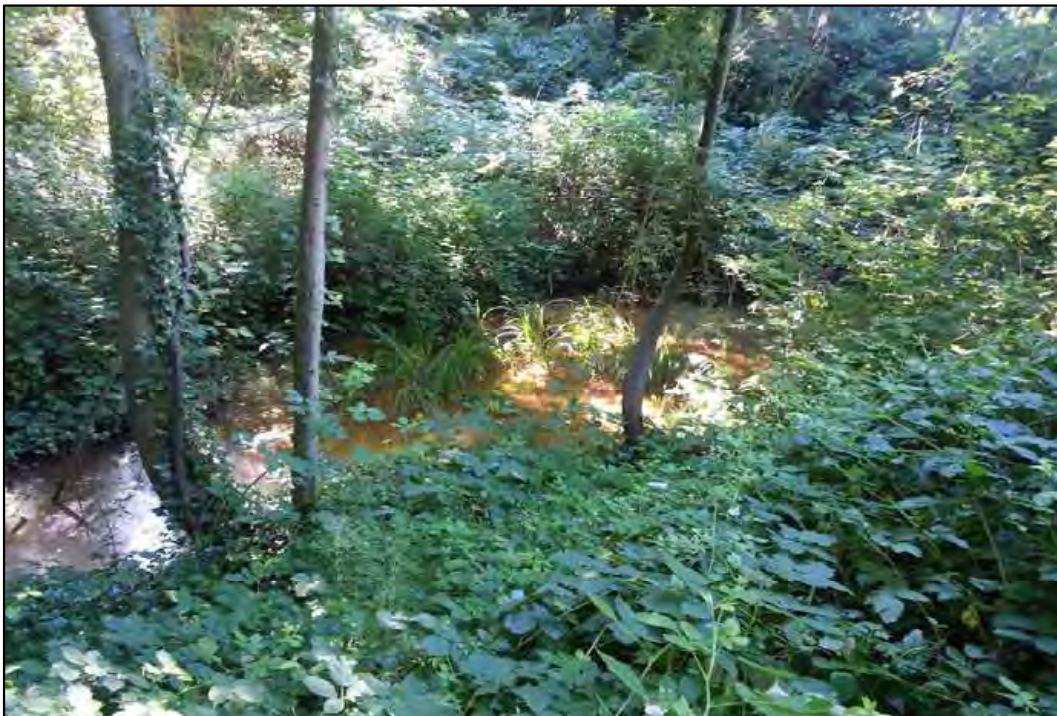
- Downstream of Marine Drive, within the Park, there is standing stagnant surface water with significant iron staining and biofilm accumulation across its width; approximately 3 m maximum. The source of the water is suspected to be discharge from the former Kinross Creek [Photographs 15-17 and 39, 40] and/or possible leaking from the adjacent sanitary sewer system.

PHOTO 39: Iron-laden water along eastern side of Kinross Ravine Park. (June 30, 2014)

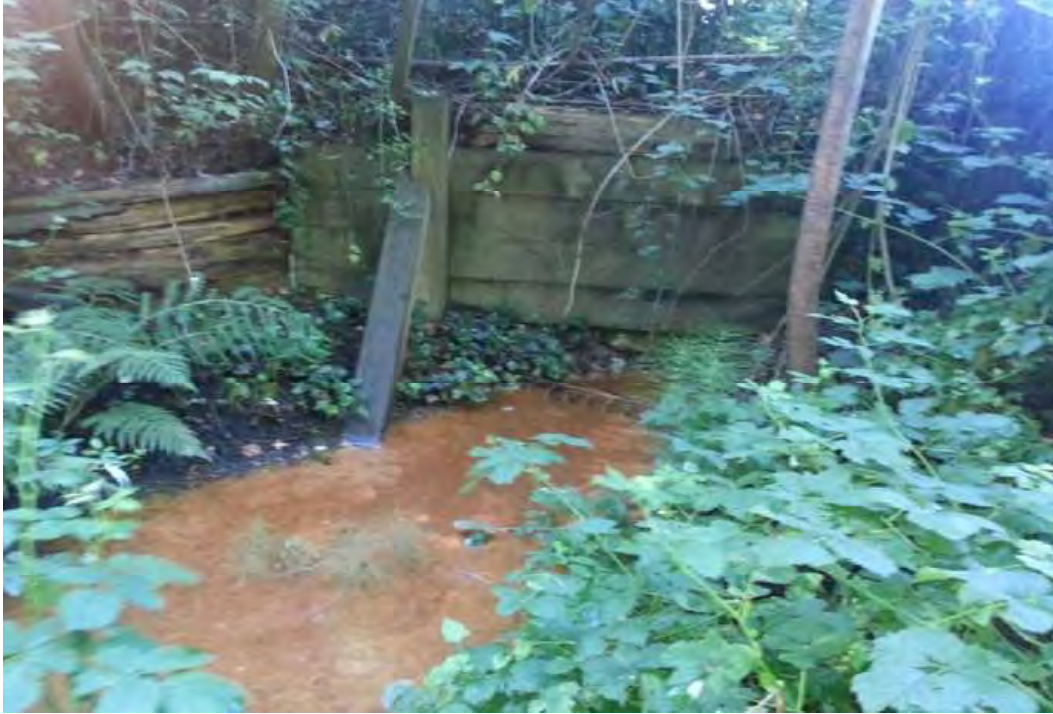
PHOTO 40: Termination of iron-laden water (wooden barricade and metallic grate). (June 30, 2014)

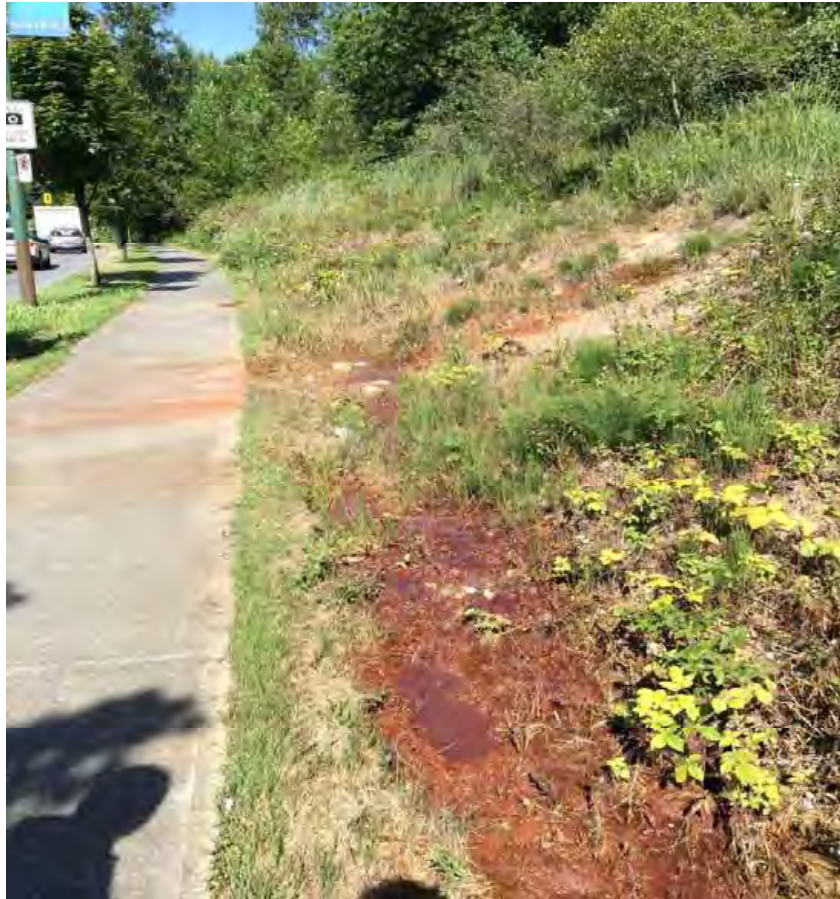
During the Site inspection, no signs of slope instability were observed. The trails along the slope crest, no tension cracks or slumping and no escarpment faces were observed. In addition, no bulging was observed along the slope toe. In general, no surface water diversion or control measures were observed along the slope crest. A shallow ditch is located at the slope toe. Minimal seepage was observed in the toe ditch, approximately 300 m east of the intersection of Marine Way and Marine Drive. More significant seepage was observed approximately 100 m east of the intersection of Marine Way and Kerr Street. The seepage at this location is occurring from approximately 2 m above the base of the slope and some minimal soil erosion was observed.

Photo 1: Seepage along south slope 100 m (approx.) east of Kerr St.

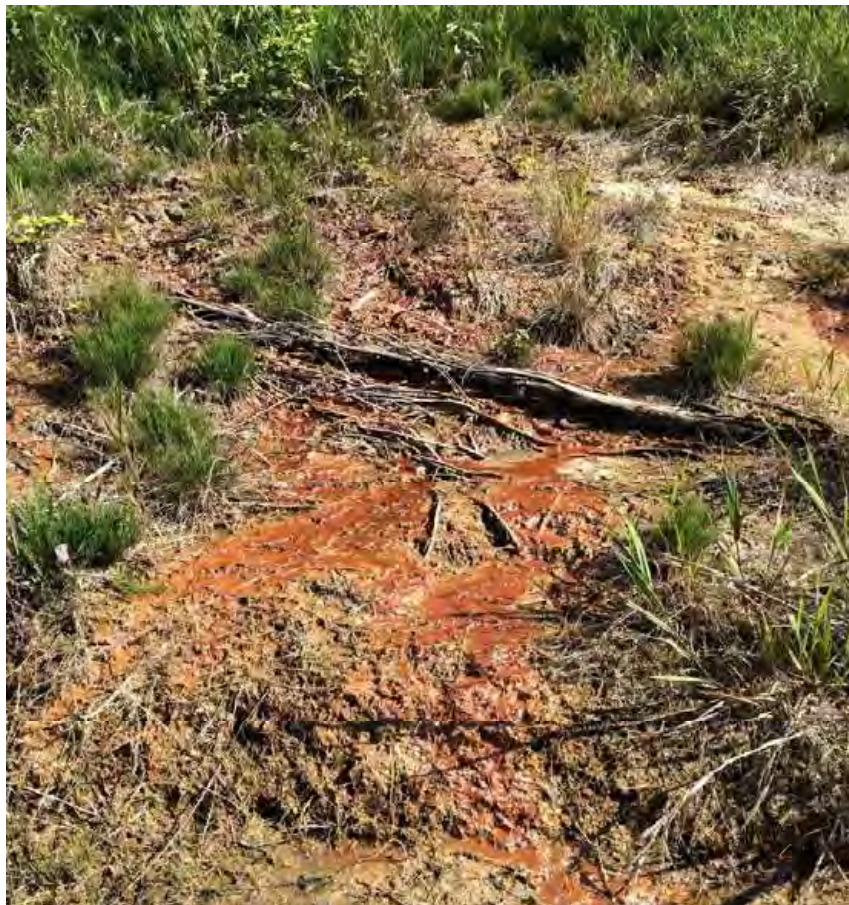
Photo 2: Seepage from 2 m above base of toe along south slope 100 m (approx.) east of Kerr St.
