**Record of City studies regarding a building condition assessment of 2294 W 10<sup>th</sup> Avenue (completed approximately April 2020), including:**

## CA Report

### SOCL\_6485\_2294 W 10th Av

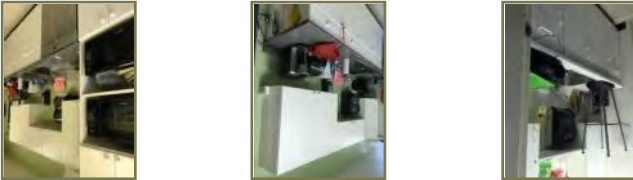
Discipline	Interiors
Category	C1080 - Kitchen Fittings & Finishes
Maintenance Type	
Element Number	3
Replacement Cost	\$6,000
Last Major Action	2000
Location/Name	First Floor Staff Room/Wood Cabinets
Brief Description	The facility is provided a kitchen in the first floor staff room. The kitchen is provided with wood cabinets and counters.
	The length of the cabinets is estimated to be approximately 5 LM.
Validated	Yes
Commentary	No significant deficiencies were observed or reported at the time of the field review.
