Subject: Update - media reports re debris falling from Granville Bridge

I am writing in follow up to recent media attention to reports regarding concrete debris falling from the Granville Bridge. In brief, Engineering staff and external consultants have determined that the debris identified by David McCann, general manager of Creekhous Industries, did not actually originate from the bridge itself.

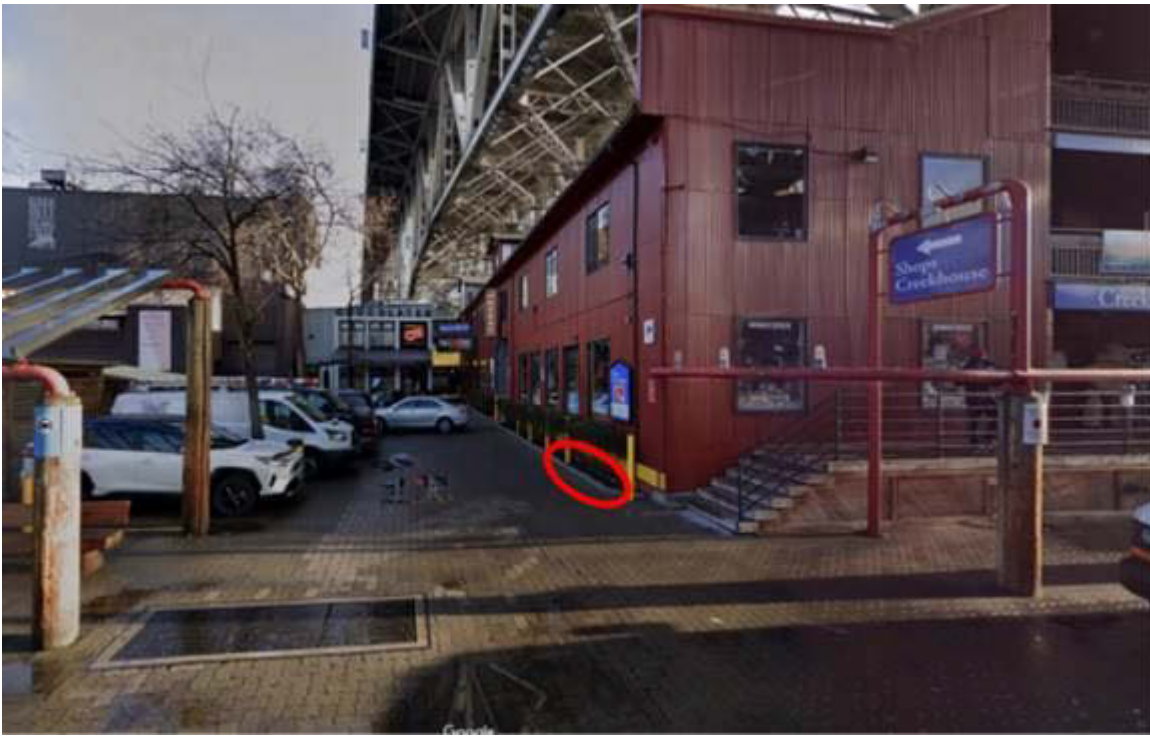
- The inspection concluded that the debris does not appear to have originated from the bridge itself.
 - An update on the inspection findings was shared with Mr. McCann and CMHC today.

- The approximate location of the concrete debris found by Mr. McCann is shown in Figures 1 & 2 below, west of Creekhous shops (circled in red):

Figure 2 – Approximate location of reported concrete debris

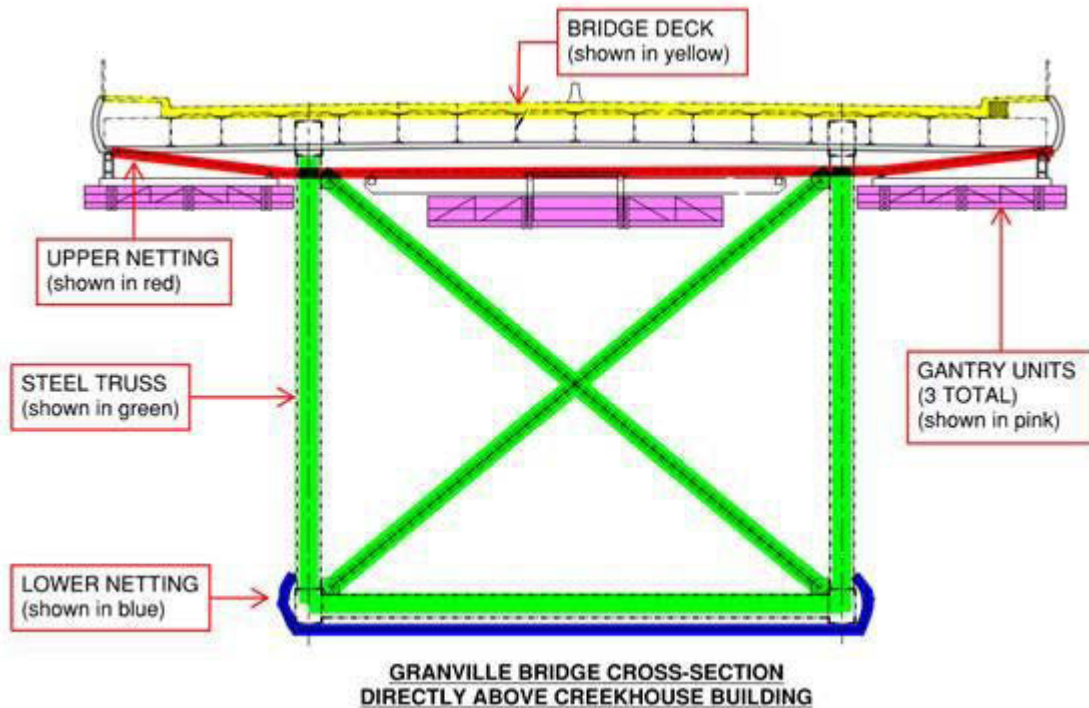
- In 2020, the City installed debris netting directly above this area as part of a pilot project. Debris netting is designed to catch falling debris from the underside of the bridge.
- During the July 15 inspection, no debris or evidence of debris penetrating the netting was identified. Figure 3 below illustrates the debris netting location (shown in red and blue), as well as the location of three gantry units that run along the length of the bridge (shown in pink). These gantry units provide access to the underside of the bridge for inspections and maintenance.

Figure 3 – Granville Bridge cross section above the Creekhous Building

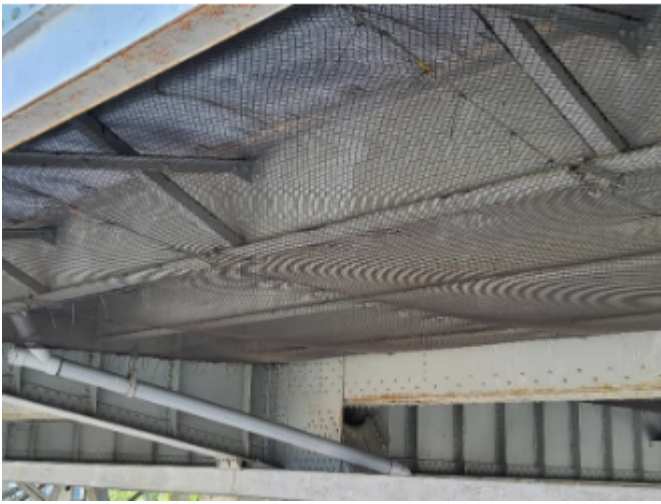
Figure 4 – Debris netting above reported debris location

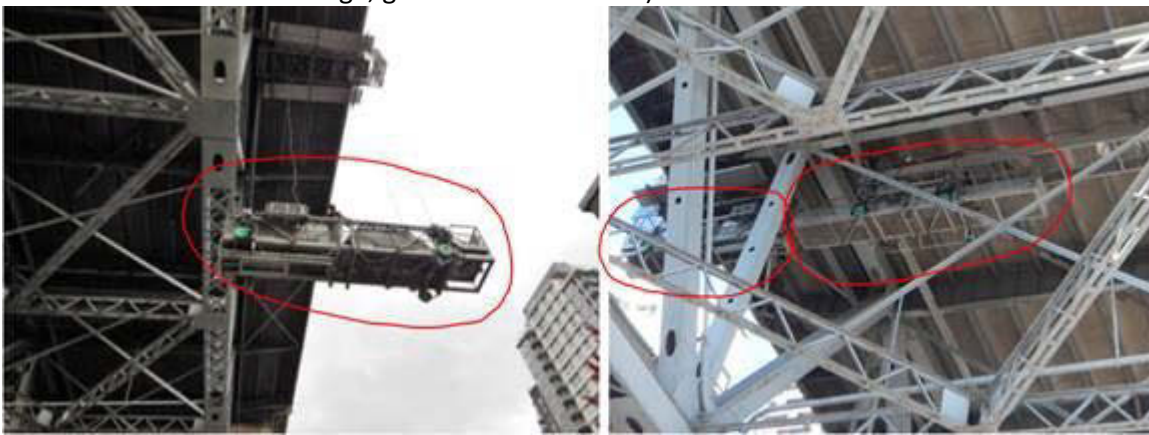
- Figures 5 & 6 show the gantry units being used by City crews for regular maintenance work (photos taken from underside of the bridge, gantries circled in red):

Figures 5 & 6 – Gantry units being used by City crews

- **Although all three of the gantry units are operational, minor repair work currently underway on the south side of the bridge has restricted movement of the gantry temporarily. Access for the inspection on July 15 was instead gained from ground level using a boom lift instead. Temporary traffic management measures were implemented outside the Creekhouse building to ensure the inspection could take place safely.**

- The gantry units are regularly inspected by City's consultants and contractors and repairs are performed on as-needed basis. In addition, City staff have put forward a recommendation to add \$1.3M to support gantry maintenance and renewals as part of the City's Capital Plan mid-term update process.
