**Regarding the March 29, 2024 derailment of the Stanley Park Train, record of the incident report, repair report and colour photographs of the damage and the incident site.**

**Doc #:** 23-080-MEMO-002

**Re:** 2024-03-29 Incident Response

**TECHNICAL FIELD REPORT****Our File:** V83290**Inspection Date:** 2024-04-09**Purchase Order:** Pay by Visa**City of Vancouver**955 Evans Avenue  
Vancouver, BC V6A 4C8Attention: Ms. Rosemary Yip  
Owner: City of VancouverInspection of Chance Train components  
Location: 250 West 70th, Vancouver

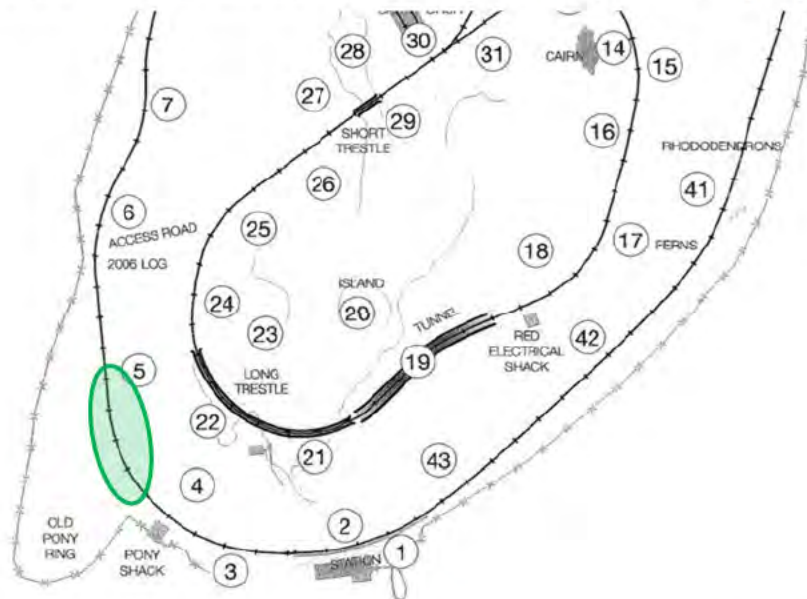
- The incident took place on the curve following the 'pony shack', highlighted in Figure 1.

Figure 1 - Track Layout (direction of travel is indicated by incrementing numbers)

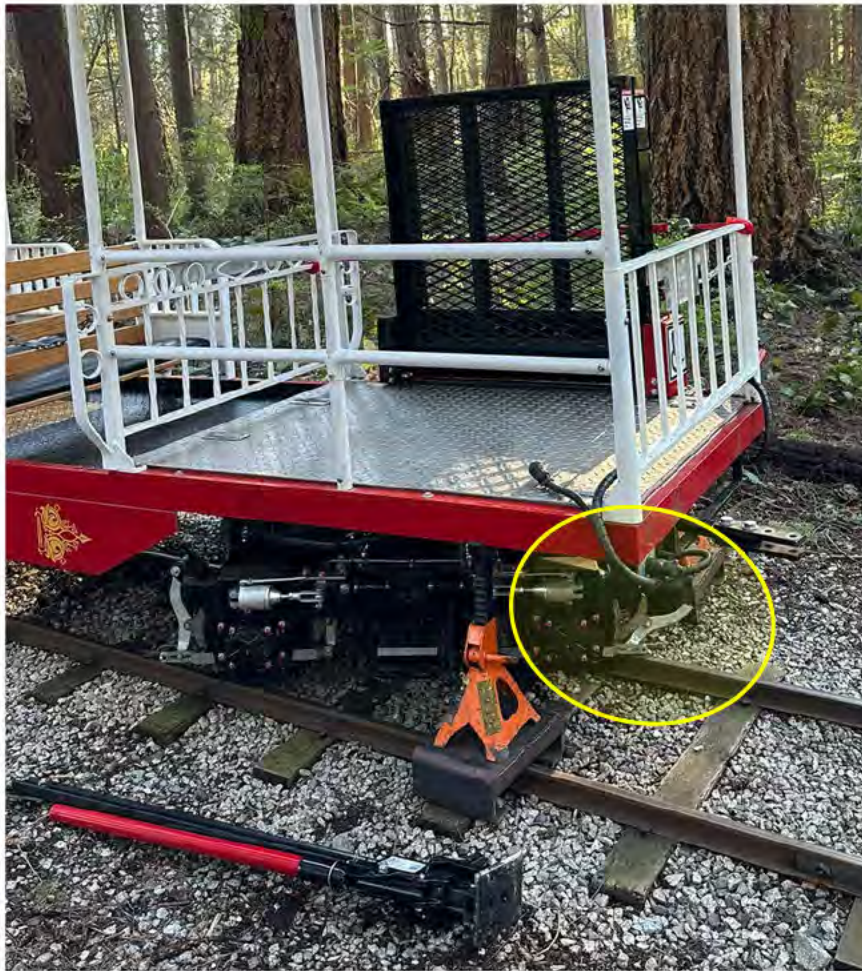
- Based on initial visual inspection and feedback from operators, the incident affected only the final carriage on a 3-carriage train. The specific carriage was A7908 'Coal Harbour', which was most recently refurbished and commissioned for operations.
- The derailment rotated and separated the forward bogie from A7908. A brake linkage was broken as a result of the impact with the ground and track components. Non-destructive testing of the bogie and carriage frame is required prior to resumption of operations.

*Figure 2 - Derailed Carriage (damaged brake linkage highlighted)*

- Carriage A7908 was repaired by replacing the brake linkage and re-assembling the bogie to the carriage. The unit appears to function normally, but not connected to a train. Additional inspection is required before operating this unit.
- The system was reconfigured with 5 carriages drawn by a single locomotive, rather than 2 trains with 3 carriages each. This is one of the standard configurations used by train operations and should not have any negative affect.
- A function test was performed by travelling over the repair multiple times, inspecting the track under load, and adjusting the track as needed. None of the previously reported binding or dragging were observed during function testing.

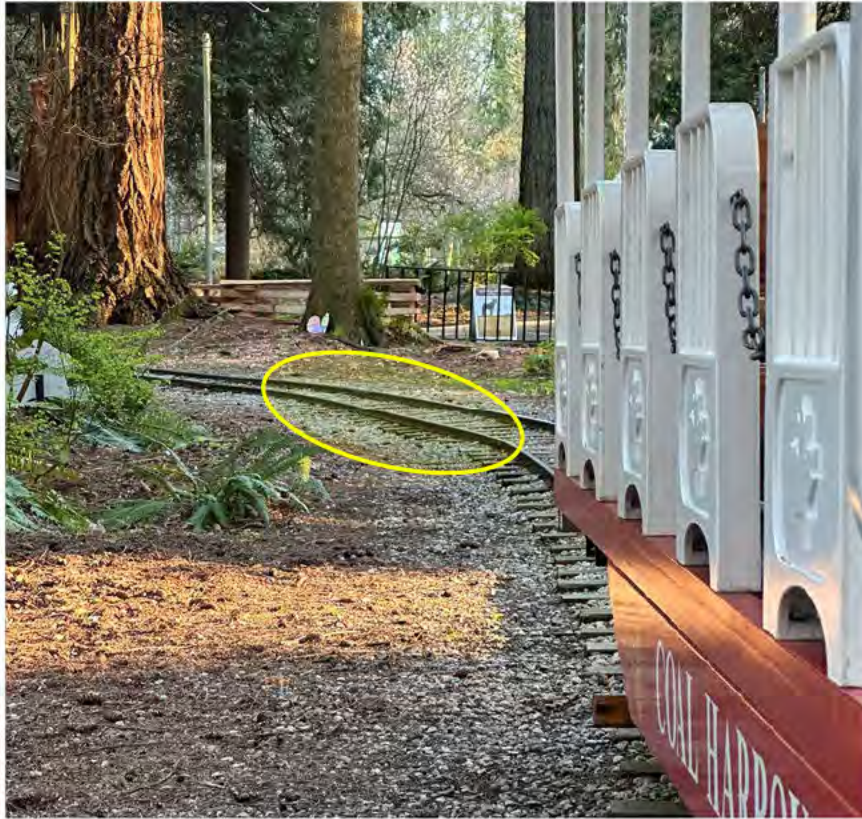
- The remainder of the train functioned normally once disconnected from the derailed carriage.
- A visually noticeable depression formed in the area of the track where the incident occurred, which is an area that is known by operators to be sensitive to environmental events.

*Figure 3 - Depression in Track*

- Significant rainfall was experienced approximately 48 hours prior to the event, which can lead to settling of the track in sensitive areas.
- One of the train operators noted multiple instances of feeling as if a carriage was 'dragging' in the area prior to the incident.

From the above, multiple root causes are plausible, most notably the condition of the track's foundation following recent weather events, as well as differences in wear-in between the newly refurbished carriage and those previously in service.

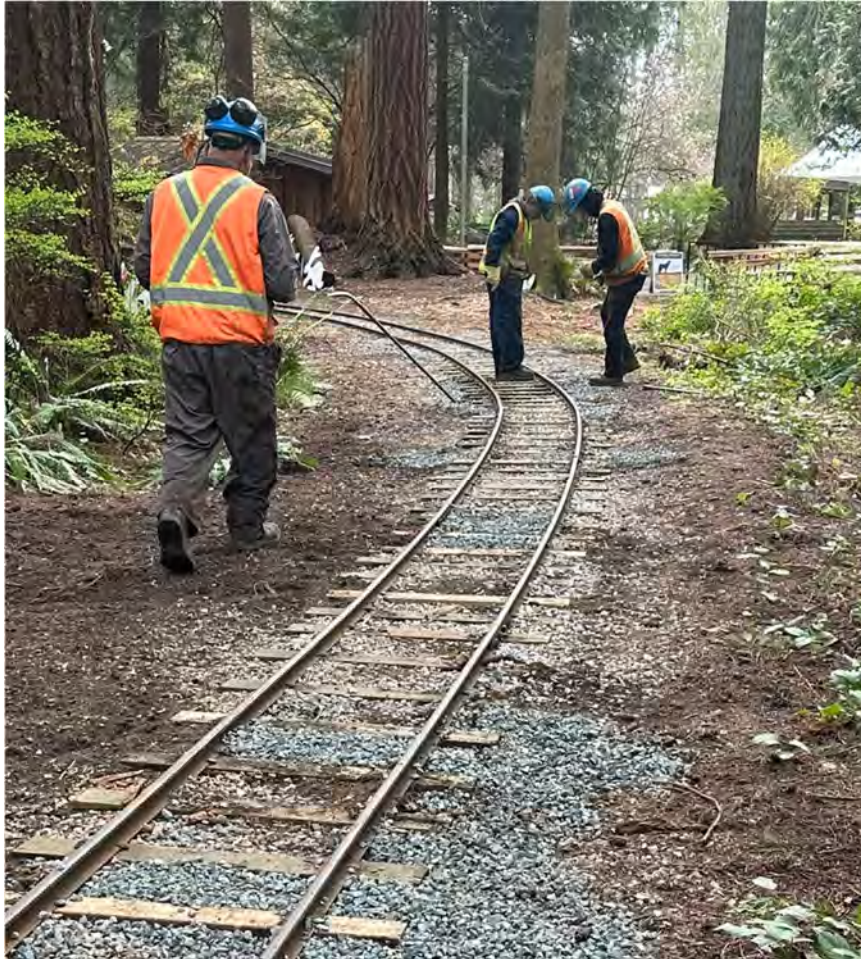
- A&B Rail re-leveled and re-aligned the section of track affected.

*Figure 4 - Track Repairs*

By repairing the track and temporarily removing the affected carriage from service, it is believed that the potential causes of a recurrence of the failure have been eliminated. Pending approval from TSBC, operations may resume. A further investigation of A7908 is required prior re-introduction. It is recommended to have a technician onsite for the remainder of operations and to closely monitor the area of concern as well as the ground conditions in general given the recent weather events.

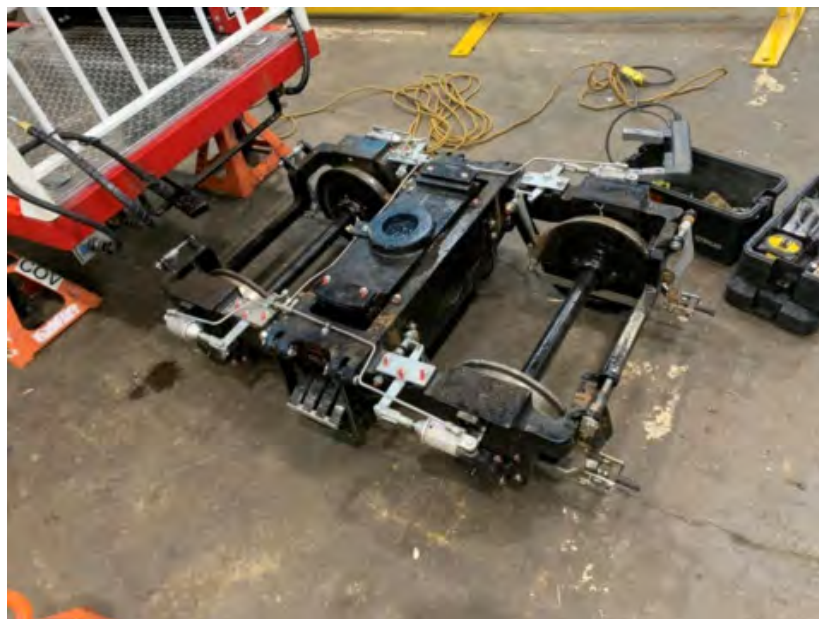
Figure 2: Bogie #4

- Truck Structure (3.5) - no defects noted.
  - Wheels (3.6) - no defects noted.
  - Axels/Shafts (3.7) - no defects noted.
  - Suspension (3.8) - no defects noted.

- Wheels & Suspension Hardware (3.9) - no defects noted.
  - Brake Lever Arms & Links (3.10) - no defects noted.
4. Bogie #6:
  - Fasteners (3.4) - no defects noted.

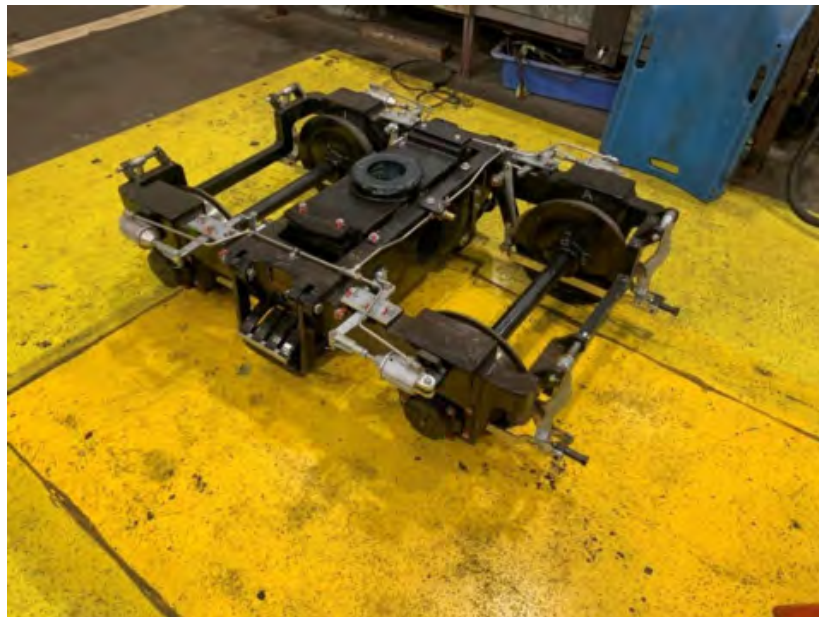
Figure 4: Bogie #6

- Truck Structure (3.5) - no defects noted.
  - Wheels (3.6) - no defects noted.
  - Axels/Shafts (3.7) - no defects noted.
  - Suspension (3.8) - no defects noted.

- Wheels & Suspension Hardware (3.9) - no defects noted.
  - Brake Lever Arms & Links (3.10) - no defects noted.
5. Hitch Bars (3.11) - no defects noted.
