File No.: 04-1000-20-2024-328

May 7, 2014

RE: Arborist Report for Henriquez Partners Architects - For property located at 1040 West Georgia St., Vancouver, BC

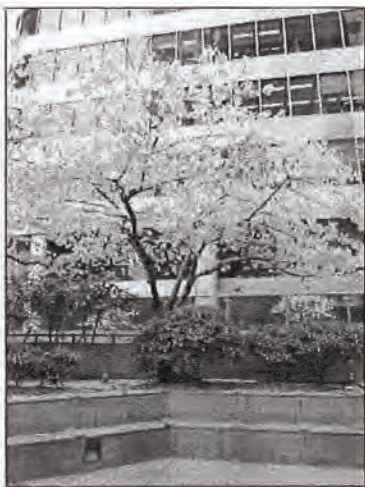
Tree #2

<u>TREE #</u>	<u>SPECIES</u>	<u>DBH</u> (cm)	<u>HEIGHT</u> (m) est.	<u>CRZ</u> radius (ft.)	<u>OBSERVATIONS & RECOMMENDATIONS</u>
1	Cherry (<i>Prunus sp.</i>)	35			<p>These trees all present the same characteristics and issues; they have been previously topped, there is extensive canker on the limbs throughout the canopy, there is evidence of Tortrix borer (especially at the graft site), and there is twig dieback also throughout the canopy which may be indicative of root disease issues. They all have wide-spreading canopies which is typical of the species; trees #1 and #2 have been trimmed back on the west side to reduce the overhang into the ramp for the parking entrance. All of these trees are situated within a raised planter that is reported to be about 3ft deep; the walls of the planter are generally 4ft to 7ft on two sides of each tree, except Tree #5 has less than 2.5ft on two sides. The extensive canker disease and insect infestation will continue to cause dieback of branches and limbs, resulting in continued decline and death.</p> <p>RECOMMENDATIONS: The feasibility of relocating these trees was questioned. Based on their declining health they would not be good candidates for relocation; these trees are over 30 years old and their confined environment has likely contributed to the issues they now present. The wide-spreading canopies would have to be cut back hard in order to relocate them. It is unlikely they would survive being relocated, due to hard pruning that would be necessary, the inevitable root disturbance that would occur, and due to their obvious declining health; for this reason removal is being recommended. Remove trees due to poor condition; they are in decline and survivability beyond five years is not likely. Removal is also required to enable the site development.</p>

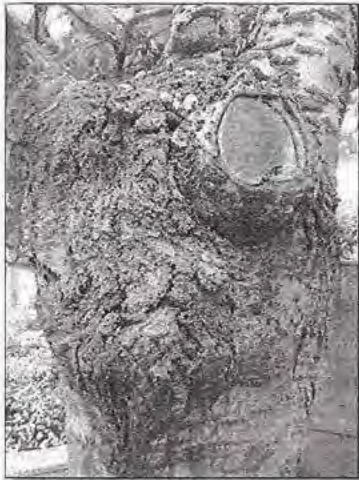
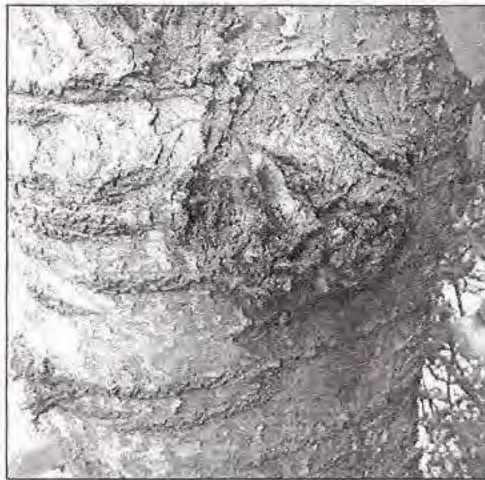
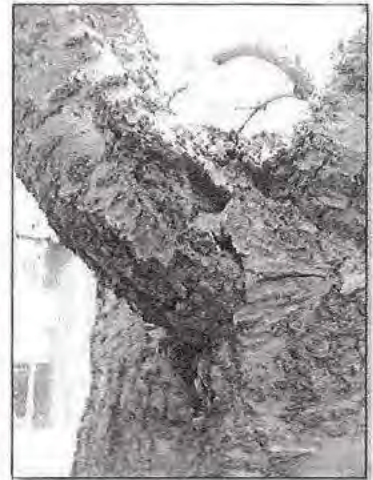
Damage from the Tortrix borer can kill trees and make them more susceptible to bacterial and fungal diseases, and other pests. Attacks from the borer results in noticeable dieback and wilting in the canopy of trees. The feeding tunnels of larvae loosen and crack the bark; heavy infestations cause swellings and cankers and eventually kill limbs or entire trees. The base of the trunk is more often attacked, but the larvae often attack pruning scars on branches or any area on the trunk or limbs that has been damaged.

Based on the observed health conditions of the Cherry trees, it is believed that these trees are nearing the end of their life cycle due to the disease and insect issues described. Further decline and death within the next five years is highly probable.

Canker and Tortrix borer noted throughout the limbs and on the stems

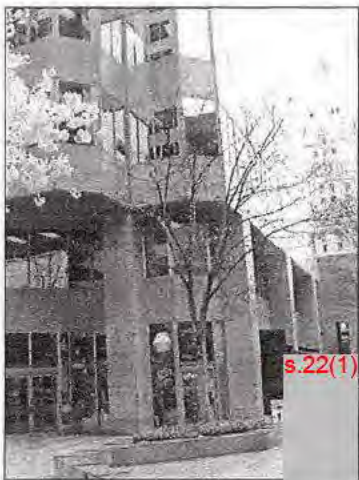
Tree #6

2	Cherry	40			
3	Cherry	33			
4	Cherry	37			
5	Cherry	32			
6	Maple (<i>Acer sp.</i>)	20	8	4.1''	<p>This tree is fairly tall and spindly, but otherwise appears fairly typical of the species. It is located within a raised planter on its own that is approximately 5' by 7' and 16'' deep. This tree will also require removal to enable the site development.</p> <p>RECOMMENDATIONS: This tree may be a good candidate for relocation.</p>

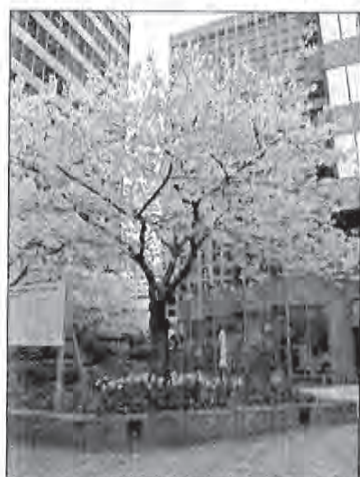
Tree #2

<u>TREE #</u>	<u>SPECIES</u>	<u>DBH</u> (cm)	<u>HEIGHT</u> (m) est.	<u>CRZ</u> radius (ft.)	<u>OBSERVATIONS & RECOMMENDATIONS</u>
1	Cherry <i>(Prunus sp.)</i>	35			<p>These trees all present the same characteristics and issues; they have been previously topped, there is extensive canker on the limbs throughout the canopy, there is evidence of Tortrix borer (especially at the graft site), and there is twig dieback also throughout the canopy. They all have wide-spreading canopies which is typical of the species; trees #1 and #2 have been trimmed back on the west side to reduce the overhang into the ramp for the parking entrance.</p> <p>All of these trees are situated within a raised planter that is reported to be about 3ft deep; the walls of the planter are generally 4ft to 7ft on two sides of each tree, except Tree #5 has less than 2.5ft on two sides.</p> <p>RECOMMENDATIONS: The feasibility of relocating these trees was questioned. Based on their declining health they would not be good candidates for relocation; these trees are over 30 years old and their confined environment has likely contributed to the issues they now present. The wide-spreading canopies would have to be cut back hard in order to relocate them. It is very doubtful they would survive being relocated, due to hard pruning that would be necessary, the inevitable root disturbance that would occur, and due to their obvious declining health; for this reason removal is being recommended. Remove trees to enable the site development or the necessary membrane replacement.</p>

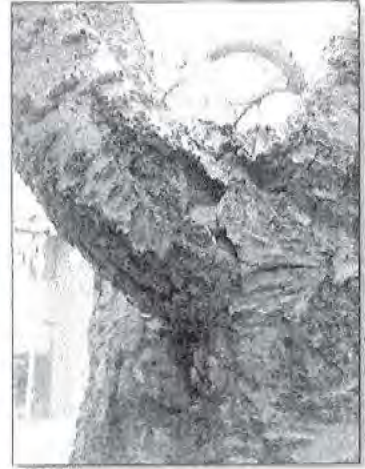
Canker and Tortrix borer noted throughout the limbs and on the stems

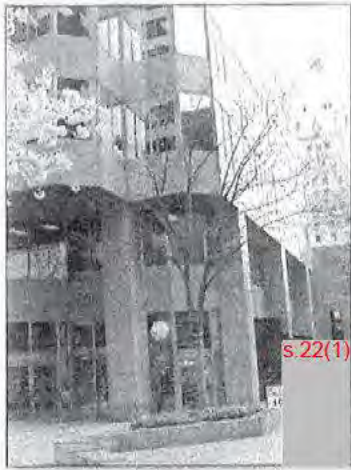
Tree #6

2	Cherry	40			
3	Cherry	33			
4	Cherry	37			
5	Cherry	32			
6	Maple <i>(Acer sp.)</i>	20	8	4.1''	<p>This tree is fairly tall and spindly, but otherwise appears fairly typical of the species. It is located within a raised planter on its own that is approximately 5' by 7' and 16" deep. This tree will also require removal to enable the site development or the replacement of the membrane.</p> <p>RECOMMENDATIONS: This tree may be a good candidate for relocation provided it does not result in damage to the membrane; the tree would need to be taken out just as the construction is to commence.</p>

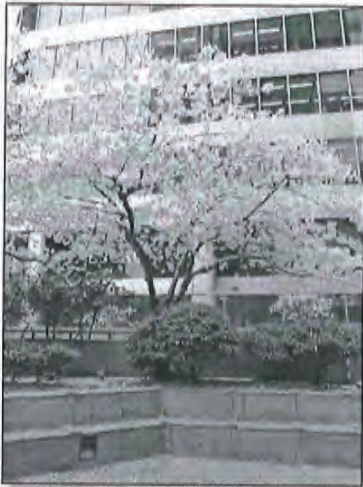
Tree #2

1	Cherry <i>(Prunus sp.)</i>	35			<p>These trees all present the same characteristics and issues; they have been previously topped, there is extensive canker on the limbs throughout the canopy, there is evidence of Tortrix borer (especially at the graft site), and there is twig dieback also throughout the canopy. They all have wide-spreading canopies which is typical of the species; trees #1 and #2 have been trimmed back on the west side to reduce the overhang into the ramp for the parking entrance.</p> <p>All of these trees are situated within a raised planter that is reported to be about 3ft deep; the walls of the planter are generally 4ft to 7ft on two sides of each tree, except Tree #5 has less than 2.5ft on two sides.</p> <p>RECOMMENDATIONS: The feasibility of relocating these trees was questioned. Based on their declining health they would not be good candidates for relocation; these trees are over 30 years old and their confined environment has likely contributed to the issues they now present. The wide-spreading canopies would have to be cut back hard in order to relocate them. It is very doubtful they would survive being relocated, due to hard pruning that would be necessary, the inevitable root disturbance that would occur, and due to their obvious declining health; for this reason removal is being recommended. Remove trees to enable the site development or the necessary membrane replacement.</p>

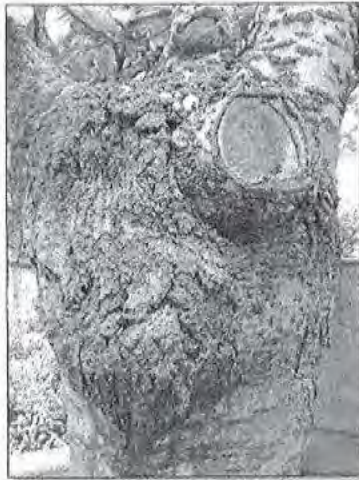
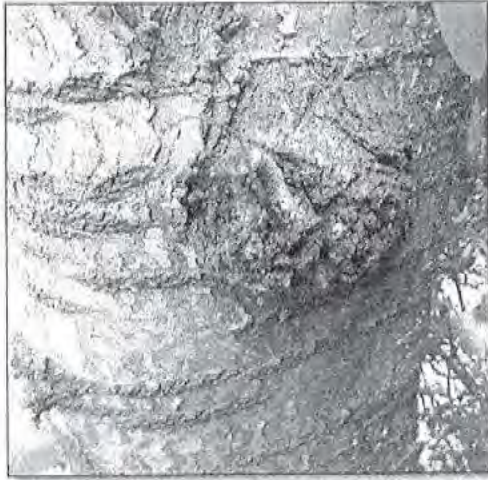
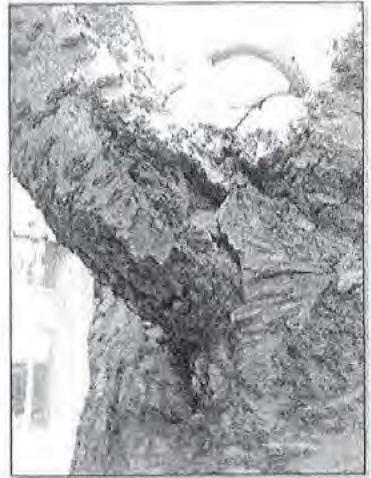
Canker and Tortrix borer noted throughout the limbs and on the stems

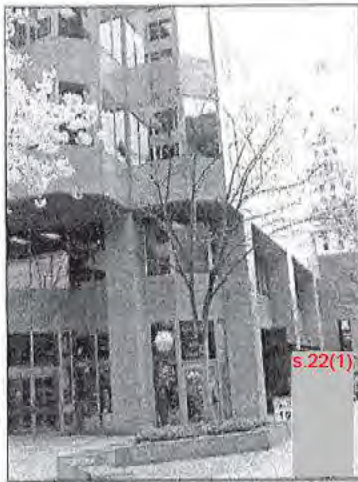
Tree #6

6	Maple <i>(Acer sp.)</i>	20	8	4.1''	<p>This tree is fairly tall and spindly, but otherwise appears fairly typical of the species. It is located within a raised planter on its own that is approximately 5' by 7' and 16'' deep. This tree will also require removal to enable the site development or the replacement of the membrane.</p> <p>RECOMMENDATIONS: This tree may be a good candidate for relocation provided it does not result in damage to the membrane; the tree would need to be taken out just as the construction is to commence.</p>
---	----------------------------	----	---	-------	---
