Expo Deck Deconstruction - Scoping Study

City of Vancouver

30 May 2023

Reference: Science World – City Heavy Deck – Condition Assessment and Options for Rehabilitation

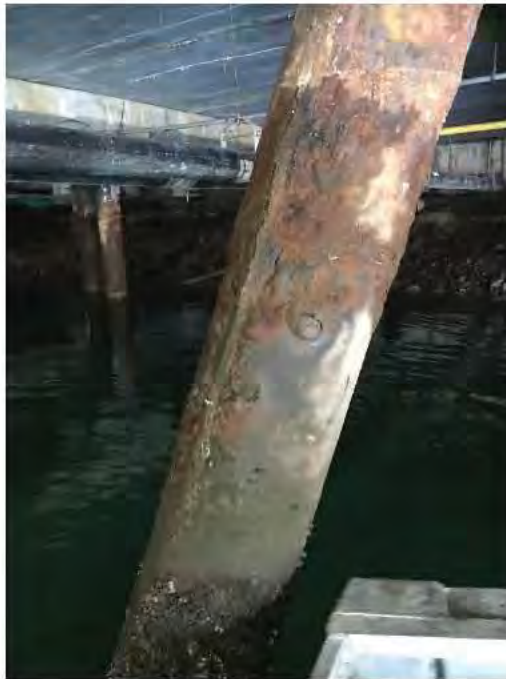
Photograph No. 1: Widespread coating failure with corrosion on steel pipe piles at the City heavy deck to the southeast of Science World

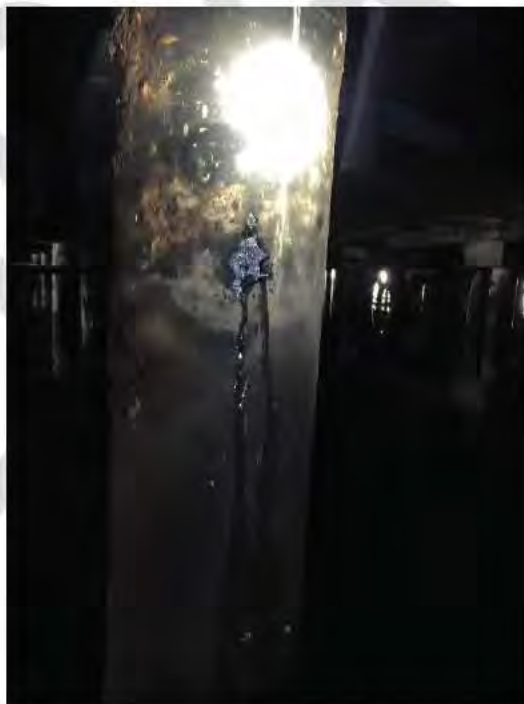
Photograph No. 2: Water ingress between pipe coating and steel pipe piles at the City heavy deck to the southeast of Science World

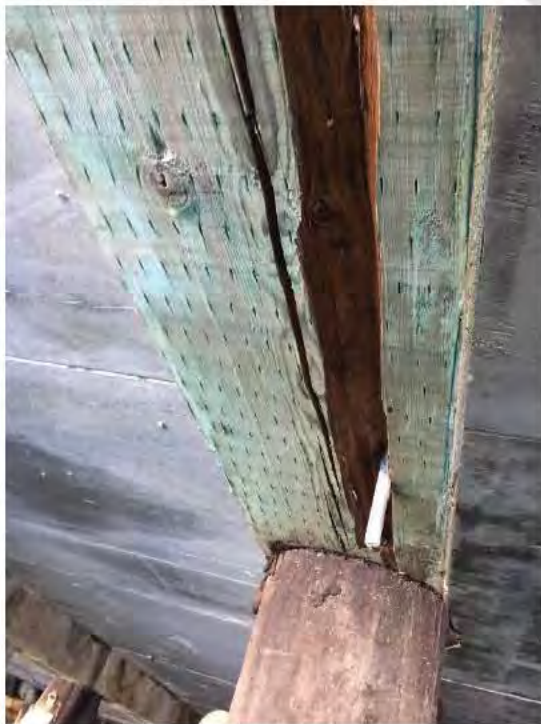
Photograph No. 4: Mechanical damage to pile cap at Bent No. 22.

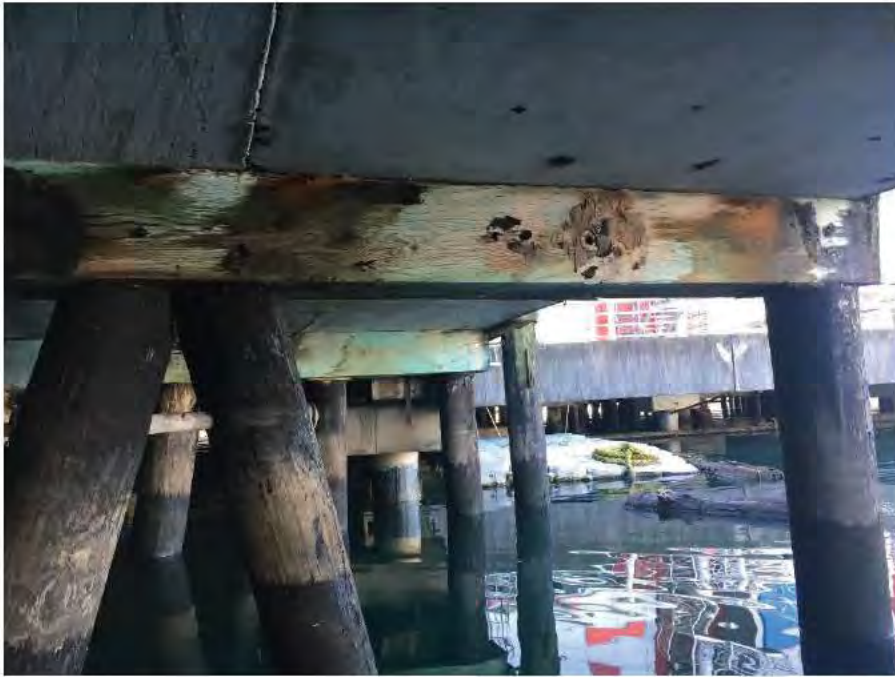
Photograph No 5: Multiple holes on side face of pile cap at Bent No. 22

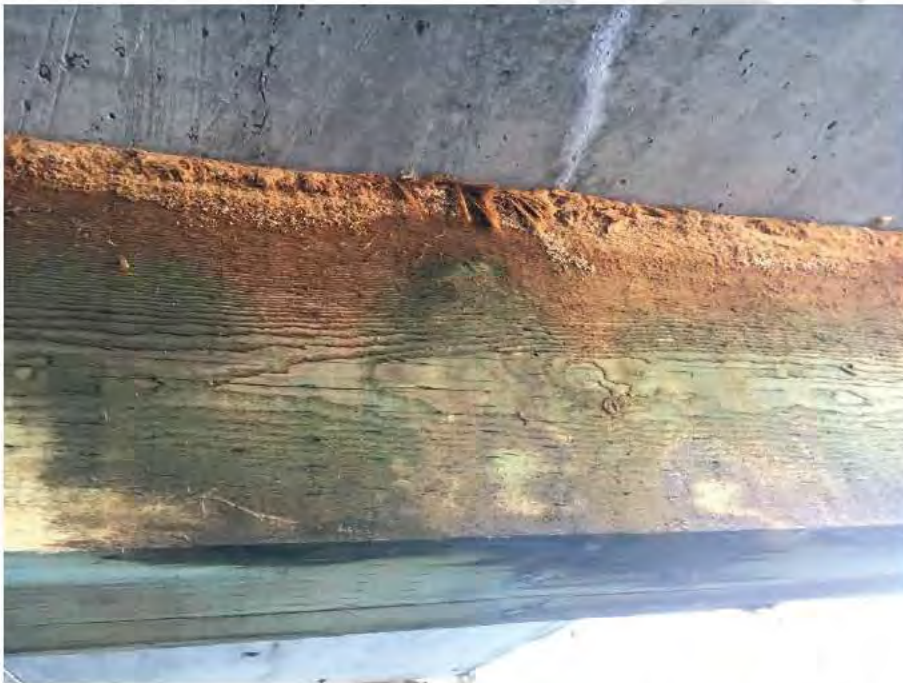
Photograph No 6: Wet internal fibres with 25 mm split at soffit of pile cap at Bent No. 22

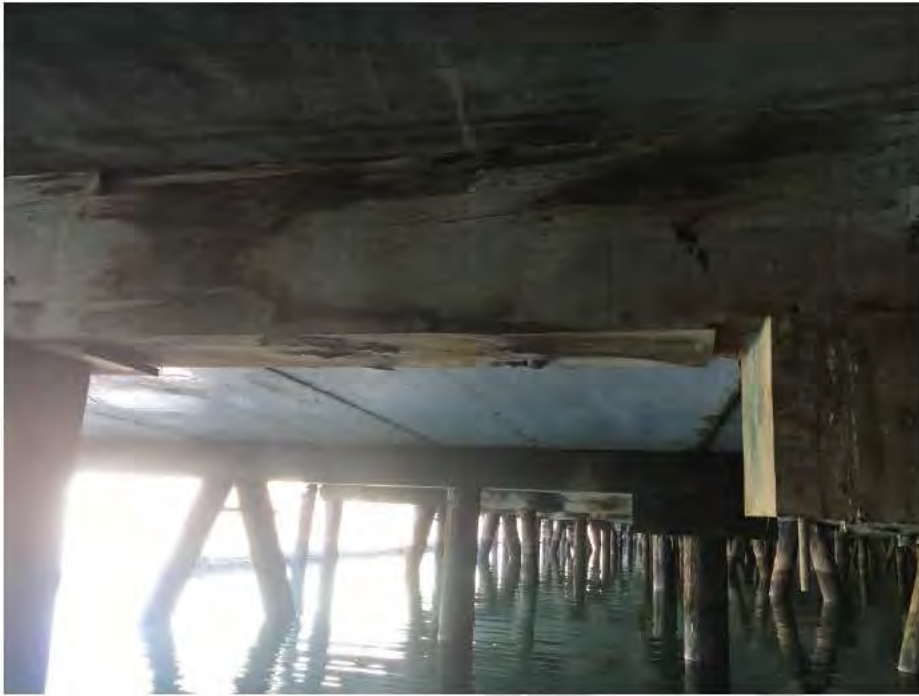
Photograph No 7: Multiple notches on pile cap at Bent No. 21

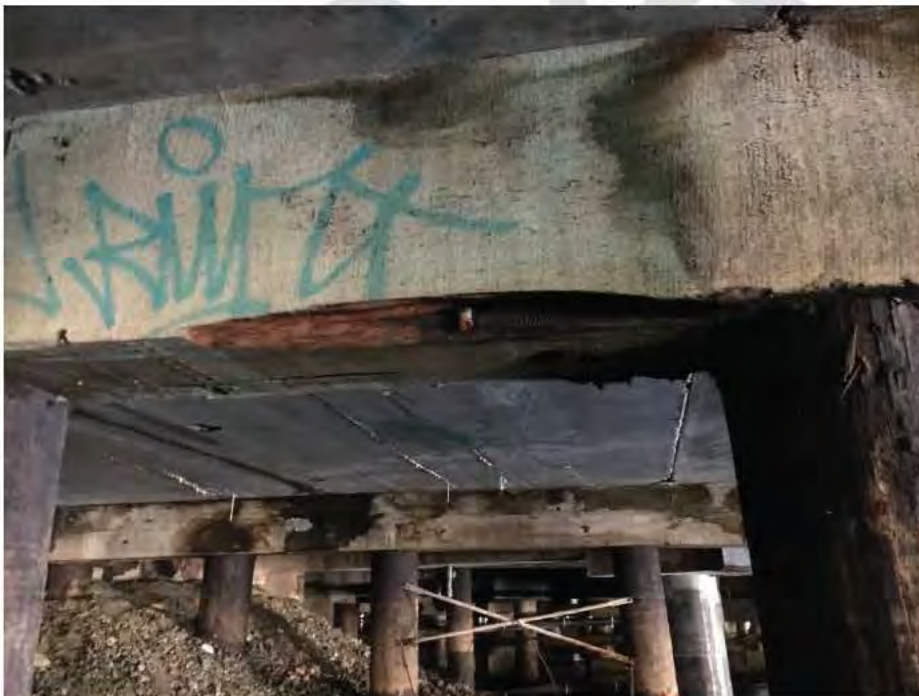
Photograph No. 8: Mechanical damage to pile cap at Bent No. 22 at location of Panel 11.

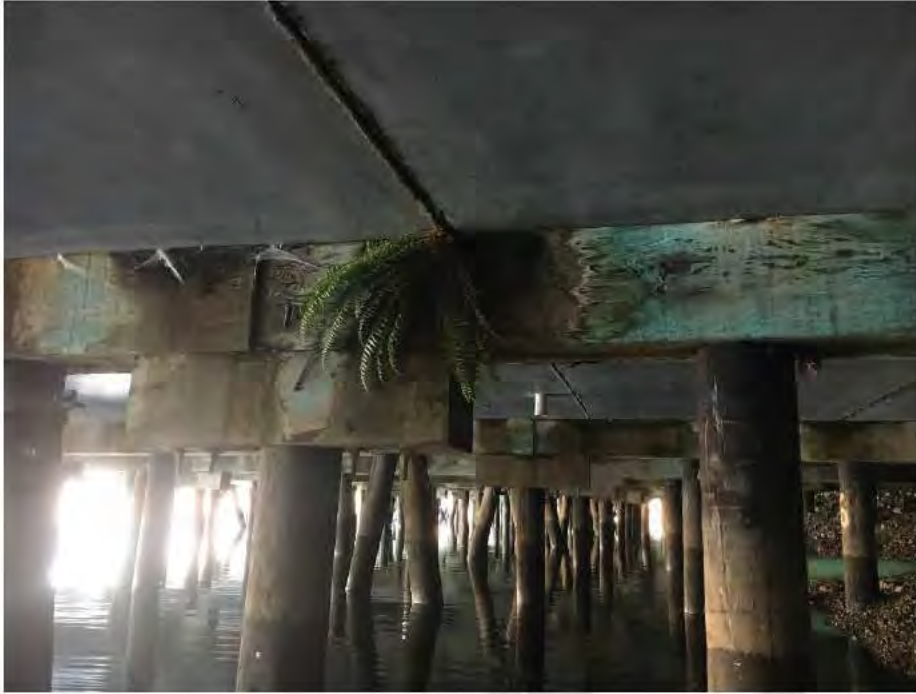
Photograph No. 9: Water ingress and vegetation growth on Pile Cap at Bent No. 18.

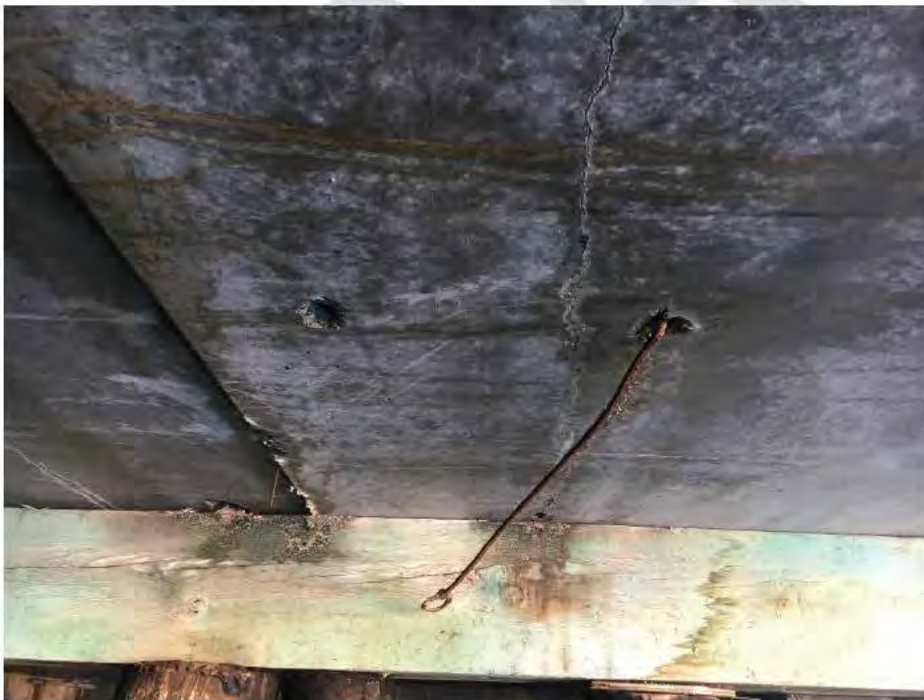
Photograph No. 10: Full length longitudinal crack and multiple spalls along the slab soffit at Panel No. 1 between Bent Nos 23 and 24.

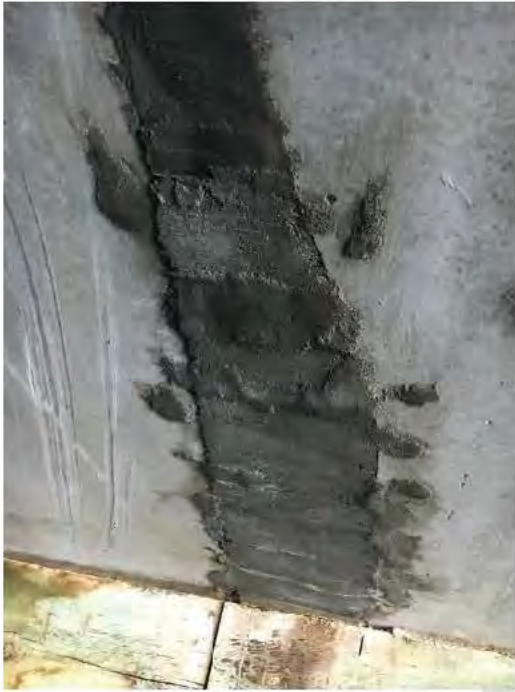
Photograph No.11: Previous grout repairs to Southeast corner of Panel No. 3 between Bent Nos 23 and 24.

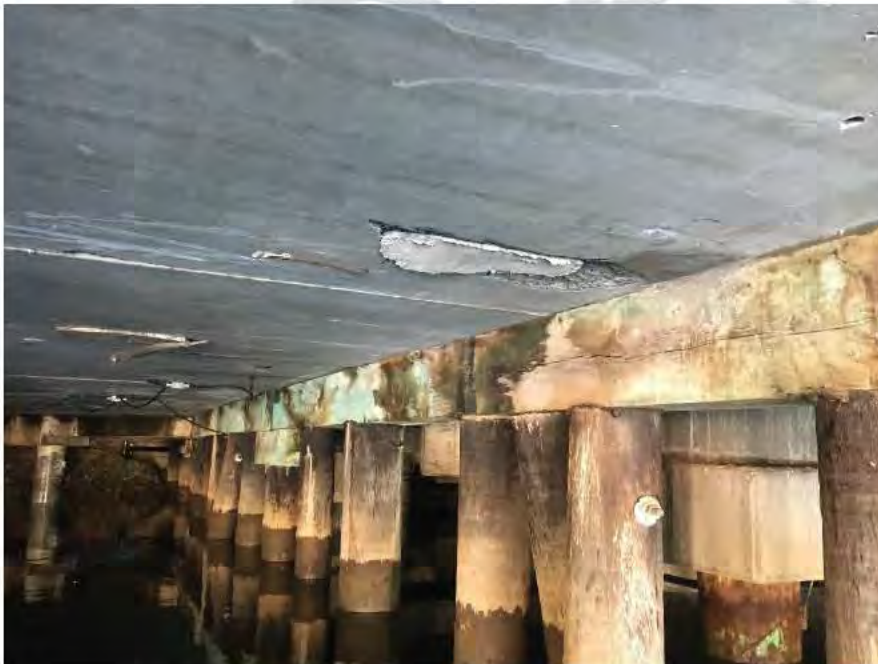
Photograph No.12: Previously installed repair at Southeast corner of Panel No. 4 between Bent Nos 23 and 24 failing.

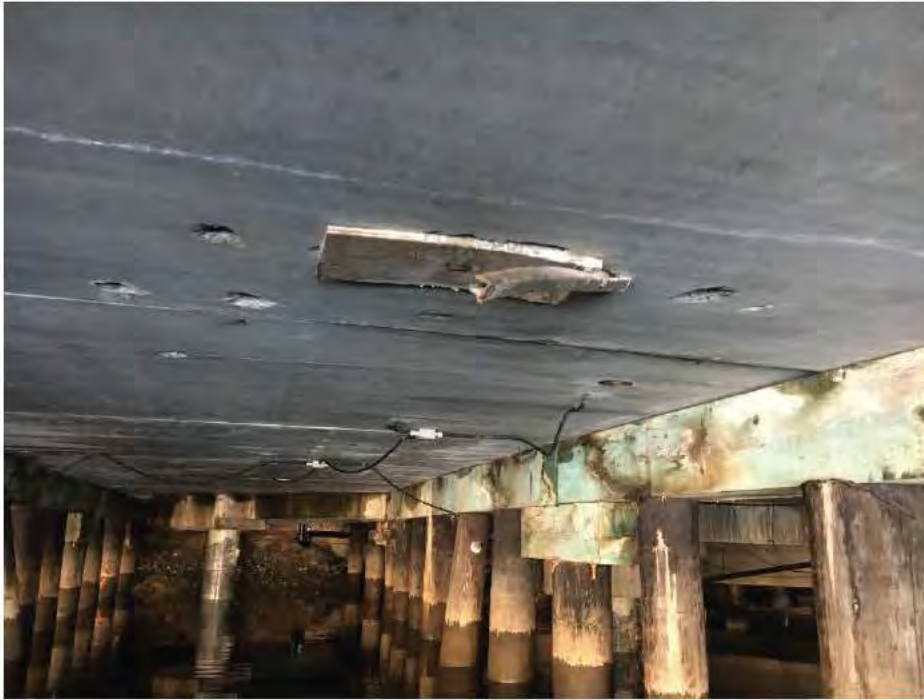
Photograph No.13: Previously installed formwork failing at Panel No. 5 between Bent Nos 23 and 24.

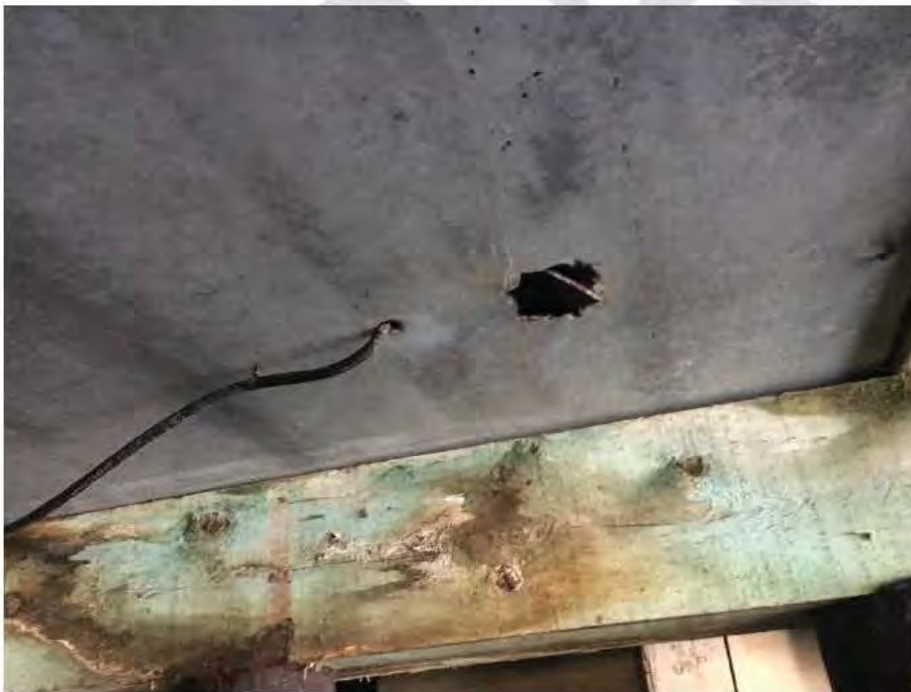
Photograph No.14: Soffit spalling at Panel No. 6 between Bent Nos 23 and 24.

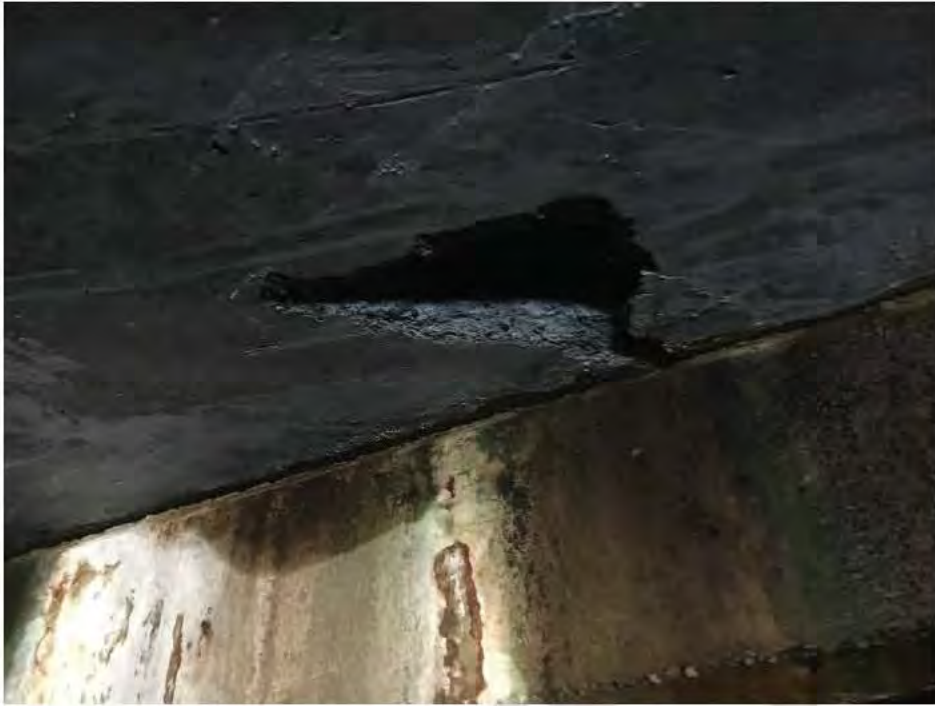
Photograph No.15: Spalling of soffit at Panel No. 11 between Bent Nos 23 and 24.

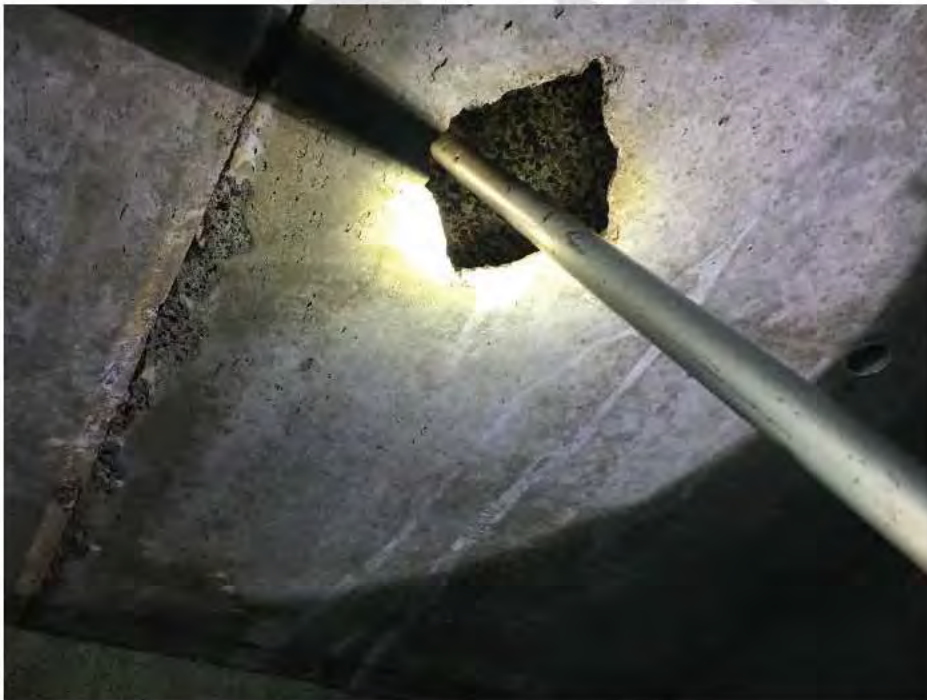
Photograph No.16: Soffit spalling at North end of Panel No. 5 between Bent Nos 22 and 23.

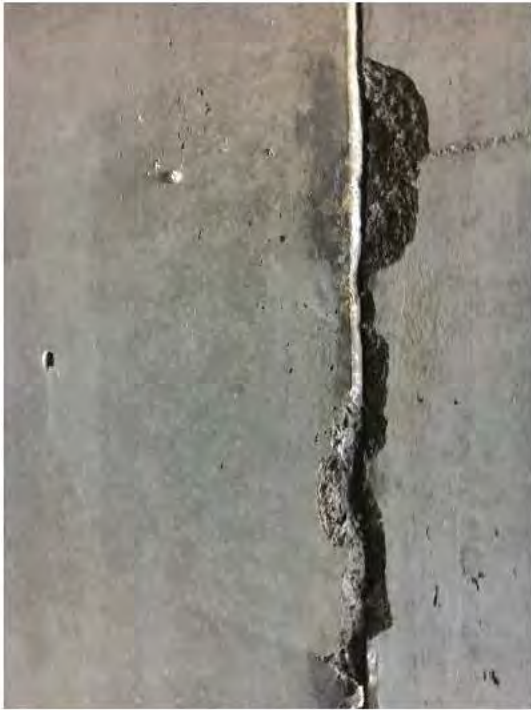
Photograph No.17: Spalling of deck soffit at interface of Panel Nos. 5 and 6 between Bent Nos 21 and 22.

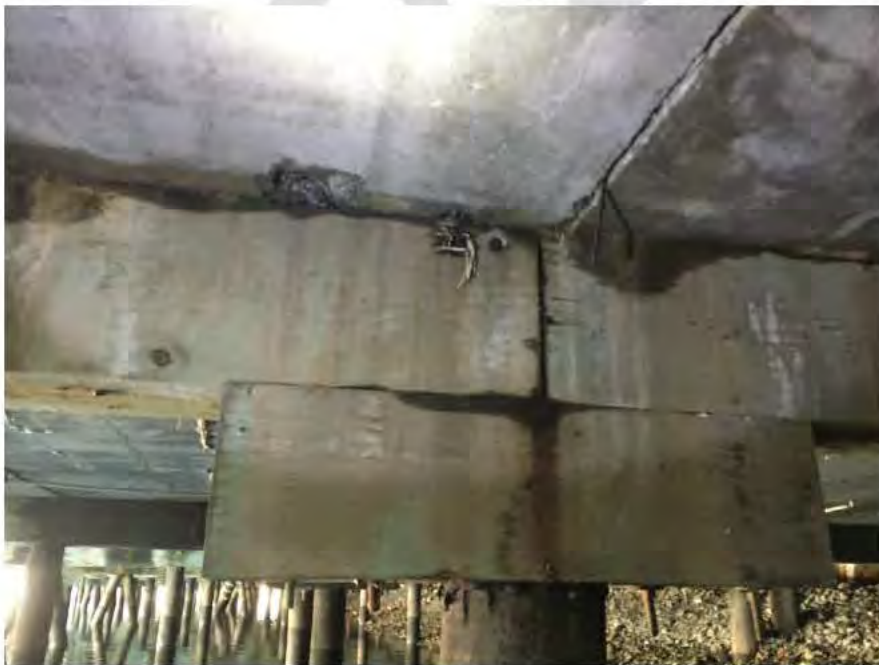
Photograph No.18: Spalled concrete at North end with exposed drift pin at Panel No. 9 between Bent Nos 21 and 22

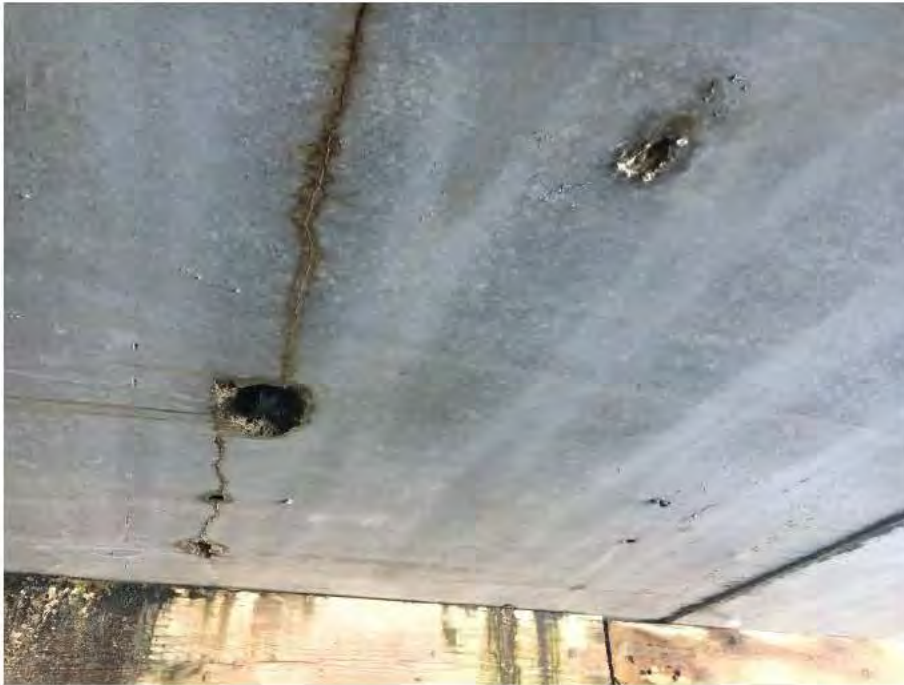
Photograph No.19: Spalling of deck soffit and cracking with efflorescence at Panel No. 4 between Bent Nos 20 and 21.

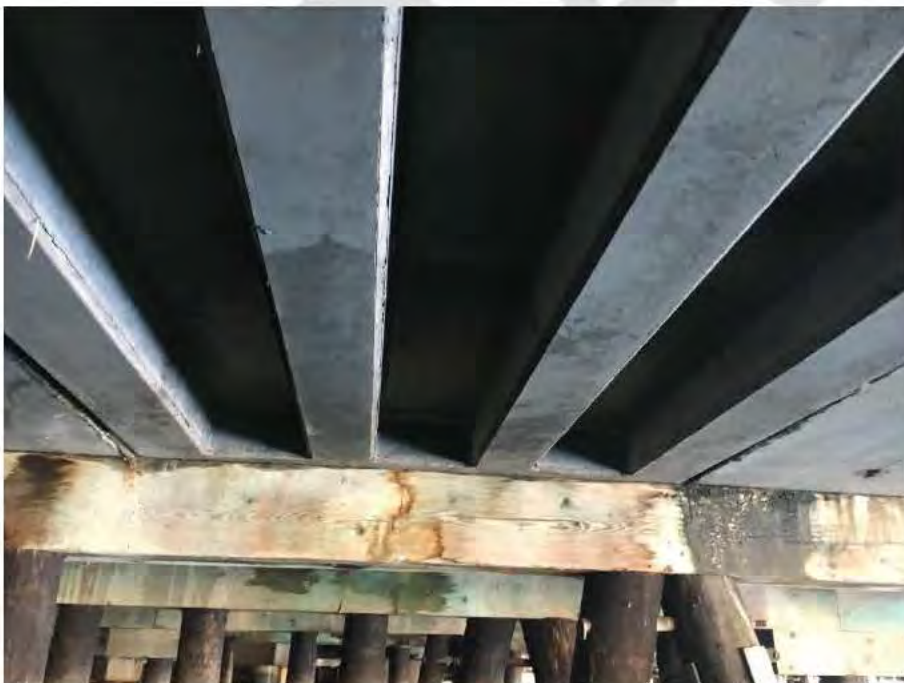
Photograph No.20: Panel No. 5 between Bent Nos 20 and 21 replaced.

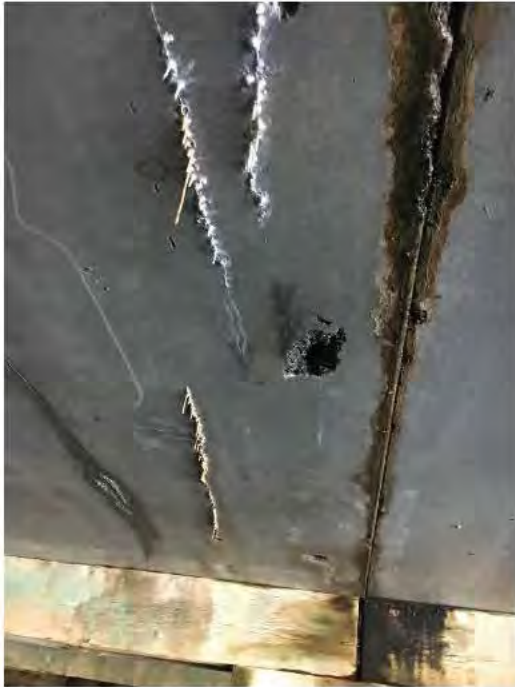
Photograph No.21: Spalling of deck soffit and cracking with efflorescence at Panel No. 7 between Bent Nos 20 and 21.
