Re: **Request for Access to Records under the Freedom of Information and Protection of Privacy Act (the "Act")**

Records relating to the demolition and hazardous materials management at David Lloyd Gerge Elementary School including:

Title: Revised Hazardous Building Materials Assessment
David Lloyd George Elementary, 8370 Cartier Street, Vancouver, BC
Prepared by: **Pinchin West Ltd.**
Dated: September 15, 2016

David Lloyd George Elementary
8370 Cartier Street, Vancouver,
BC

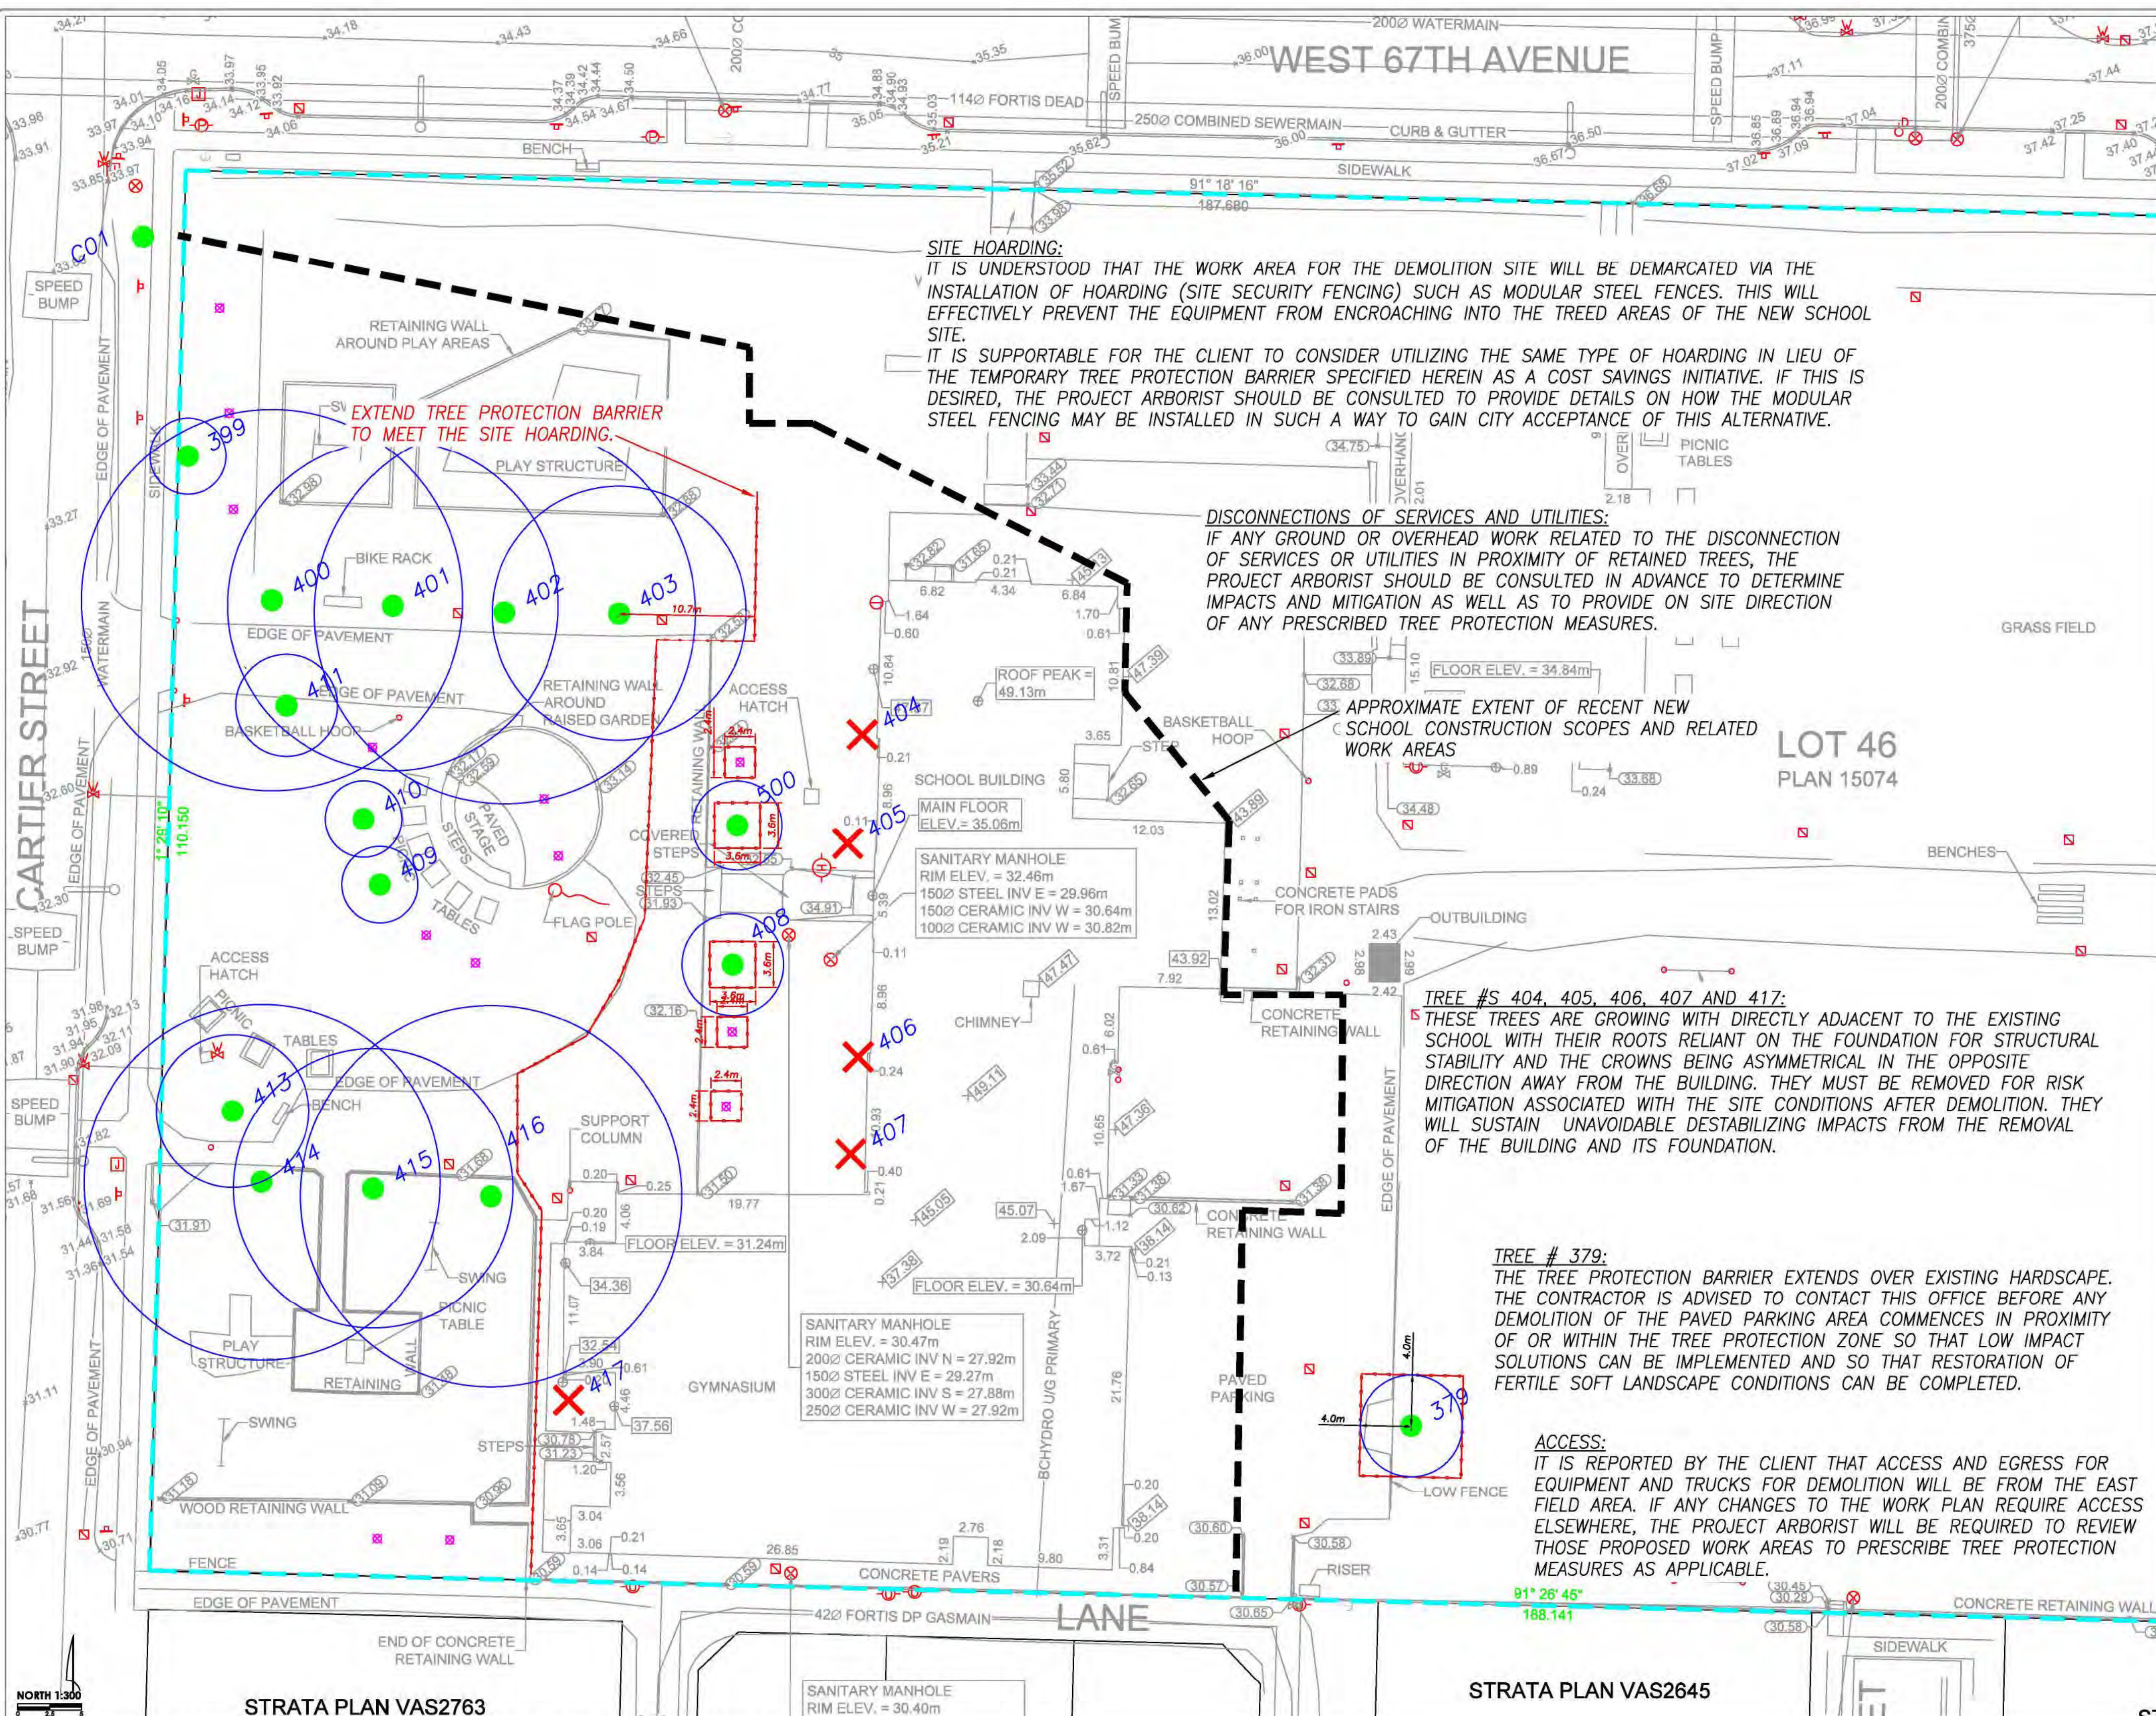
ISSUED FOR DEMOLITION - IFC APPENDIX C: TREE MANAGEMENT DRAWING - DEMO PHASE

- Tree Tag/ID's:
404, 405, 406, 407 and 417
- These trees cannot be safely retained due to their reliance on the existing school building and foundation for structural stability, and the removal of that structure which will render the trees destabilized and high risk.

TREE #S 404, 405, 406, 407 AND 417: THESE TREES ARE GROWING WITH DIRECTLY ADJACENT TO THE EXISTING SCHOOL WITH THEIR ROOTS RELIANT ON THE FOUNDATION FOR STRUCTURAL STABILITY...

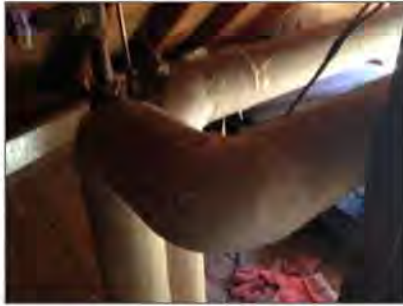
Unlabelled asbestos-containing pipe elbows.

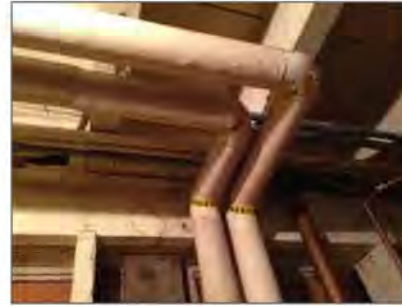
Labelled asbestos-containing pipe elbows.

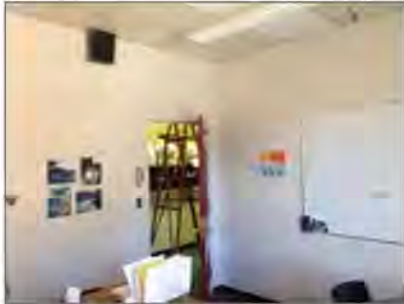
Drywall (gypsum board) and drywall joint compound present as a wall finish in locations 10 and 11 was previously sampled and determined to be asbestos-containing.

Drywall walls with asbestos-containing joint compound.

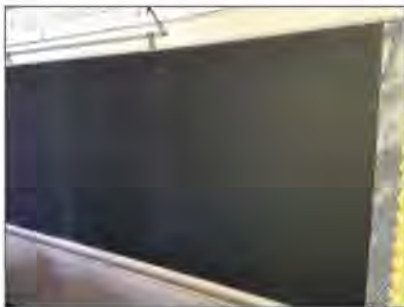
Green and black chalkboards present in classrooms throughout the school were presumed to be asbestos-containing. Mastic adhesive present behind the chalkboards was previously determined to be asbestos-containing. Destructive testing was not performed as the chalkboards were still in use. Transite and mastic adhesive are non-friable materials and in good condition.

An example of a chalkboard presumed to contain asbestos.

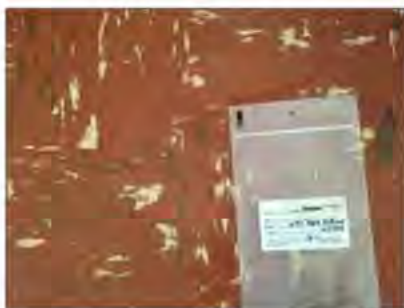
Asbestos-containing vinyl floor tiles.

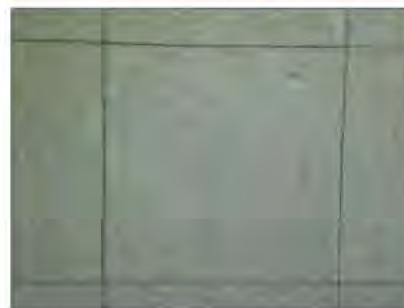
Non asbestos floor tiles concealing asbestos-containing mastic.

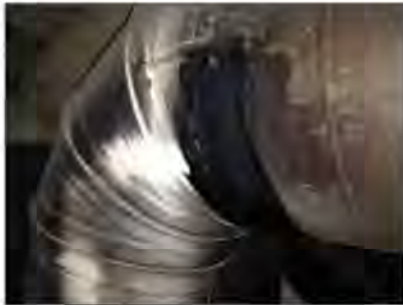
Asbestos-containing black duct mastic.

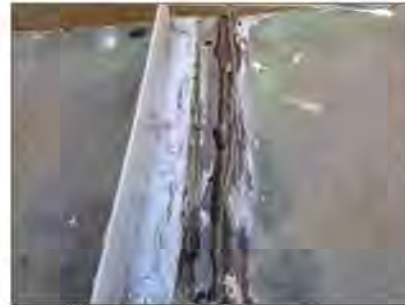
Silver duct mastic found on exterior ductwork was sampled (S0015) and determined to be asbestos-containing.

Asbestos-containing silver duct mastic.

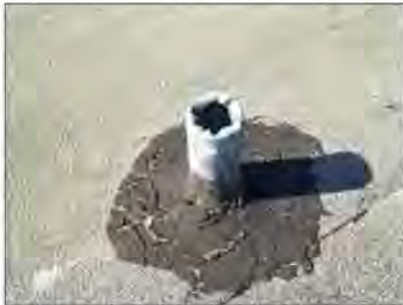
Solid lead is present as lead flashing around exhaust pipes on the roof.

An example of lead flashing around exhaust pipes on the roof.

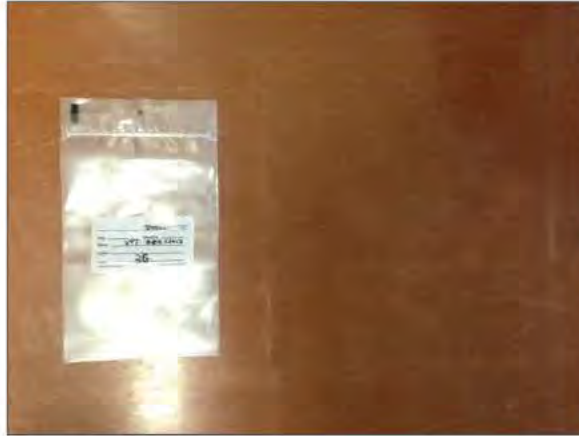
Asbestos-containing vinyl floor tiles.

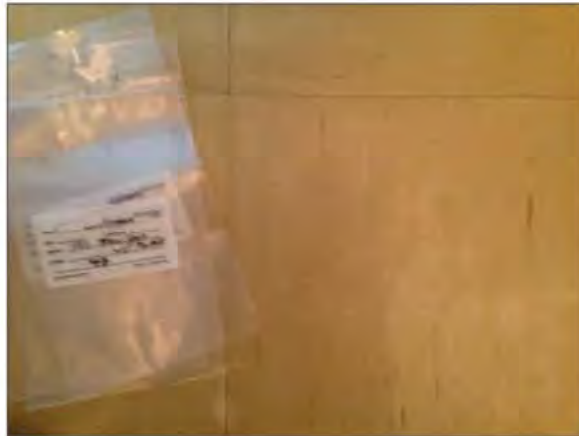
Asbestos-containing vinyl floor tiles.

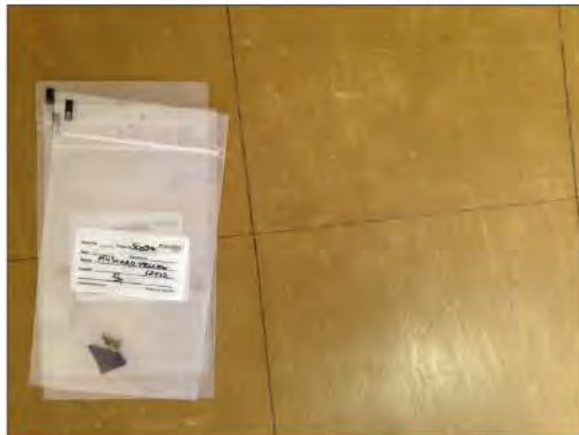
Asbestos-containing vinyl floor tiles with asbestos-containing mastic.

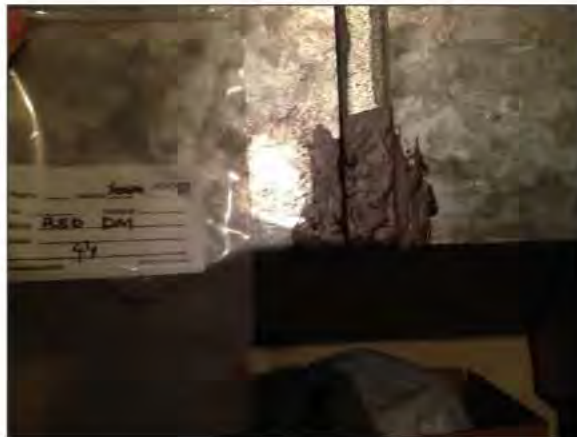
Red duct mastic found on ductwork in location 44 was sampled (S0029) and determined to be asbestos-containing.

Asbestos-containing red duct mastic.
