Title: Pre-Demolition Hazardous Materials Survey (Update)  
David Lloyd George Elementary School, 8370 Cartier Street, Vancouver, BC  
Prepared by: **Alliance EHS Consulting Inc.**  
Dated: April 5, 2022

# PRE-DEMOLITION HAZARDOUS MATERIALS SURVEY (UPDATE)

**David Lloyd George Elementary School  
8370 Cartier Street, Vancouver, BC**

**FINAL**  
**REVISED Hazardous**  
**Building Materials**  
**Assessment**

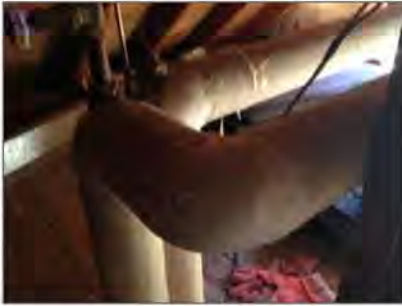
Unlabelled parging cement insulation present on pipe elbows found in locations 19, 23, 31, 38, 39, 40, 44, 53, 54, 56, 57 and 61 was sampled (S0012A-B) and determined to be asbestos-containing. Parging cement is a friable material and is in good condition.

Unlabelled asbestos-containing pipe elbows.

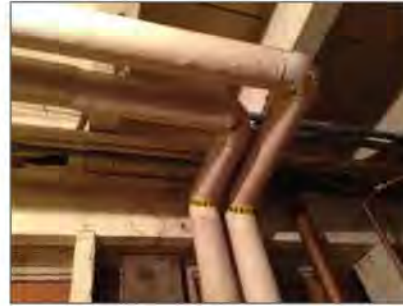
Parging cement pipe insulation, previously determined to contain asbestos (and labelled), is present on pipe elbows found in locations 24-26, 28-30, 33-35, 42-44 and 46. Parging cement is a friable material and is in good condition.

Labelled asbestos-containing pipe elbows.

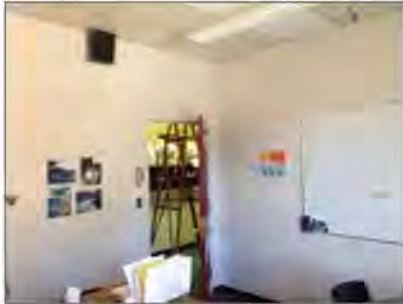
Drywall (gypsum board) and drywall joint compound present as a wall finish in locations 10 and 11 was previously sampled and determined to be asbestos-containing.

Drywall walls with asbestos-containing joint compound.

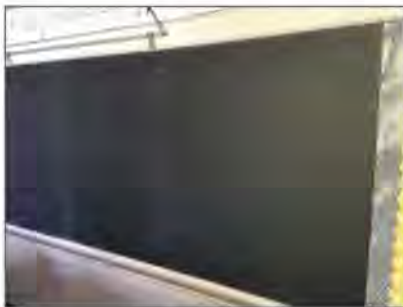
Green and black chalkboards present in classrooms throughout the school were presumed to be asbestos-containing. Mastic adhesive present behind the chalkboards was previously determined to be asbestos-containing. Destructive testing was not performed as the chalkboards were still in use. Transite and mastic adhesive are non-friable materials and in good condition.

An example of a chalkboard presumed to contain asbestos.

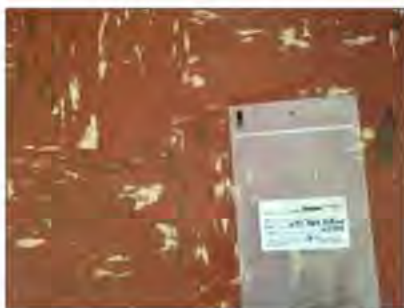
Asbestos-containing vinyl floor tiles.

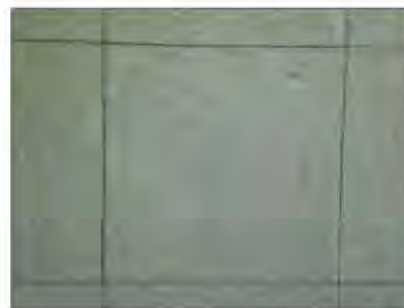
Non asbestos floor tiles concealing asbestos-containing mastic.

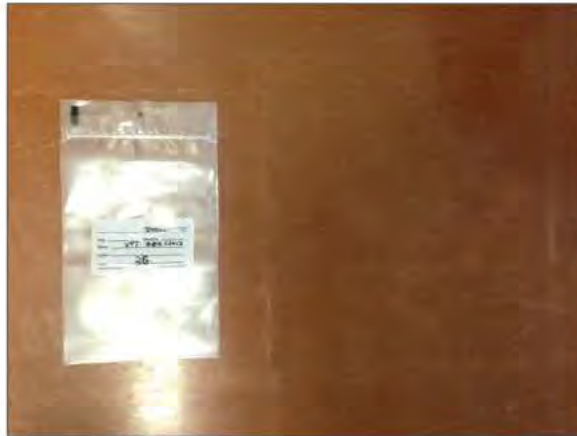
Asbestos-containing vinyl floor tiles.

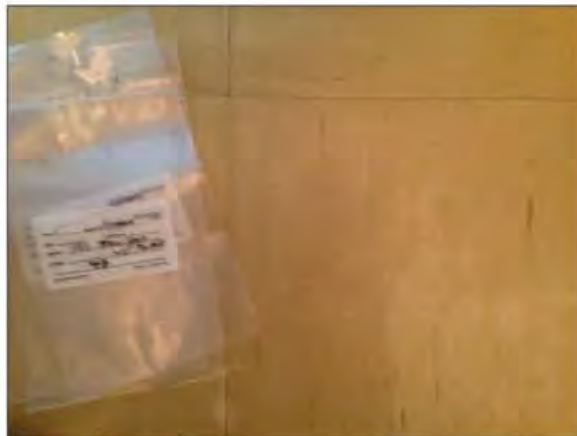
Asbestos-containing vinyl floor tiles.

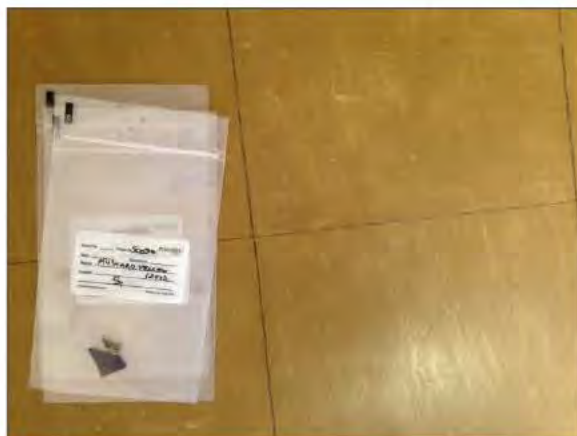
Asbestos-containing vinyl floor tiles with asbestos-containing mastic.

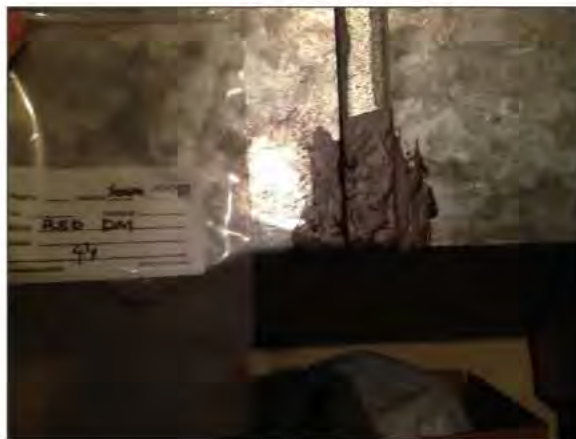
Red duct mastic found on ductwork in location 44 was sampled (S0029) and determined to be asbestos-containing.

Asbestos-containing red duct mastic.
