**Record of Hazardous Building Materials Report for 8370 Cartier Street, former David Lloyd George Elementary, (Development Application DP-2023-00112). Date range: November 1, 2024 to September 12, 2025.**

Title: Revised Hazardous Building Materials Assessment  
David Lloyd George Elementary, 8370 Cartier Street, Vancouver, BC  
Prepared by: **Pinchin West Ltd.**  
Dated: September 15, 2016

**FINAL**  
**REVISED Hazardous**  
**Building Materials**  
**Assessment**

David Lloyd George Elementary  
8370 Cartier Street, Vancouver,  
BC

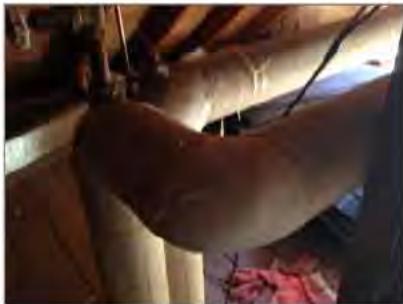
Unlabelled parging cement insulation present on pipe elbows found in locations 19, 23, 31, 38, 39, 40, 44, 53, 54, 56, 57 and 61 was sampled (S0012A-B) and determined to be asbestos-containing. Parging cement is a friable material and is in good condition.

Unlabelled asbestos-containing pipe elbows.

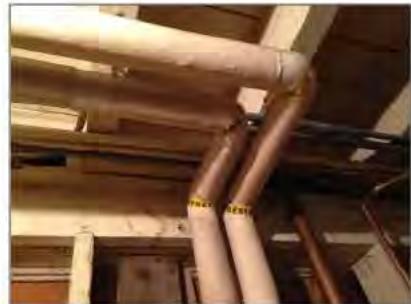
Parging cement pipe insulation, previously determined to contain asbestos (and labelled), is present on pipe elbows found in locations 24-26, 28-30, 33-35, 42-44 and 46. Parging cement is a friable material and is in good condition.

Labelled asbestos-containing pipe elbows.

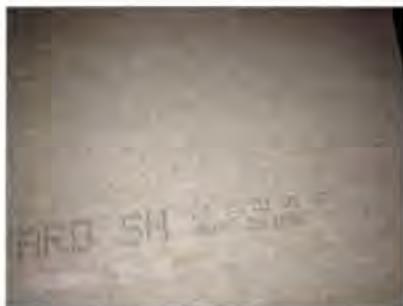
The 2001 date stamp found on some ceiling tiles.

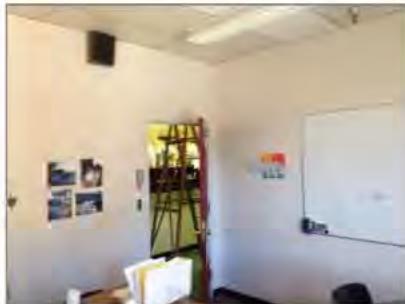
Drywall (gypsum board) and drywall joint compound present as a wall finish in locations 10 and 11 was previously sampled and determined to be asbestos-containing.

Drywall walls with asbestos-containing joint compound.

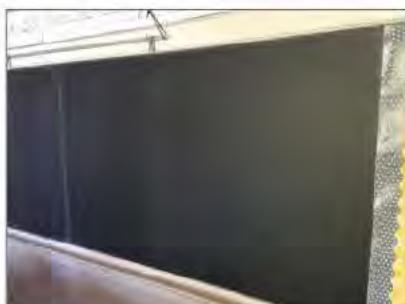
Green and black chalkboards present in classrooms throughout the school were presumed to be asbestos-containing. Mastic adhesive present behind the chalkboards was previously determined to be asbestos-containing. Destructive testing was not performed as the chalkboards were still in use. Transite and mastic adhesive are non-friable materials and in good condition.

An example of a chalkboard presumed to contain asbestos.

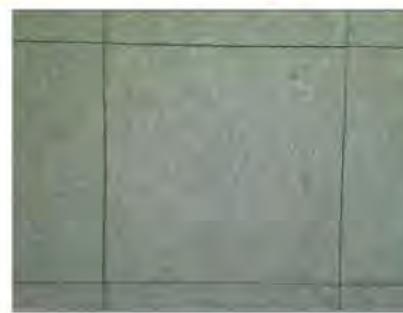
Non asbestos floor tiles concealing asbestos-containing mastic.

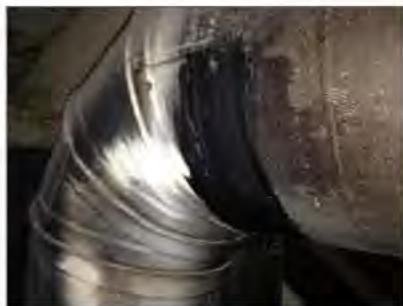
Black duct mastic found on ductwork in locations 19 and 63 was sampled (S0011) and determined to be asbestos-containing.

Asbestos-containing black duct mastic.

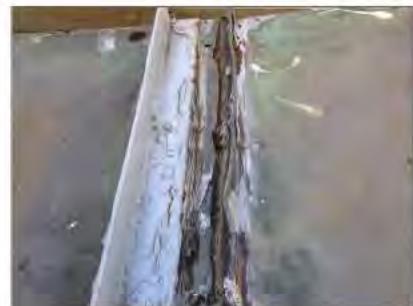
Silver duct mastic found on exterior ductwork was sampled (S0015) and determined to be asbestos-containing.

Asbestos-containing silver duct mastic.

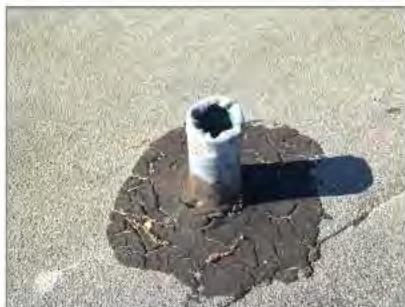
Solid lead is present as lead flashing around exhaust pipes on the roof.

An example of lead flashing around exhaust pipes on the roof.

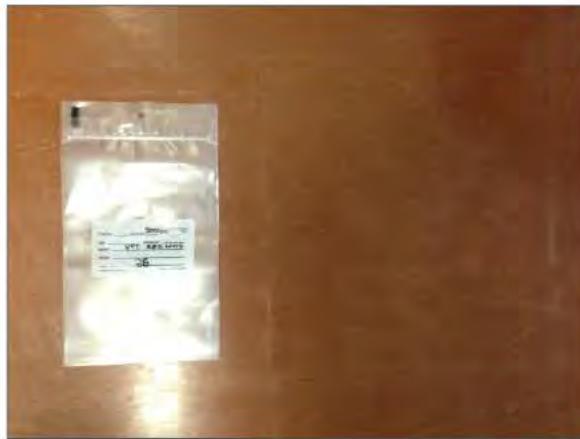
Asbestos-containing vinyl floor tiles.

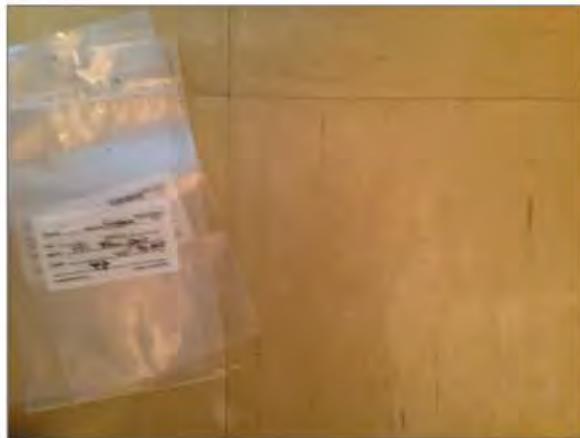
Asbestos-containing vinyl floor tiles.

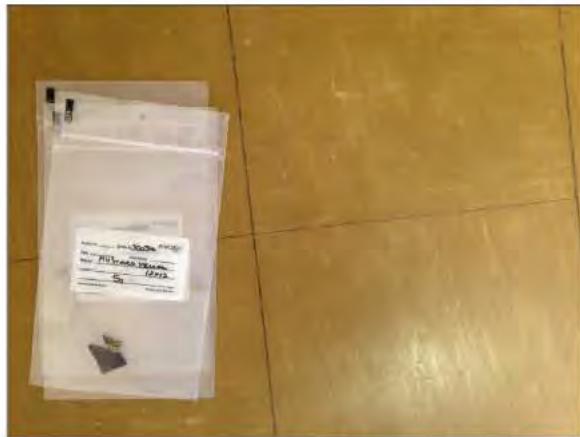
Asbestos-containing vinyl floor tiles with asbestos-containing mastic.

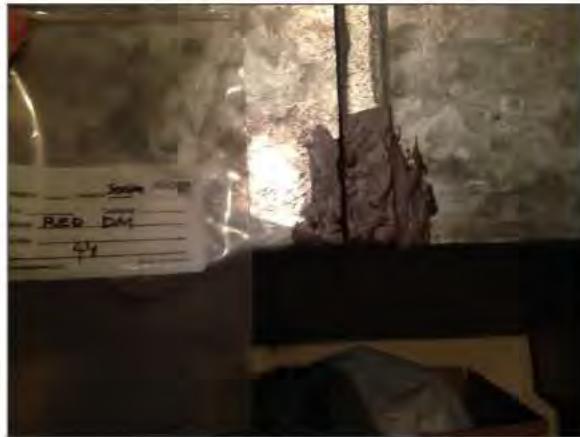
Red duct mastic found on ductwork in location 44 was sampled (S0029) and determined to be asbestos-containing.

Asbestos-containing red duct mastic.

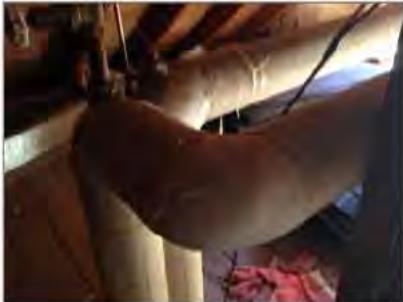
Unlabelled asbestos-containing pipe elbows.

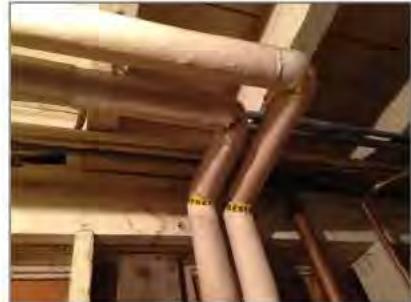
Labelled asbestos-containing pipe elbows.

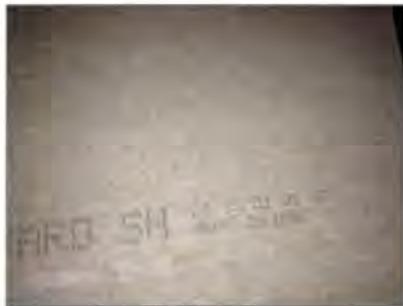
The 2001 date stamp found on some ceiling tiles.

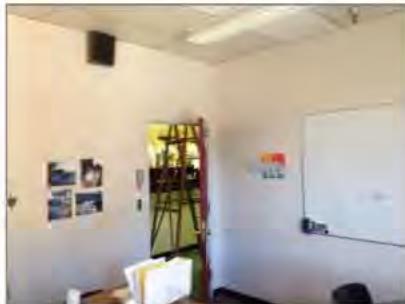
Drywall (gypsum board) and drywall joint compound present as a wall finish in locations 10 and 11 was previously sampled and determined to be asbestos-containing.

Drywall walls with asbestos-containing joint compound.

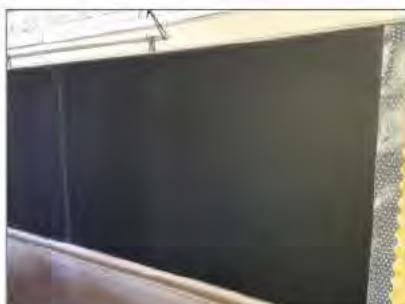
Green and black chalkboards present in classrooms throughout the school were presumed to be asbestos-containing. Mastic adhesive present behind the chalkboards was previously determined to be asbestos-containing. Destructive testing was not performed as the chalkboards were still in use. Transite and mastic adhesive are non-friable materials and in good condition.

An example of a chalkboard presumed to contain asbestos.

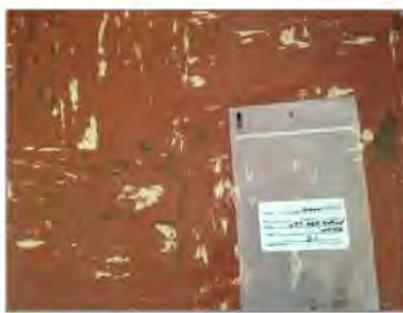
Asbestos-containing vinyl floor tiles.

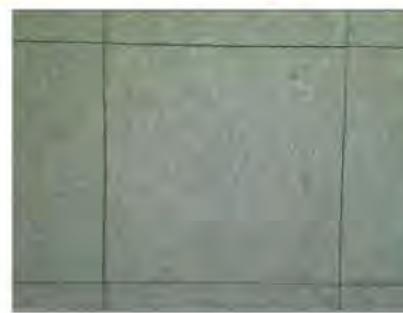
Non asbestos floor tiles concealing asbestos-containing mastic.

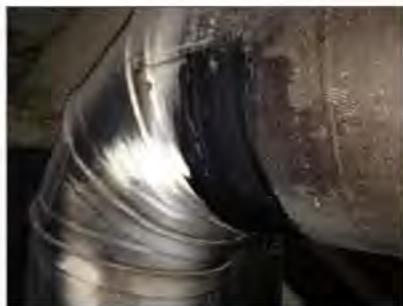
Asbestos-containing black duct mastic.

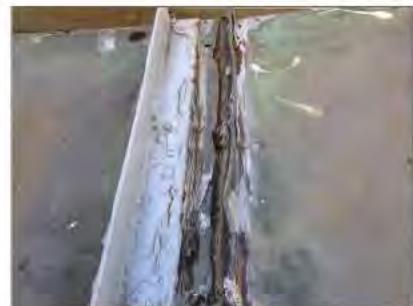
Silver duct mastic found on exterior ductwork was sampled (S0015) and determined to be asbestos-containing.

Asbestos-containing silver duct mastic.

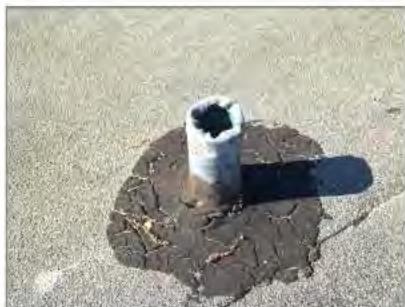
Solid lead is present as lead flashing around exhaust pipes on the roof.

An example of lead flashing around exhaust pipes on the roof.
