TITLE:
DAVID LLOYD GEORGE ELEMENTARY
V.S.B. BUILDING No. 17
SECOND & ROOF FLOOR

Project: David Lloyd George Elementary

Project #: 12952L	Site: 8370 Cartier Street, Vancouver, BC	Building Name: David Lloyd George Elementary	Surveyor: Gordon Watkins	Survey Date: 2016-05-02
HAZARDOUS MATERIALS SUMMARY - LEAD (PB) PRODUCTS				
Component	Total Quantity (Estimated)	Location(s)		
LEAD PIPES	30			20

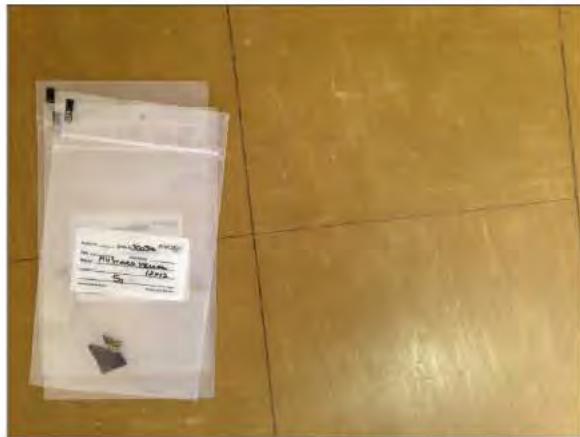
Asbestos-containing vinyl floor tiles with asbestos-containing mastic.
