# Tree Removal for Dunbar Slope Assessment Project, City of Vancouver

January 30, 2026

Blackwell Consulting Ltd. was retained by the City of Vancouver to assess the health and conditions of 10 target trees on a steep slope at the foot of Dunbar St. and north of Cameron Ave.

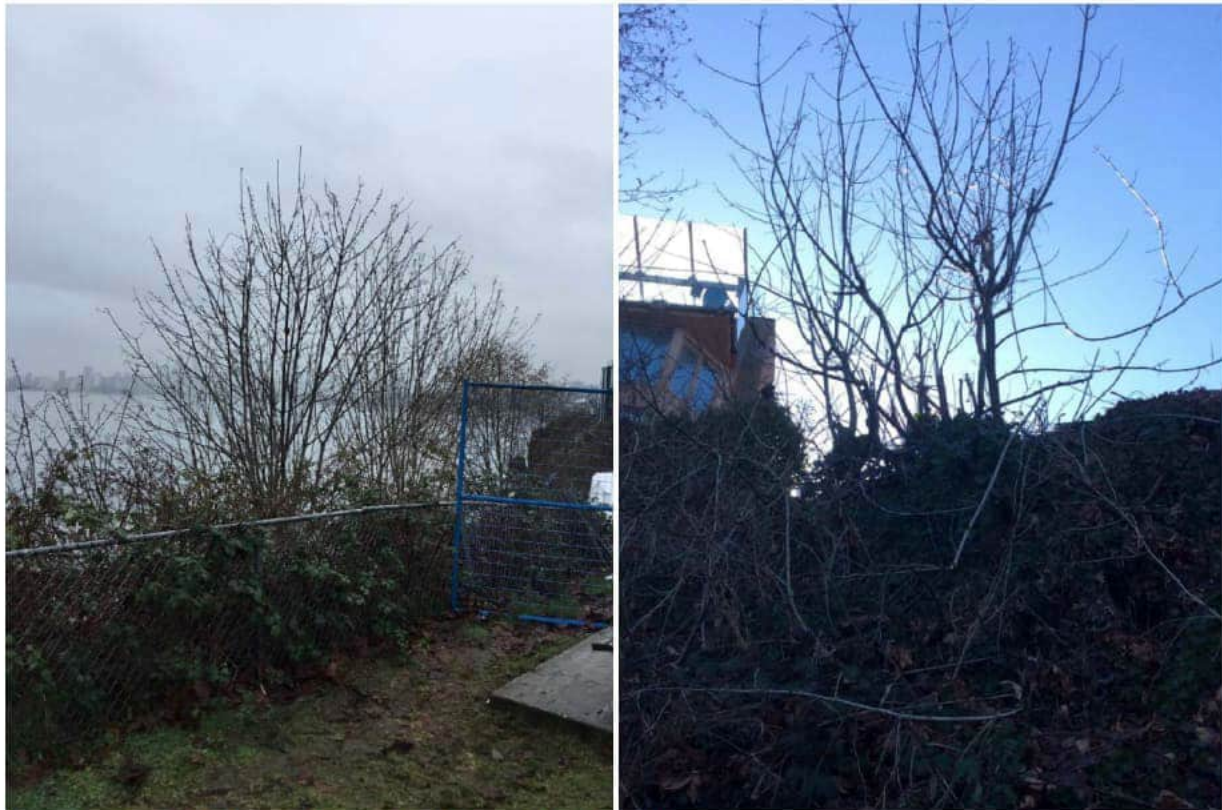
| Tree # | Species | DBH (cm) | Height (m) | Condition | Comments | Recommendation |
|---|---|---|---|---|---|---|
| 1 | Red alder | 28 | 7 | Poor | Repeatedly topped, multiple stems (5), on 80-90% slope, dense ivy and blackberry | >20% pruning over 3–5-year period |

Trees # 1, 12, 13, and 18 are located on top of the slope and have been previously topped (Figure 1 - 3). Their canopy is mainly formed with multiple sprouts. They are in fair condition and play an important role in retaining the soil and preventing erosion. Trees #1 and 13 are partially covered with ivy, which needs to be removed to offload some of the weight. For all trees #1, 12, 13, and 18, it is recommended to limit pruning to below 20% and to prioritize dead and diseased branches. It is recommended to conduct the pruning over a 3-5-year period in smaller sessions. The pruning should be performed in a uniform fashion to maintain the current shape of the crown without leaving the side of the tree leaning towards the slope more heavily. The trees' health and condition should be monitored within 6–12 months after each session, and any visible decline in health should be documented.

Figure 1. Tree #1, photos taken in 2026 (left) and 2023 (right).

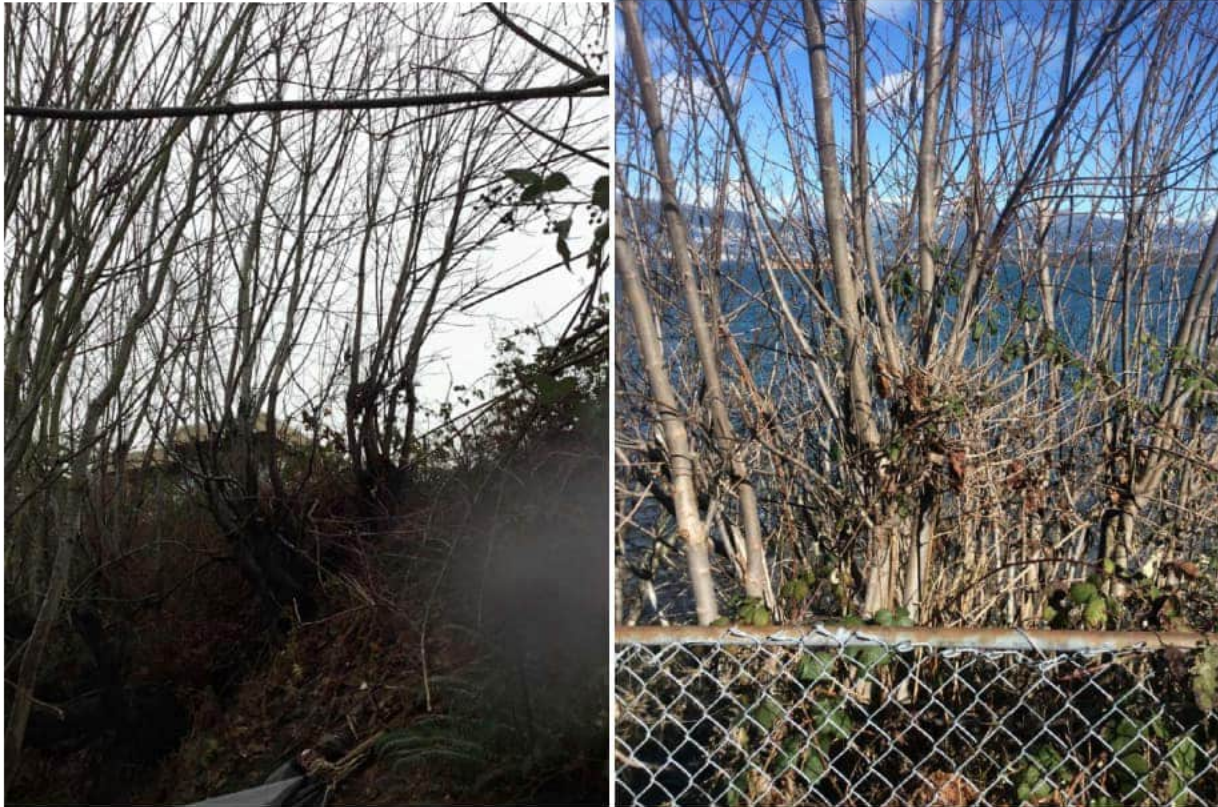
| Tree # | Species | DBH (cm) | Height (m) | Condition | Comments | Recommendation |
|---|---|---|---|---|---|---|
| 12 | Red alder | 25 | 5 | Fair | 10 stems, vigorous regrowth, topped repeatedly, top of bank | >20% pruning over 3–5-year period |
| 18 | Red alder | 25 | 7 | Fair | Repeatedly topped, multiple stems (5), 80-90% Slope, dense ivy and blackberry, beside top walkway | >20% pruning over 3–5-year period |

Figure 2. Tree #12 (left) and 18 (right).

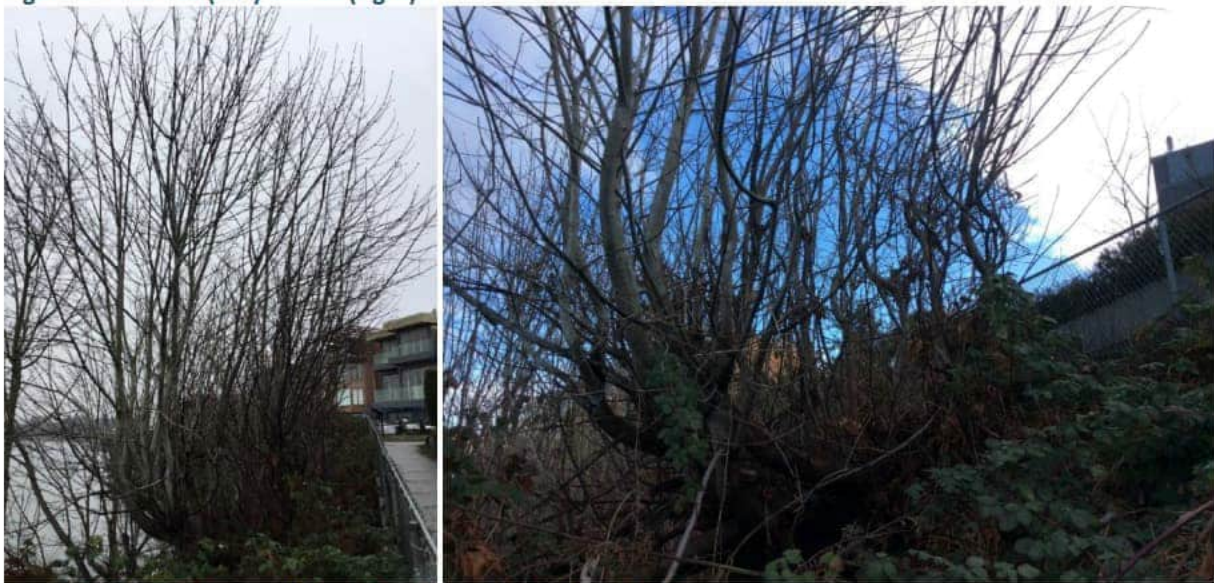
| Tree # | Species | DBH (cm) | Height (m) | Condition | Comments | Recommendation |
|---|---|---|---|---|---|---|
| 13 | Big-leaf maple | 100 | 9 | Fair | 5 large stems, 32 30 30 28 25, topped multiple times, old tree, vigorous new growth, top of slope | >20% pruning over 3–5-year period |

Figure 3. Tree #13 the trunk (left) and view of branches (right).

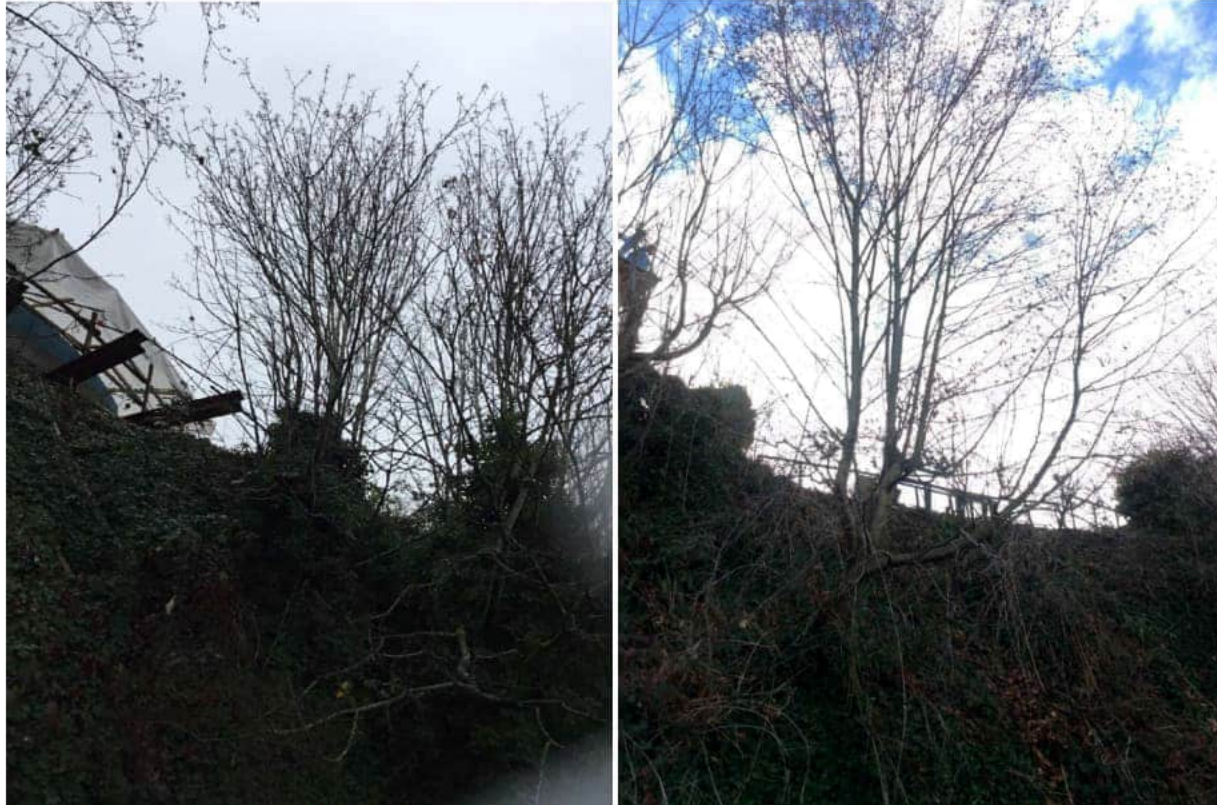
| Tree # | Species | DBH (cm) | Height (m) | Condition | Comments | Recommendation |
|---|---|---|---|---|---|---|
| 2 | Red alder | 35 | 13 | Good | Vigorous young tree perched on edge of cliff precipice, healthy | >20% pruning over 3–5-year period |

**Tree #2**, a red alder on a  $\sim 85^\circ$  slope, plays an important role in retaining soil and preventing erosion (Figure 4). It is in good condition, however, since the last site visit in 2023, ivy has grown and covered most of its trunk. The tree may sustain up to 20% pruning, but it is recommended to distribute it in smaller amounts (5%) over a 3–5-year period. The first-year pruning should include removing ivy from the trunk and branches. Removal of the large branch towards the slope may relieve some weight but also trigger sprouting that requires periodic pruning. It is recommended to monitor the tree's health and stability 6–12 months after each pruning session.

Figure 4. Tree #2 taken in 2026 (left) and 2023 (right). Growth of ivy since the last visit in 2023 is visible.

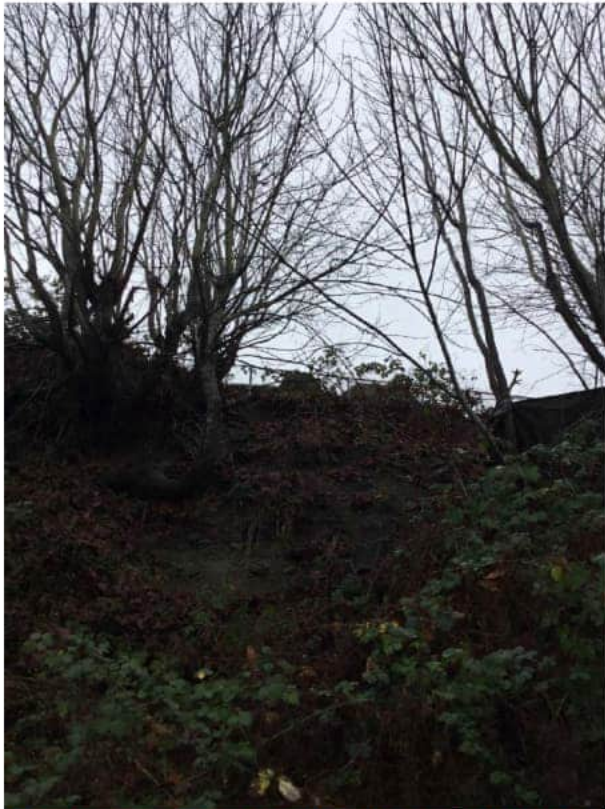
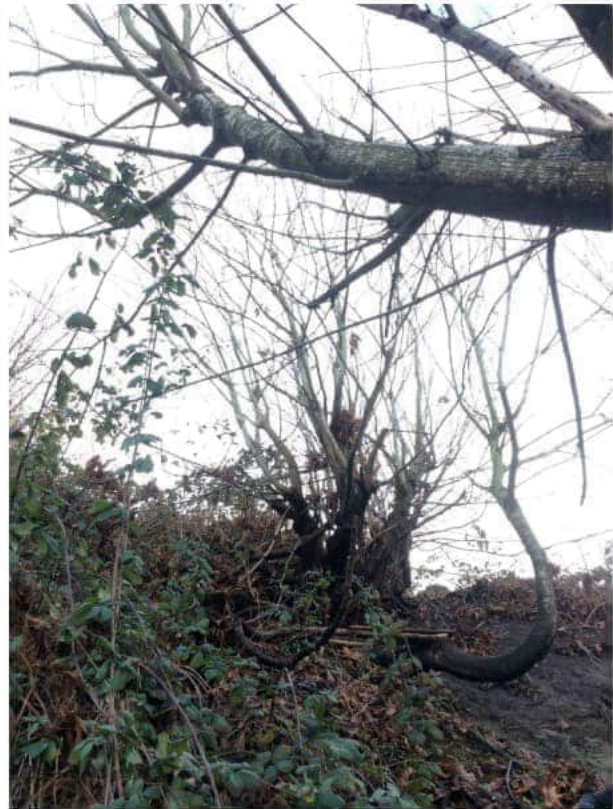
| Tree # | Species | DBH (cm) | Height (m) | Condition | Comments | Recommendation |
|---|---|---|---|---|---|---|
| 7 | Big-leaf maple | 50 | 12 | Fair | Mid slope, exposed sloughing soil, topped, multiple stems, vigorous re-growth | >20% pruning over 3–5-year period |

**Tree #7** is a bigleaf maple (*Acer macrophyllum*) in fair condition, located on the mid-slope. It has been topped and responded in vigorous sprouting (Figure 5). Soil erosion is visible around the base of the tree, which may be accelerated, as tree #8, which holds some of the soil, has now failed. It is recommended that the pruning be limited to under 20% and be conducted in smaller sessions over a period of 3–5 years. The first pruning session should focus on dead and diseased branches. Since tree #7 plays an important role in reducing erosion, its health and stability should be monitored within 6–12 months after each pruning session.

Figure 5. Tree #7 taken in 2026 (left) and 2023 (right).

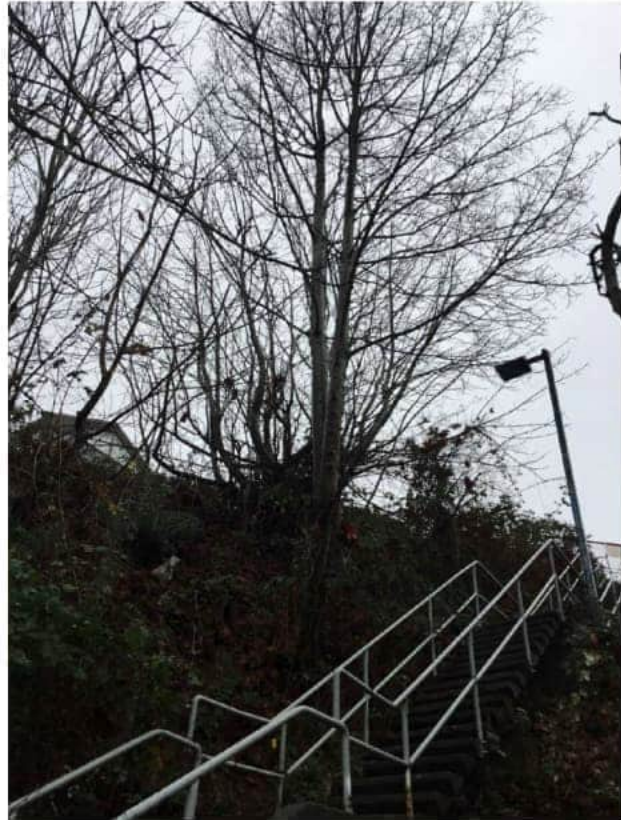
Figure 6. Tree #11.

| Tree # | Species | DBH (cm) | Height (m) | Condition | Comments | Recommendation |
|---|---|---|---|---|---|---|
| 11 | Sycamore maple | 33 | 13 | Good | Vigorous, beside stairs, codominant stem at 2 m | >20% pruning over 3–5-year period |

*Tree #11* is a sycamore maple just beside the staircase rail at mid slope in good condition (Figure 6). It consists of two co-dominants with a relatively straight form. Pruning should be limited to no more than 20% in a balanced way to prevent stress, and dead or decayed branches must be prioritized. The pruning should be done in a smaller amount (~5%) over a 3-5-year period. Since heavy sap bleeding can occur, especially during winter and early spring, it is recommended to try a small pruning session in late summer or early fall and monitor the tree's response.

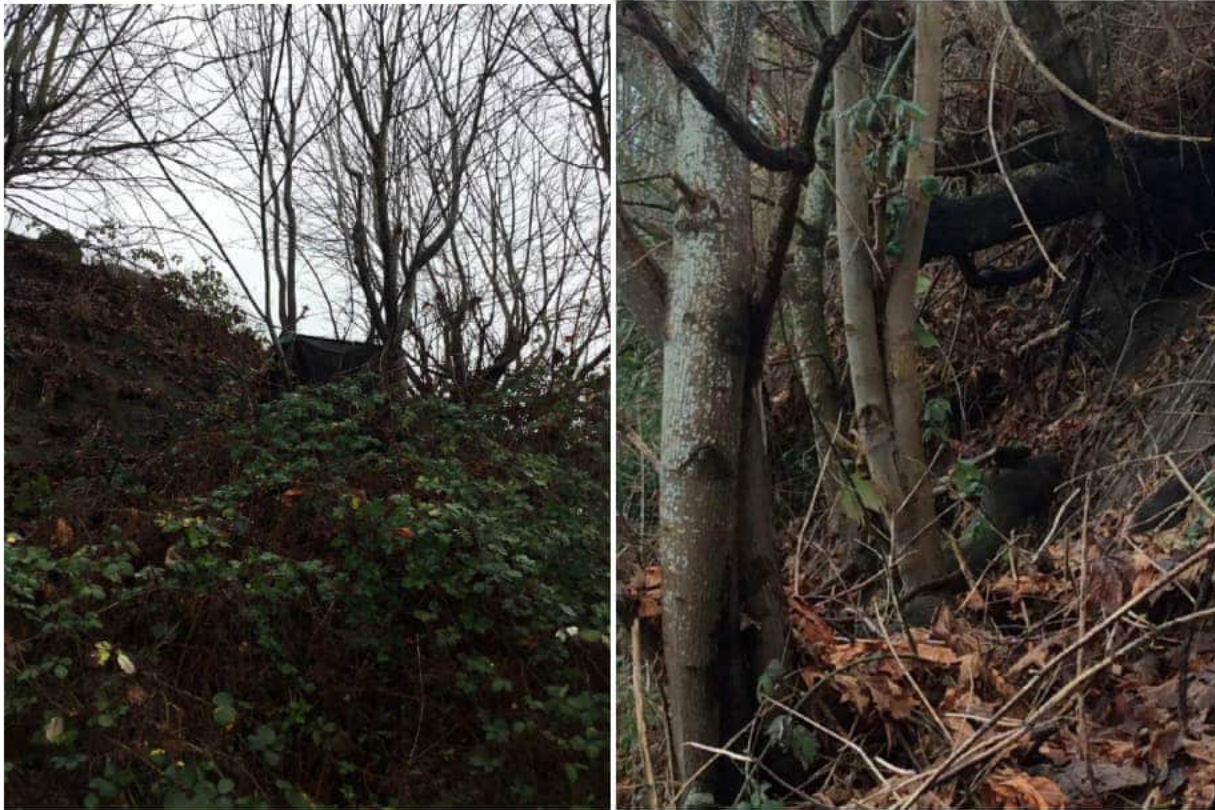
| Tree # | Species | DBH (cm) | Height (m) | Condition | Comments | Recommendation |
|---|---|---|---|---|---|---|
| 20 | Sycamore maple | 26 | 6 | Fair | Young codominant with 2 stems and heavily included bark, mid slope | >15% pruning over 3–5-year period |

*Tree #20* is located at mid-slope in fair condition (Figure 7). Due to its role in soil retention and erosion prevention, pruning should be limited to less than 15% and spread over several sessions over a 3-5-year period. The tree response should be monitored within 6-12 months after each session.

Figure 7. Tree #20 the trunk (left) and view of branches (right).

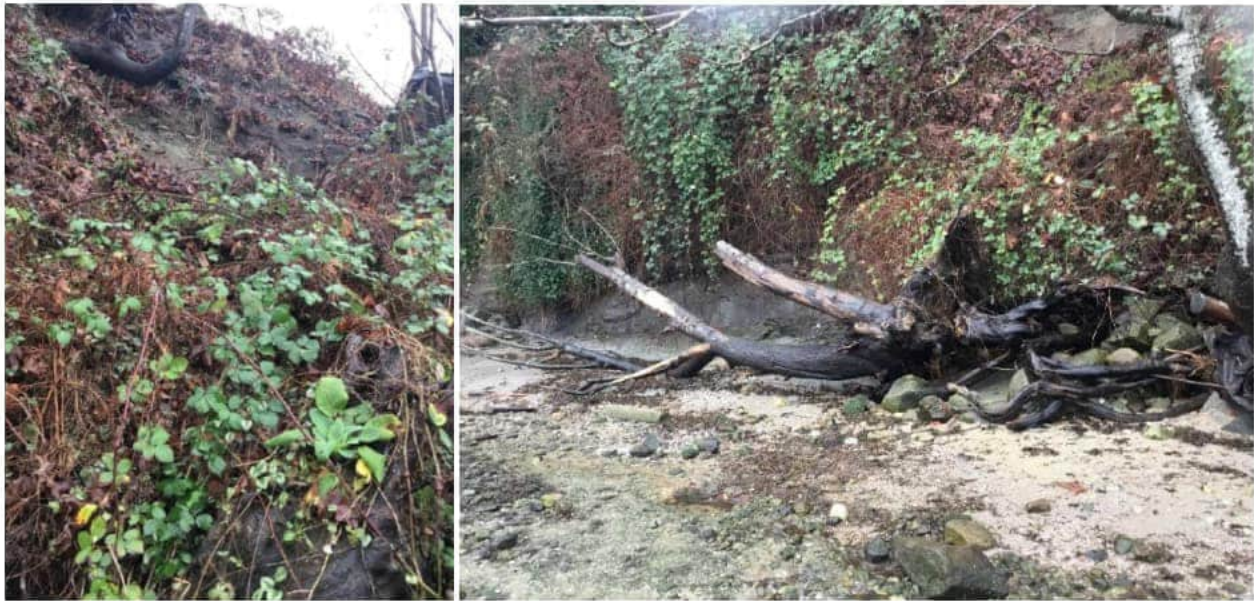
The target trees are located on a steep slope and play an important role in preventing erosion of the soil layer that has accumulated there. Since the last arborist assessment in February 2023, 1 of 10 target trees (tree #8) has failed, resulting in minor erosion. There were no noticeable changes in the conditions of the other target trees, and the site conditions appear to remain unchanged.

| Tree # | Species | DBH (cm) | Height (m) | Condition | Comments | Recommendation |
|---|---|---|---|---|---|---|
| 8 | Big-leaf maple | 40 | 10 | Dead | Multiple stem (6), only 1 alive, exposed root from tide and wave action | - |

*Tree # 8*, located at the foot of the slope, has recently failed (Figure 8). The cause of failure was likely a combination of exposure to high tide and wind, and low nutrient availability. The remaining limbs and branches can be left at the site.

Figure 8: Soil erosion after tree #8 failure (top) and remaining branches (bottom).

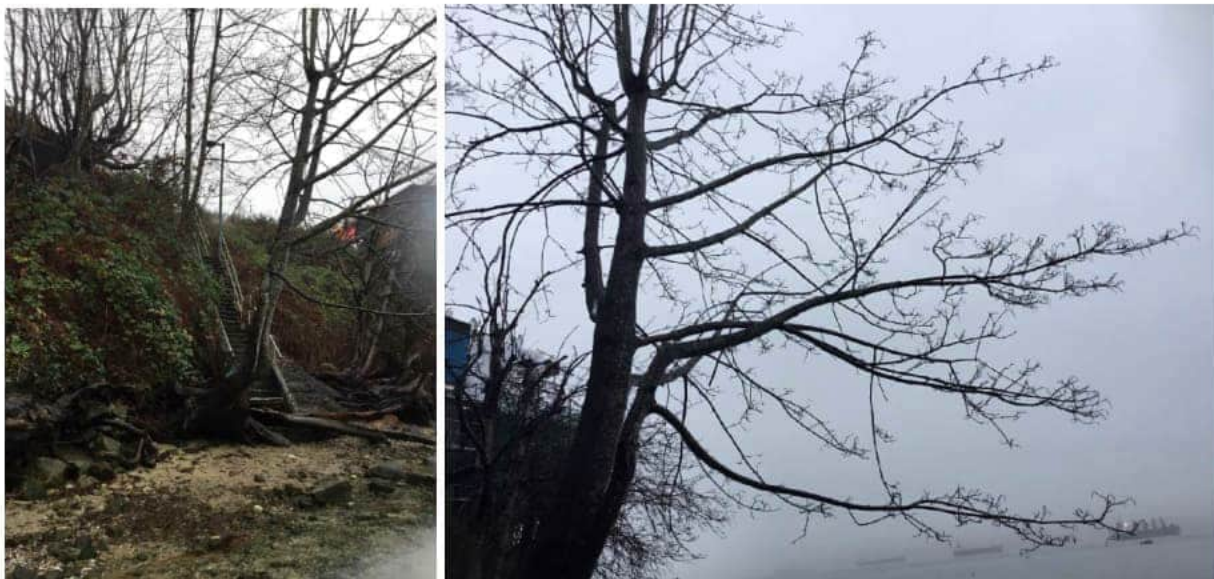
| Tree # | Species | DBH (cm) | Height (m) | Condition | Comments | Recommendation |
|---|---|---|---|---|---|---|
| 9 | Big-leaf maple | 42 | 13 | Fair | Multiple stem (2), mechanical injury lower bole, exposed roots from tides | >15% pruning over 3–5-year period |

*Tree #9* is a bigleaf maple located at the foot of the slope in fair condition, which, due to the exposure to tides and salt, will get worse over time (Figure 9). It has also sustained mechanical damage, and it is recommended to limit the total pruning to below 15% and in several sessions over a 3-5-year period. The first session should focus on the heavy branch on the north side of the tree to offload some of the load and improve stability. Similar to tree #8, this tree is also exposed to high tide and wind, as well as low nutrient availability, and its failure is probable. If the City is concerned about its risk, a follow-up tree risk assessment (Level 2) is recommended within the next year.

Figure 9. Tree #9 the trunk (left) and view of branches (right).
