File No.: 2026-173

Re: **Request for Access to Records under the Freedom of Information and Protection of Privacy Act (the "Act")**

1. **Geotechnical Factual Report - Dunbar Slope Assessment, Apr 26, 2024, Horizon Engineering;**
2. **Geotechnical Conceptual Design Report - Dunbar Slope Assessment, Jan 27, 2025, RAM;**
3. **Archaeological Letter Report for the Dunbar Slope Assessment Project, November 11, 2023, Inlailawatash; and**
4. **Tree Risk and Windthrow Assessment - Point Grey Slope Remediation, May 29, 2024, Blackwell.**

GEOTECHNICAL ASSESSMENT  
Dunbar Slope, Vancouver, BC

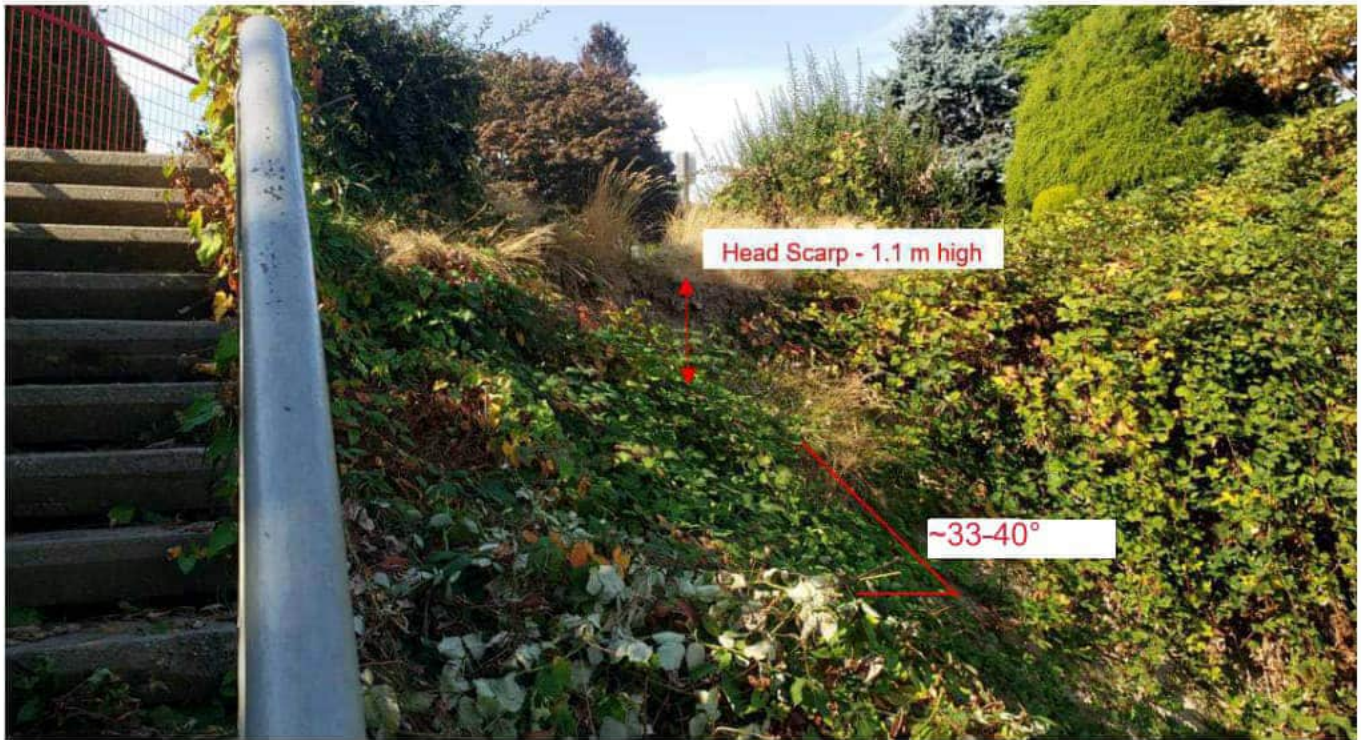
- As shown in Photograph 1 of Figure 3, the headscarp of the landslide was approximately arc-shaped in plan and measured to be 1.1 meters in height. The headscarp area was observed to be

- moderately vegetated with small shrubs and exhibited a near-vertical profile. Where exposed, the soils at the headscarp area of the landslide generally consisted of brown silty sand with some to gravelly. No obvious indicator signs of seepage were observed at the headscarp area of the landslide.

Based on the above observations, the landslide was inferred to have been triggered within the loose, surficial, sandy deposits mantling the subject slope.

Photograph 1: Headscarp of North Slope (looking North from top of staircase)

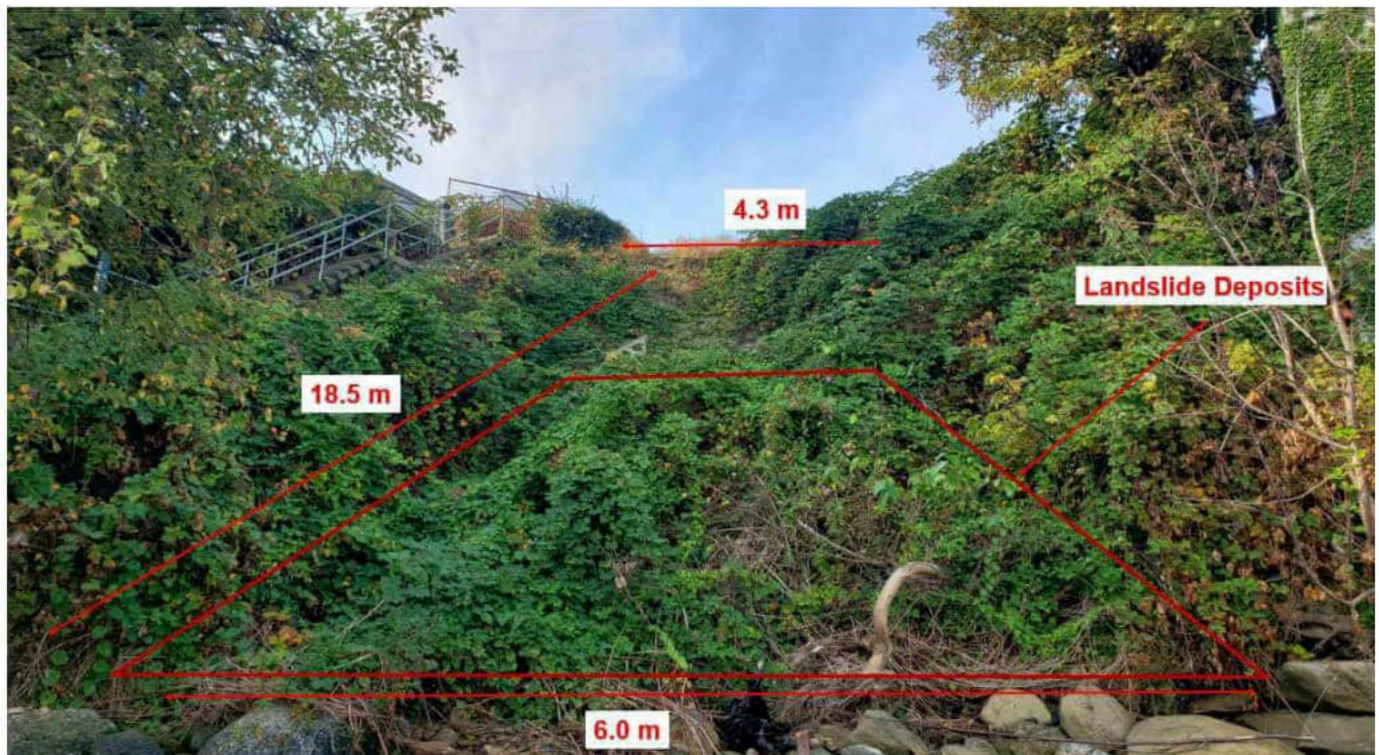
Photograph 2: Landslide scarp at North Slope (looking upslope from bottom of slope)

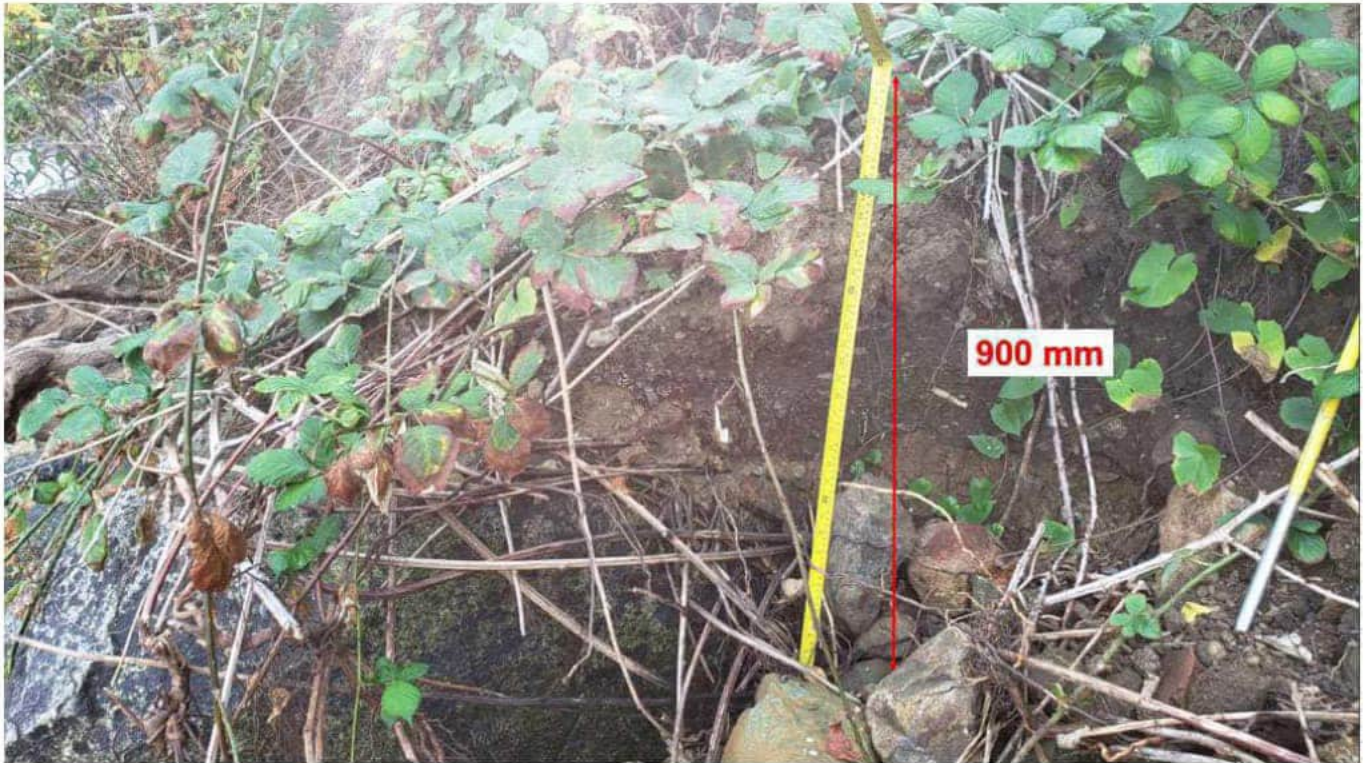
Photograph 3: 900 millimetre thick deposit of colluvium/landslide debris at bottom of North Slope

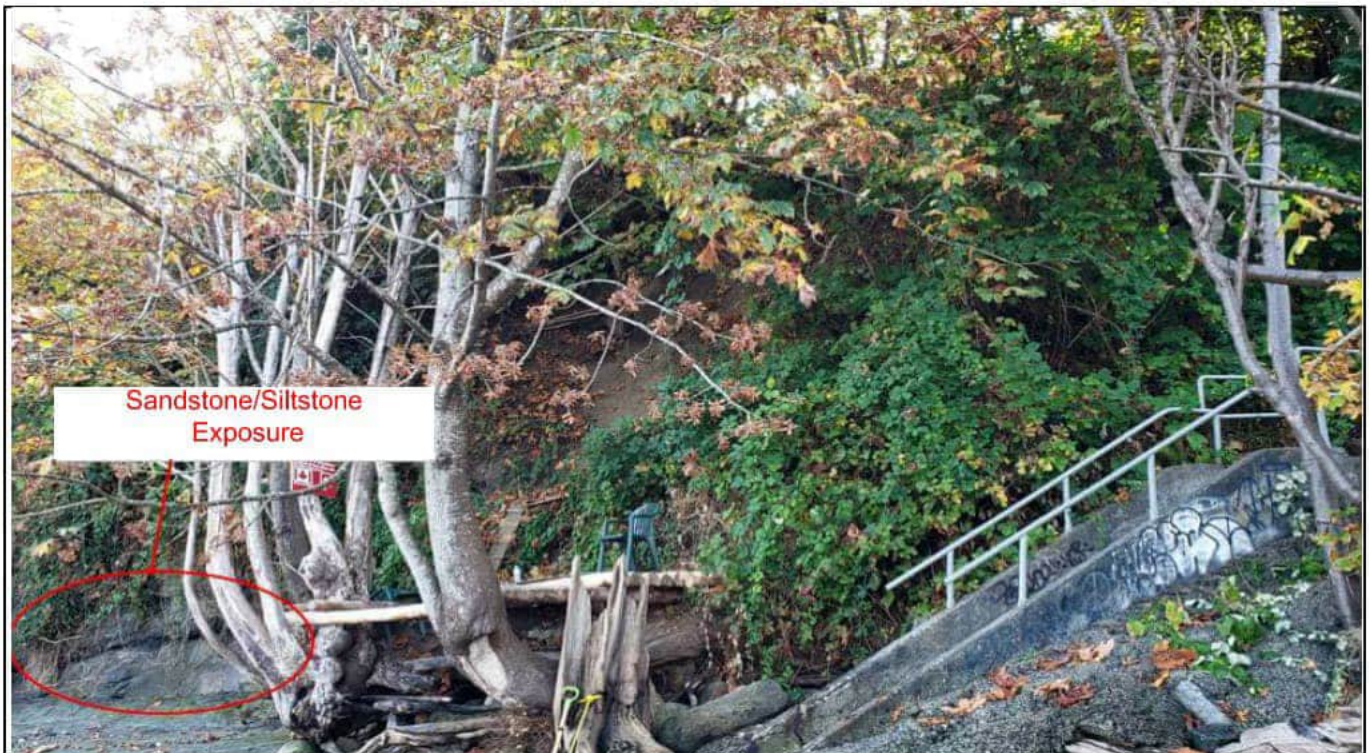
The South Slope was observed to be overlain by low lying vegetation (i.e. shrubs and bushes) and small trees. The subject slope was estimated to be generally steeply sloping at gradients of approximately 50 degrees from horizontal. The section of this slope situated below the lawn arealocated at the north terminus of Dunbar Street was noted to steepen to near-vertical at the bottom 3 metres where bedrock outcrops comprising sandstone/siltstone were present. A photograph of the South Slope, looking upslope from the beach is provided as Photograph 4 in Figure 4.

Photograph 4: Existing Condition of South Slope (looking upslope from beach)

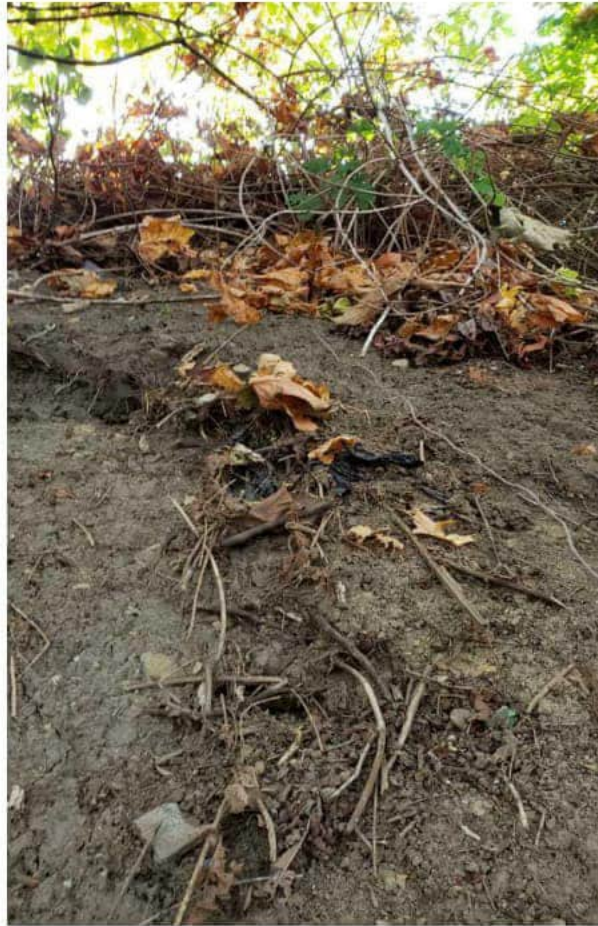
A ground traverse of the subject slope completed during this site visit indicated that the subject slope is overlain by a thin deposit of inferred fill materials comprising light grey to brown sandy silt mixed with trace to some organics (i.e. roots and rootlets) and trace amounts of various debris, which included plastic bags and beverage containers. A photograph of the typical surficial materials overlying the slope are shown in Photograph 5. An exposure of light brown to grey silt, inferred to be a hard, natural material was also observed at the mid-slope portion of this slope, as shown in Photograph 6 of Figure 5. No obvious indicator signs of slope instability were observed at the South Slope, however, as previously documented in our slope monitoring memorandum dated March 16, 2023, an approximately 38 millimetre wide gap was present between the existing pathway and backside of the retaining wall that is currently supporting it, located at the crest of this slope. As discussed in the memorandum, it is possible that the presence of this gap could be consistent with previous movement of the slope and/or retaining wall.

Photograph 5: Inferred fill materials, mixed with debris overlying South Slope

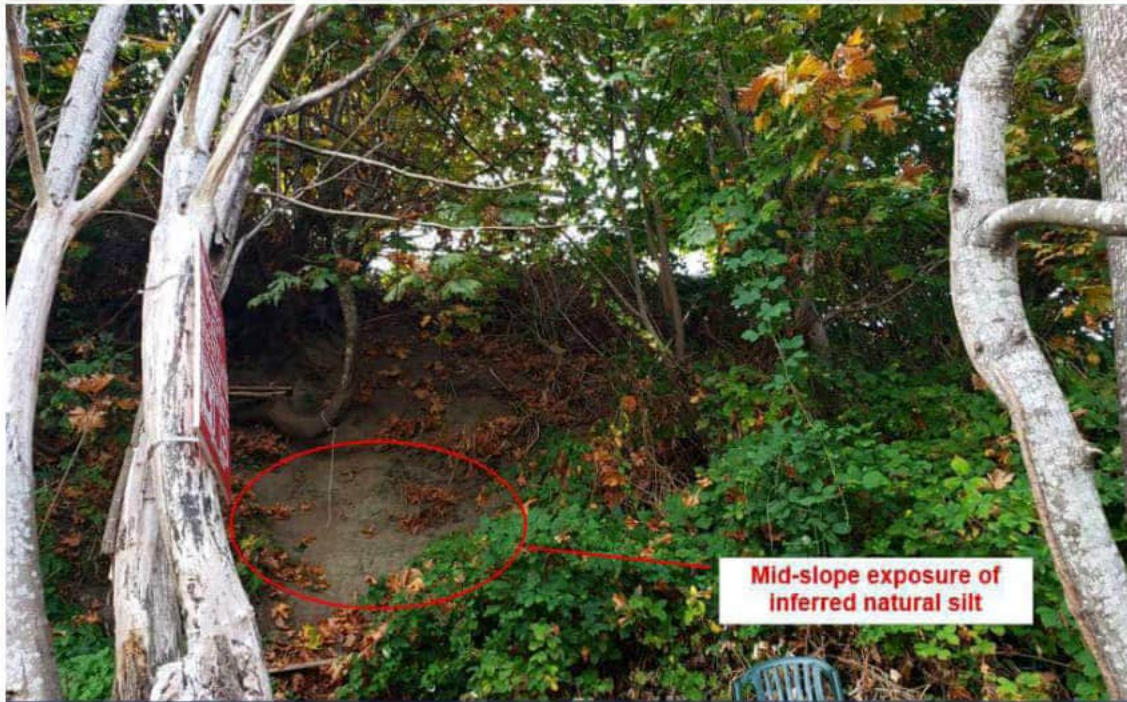
Photograph 6: Existing Condition of South Slope (looking south and upslope from beach)

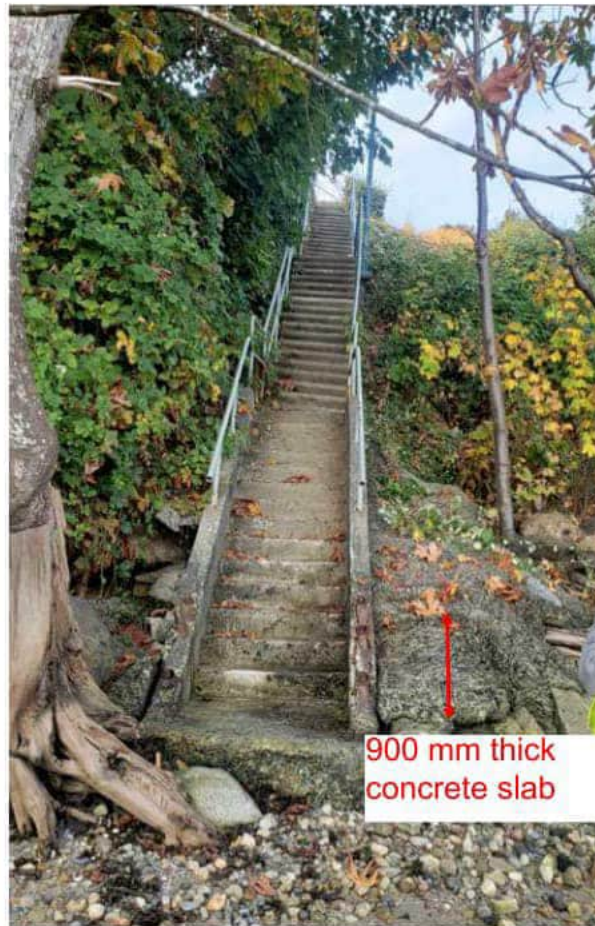
The observed conditions of the staircase are shown in Photograph 8 of Figure 6.

Photograph 8: Existing condition of beach access staircase, looking up from bottom

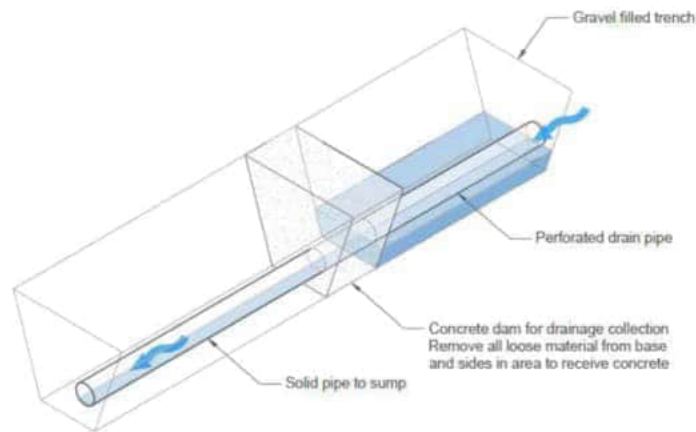
*Schematic 1: Proposed Interceptor Trench and Seepage Collar Detail (reference: Builder Guide to Site and Foundation Drainage Best Practices for Part 9 Buildings in British Columbia)*

A conceptual detail of the interceptor trench and seepage collar is provided in Schematic 1 below. It should be noted that the depths of the proposed interceptor trench and subdrains, as described above, could be subject to modifications depending on the actual subsurface conditions encountered during installation if this option is to be incorporated into the slope remediation works.
