CITY OF VANCOUVER  
453 West 12th Ave, Vancouver, BC

GEOTECHNICAL ASSESSMENT  
Dunbar Slope, Vancouver, BC

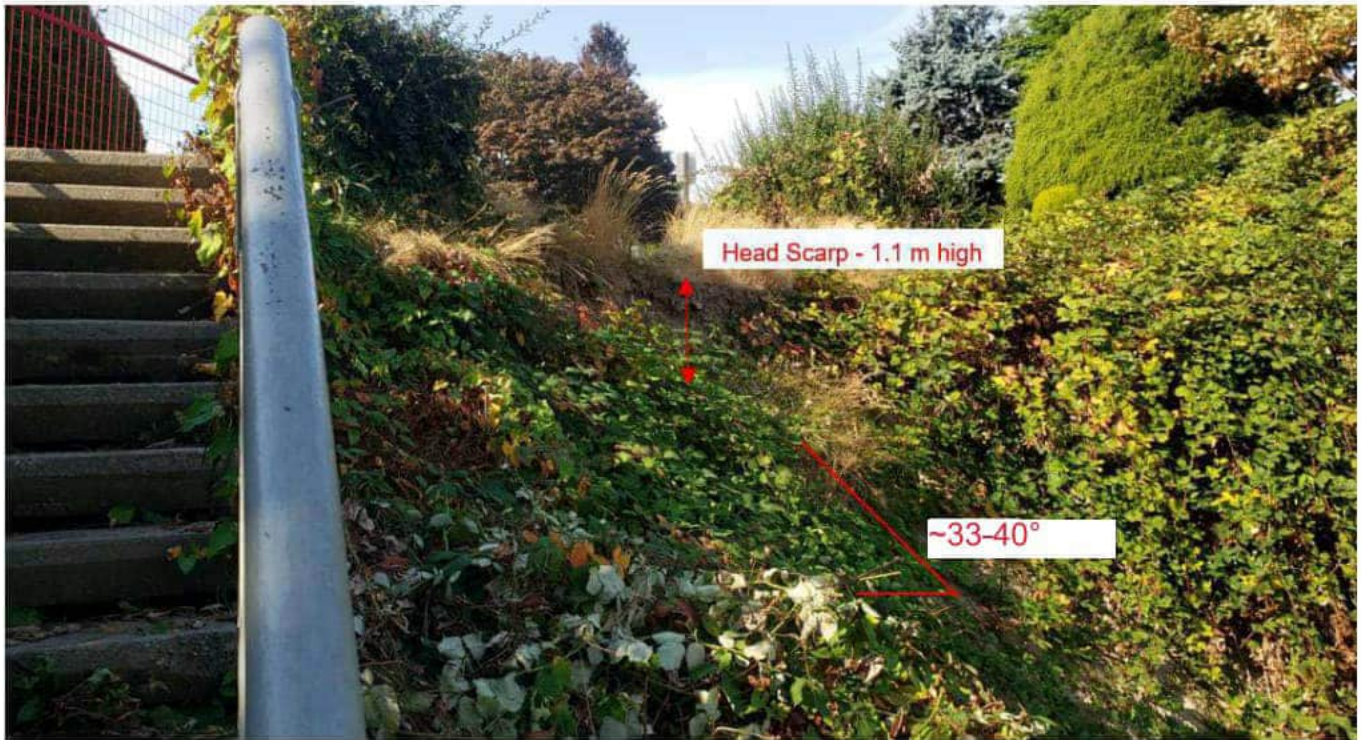
Photograph 1: Headscarp of North Slope (looking North from top of staircase)

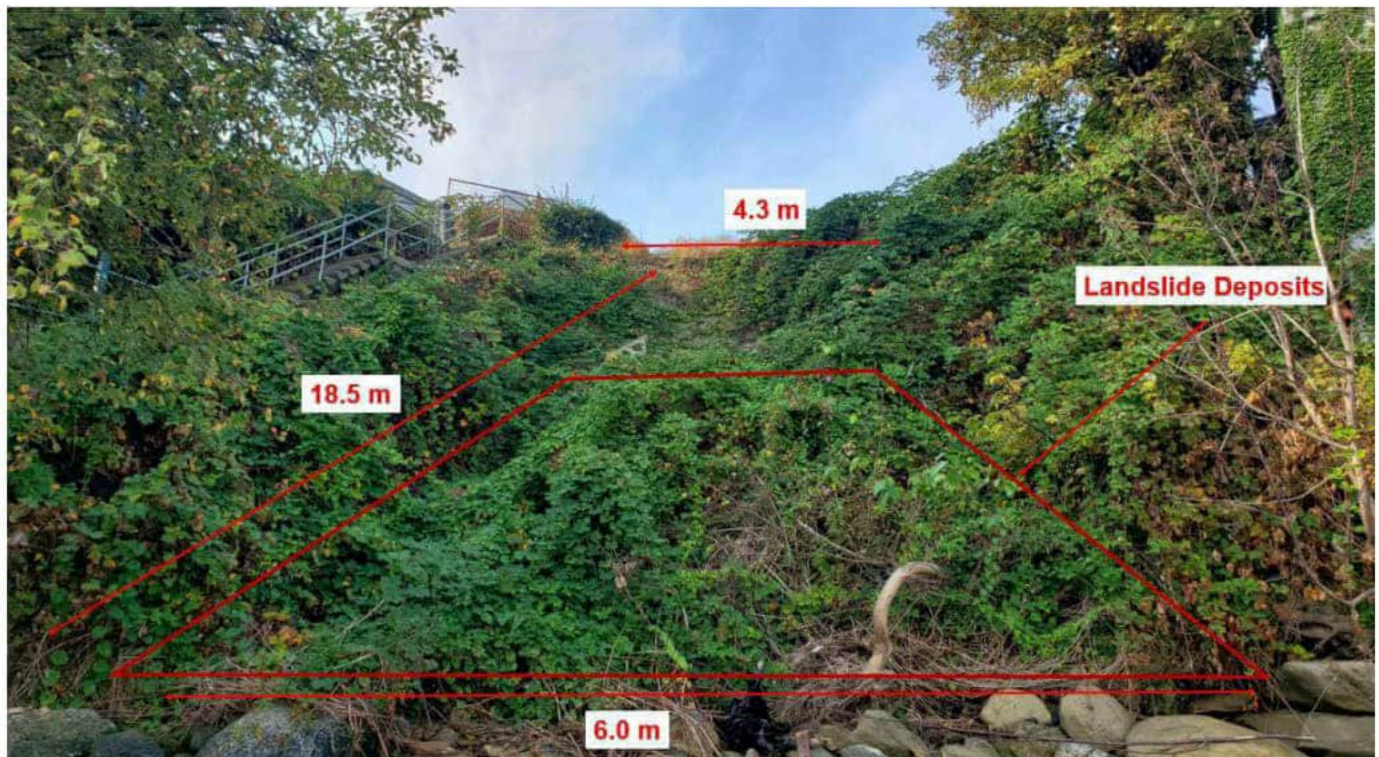
Photograph 2: Landslide scarp at North Slope (looking upslope from bottom of slope)

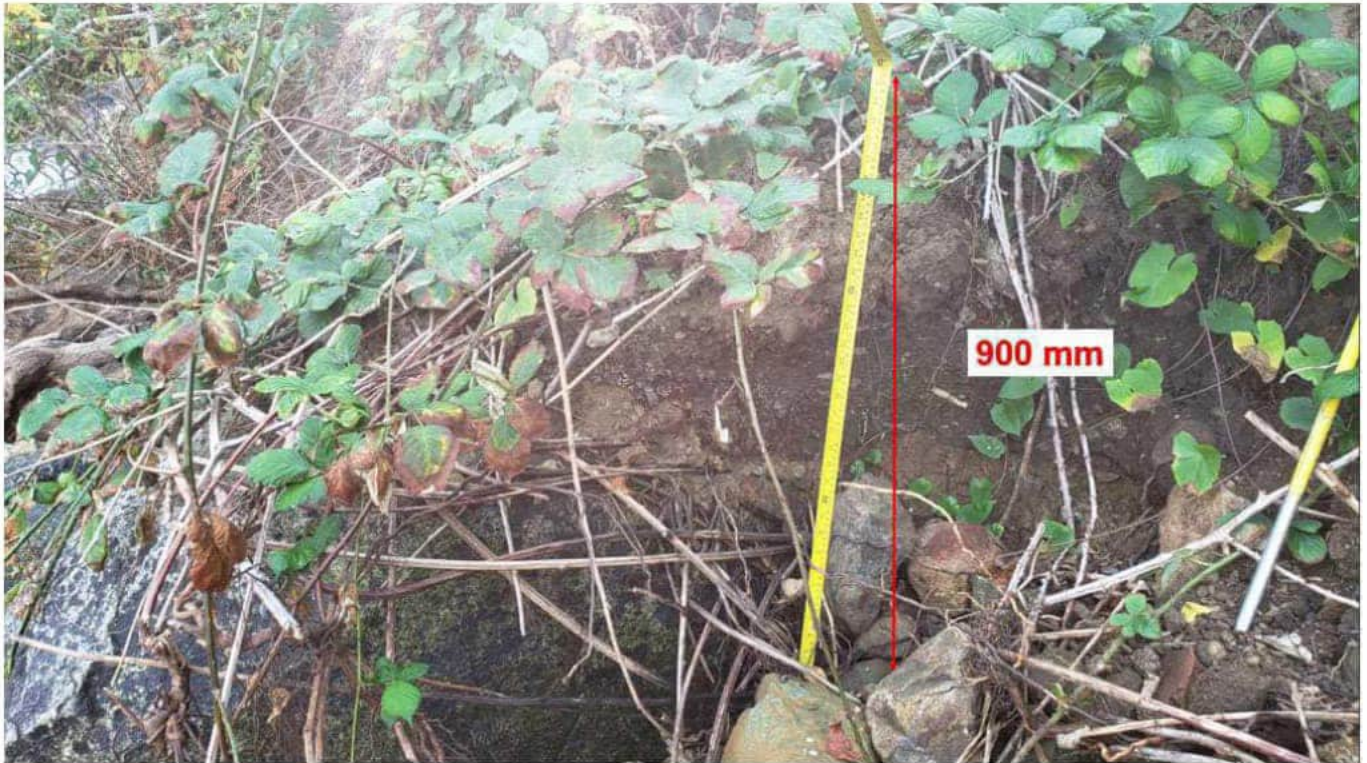
Photograph 3: 900 millimetre thick deposit of colluvium/landslide debris at bottom of North Slope

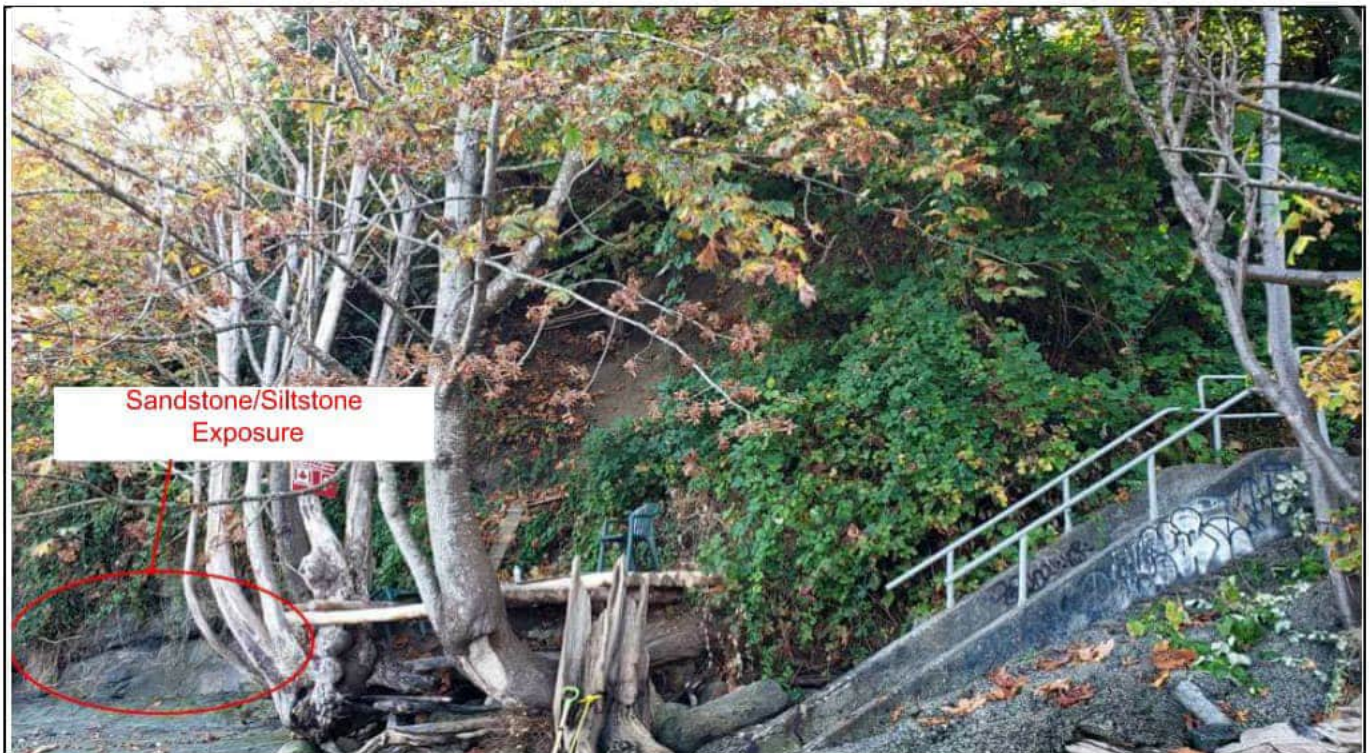
Photograph 4: Existing Condition of South Slope (looking upslope from beach)

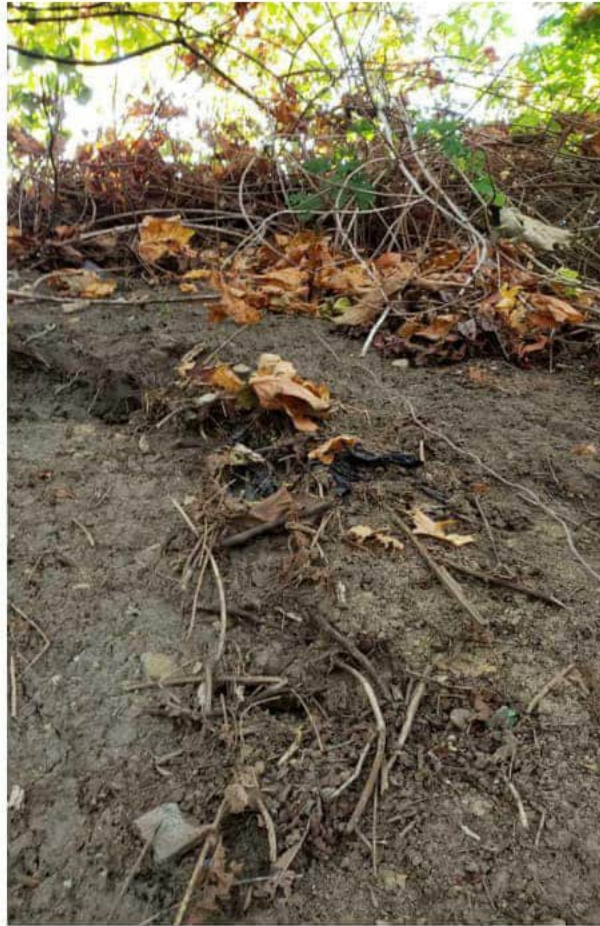
Photograph 5: Inferred fill materials, mixed with debris overlying South Slope

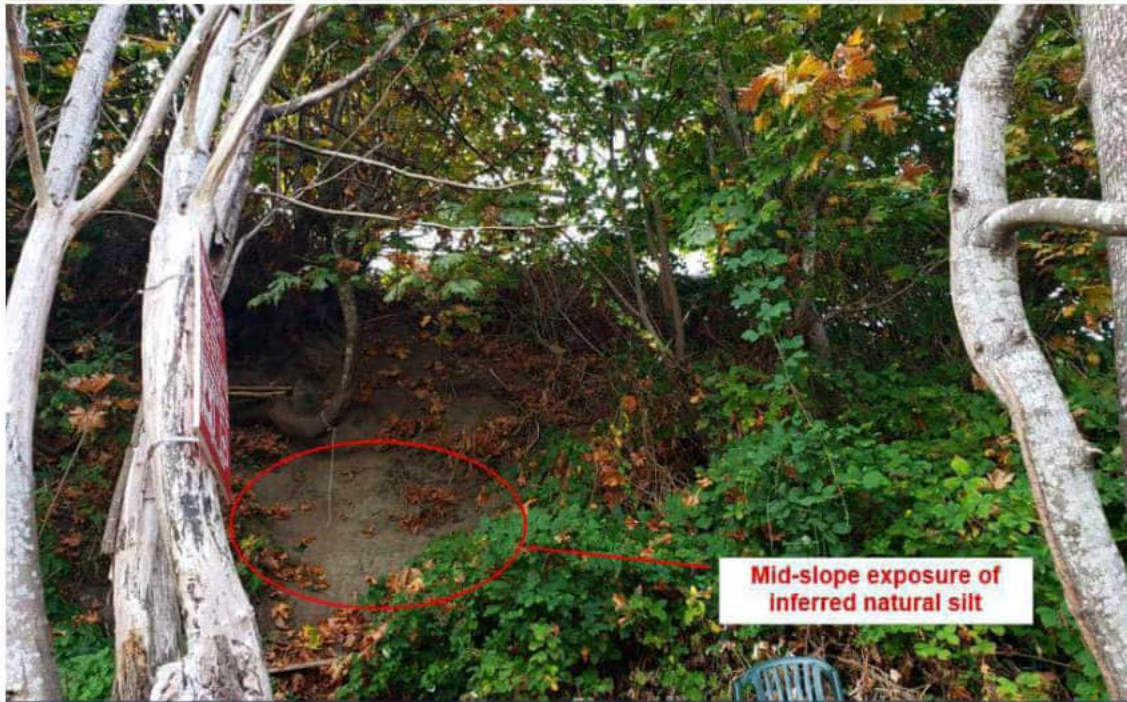
Photograph 6: Existing Condition of South Slope (looking south and upslope from beach)

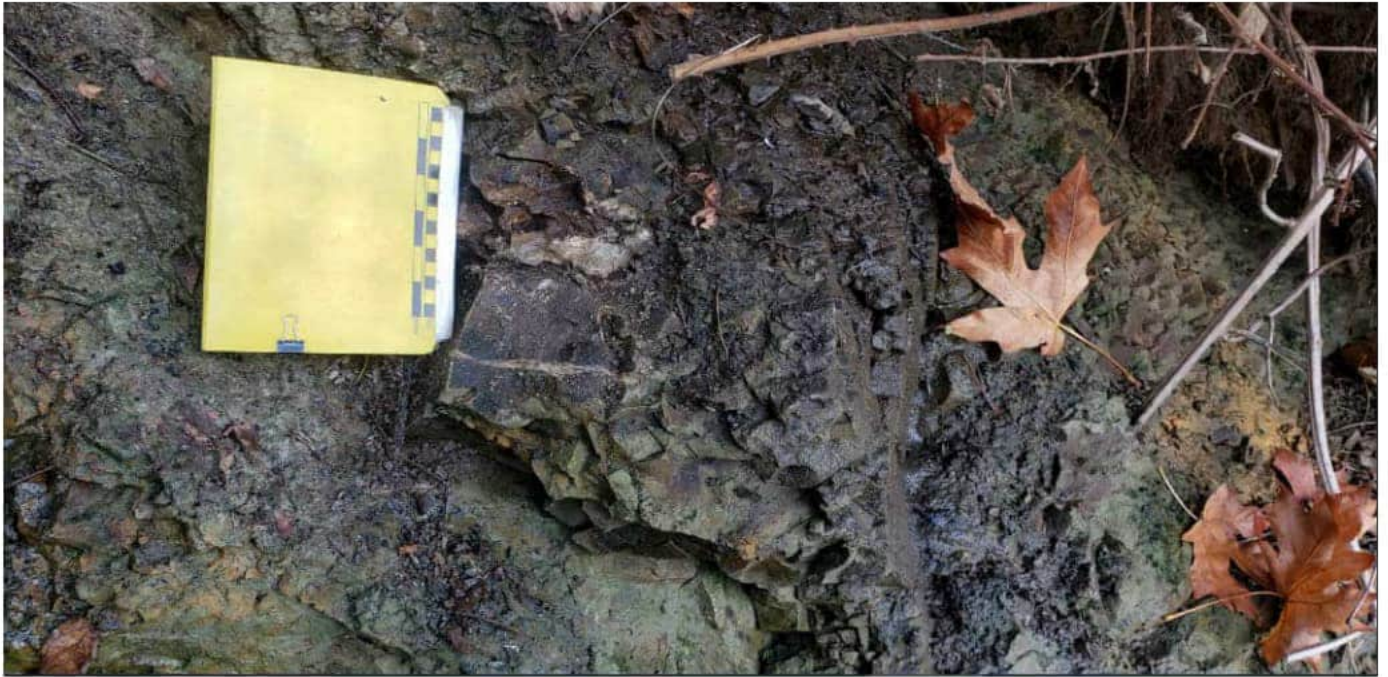
Photograph 7: Bedrock exposure at bottom of South Slope

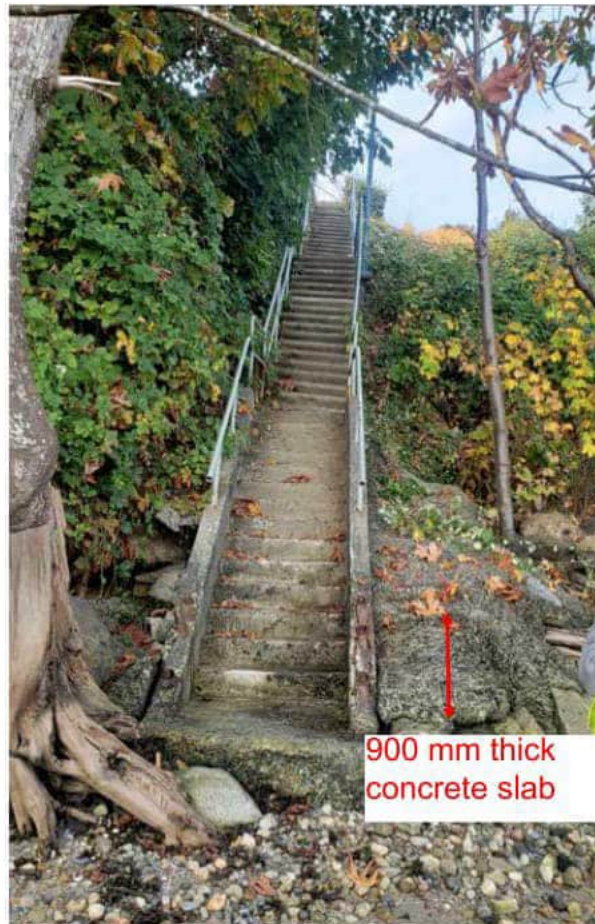
It is inferred that the distortion of the beach access staircase is partially attributed to differential settlement of its foundations which are inferred to be bearing on loose/soft subgrade materials that overly the North Slope. Furthermore, as the North Slope is expected to be susceptible to surficial instabilities, which include the raveling of loose materials, the staircase foundations could potentially be undermined if the subgrade materials supporting these foundations were to be subjected to these instabilities. In consideration of these conditions, it is envisaged that the installation of the underpinning system, utilizing threadbar anchors as described in Section 9.2, would eliminate the aforementioned risks as the anchors would be sufficiently embedded into competent, dense to very

In its current condition, it is envisaged that the staircase presents a tripping hazard to its users as it has been subjected to settlement-induced structural distortion. However, hazards related to structural destabilization of the staircase could potentially develop if further failures of the North Slope were to result in the staircase foundations being undermined or if the slope failures were to result in further loss of lateral confinement of the subgrade supporting these foundations. These hazards and the risks to the public would generally depend on the extents to which the foundations are undermined and whether the influence zones of the pad foundations are impacted by the slope failures. Thus, the risks associated with undermined staircase foundations cannot be assessed at this time, however, it should be noted that the likelihood that the staircase foundations would become undermined based on the existing site conditions is considered to be "moderate", as the slope that these foundations are bearing on is assessed to have a "moderate" likelihood of movement.

Photograph 8: Existing condition of beach access staircase, looking up from bottom

dense strata. Thus, the installation of this underpinning system would suitably mitigate both settlement of the foundations and also risks of the foundations being undermined by surficial slope movement as these failures are not expected to be triggered within the dense to very dense strata underlying the slope. Battered anchors could also be installed to provide resistance to lateral movements of the staircase, if found to be structurally required.

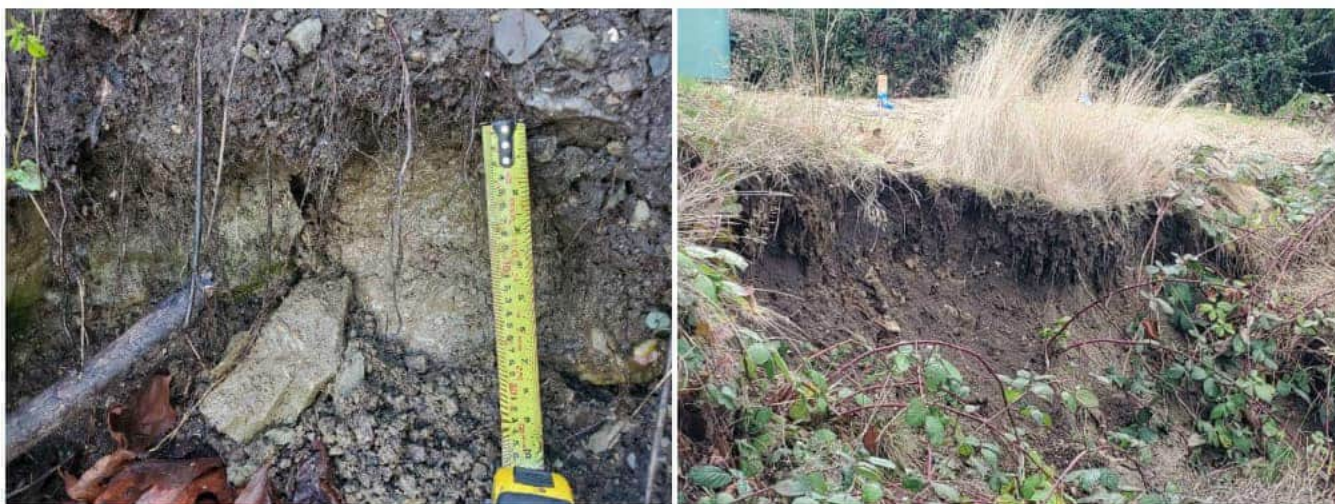
Figure 2. Soil formation on the south section (Left) and north section with exposed profile due to the erosion (right).

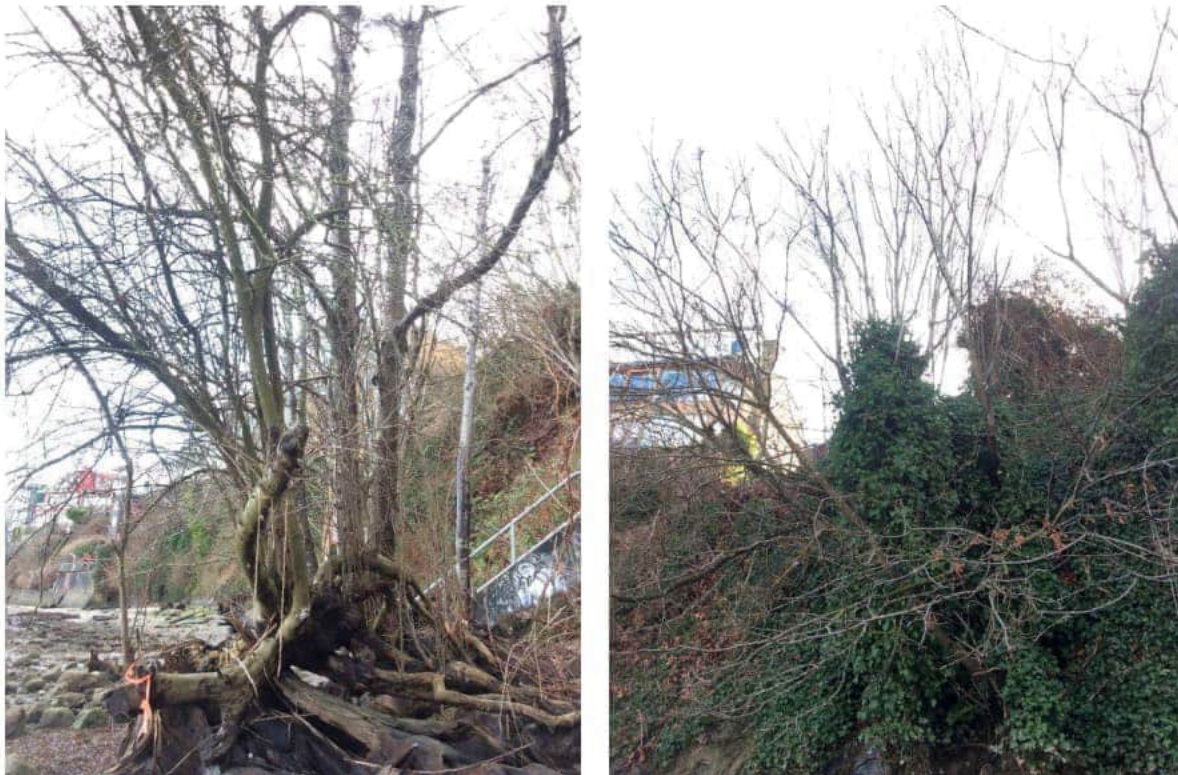
Figure 4. Trees at the toe of slope (left - #15); and infested with English ivy into the crown (right - Tree #4)

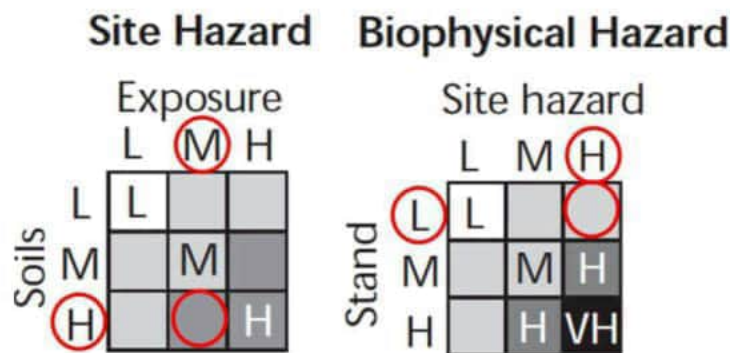
Figure 5. The biophysical hazard rating for subject area is moderate
