PROJECT: HARTNEY CHAMBERS

SERVICE: HERITAGE CONSERVATION PLAN

ADDRESS: 343 WEST PENDER STREET

DATE: July 2025 (Revised August 2025)

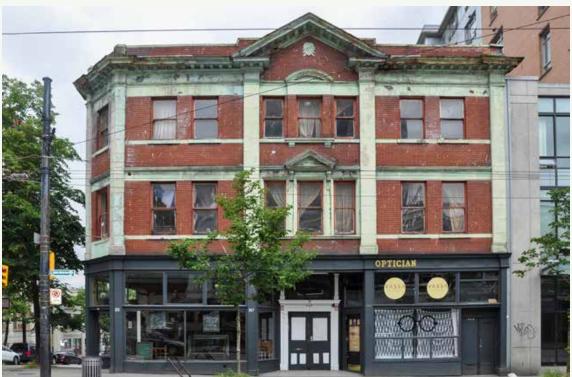
West Pender Street façade of Hartney Chambers. Luxton

Based on visual observation of the exterior masonry walls from the street level, as well as from accessible interior spaces through wall openings, the existing brick masonry walls show varying degrees of weathering and deterioration. Overall, the brick and mortar are in poor to fair condition. Deterioration of masonry units and mortar may be attributed to past unsympathetic interventions,

lack of maintenance, and water ingress resulting in prolonged saturation of the masonry. Deterioration evident included step cracks, hairline fissures, spalled brick, efflorescence, discolouration, and organic growth. Mortar loss was significant in areas and the mortar was soft and absent in multiple locations impacting the performance of the wall assembly. Missing bricks were also evident. The north wall has been parged, which is not original, and the parging is deteriorated and missing in areas. Where the parging has fallen off, many of the exposed bricks are spalled.

- Preserve the masonry of the two retained street façades.
- Where necessary due to structural and/or safety conditions, carefully deconstruct the brick masonry from the parapet cornice frieze to the parapet cap. Carefully clean mortar from salvaged brick and store in manner and location which does not result in its deterioration. Reconstruct upper portion of façade to match original appearance using salvage brick
- Retain sound masonry of the retained façades.

- Repair masonry that is deteriorated using suitable heritage repair mortars or replace in-kind masonry that is too deteriorated to retain.
- Cleaning masonry using gentlest means possible.
 Only approved chemical restoration cleaners
 may be used. Sandblasting or any other abrasive
 cleaning method of any kind is not permitted.
 Complete mock up prior to cleaning masonry in its
 entirety

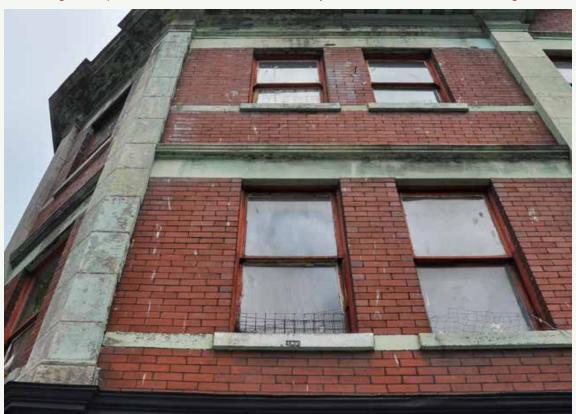
The Oamaru stone on Hartney Chambers has been painted concealing the stones original colour. Painting exterior masonry surfaces, either for aesthetic reasons or to conceal deterioration, can exacerbate its deterioration. The paint on the Oamaru stone is not original and is

Oamaru stone pilasters, sills, and lintels of the West Pender Street façade of Hartney Chambers. Luxton

failing in multiple locations. The stone appears to be in good condition; however the paint limits its assessment. As part of the proposed redevelopment, the stone of the street façades will be preserved and its appearance restored.

The paint should be removed through a non-abrasive and gentle approach. All efforts should be made to ensure that all surviving, original decorative stone elements are preserved, paint removed and deteriorated stone repaired. Should it be determined, once the paint is removed, that the stone requires a protective coating, mineral paint is an acceptable product that could be applied to the stone.

- Remove paint from Oamaru stone. Stone should not be damaged during paint removal. Complete mock up prior to removing paint from stone in its entirety. If determined that paint cannot be removed from the stone in its entirety, repaint stone using mineral paint.

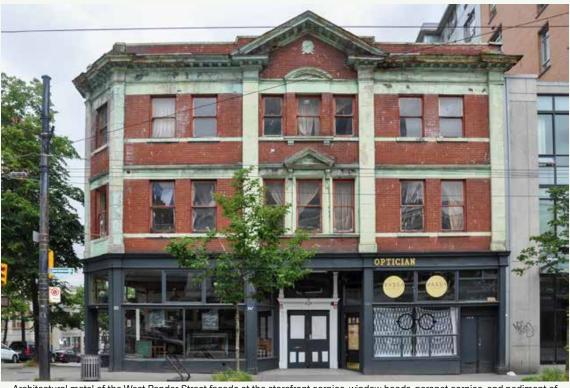
Architectural metal of the West Pender Street façade at the storefront cornice, window hoods, parapet cornice, and pediment of Hartney Chambers. *Luxton*

The existing metalwork is original to the building's construction. Visual review from the street level identified significant deterioration of the architectural metalwork on both street façades. Deterioration identified included heavy corrosion, staining, paint failure, missing and loose components, and deformations. The anchoring of the metalwork and its condition is not known. The metalwork above the storefront cornice level is more deteriorated than the storefront cornice.

was completed in early 2024. RJC reviewed the street façades' architectural metalwork from scaffolding and noted that the metalwork above the storefront level cornice was extremely corroded with large holes and missing components present at multiple locations. They also observed a single steel strap anchoring the parapet cornice to the parapet which was heavily corroded.

Due to the condition of the parapet metal cornice and masonry parapet (see Exterior Masonry Walls section), RJC recommended that the street façades from the frieze of parapet cornice to the parapet cap be temporarily disassembled to protect the public as well as the materials themselves. This intervention would require the documentation, careful deconstruction, storage, and reconstruction of the uppermost portion of the street façades with salvaged materials. A point cloud scan of the building's exterior has already been completed to

- Repaired metalwork as required. Work to be physically and visually compatible with existing and only identifiable on close review.
- Stabilize and re-anchor architectural metalwork elements by structural reinforcement or correction of unsafe conditions, as required and in accordance with Structural Engineer's assessment. Repairs should be physically and visually compatible.
- Remove deteriorated paint, corrosion, and clean metalwork prior to repainting. Apply appropriate primer for galvanized surfaces. Paint in historically appropriate colour, based on colour schedule prepared by Heritage Consultant.

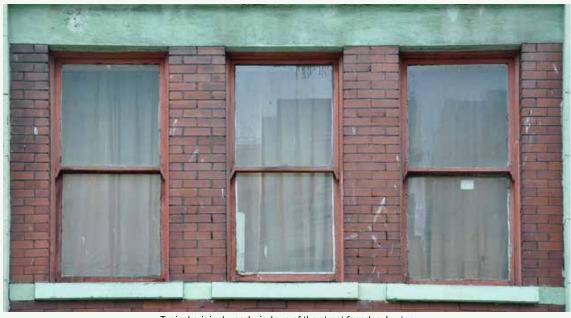
Typical original wood windows of the street façades. Luxton

- Preserve existing window openings of the second and third floors.
- Preserve existing wood window jambs and repair as required.
- Rehabilitate glazing of second and third floor windows with new sealed units in new wood sashes matching material and appearance of originals with integrated sash horns.

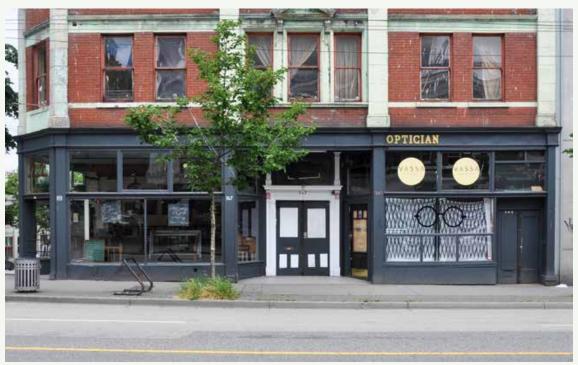
Storefront along West Pender Street with large plate glass storefront window, single-lite fixed and operable transoms. Some storefront glazing has been altered (far right) and the windows of the storefront bulkheads have been removed and/or covered over.

- Rehabilitate storefront bulkhead windows with new glazing where windows are being retained. Retain wood assemblies and repair or replace in-kind with new if wood components are too deteriorated to repair.
- Window conservation work should be undertaken by a contractor skilled in heritage window restoration.
- Prime and repaint as required in appropriate colour, based on colour schedule devised by Heritage Consultant.
