MAIN POST OFFICE

349 WEST GEORGIA STREET, VANCOUVER, BC

CONSERVATION PLAN

APRIL 23, 2018

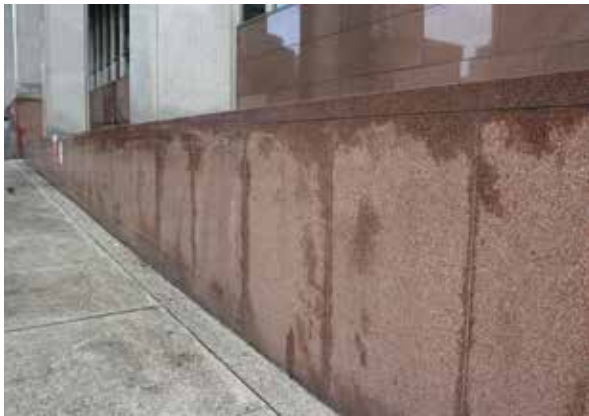
In general, the original granite panels appear to be in good condition, with minor signs of deterioration and damage in localized areas, as evident by staining, hairline cracking, redundant holes, surface scratching, missing parts, and varying degrees of impact damage. Missing grey granite spandrel panels have been replaced with pressed metal that are finished with paint in similar grey tone.

Photos showing typical conditions of polished red granite at the base of the Main Post Office.

As part of the proposed redevelopment scheme, the base of the building will be rehabilitated to include a series of storefronts on all elevations. This would require the removal of polished red granite cladding to accommodate the new openings. All original stone panels in good and repairable condition that require dismantling should be salvaged and stored safely to replace any damaged stone as required, or repurposed where possible.

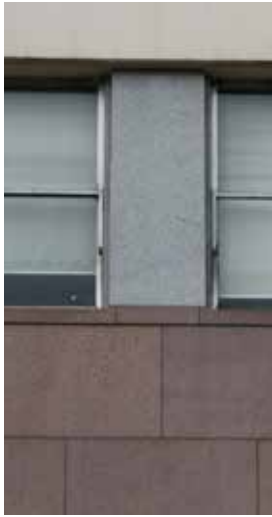
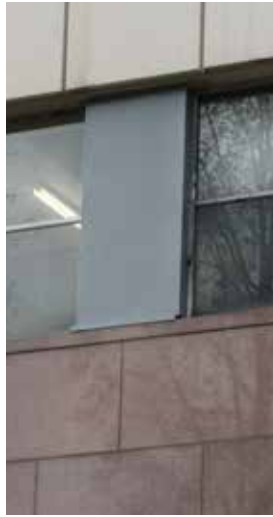
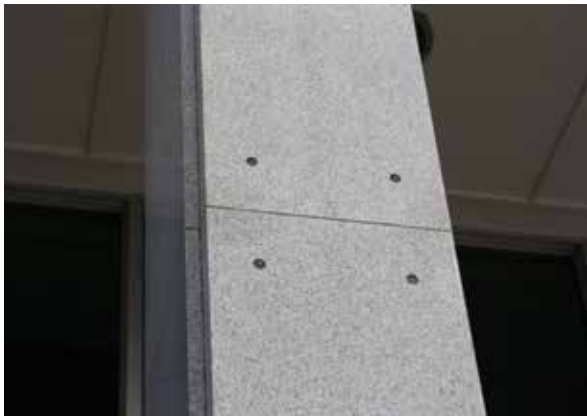
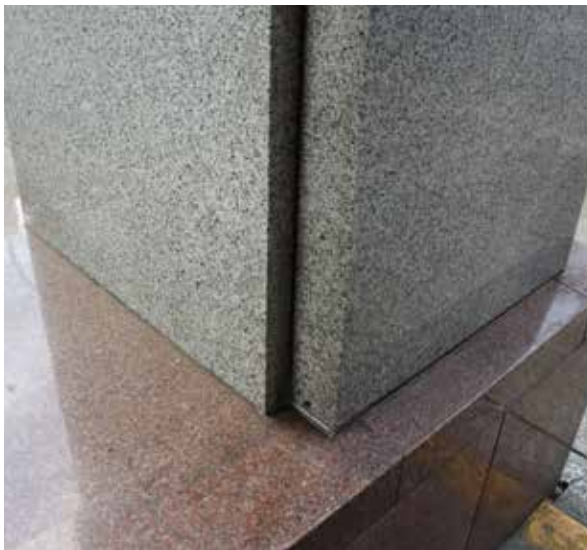
Photos showing typical conditions of polished grey granite at the base of the Main Post Office.. Note some panels are missing (top, right).

- Salvage all original granite elements in good and repairable condition where new openings are proposed. All efforts should be made to minimize damaging historic materials retained in situ.
- Make good missing and/or damaged granite elements to match existing as close as possible.
- Holes and other small areas of damage should be repaired using an appropriate restoration mortar that matches the colour and finish of the granite.
- All repairs to the granite must be undertaken by qualified masons who are experienced in heritage restoration.
- The original granite elements should be cleaned using the gentlest means possible. Abrasive cleaning methods are not permitted.

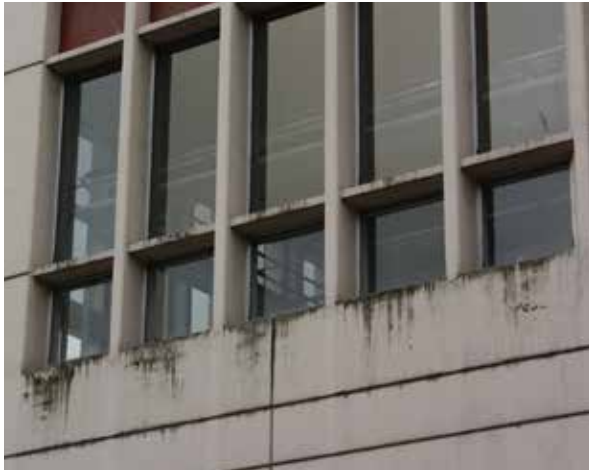
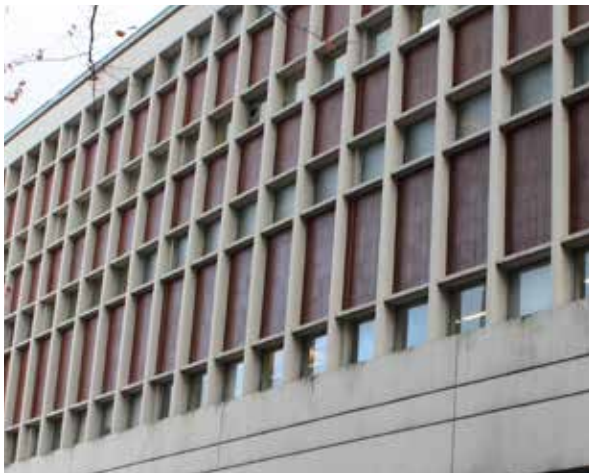
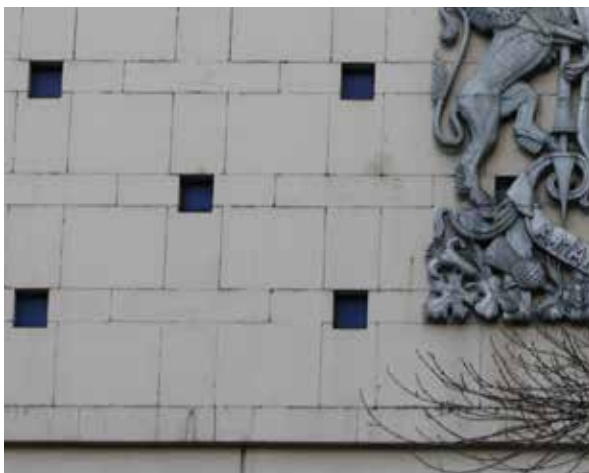
In general, the concrete elements appear to be in good condition, showing signs of varying degrees of deterioration, as evident by: staining and discolouration; organic build-up; paint loss; and localized crack. The majority of the staining and biological growth were notable in areas where water saturation and moisture retention are high, which could be attributed to limited sun exposure, particularly on the north elevation.

Photos showing typical deteriorated conditions of precast concrete and terra cotta elements of the exterior walls of the Main Post Office.

As part of the proposed redevelopment scheme, the concrete elements on all elevations should be preserved in situ, and repaired in-kind as necessary. Efforts should be made to ensure that all structural and/or envelope upgrades are limited from the interior side in order to minimize potential visual

- Preserve the original painted concrete elements in situ.
- Damages to the original concrete elements should be repaired using an appropriate restoration mortar to match existing paint colour and finish of the concrete.
- Structural or envelope upgrades should be undertaken from the interior where possible, and should not affect the original exterior appearance of the Main Post Office.
- All repairs to the concrete walls must be undertaken by a qualified contractor who is experienced in heritage restoration.
- The painted concrete elements should be cleaned using the gentlest means possible. Abrasive cleaning methods are not permitted.

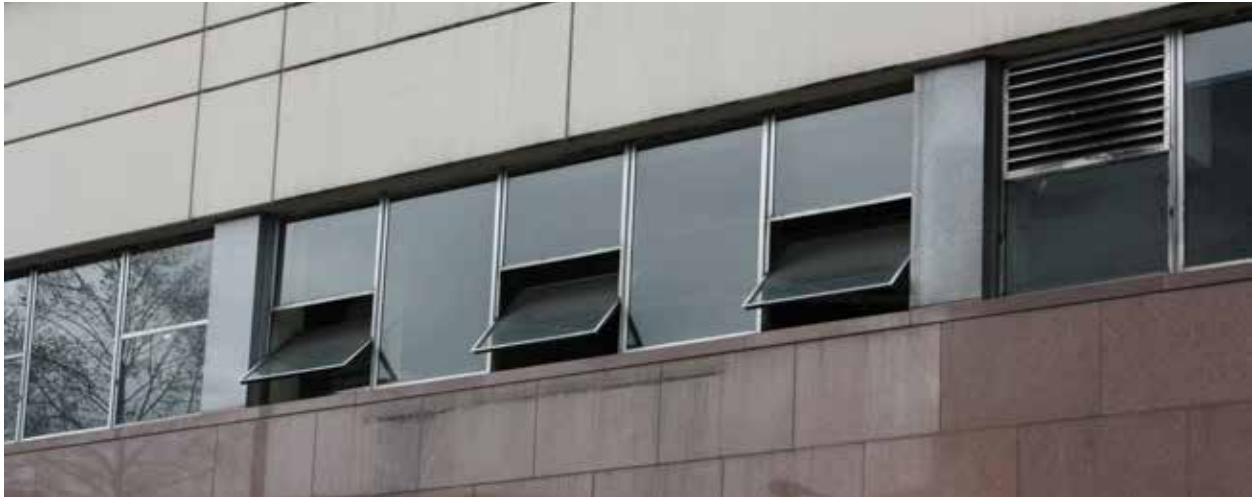
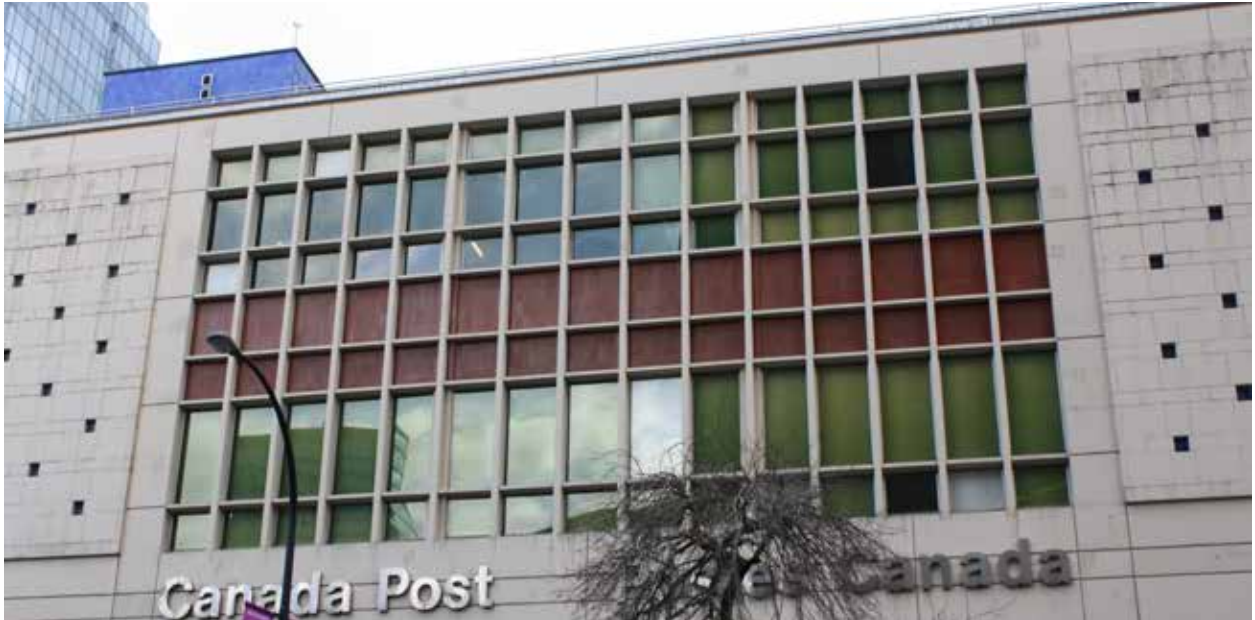
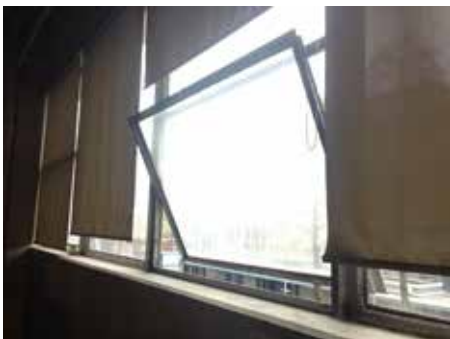
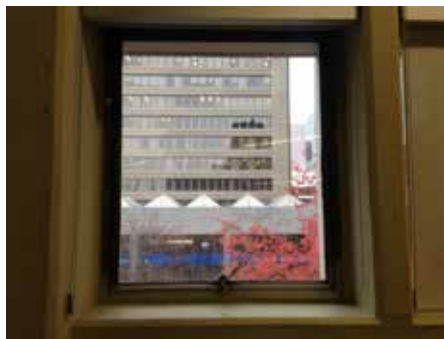
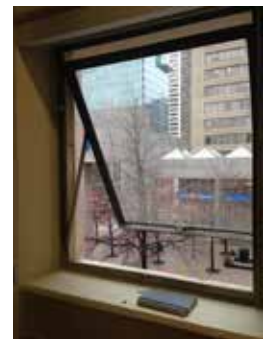
In general, the original aluminum windows are intact, and appear to be in good to fair condition. Minor modifications were noted in some areas, including, but not limited to: the replacement of glazing units with metal louvres; and the removal of precast concrete mullions to accommodate an enlarged opening (on the east elevation). In general, the original aluminum window assemblies are in good condition, with signs of natural weathering

and deterioration, particularly on the north elevation. A number of the window hardware were also rehabilitated at some point in time.

Photos showing typical conditions of original windows, as seen from the exterior (top photos) and exterior (bottom photos) side of the Main Post Office.

- Inspect window condition and complete a detailed window inventory to determine extent of recommended repair or replacement.
- Develop a detailed window rehabilitation program for retained and replacement windows. Determine where new window openings, assemblies, and mechanical louvres are required for functional reasons.
- Retain original window openings throughout the structural grid of the main facades. New window openings may be added, as required, for functional reasons.
- Retain and rehabilitate original aluminum windows of the Main Post Office, where possible.
- Heritage Consultant should review all window shop drawings and mock-ups for replacement windows.
- Any coloured film on retained windows should be removed.

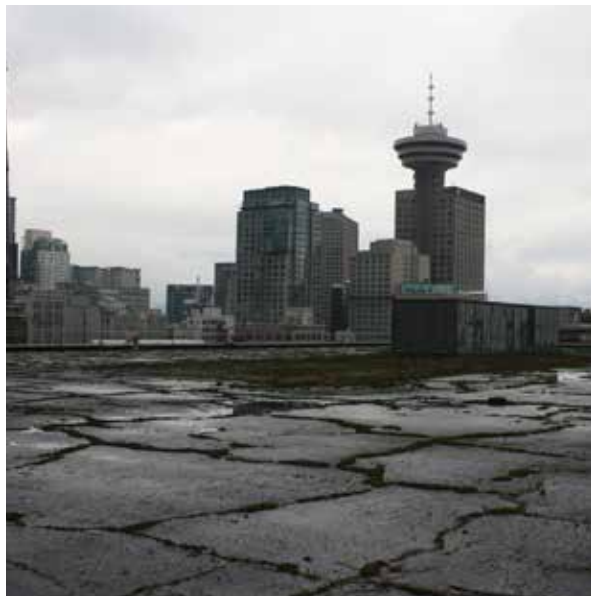
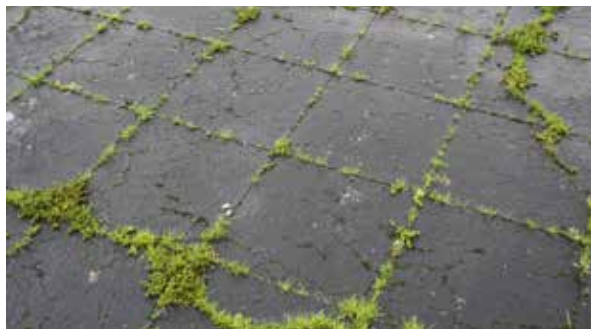
Photos showing typical deteriorating condition of the roof.

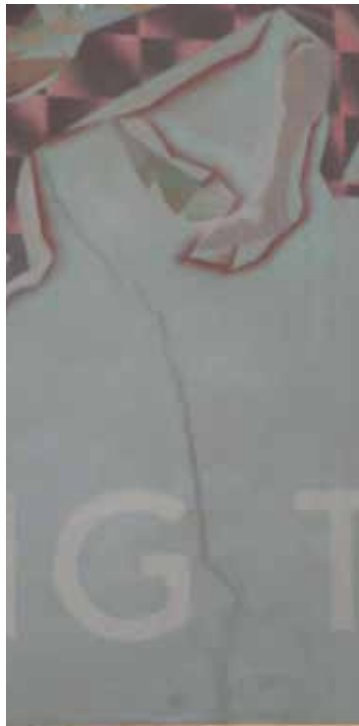
The elevator lobby of the Main Post Office, accessed from Homer Street, features a large painted mural by Orville Fisher above the elevator doors. The mural depicts early methods of transportation in British Columbia. In general, the painted mural appears to be in good condition, with minor signs of deterioration, as evident by a few cracks, and some discolouration in localized areas. Further testing and investigation by a conservator is required to determine the appropriate extent of intervention

Detail photo showing cracked plaster.

- The painted mural should be relocated within the building. The new location must allow for the painted mural to exist in its full dimension, and should retain its prominence in an unobscured manner (i.e. not visually obstructed).
- A professional conservator should be retained to coordinate the relocation and restoration process.
- The painted mural may be cut into multiple sections in order to be relocated. The cut lines should follow the natural divisions of 'tiled' colours of the mural. Care should be taken to ensure that surrounding mural material is not damaged during cutting, removal, relocation, or reinstatement.
- Once relocated, the painted mural should be restored, which will include the repair of cut seams. A professional conservator should

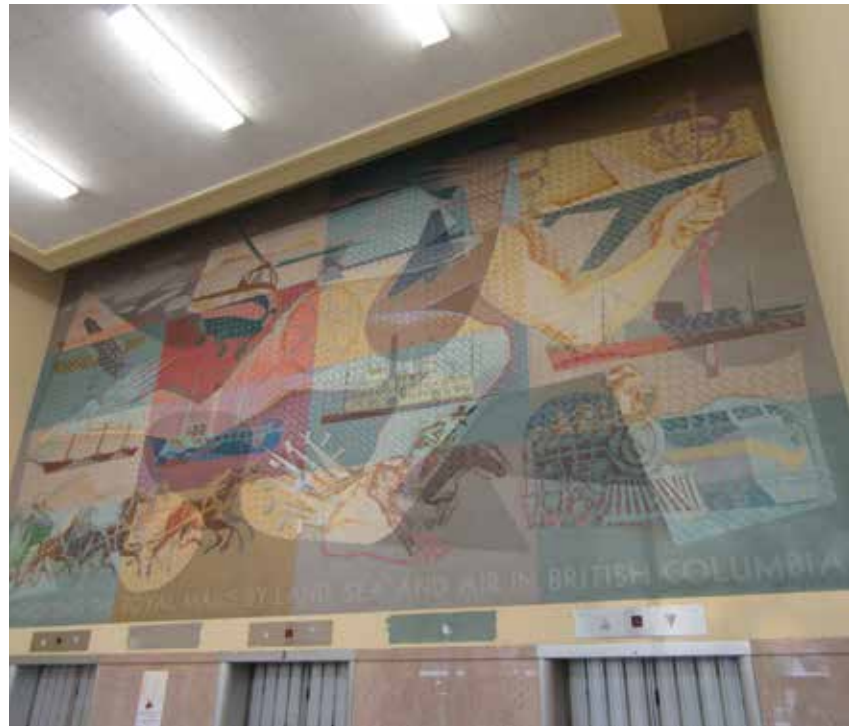
Painted mural at elevator lobby of the Main Post Office.
