Subject: 2880 Venables (DP2018-00128) - Review of Lombardy Poplar on West Side of Property

VDZ Project File No.:	PR2016-18
Project Name:	Notre Dame Regional Secondary School
Site Address:	2880 Venables Street, Vancouver, BC
Project Arborist:	Kelly Koome – van der Zalm + associates inc.
Consulting Arborist	Kelly Koome (PN 5962A) Arminder Virk (PN 8443A)

Updated: Arboricultural Opinion
Notre Dame Regional Secondary School
2855 Parker Street, Vancouver

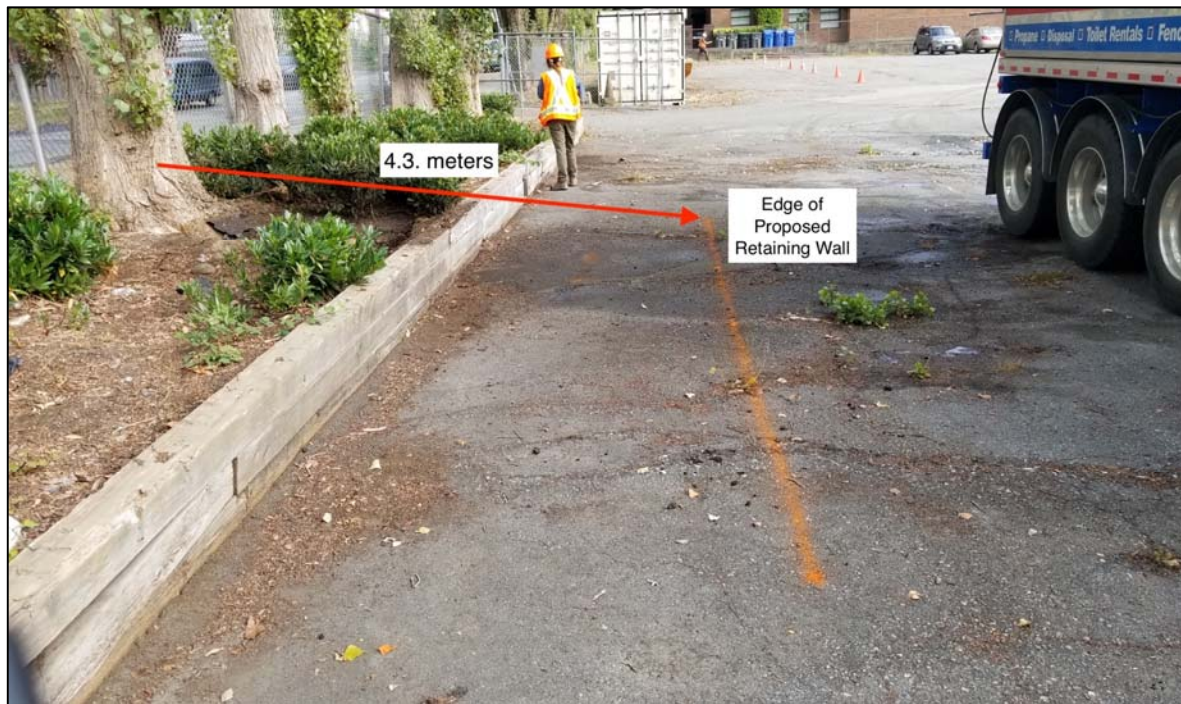
Fig. 1 – View of edge of proposed retaining wall, which is located 4.3 meters from the edge of poplars' trunks

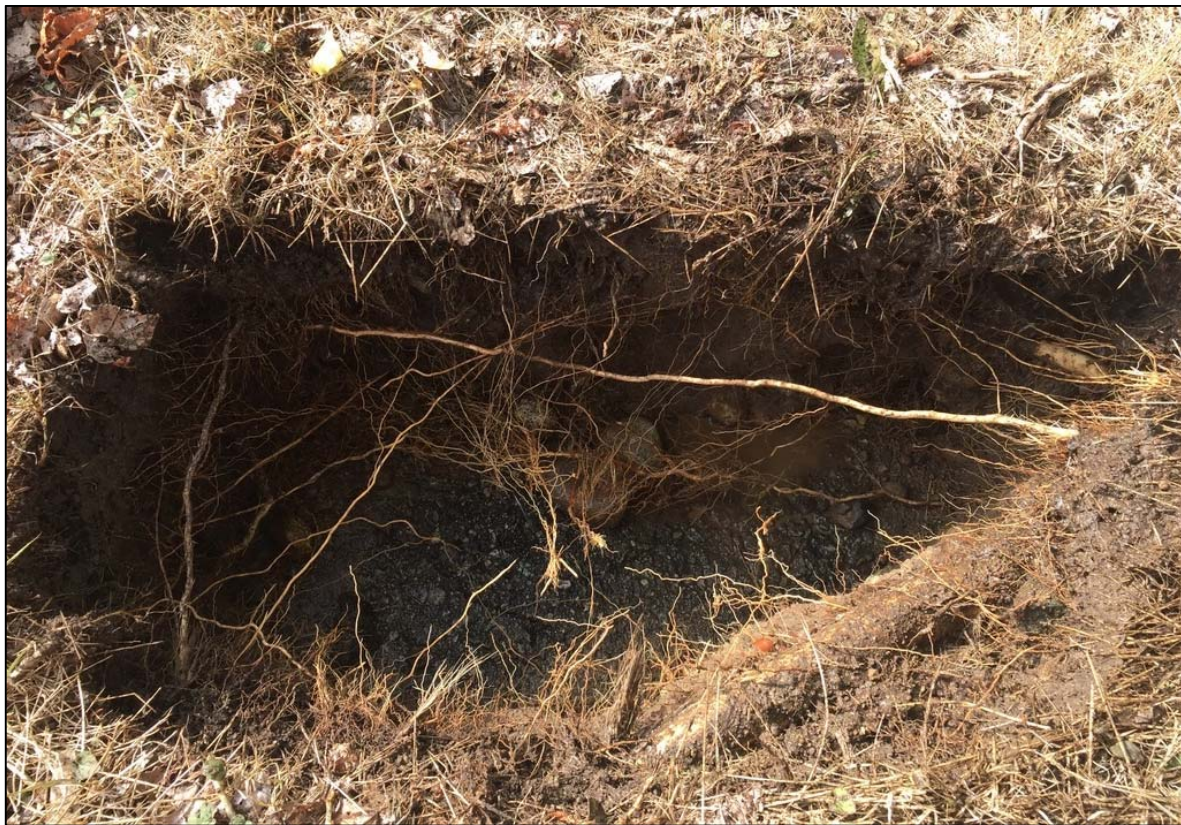
uncovered structural roots, as well as a layer of asphalt approximately 0.5 meters below the soil surface, which was paved up to the trees' roots (Fig. 2). It is assumed during the construction of the parking lot, asphalt was poured up to these trees' roots and soil for the garden bed was added on top of the pavement at a later date. Tree 034 was also observed to have roots extending underground and resurfacing in the parking approximately 6.0 meters away, while Tree 024 had roots extending 30.0 meters away (Fig. 4).

Fig. 2 – Excavated trench east of Tree 034, which uncovered a layer of asphalt 0.5 meters from the surface

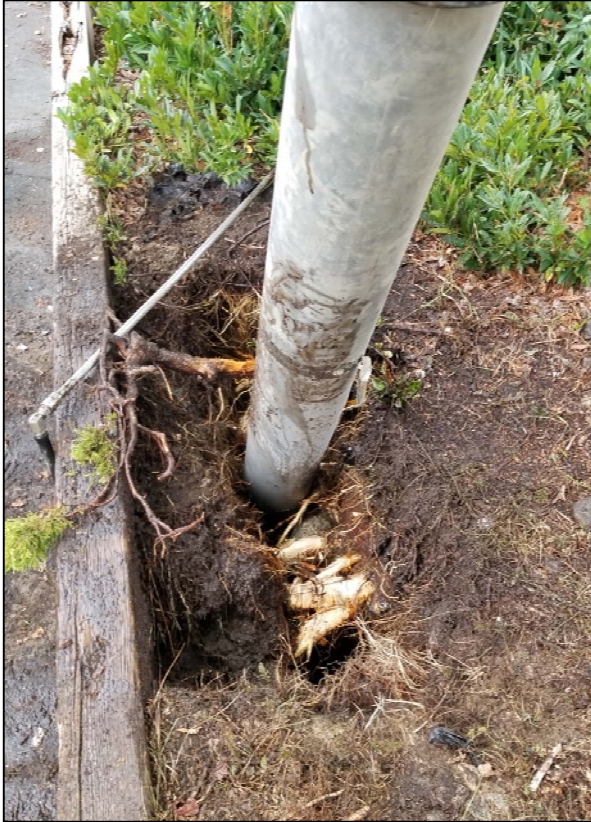
Fig. 3 – Hydrovac excavation of trenches

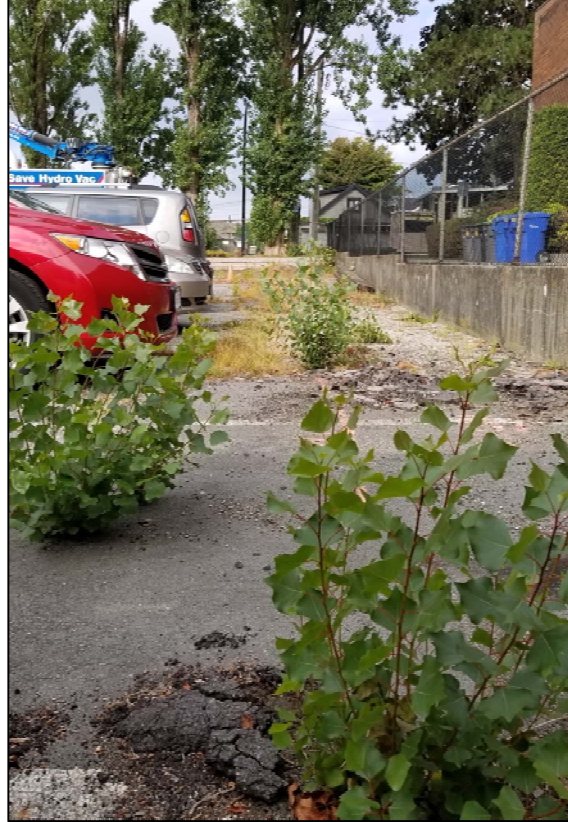
Fig. 4 – Roots of Tree 024 in parking lot

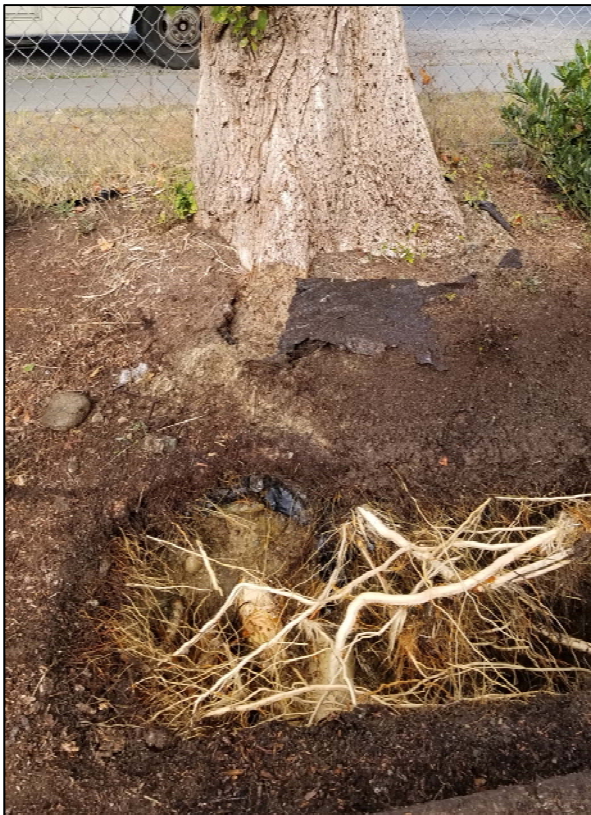
The Hydrovac excavation of trenches took place less than 1.0 meter east of Trees 024, 034, 036, 039. Excavation on the east side of Trees 036 and 039 uncovered multiple roots of various sizes close to the soil surface (Fig. 5). Observations found roots from Tree 036 extending underground and resurfacing in the parking lot approximately 6.0 meters east (Fig. 6). Excavation on the east side of Trees 024 and 034

Fig. 5 – Exposed structural roots of Tree 036

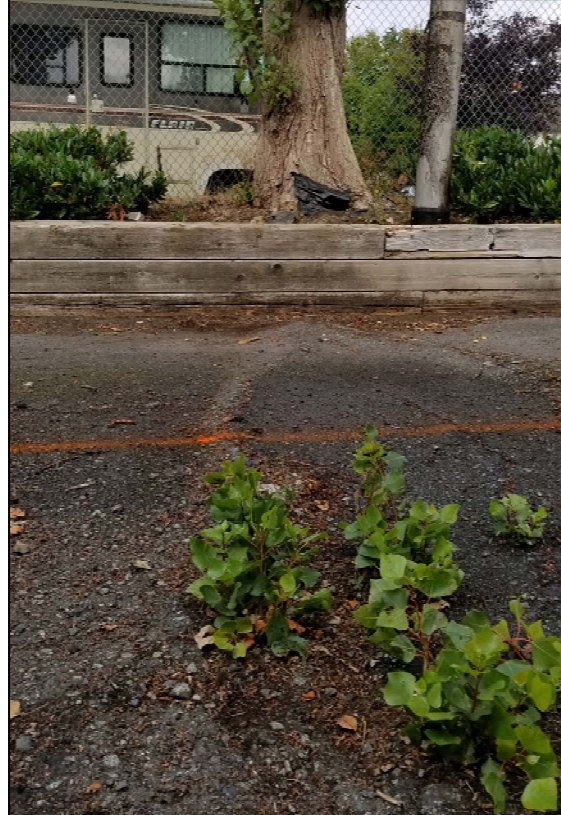
Fig. 6 – Roots of Tree 036 in parking lot

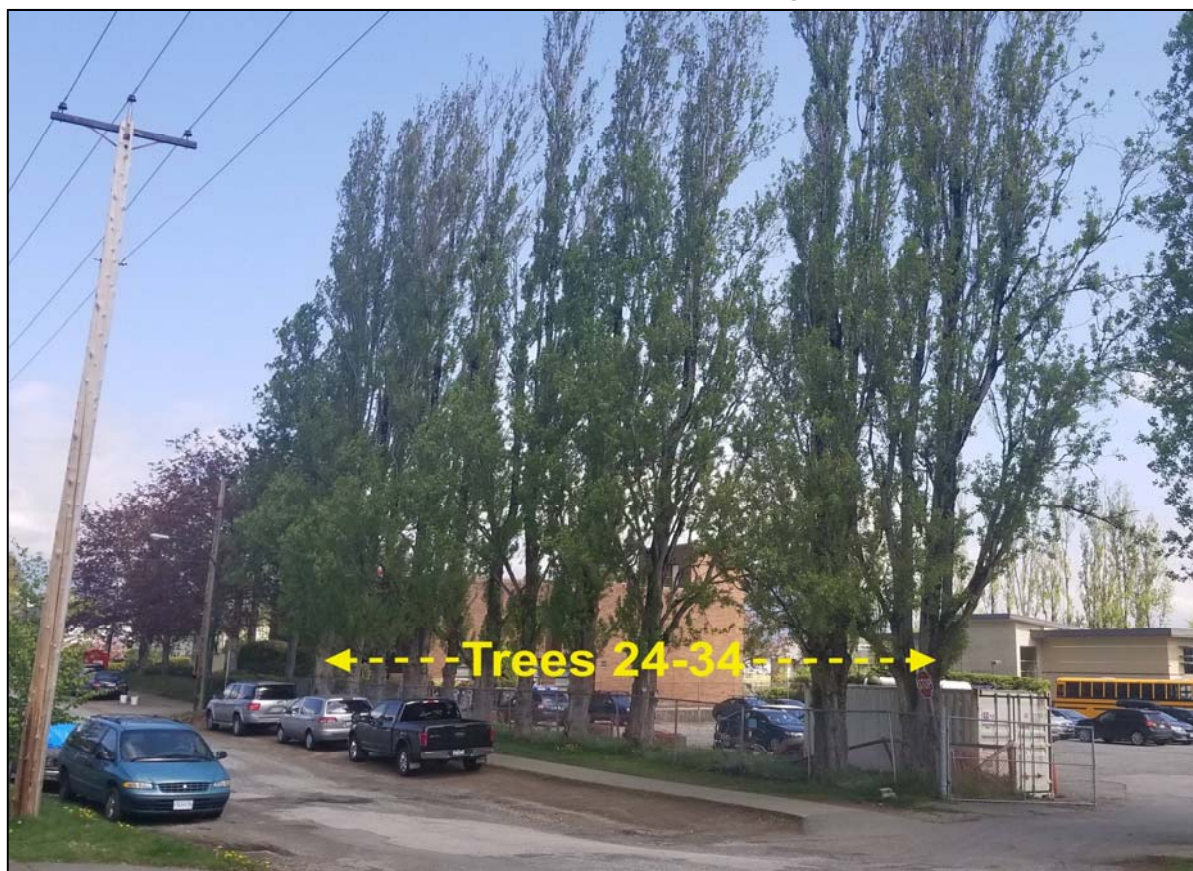
Image 2 – Left to right: trees 24 to 34 on west side of proposed development area.

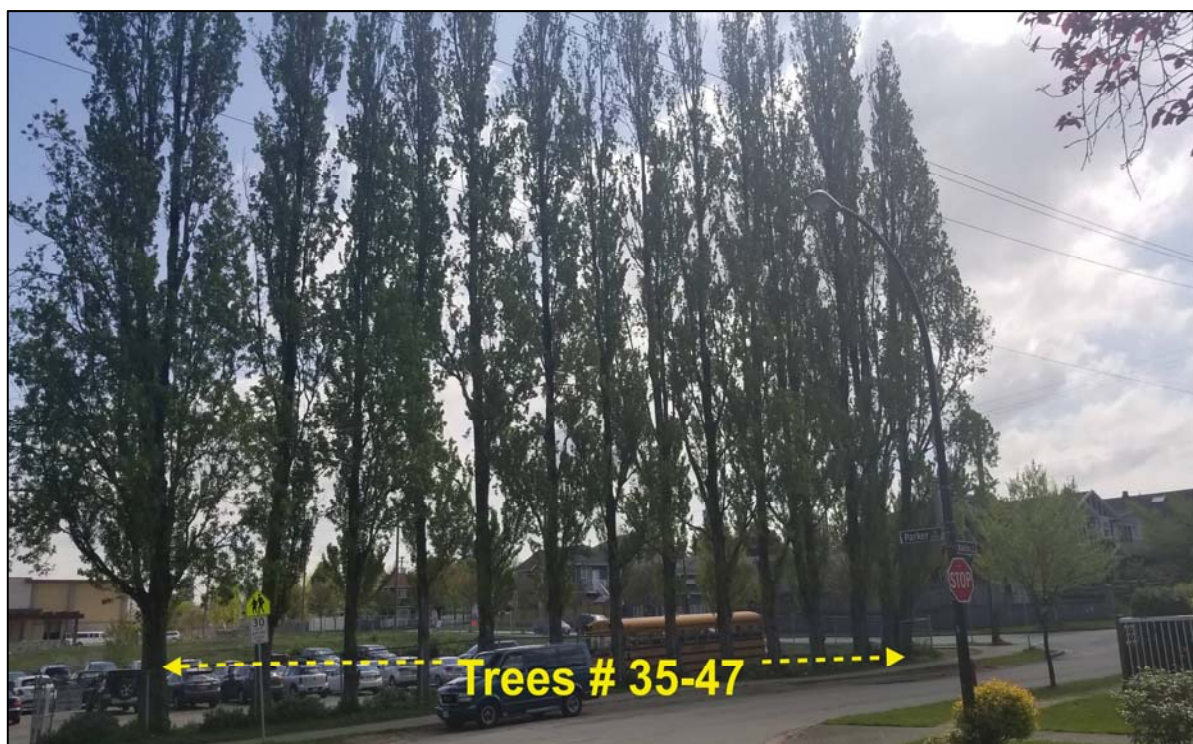
Image 3 – Left to right: trees 35 to 47 on west side of proposed development area.

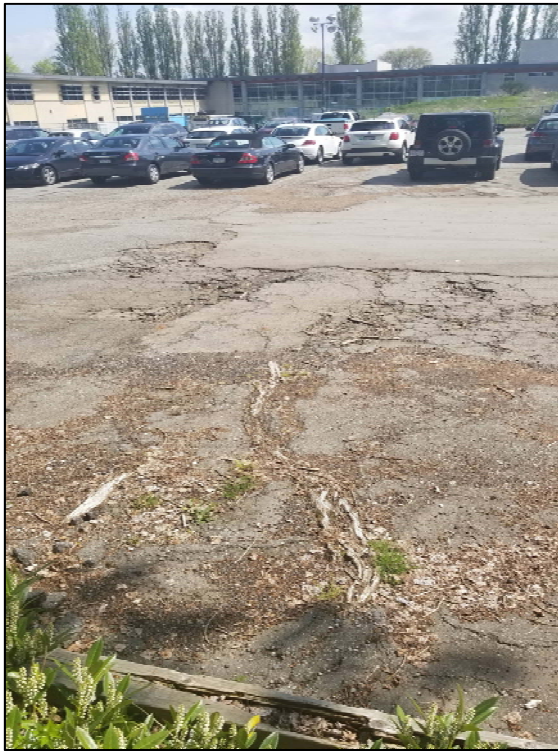
Image 4 - Cracks and lifting of asphalt.

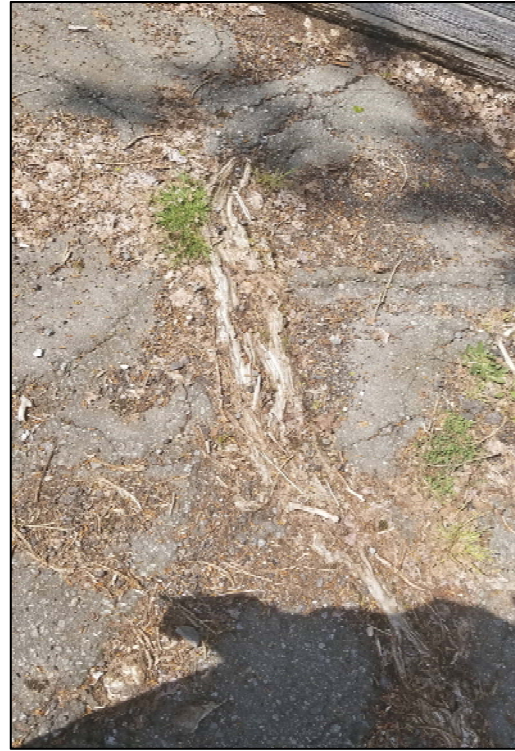
Image 5 - Structural roots extending through asphalt

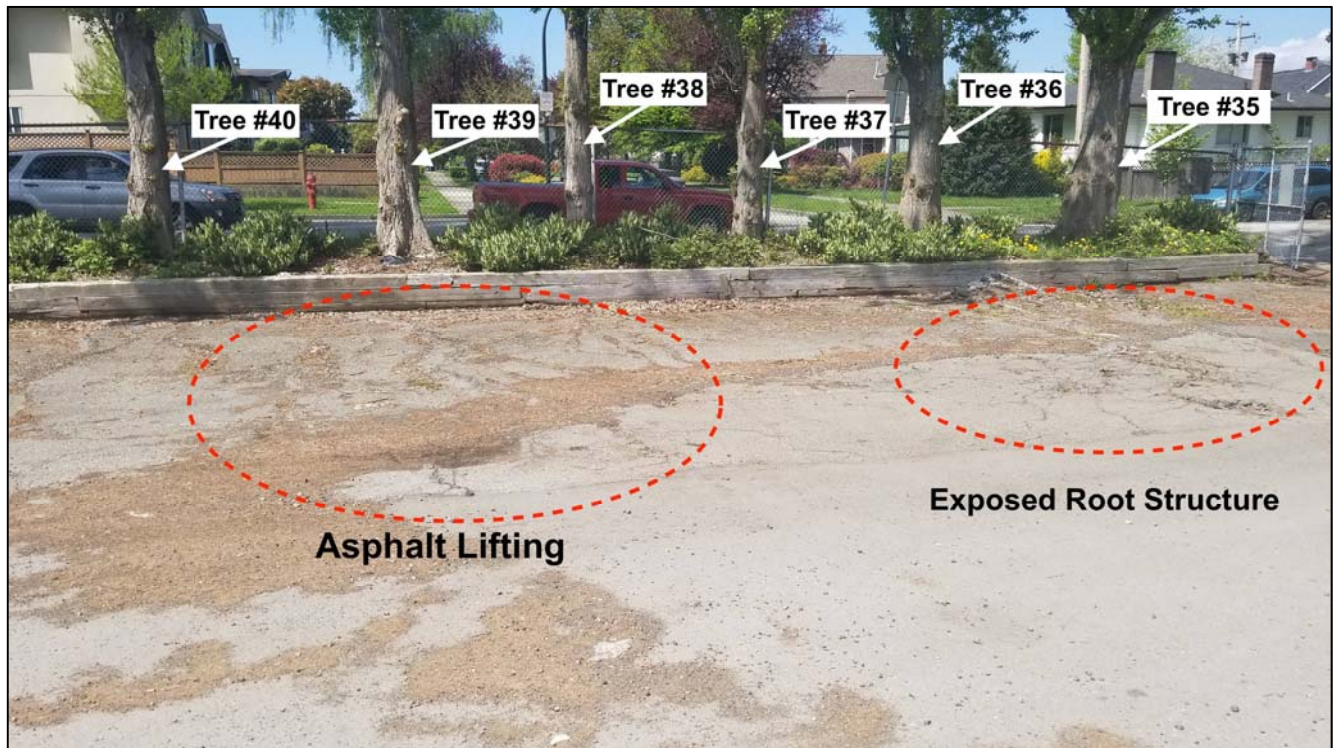
Image 6 - All the trees will have their root structure severely impacted by the proposed excavation.

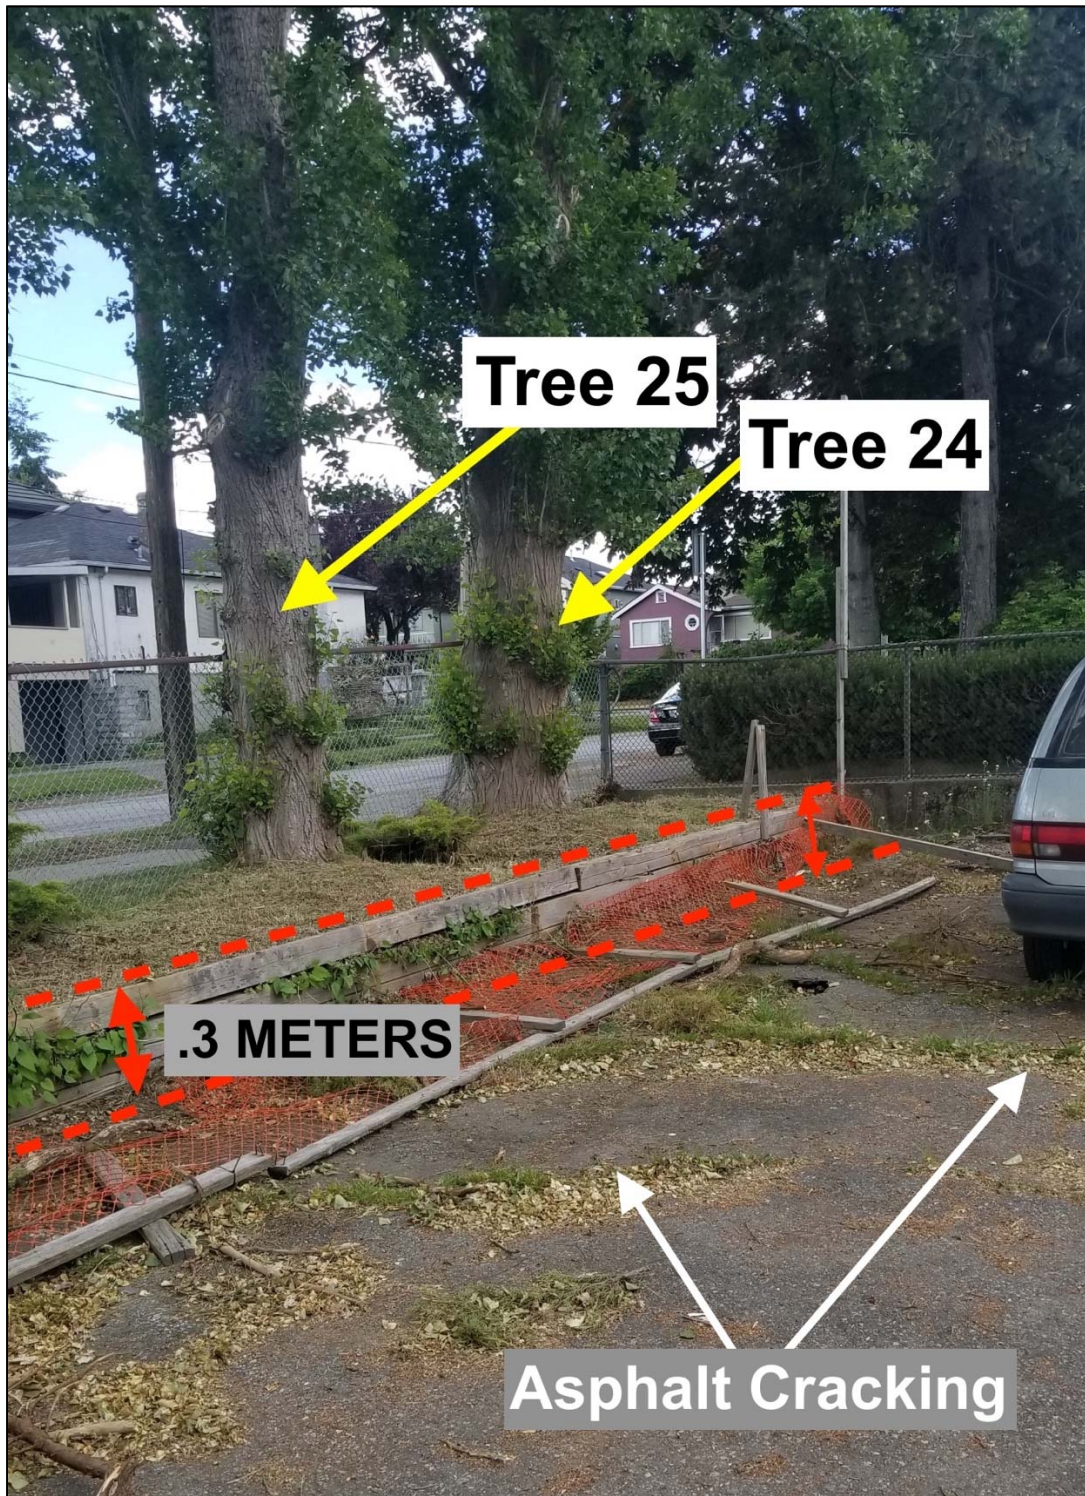
Tree #	Common Name (<i>Botanical name</i>)	DBH (m.)	Risk Rating	Comments
24	Lombardy Poplar <i>Populus nigra</i>	0.77	IMAGES 1,3,4	LOCATION – West side of property TRUNK – Growing beside chain link fence ROOTS- Restricted by retaining wall on east
<p>CURRENT RATING Over the next 15-years, the tree part most likely to fail is the roots. The targets include vehicles, pedestrians, Fire Hall and a house. Given the likelihood of such a failure over the next 15 years, and the possible consequences and impact on the targets, the risk rating = MODERATE</p> <p>WITH PROPOSED DEVELOPMENT Over the next 15-years, the tree part most likely to fail is the roots. The targets include vehicles, pedestrians, proposed sports field, Fire Hall and a house. Given the likelihood of such a failure over the next 15 years, and the possible consequences and impact on the targets, the risk rating = HIGH</p>				
25	Lombardy Poplar <i>Populus nigra</i>	0.58	IMAGES 1,4	LOCATION – West side of property TRUNK – Growing beside chain link fence ROOTS- Restricted by retaining wall on east

<p>CURRENT RATING Over the next 15-years, the tree part most likely to fail is the roots. The targets include vehicles, pedestrians, Fire Hall and a house. Given the likelihood of such a failure over the next 15 years, and the possible consequences and impact on the targets, the risk rating = MODERATE</p> <p>WITH PROPOSED DEVELOPMENT Over the next 15-years, the tree part most likely to fail is the roots. The targets include vehicles, pedestrians, proposed sports field, Fire Hall and a house. Given the likelihood of such a failure over the next 15 years, and the possible consequences and impact on the targets, the risk rating = HIGH</p>				
26	Lombardy Poplar <i>Populus nigra</i>	0.49	IMAGE 4	LOCATION – West side of property TRUNK – Growing beside chain link fence ROOTS- Restricted by retaining wall on east
<p>CURRENT RATING Over the next 15-years, the tree part most likely to fail is the roots. The targets include vehicles, pedestrians, Fire Hall and a house. Given the likelihood of such a failure over the next 15 years, and the possible consequences and impact on the targets, the risk rating = MODERATE</p> <p>WITH PROPOSED DEVELOPMENT Over the next 15-years, the tree part most likely to fail is the roots. The targets include vehicles, pedestrians, proposed sports field, Fire Hall and a house. Given the likelihood of such a failure over the next 15 years, and the possible consequences and impact on the targets, the risk rating = HIGH</p>

Image 1 –Tree 24 and 25 with retaining wall on east side

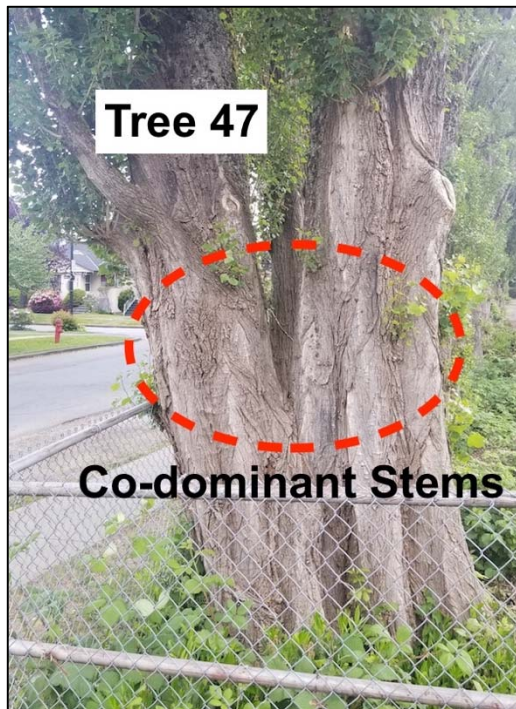
47	Lombardy Poplar <i>Populus nigra</i>	0.80 0.73 0.33	IMAGE 2,4,5 LOCATION – West side of property TRUNK – Growing beside chain link fence ROOTS- Restricted by retaining wall on east	
<p>CURRENT RATING</p> <p>Over the next 15-years, the tree parts most likely to fail are roots and the union of the codominant stems.</p> <p>The targets include vehicles and pedestrians. Given the likelihood of such a failure over the next 15 years, and the possible consequences and impact on the targets, the risk rating = MODERATE</p> <p>WITH PROPOSED DEVELOPMENT</p> <p>Over the next 15-years, the tree parts most likely to fail are roots and the union of the codominant stems.</p> <p>The targets include vehicles, pedestrians and proposed sports field. Given the likelihood of such a failure over the next 15 years, and the possible consequences and impact on the targets, the risk rating = HIGH</p>

Image 2 –Tree 47 with co-dominant stems

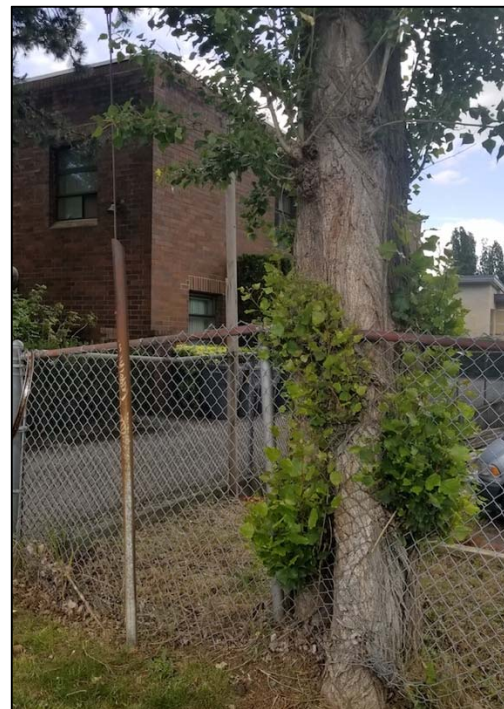
Image 3 –Tree 24 growing beside fence

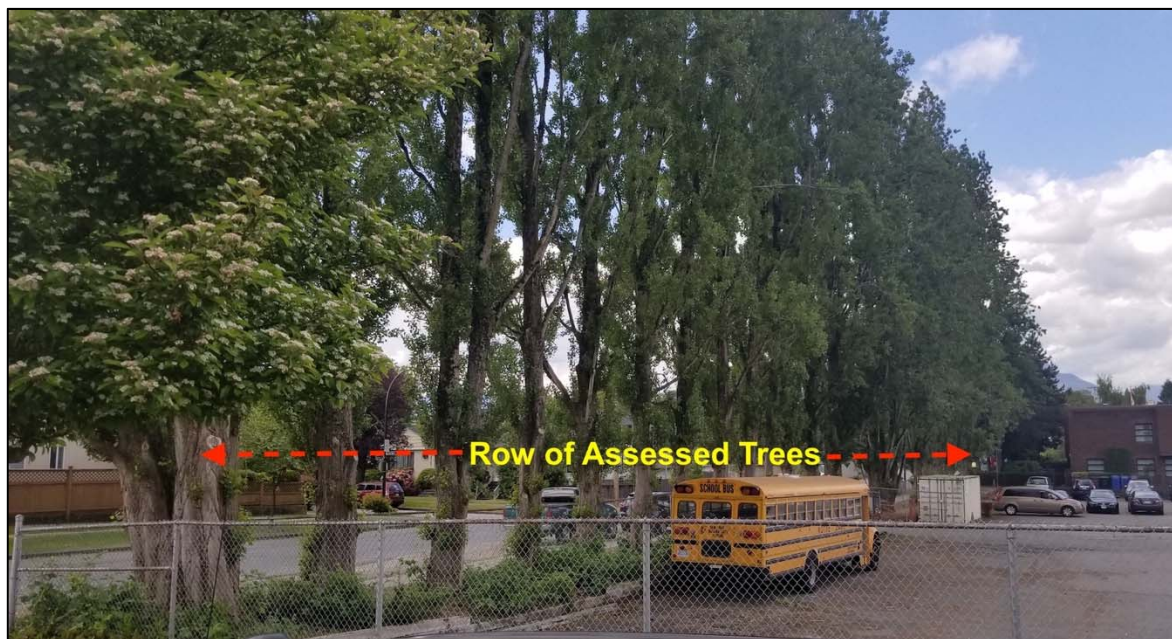
Image 4 – Row of assessed trees

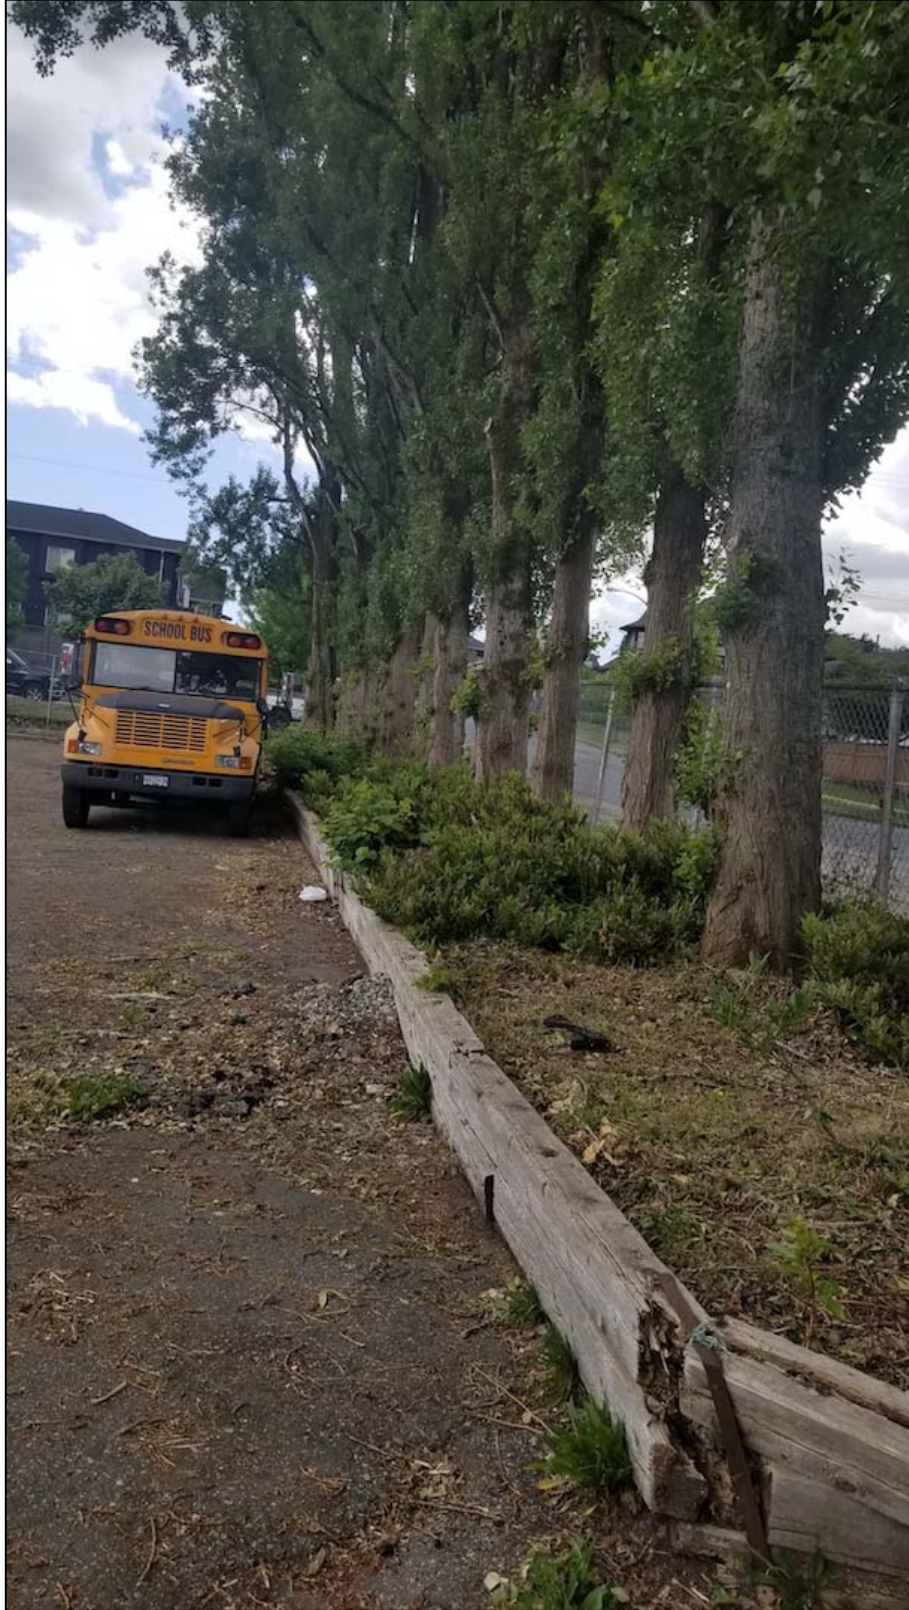
Image 5 – View of trees 35-47 with retaining wall and parking lot
