Diamond Head Consulting Ltd. Preliminary Tree Assessment

South False Creek Seawall – Creekside Drive
and Island Park Walk
Vancouver, BC

September 18, 2015

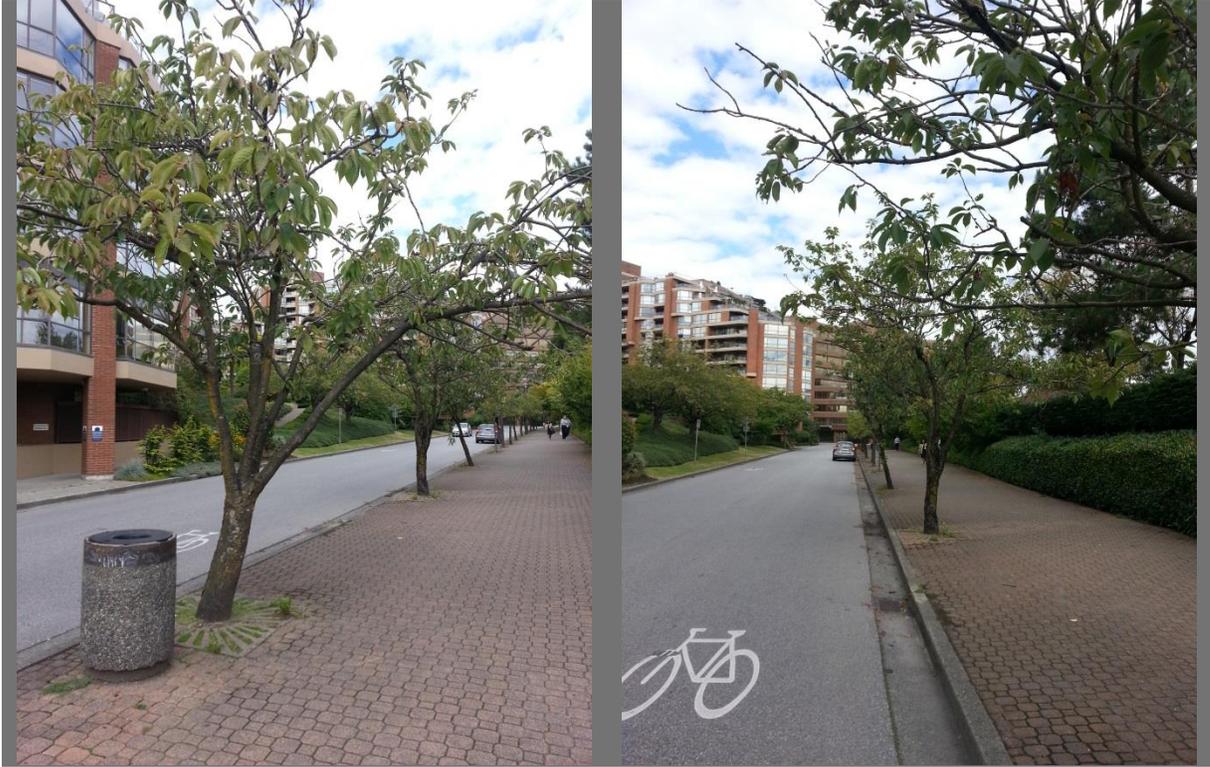
There are 17 trees growing along the south side of Creekside Drive that are included within the scope of this study. These trees appear to have minor infections of bacterial blight, and are in overall fair health and structural condition. The trees are growing adjacent to the curb and the root zones are covered by hardscape. The majority of these trees could be transplanted if there are found to be in conflict with the proposed plans.

Photo 1 and 2. Showing the subject trees along Creekside Drive.

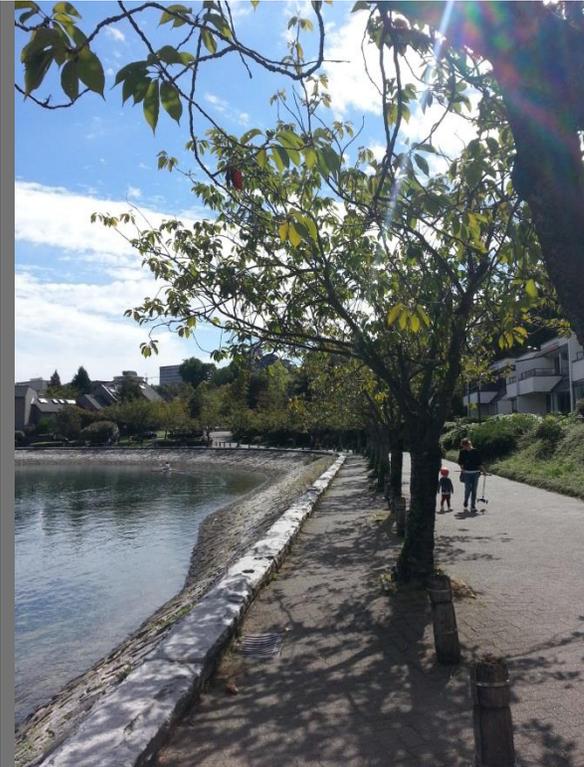
The trees included within the scope of this study are, 17 trees growing in this section of the Seawall path and 9 trees that are growing within a small park adjacent the Seawall. The trees along the Seawall appear to have severe infections of bacterial blight and bacterial canker, as well as infestations of Cherry Bark Tortrix are present. These trees are in overall very poor health and structural condition. In addition the trees are located in a harsh growing environment along the seaside with hardscape covering the root zones.

Photo 3. Showing the subject trees along the Seawall at Island Park Walk.

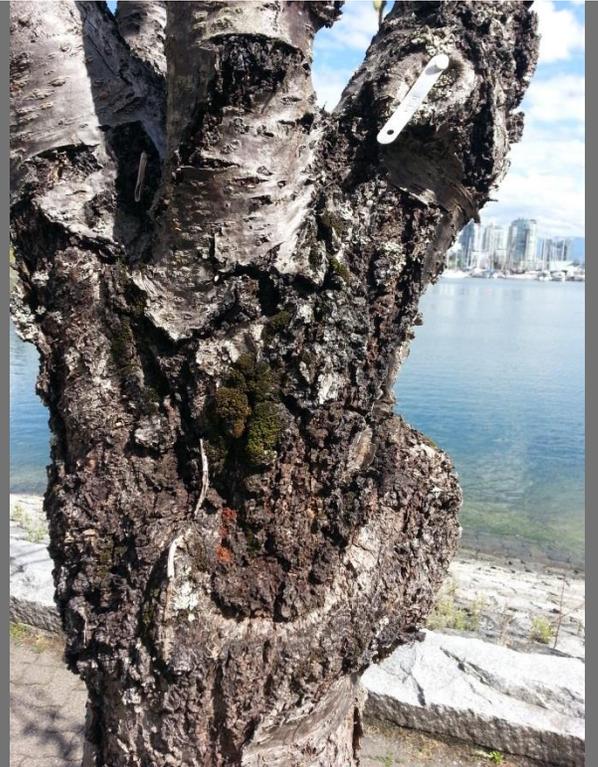
Photo 4. These trees are infected with bacterial canker.
