CITY OF VANCOUVER

# GEORGIA AND DUNSMUIR VIADUCTS LIMITED SEISMIC SCOPE STUDY FINAL REPORT

Project No. 5014103-003 | May 2015

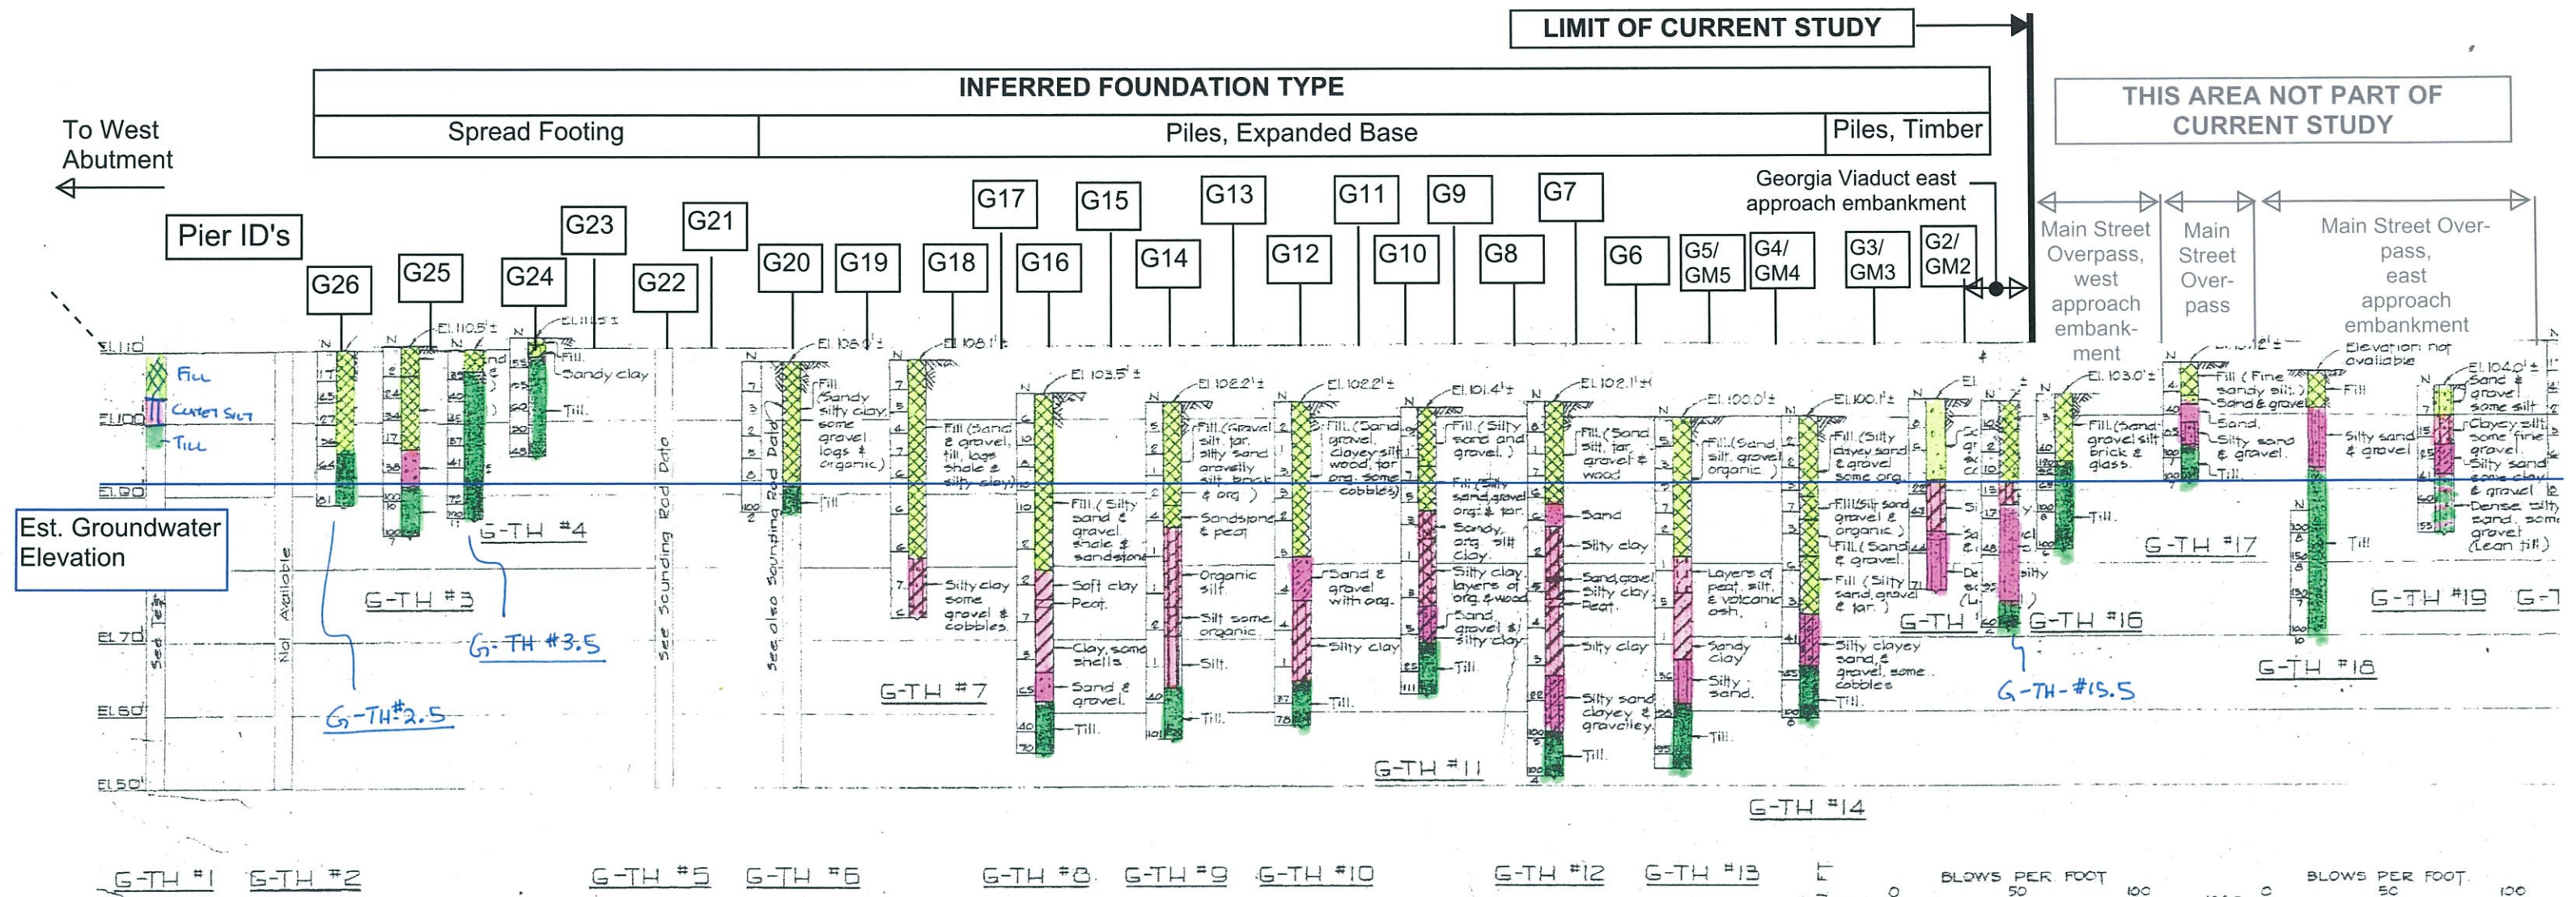
Loose fill encountered below the groundwater table with N-values of 15 or less is likely to be liquefiable during the design earthquake. The soft silt / clay deposit encountered between piers G2 to G19, GM3 to GM5, D2 to D19 and DM2 to DM5 are likely to be susceptible to strain softening under the design earthquake. Figures 2a and 2b provides additional details on where liquefaction / strain softening is anticipated.

Pier ID	Performance relative to Base Case Retrofit Scenario*	Liquefaction / Strain Softening	Kinematic Loading Issue	Conceptual Seismic Retrofit Options	Pier ID	Performance relative to Base Case Retrofit Scenario*	Liquefaction / Strain Softening	Kinematic Loading Issue	Conceptual Seismic Retrofit Options
West Abutment	Better	Not Likely	Not Likely	None anticipated	G13	Worse	Likely	Not Likely	Drilled Shafts or Jet Grouting
G26	Similar	Not Likely	Not Likely	Soil Anchors	G12	Worse	Likely	Not Likely	Drilled Shafts or Jet Grouting
G25	Similar	Not Likely	Not Likely	Soil Anchors	G11	Worse	Likely	Not Likely	Drilled Shafts or Jet Grouting
G24	Similar	Not Likely	Not Likely	Soil Anchors	G10	Worse	Likely	Not Likely	Drilled Shafts or Jet Grouting
G23	Similar	Not Likely	Not Likely	Soil Anchors	G9	Worse	Likely	Not Likely	Drilled Shafts or Jet Grouting
G22	Similar	Not Likely	Not Likely	Soil Anchors	G8	Worse	Likely	Not Likely	Drilled Shafts or Jet Grouting

G21	Similar	Not Likely	Not Likely	Soil Anchors	G7	Worse	Likely	Not Likely	Drilled Shafts or Jet Grouting
G20	Worse	Likely	Not Likely	Soil Anchors	G6	Worse	Likely	Not Likely	Drilled Shafts or Jet Grouting
G19	Worse	Likely	Not Likely	Soil Anchors	G5/GM5	Worse	Likely	Not Likely	Drilled Shafts or Jet Grouting
G18	Worse	Likely	Not Likely	Drilled Shafts or Jet Grouting	G4/GM4	Worse	Likely	Not Likely	Drilled Shafts or Jet Grouting
G17	Worse	Likely	Not Likely	Drilled Shafts or Jet Grouting	G3/GM3	Worse	Likely	Not Likely	Drilled Shafts or Jet Grouting
G16	Worse	Likely	Not Likely	Drilled Shafts or Jet Grouting	G2/GM2	Worse	Likely	Likely	Drilled Shafts or Jet Grouting
G15	Worse	Likely	Not Likely	Drilled Shafts or Jet Grouting	East Approach Embankment	Worse	Likely	Likely	Jet Grouting (Seismic Dike) See Figure 3
G14	Worse	Likely	Not Likely	Drilled Shafts or Jet Grouting

**FIGURE 2A - Interpreted geologic profile along Georgia Viaduct alignment and approximate pier locations and foundation type. Summary of conceptual geotechnical seismic retrofit measures tabulated as shown**

At piers G19 to G26 and D19 to D22 till-like soil is relatively shallow and the use of soil anchors consistent with Cochrane's "base case retrofit" is considered the most reasonable retrofit option. Soil anchors would be installed in both the longitudinal and transverse direction to resist inertial loads on the foundations. Soil anchors are generally not considered feasible where liquefiable soil layers more than about 3 m thick are present due to the potential for buckling and/or loss of lateral support. From an installation perspective, soil anchors are relatively simple given the ability to use small equipment. A key consideration related to soil anchors is the complex layout geometry with installation of inclined anchors and the potential for conflicts when coring through the pile cap and / or utility conflicts.

Soil conditions at Piers G19 and G20 and D19 and D20 are transitional. Soil anchors are still considered feasible but may require additional anchors with permanent casing to address buckling and loss of lateral support. Although piers D19 and D20 were part of Cochrane's study, Table 2b identifies its performance relative to the "base case retrofit" as being worse due to the

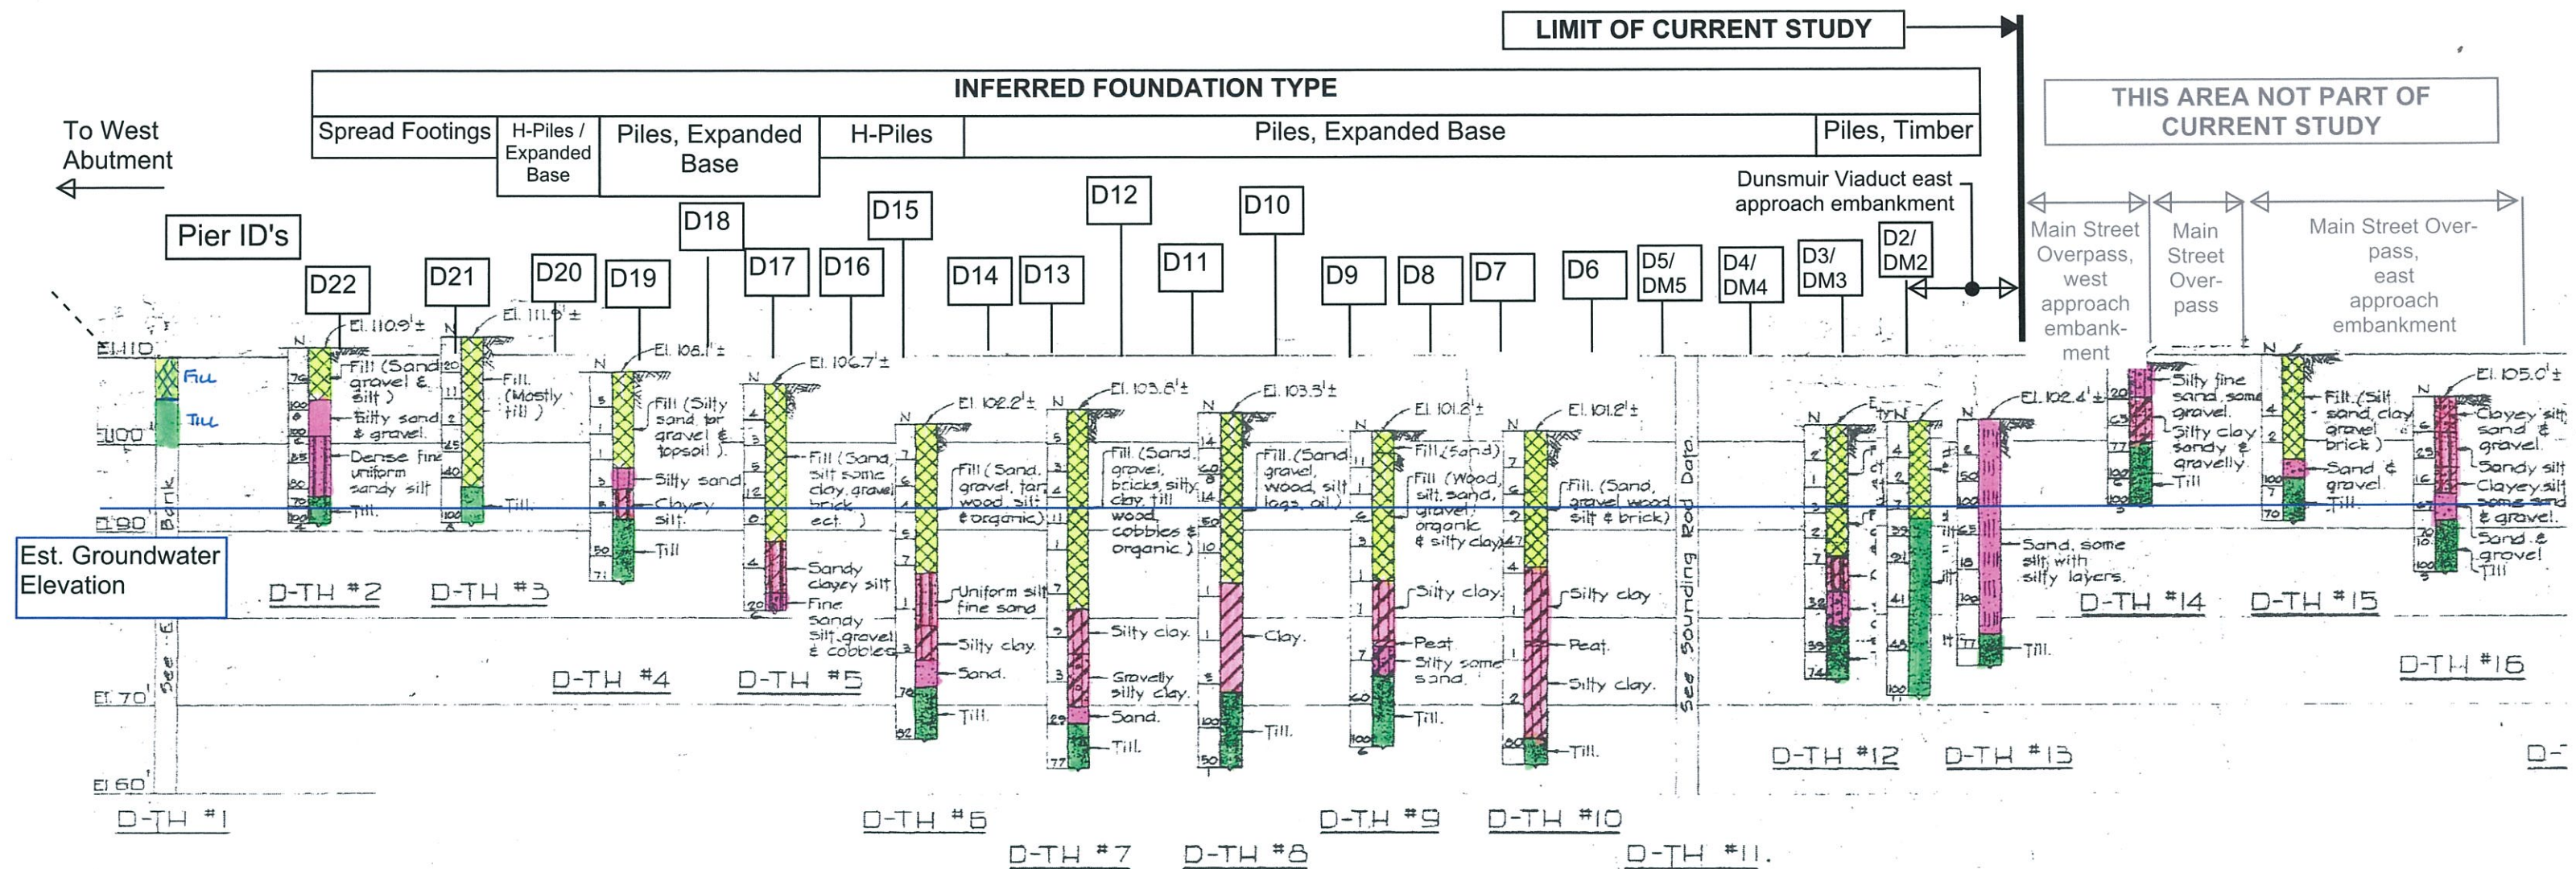
Pier ID	Performance relative to Base Case Retrofit Scenario*	Liquefaction / Strain Softening	Kinematic Loading Issue	Conceptual Seismic Retrofit Options	Pier ID	Performance relative to Base Case Retrofit Scenario*	Liquefaction / Strain Softening	Kinematic Loading Issue	Conceptual Seismic Retrofit Options
West Abutment	Better	Not Likely	Not Likely	None anticipated	D11	Worse	Likely	Not Likely	Drilled Shafts or Jet Grouting
D22	Similar	Not Likely	Not Likely	Soil Anchors	D10	Worse	Likely	Not Likely	Drilled Shafts or Jet Grouting
D21	Similar	Not Likely	Not Likely	Soil Anchors	D9	Worse	Likely	Not Likely	Drilled Shafts or Jet Grouting
D20	Worse	Likely	Not Likely	Soil Anchors	D8	Worse	Likely	Not Likely	Drilled Shafts or Jet Grouting
D19	Worse	Likely	Not Likely	Soil Anchors	D7	Worse	Likely	Not Likely	Drilled Shafts or Jet Grouting
D18	Worse	Likely	Not Likely	Drilled Shafts or Jet Grouting	D6	Worse	Likely	Not Likely	Drilled Shafts or Jet Grouting

D17	Worse	Likely	Not Likely	Drilled Shafts or Jet Grouting	D5/DM5	Worse	Likely	Not Likely	Drilled Shafts or Jet Grouting
D16	Worse	Likely	Not Likely	Drilled Shafts or Jet Grouting	D4/DM4	Worse	Likely	Not Likely	Drilled Shafts or Jet Grouting
D15	Worse	Likely	Not Likely	Drilled Shafts or Jet Grouting	D3/DM3	Worse	Likely	Not Likely	Drilled Shafts or Jet Grouting
D14	Worse	Likely	Not Likely	Drilled Shafts or Jet Grouting	D2/DM2	Worse	Likely	Likely	Drilled Shafts or Jet Grouting
D13	Worse	Likely	Not Likely	Drilled Shafts or Jet Grouting	East Approach Embankment	Worse	Likely	Likely	Jet Grouting (Seismic Dike) See Figure 3
D12	Worse	Likely	Not Likely	Drilled Shafts or Jet Grouting

**FIGURE 2B - Interpreted geologic profile along Dunsmuir Viaduct alignment and approximate pier locations and foundation type. Summary of conceptual geotechnical seismic retrofit measures tabulated as shown**

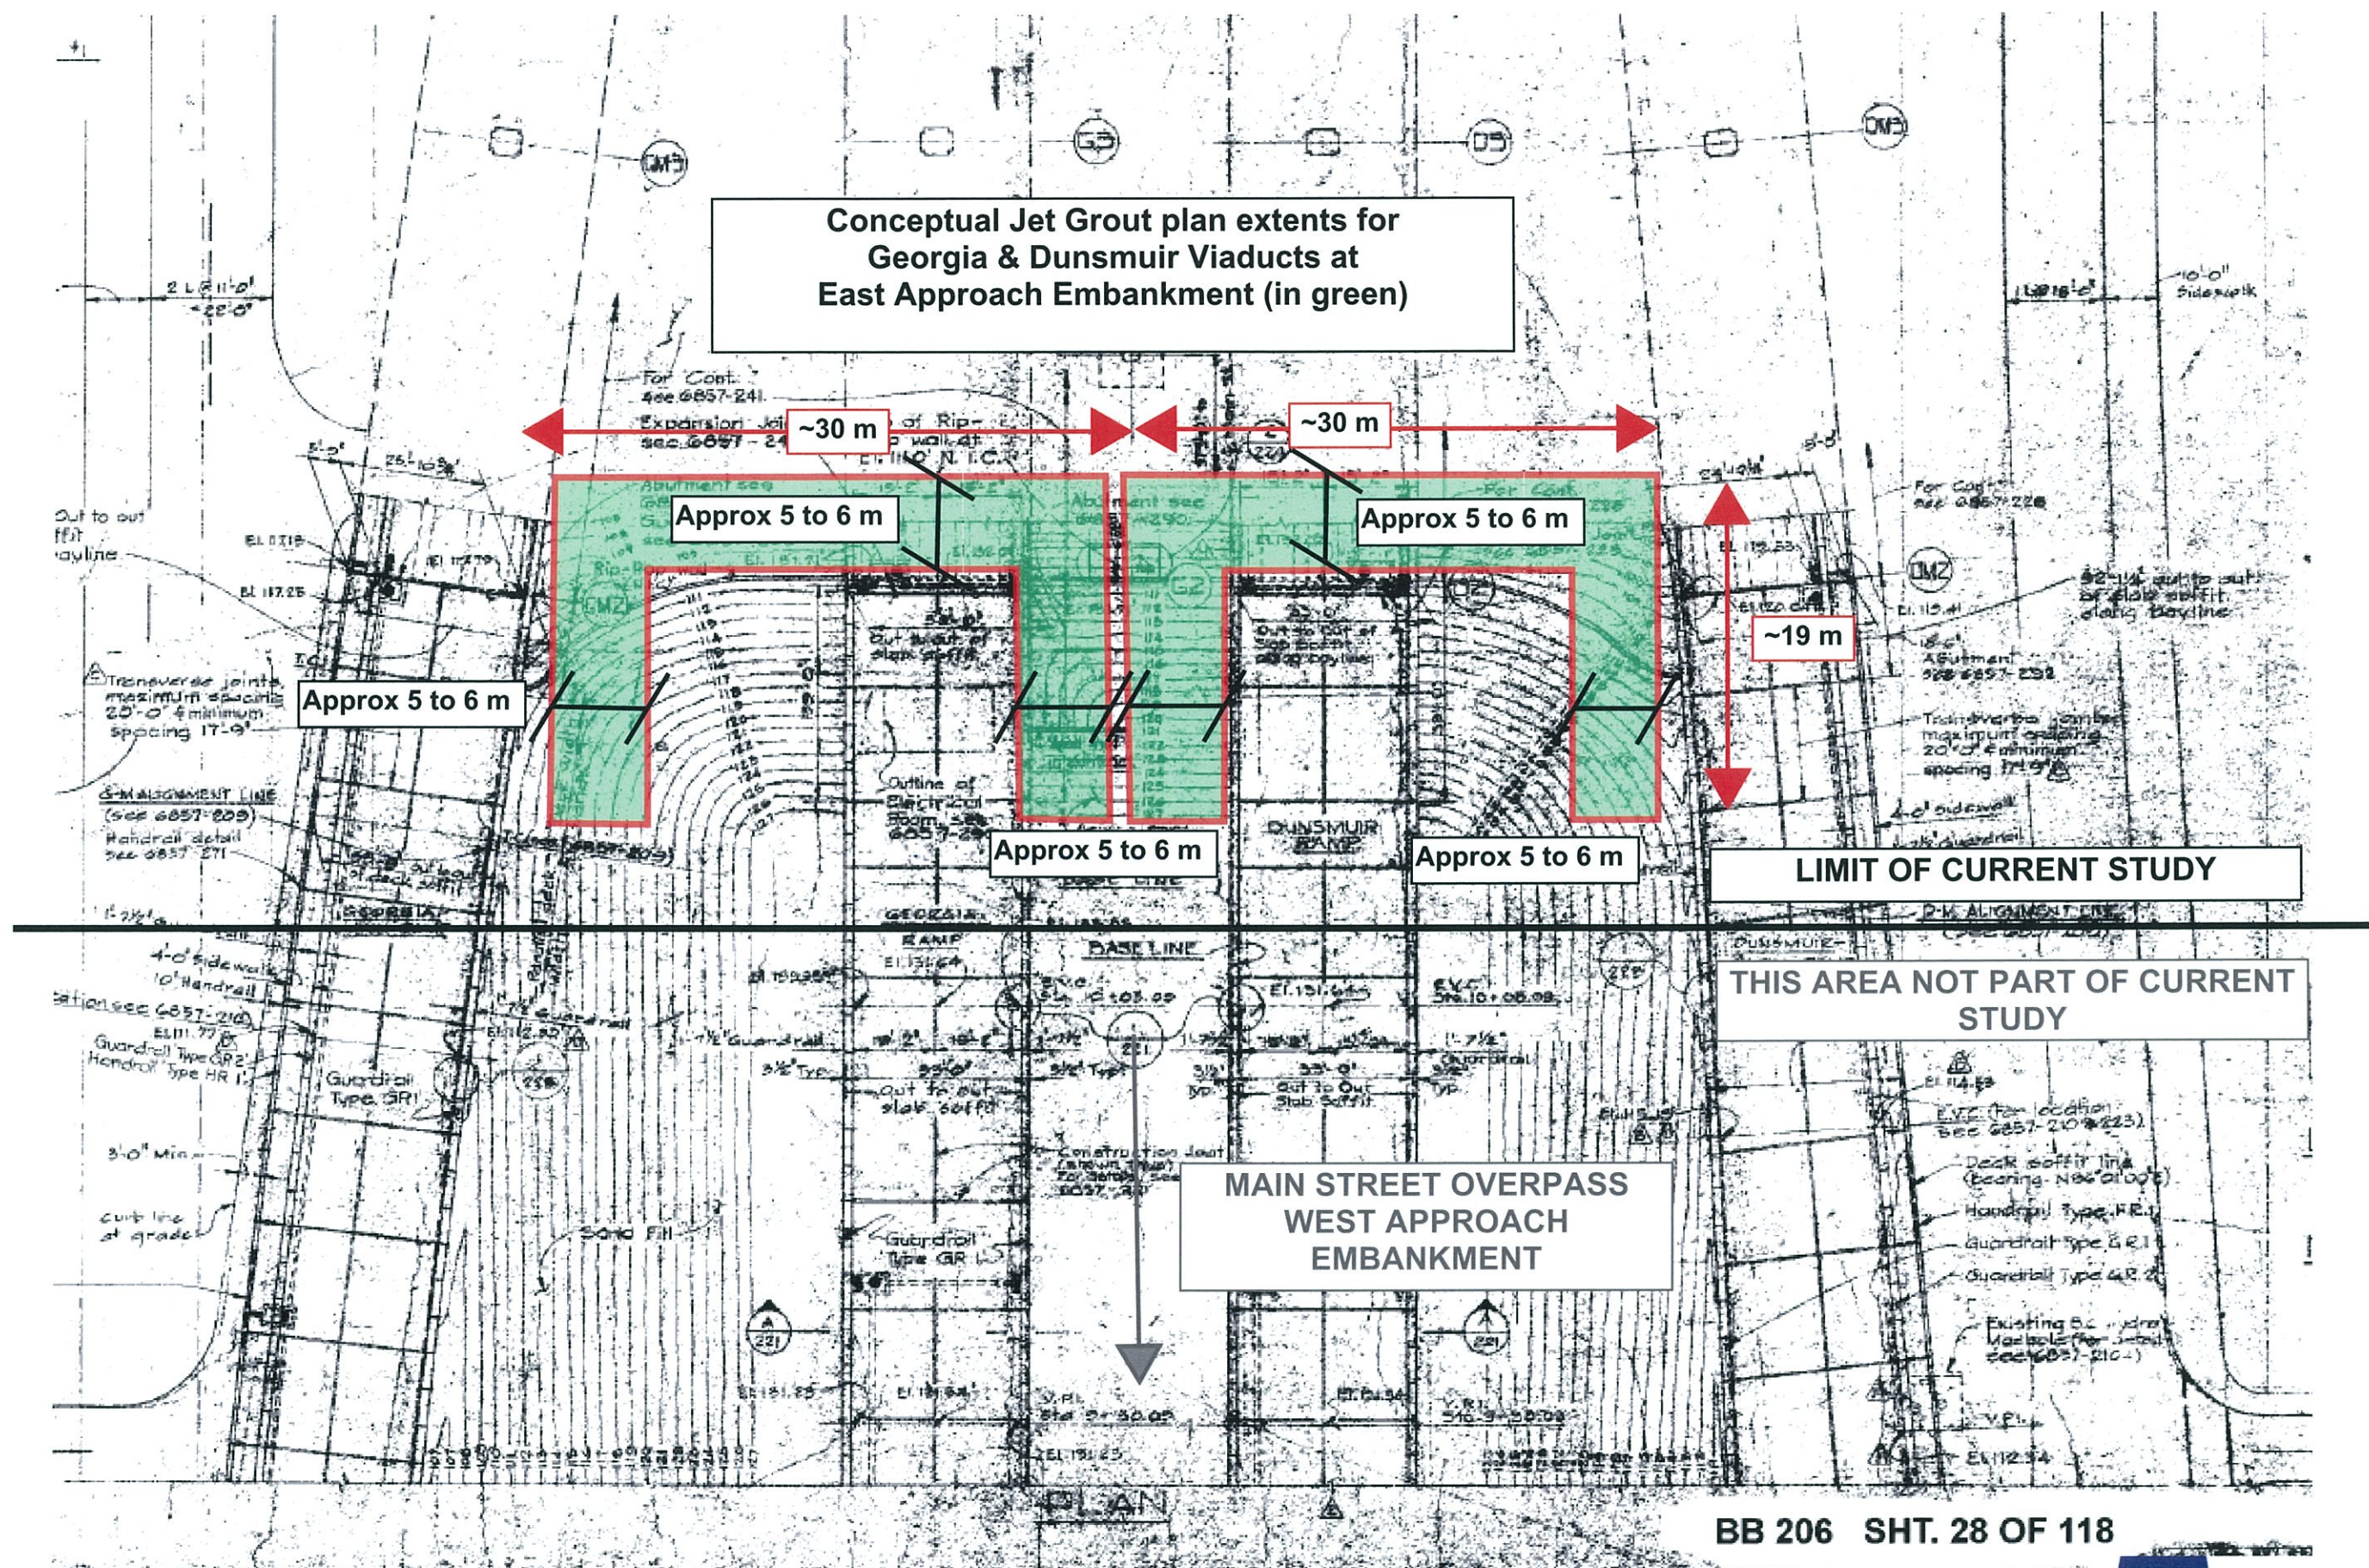
At the east approach embankment adjacent to piers G2, GM2, D2 and DM2, deformation of the approach embankment is anticipated and the deformation will result in large kinematic loads on these foundations. Due to the approach embankment height, kinematic loads are expected to be sufficiently high that designing foundation elements to resist the kinematic loads will likely be problematic. Accordingly, we recommend conceptual retrofit measures in the vicinity of the east approach embankment include jet grout columns to improve foundation strength and reduce seismic deformation. Jet grout columns forming a U-shaped block around the piers and abutments, similar to a seismic dike, is recommended as shown on Figure 3. Additional retrofit measures for the pier foundations are also required and discussed below. The concept shown on Figure 3 assumes the retrofit of each viaduct will be completed independently and kinematic loading on the Main Street ramps must be address. If the retrofit were to be completed on both viaducts concurrently and the Main Street ramps were excluded from the retrofit, the amount of jet grouting could be reduced by about 30%.

FIGURE 3 - Conceptual Jet Grout Plan Area (in green) for Georgia & Dunsmuir Viaducts at East Approach Embankment
