Still Creek Stewardship Society

Renfrew Ravine Hydrology And Geotechnical Study

September 2008

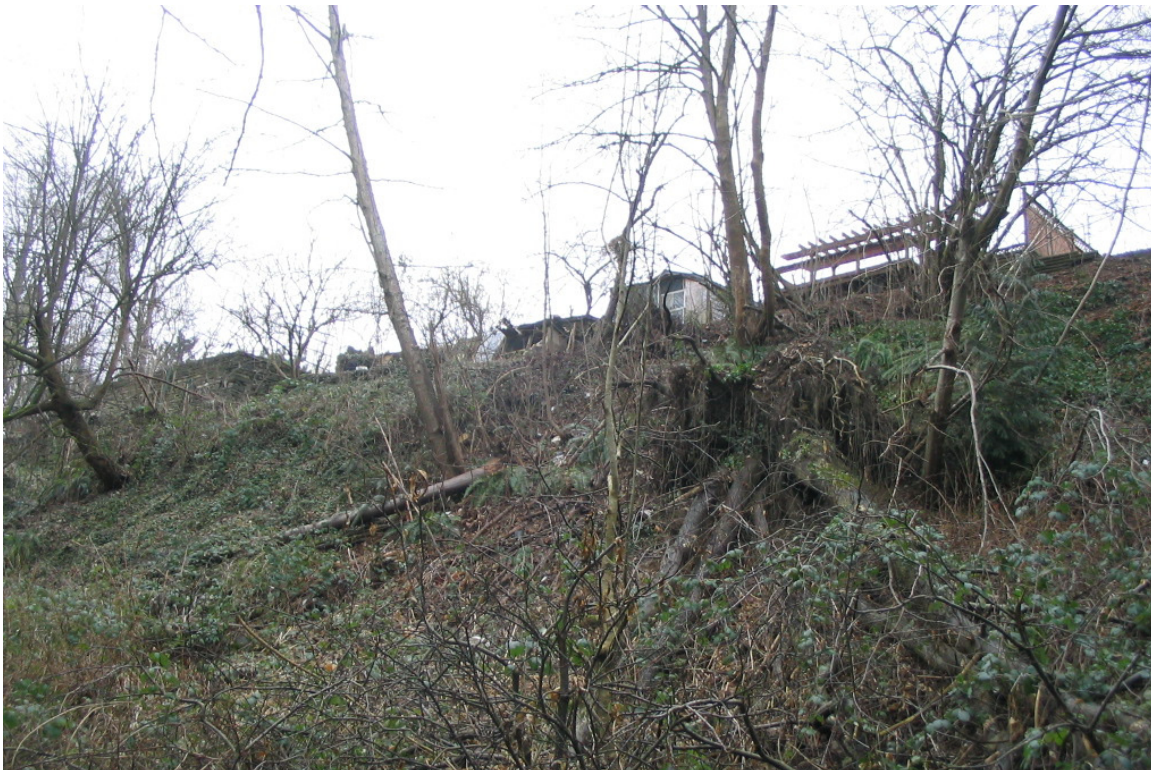
Photo 2
Looking at west bank from stream channel – Class IV to V terrain stability class

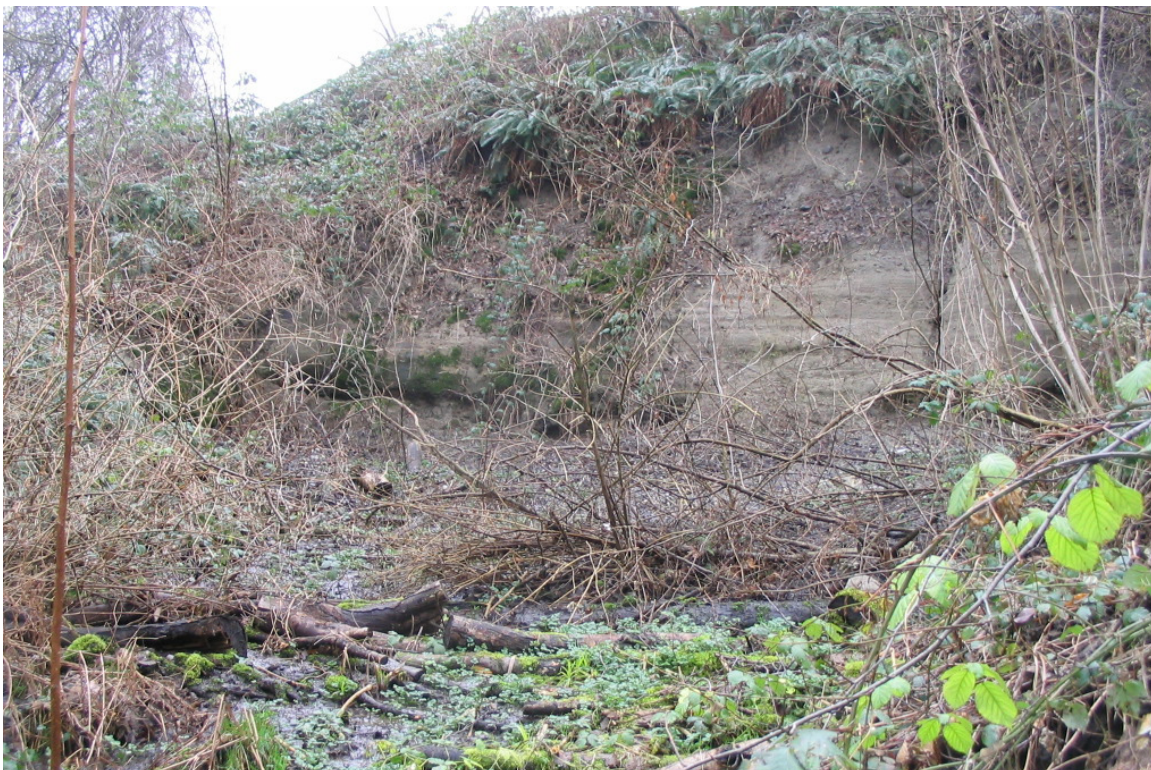
Photo 4
Looking at large failure surface on east slope of Renfrew Ravine downstream of 27th Ave

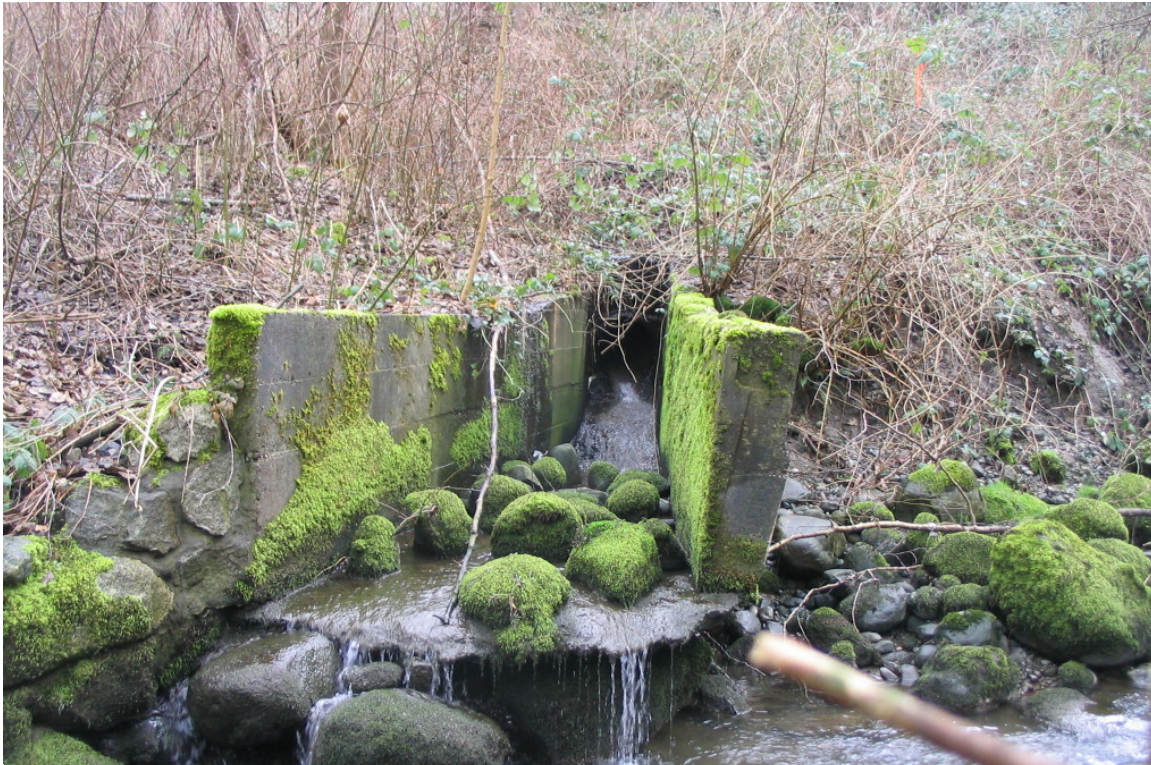
Photo 5
Looking at stormwater outfall at 26th Avenue – note the channel incision since construction

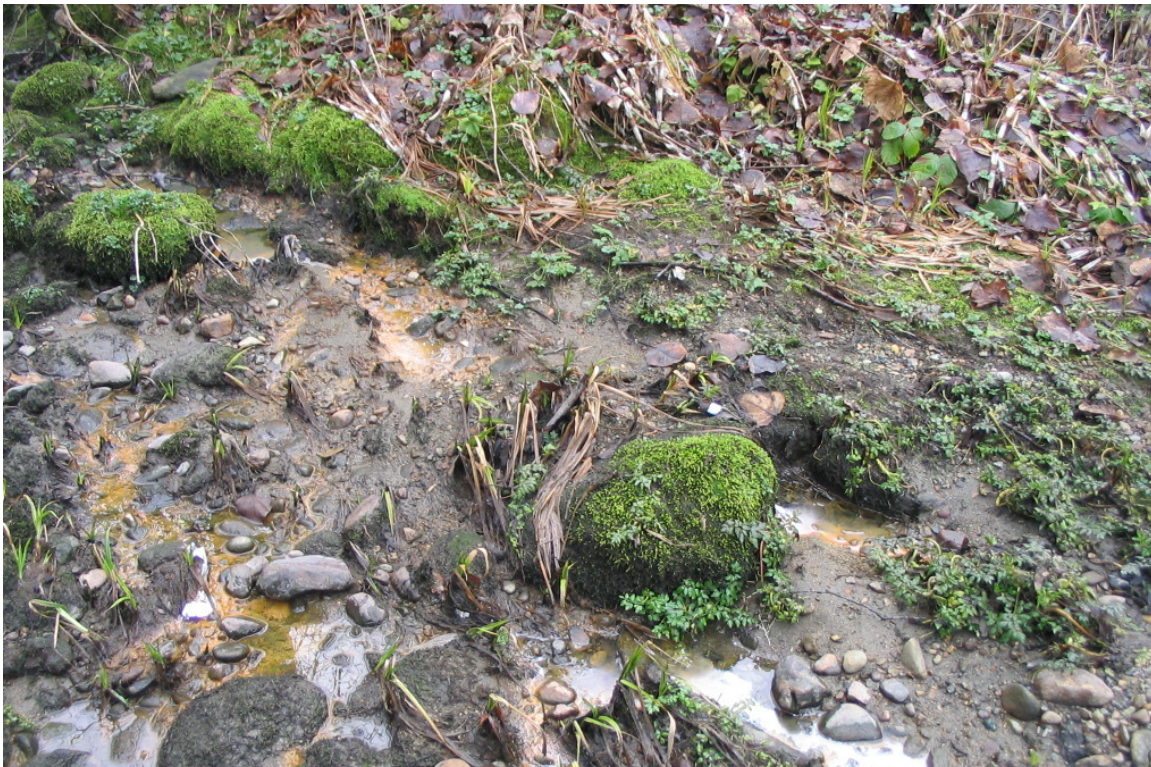
Photo 6
Some iron coloured sediment and seepage on small bar downstream of 26th Avenue

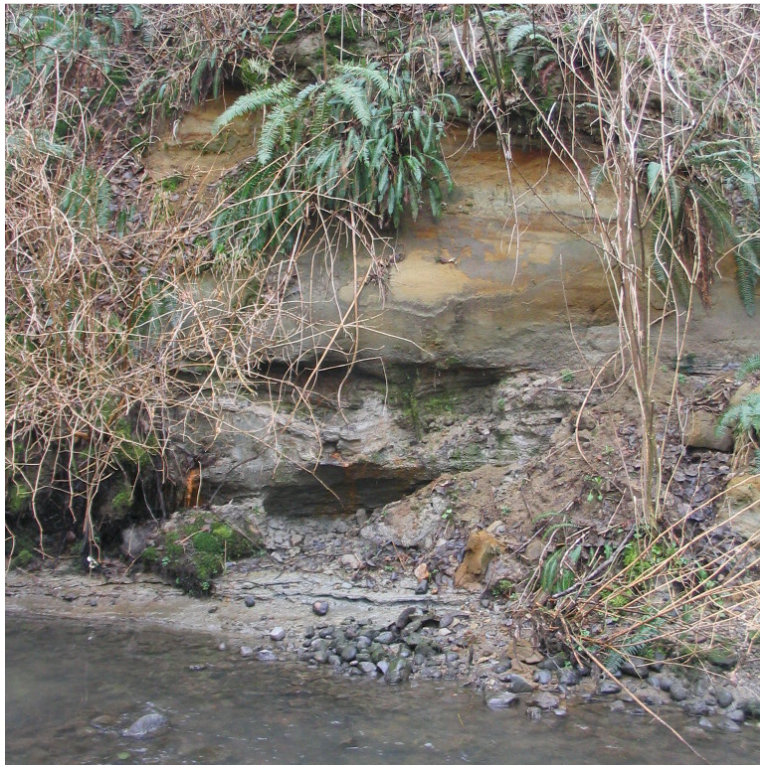
Photo 7
Exposure of glaciolacustrine or glaciofluvial sediment on west slope near Boyd Diversion

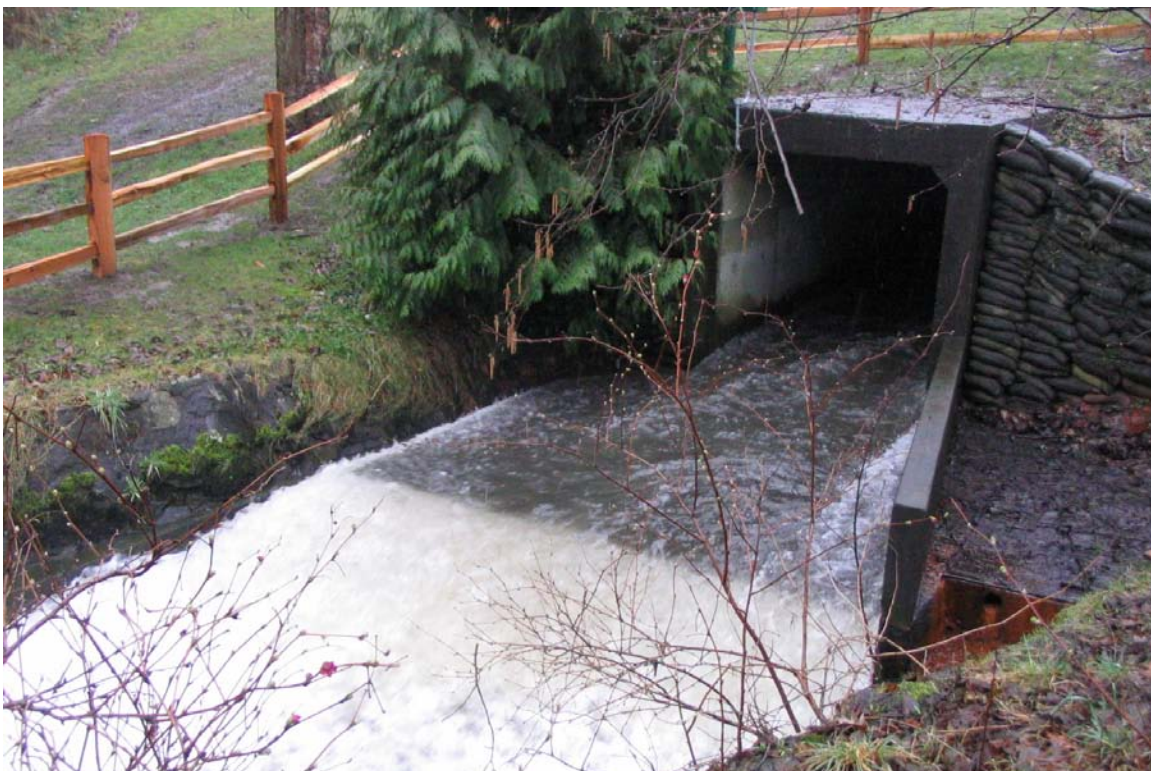
Photo 10
Outlet of 22nd Avenue culvert under higher flows

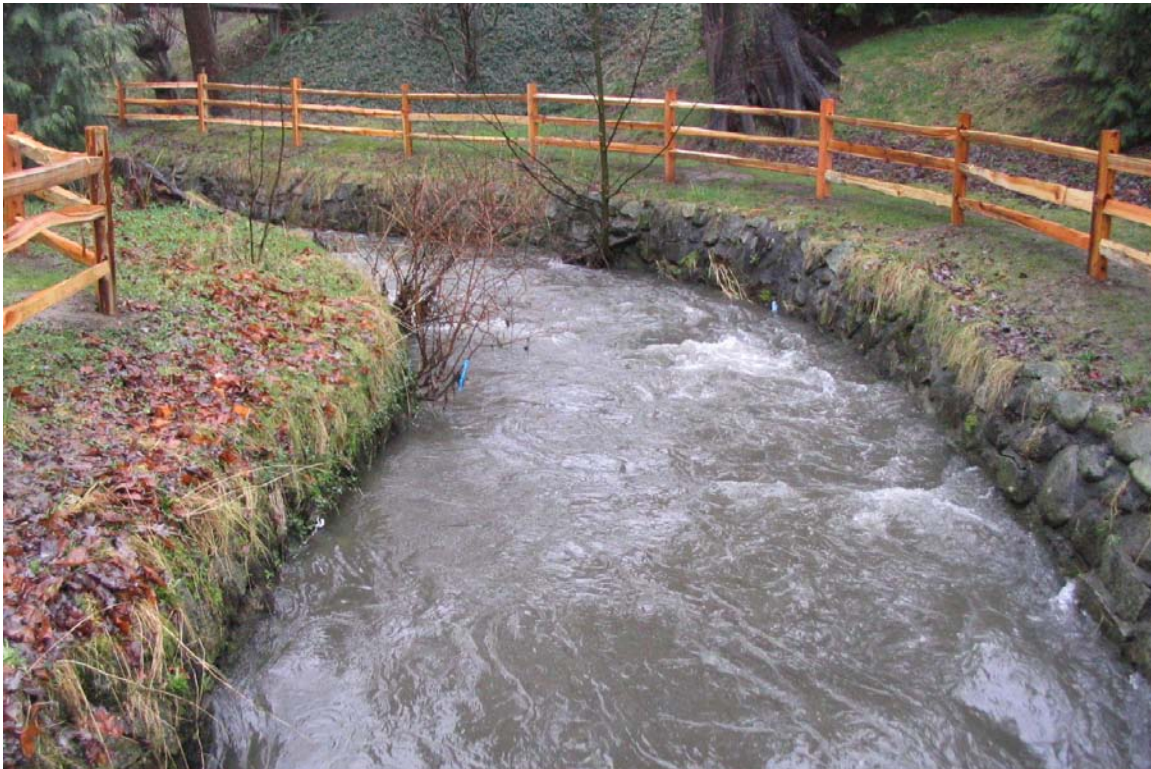
Photo 12
Looking upstream from footbridge under higher flow condition – note blue flagging indicates previous high water mark

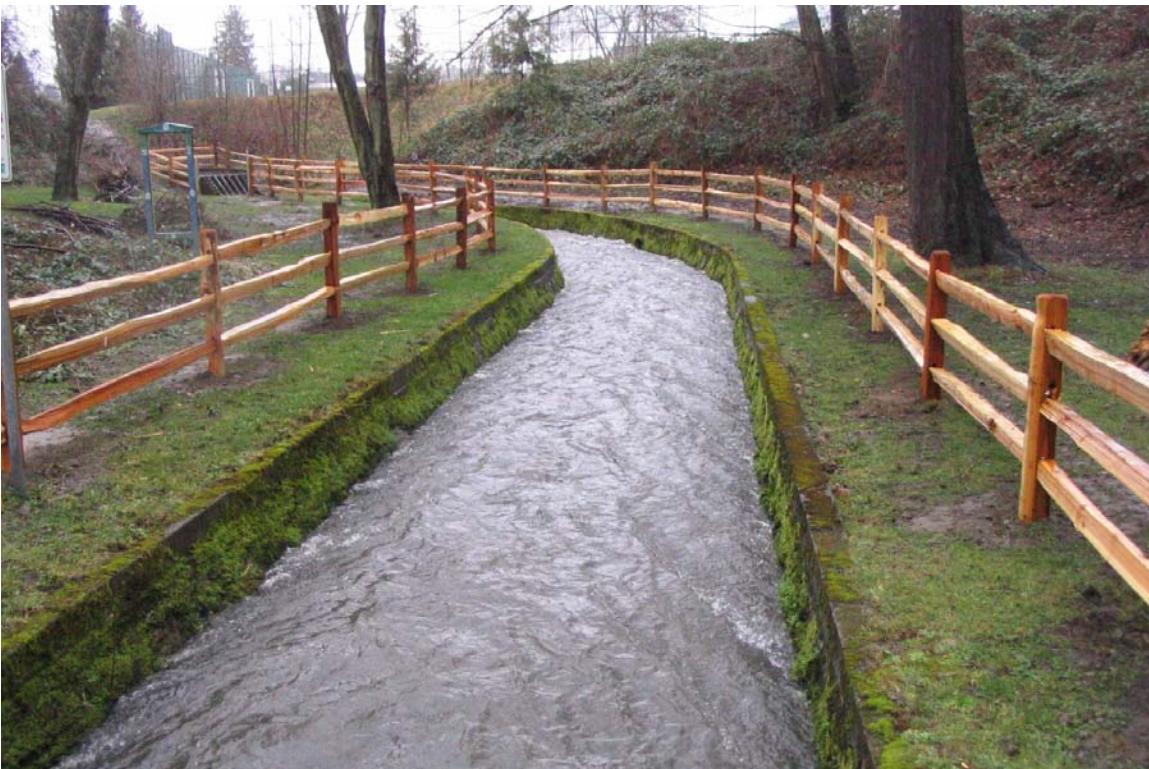
Photo 14
Looking downstream in concrete channel section under higher flow condition

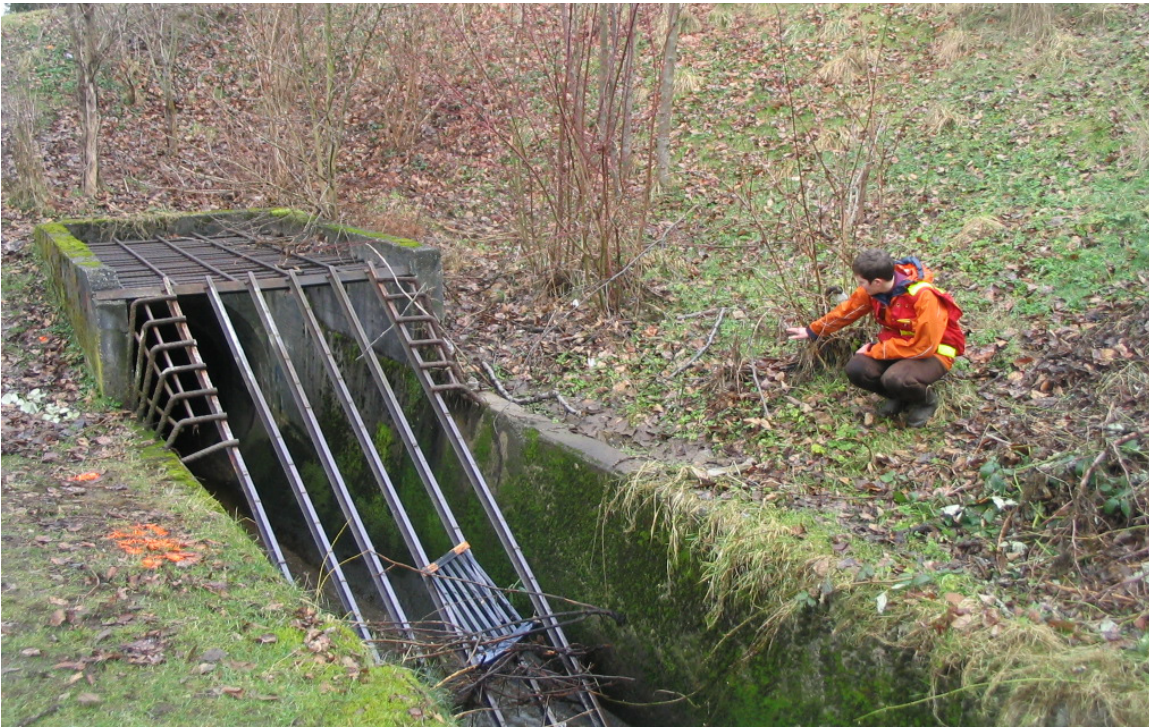
Discussions with the Metro Vancouver also indicated that the culvert at the downstream end of Renfrew Community Park (near Renfrew Street) has been sufficiently blocked in the past so that backwatering occurred to such an extent that water overtopped the ravine slope. An indication of this phenomenon was seen in the field (as shown in Photos 15, 16, and 17 of Appendix A). While there is likely a limited ability for the upstream catchment to convey the floods in excess of 10 to 20-year return period, the potential for blocking of culverts could cause flooding that would exceed inundation depths expected for the flood discharge.

Photo 15
Renfrew Street culvert inlet – note rafted debris indicated in the field near the top of debris rack

- The trash rack / inlet conditions at downstream end of Renfrew Community Park at Renfrew Street could be improved to limit possible flooding.
- The City of Vancouver Engineering department should review the BGC report and consider the longer term requirements for houses situated near Renfrew Ravine.
- Opportunities for stormwater treatment at the end of pipe could be undertaken for the existing stormwater outfalls at 20th Avenue and 26th Avenue and at the outlet of 29th Avenue, if feasible. These initiatives would likely be implemented by the City of Vancouver Engineering and Metro Vancouver and may not form part of the Park Management Plan.

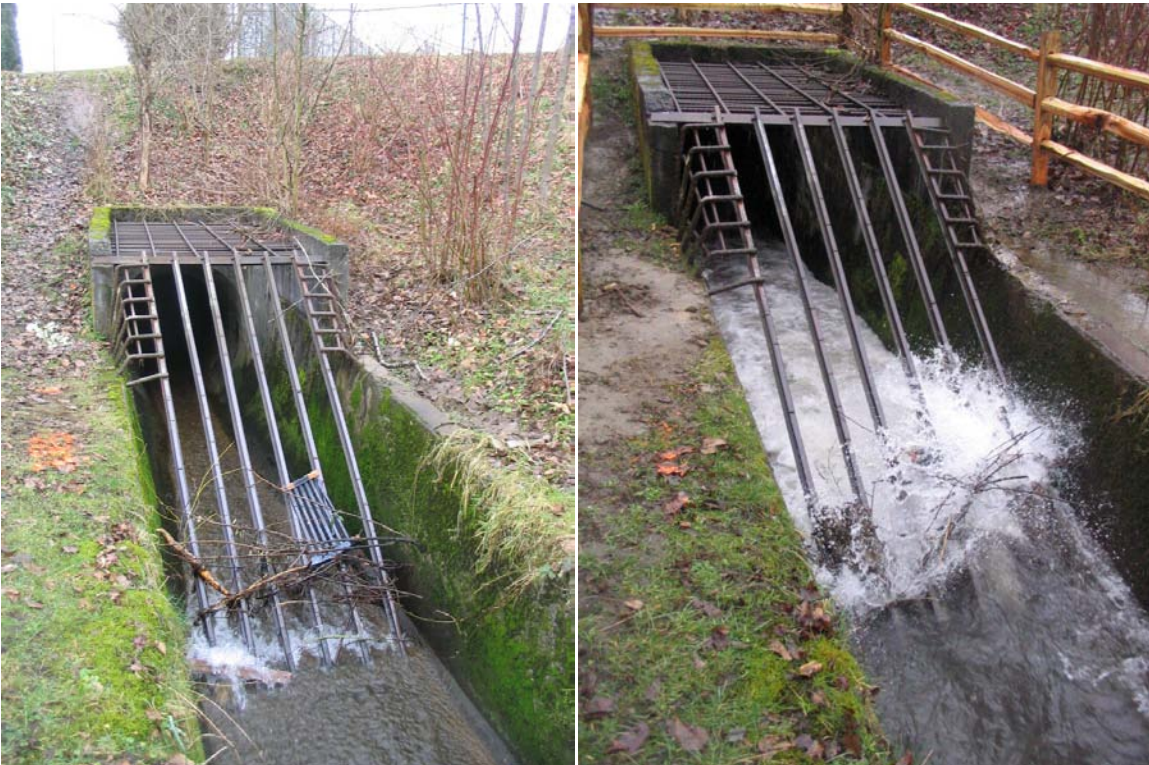
Photo 16/17
Looking downstream at debris rack under low flow on the left and higher flow on the right. Note the debris on the rack.
