Study Update

**The South False Creek
Seawall Study**

This study is an assessment of the existing physical conditions and usage of the seawall section between Vanier Park at Chestnut Street and Spyglass Place at the south end of the Cambie Street Bridge. Please see the map below for the study area. The results of this assessment are summarized below for each segment of the study area.

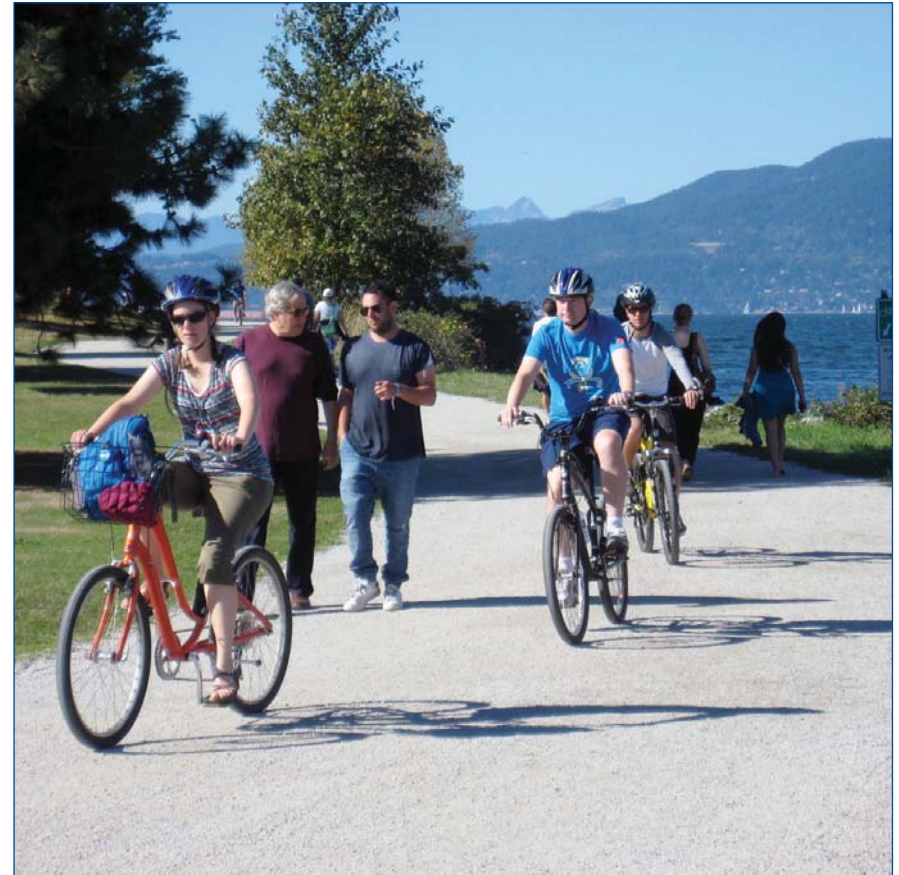
Seaside Greenway in Vanier Park, North of Whyte Avenue

SEGMENT 1: Chestnut Street to Creekside Drive

The seawall is a shared gravel pathway through Vanier Park. At Whyte Avenue, there is an option for cyclists to bypass the seawall and travel on a marked path across the Burrard Civic Marina parking lot. This marked path is linked to Creekside Drive by a separated pathway under the bridge.

- In Vanier Park, there are potential conflicts with vehicles where the gravel pathway crosses two wide vehicular accesses at the public boat launch near the Whyte Avenue junction.
- At the Burrard Civic Marina and its parking lot, there are potential conflicts between cyclists, vehicles with boat trailers, and pedestrians.

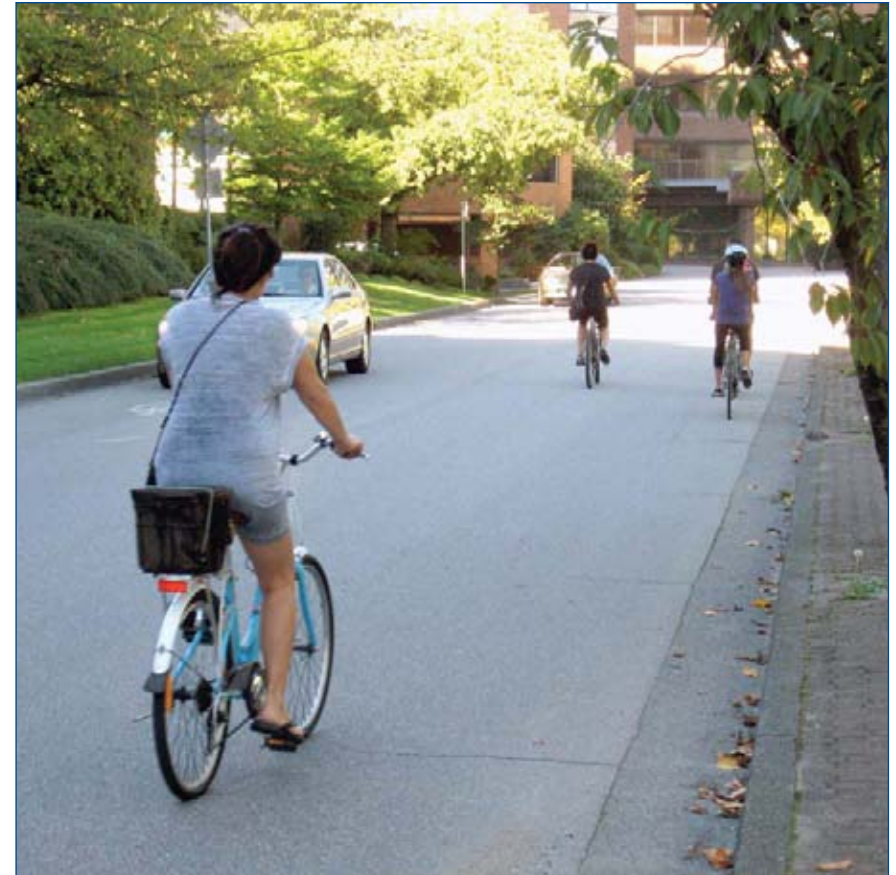
Creekside Drive north of West 1st Avenue

SEGMENT 2: Creekside Drive to Connection onto the Seaside Greenway (Seawall)

This segment of the Seaside Greenway is on Creekside Drive. Along with parking and private building accesses, cyclists share the road with two-way local traffic (average 800 vehicles per day), which is in excess of what a comfortable AAA (All Ages and Abilities) route typically experiences. Pedestrians are fully separated from cyclists by the wide sidewalk, which has a row of trees between the walkway and the street.

- On Creekside Drive, cyclists share the street with moving and parked cars.
- On Creekside Drive, sight lines from the driveways are constrained by walls and the angle of the pathway bend.
- Along the laneway connection west of the seawall, there are potential conflicts with vehicles where pedestrians and cyclists cross an underground parking garage access, a local service driveway, and a series of private garage driveways.
- At the connection to the seawall, the bollards that separate the laneway from the seawall can be potential hazards when the seawall experiences high pedestrian and cyclist traffic during the peak summer months.
- On the seawall, there is a pedestrian access to a public fish market, which can generate high pedestrian foot traffic during peak summer months, and potential conflicts.

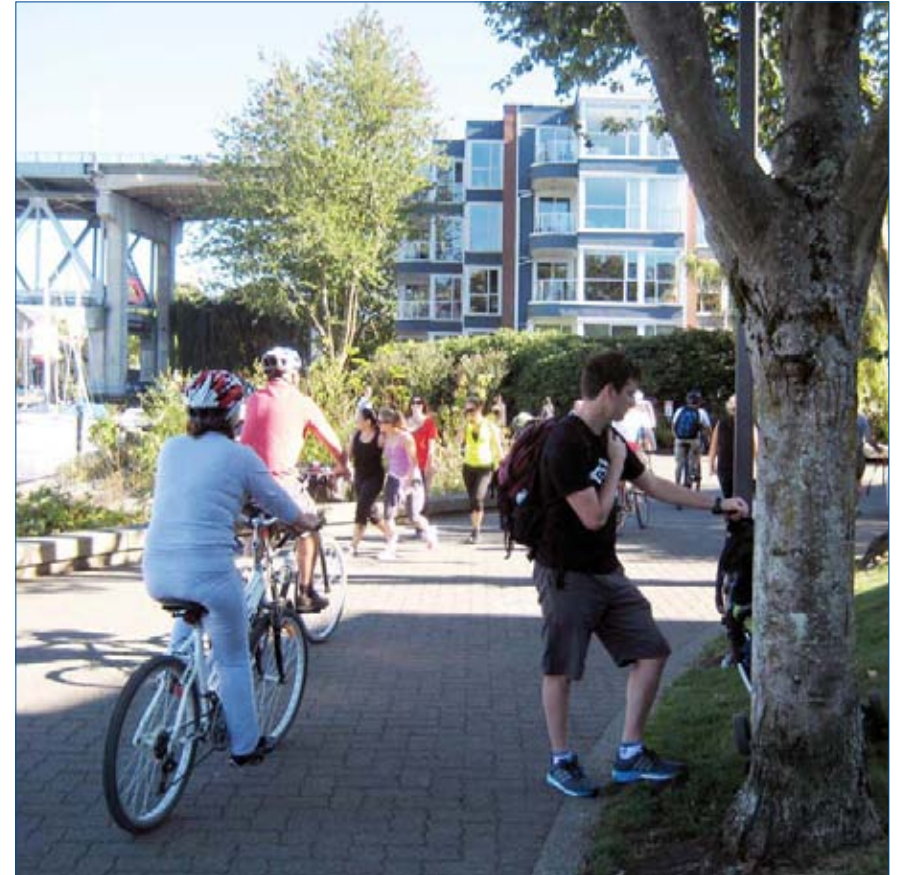
Island Park Walk between West 1st Avenue and Anderson Street

SEGMENT 3: Seaside Greenway (Seawall) to Anderson Street (Granville Bridge)

This segment of the Seaside Greenway is bordered by the water on the north side and residential developments on the south side connecting to a busy vehicular street, Anderson Street. Not only is Anderson Street the single vehicular access to and from Granville Island, it is also the only four lane vehicle crossing of the seawall.

- The seawall is a shared pathway with several bends, which can result in limited sight lines between pedestrians and cyclists.
- At Anderson Street, vehicle sight lines for pedestrians and cyclists crossing are obscured by the bridge piers, which are located immediately south of the seawall crossing.

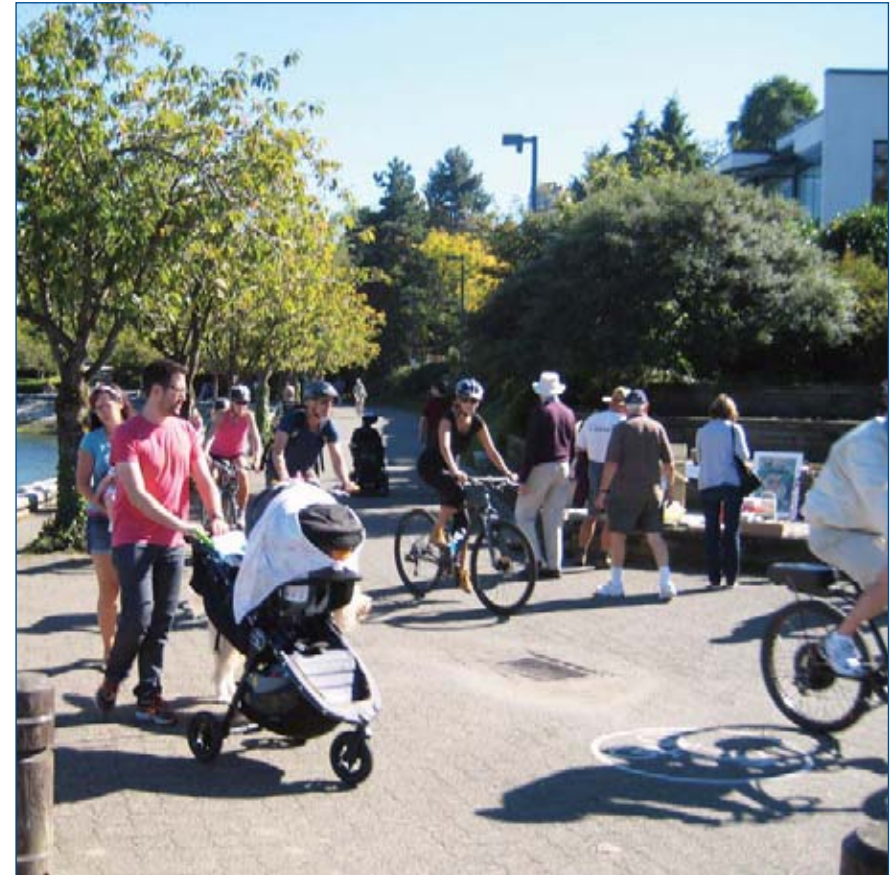
Island Park Walk at Alder Bay Walk

SEGMENT 4: Anderson Street (Granville Bridge) to The Castings/Sutcliffe Park

This segment of the Seaside Greenway is primarily a shared narrow pathway adjacent to pocket parks, a children's playground, and residential apartments. Boardwalk areas are located east of Anderson Street and Granville Island providing an area for social interaction. The pathway east of Anderson Street is bordered by greenery and flower beds that provide a pleasing and shaded environment.

- The junction at The Castings and the pathway requires pedestrians and cyclists to share the space with the existing tree line and bollards, which can be crowded during peak summer months.
- Along the seawall, greenery and flower beds may at times become overgrown to further narrow the pathway.

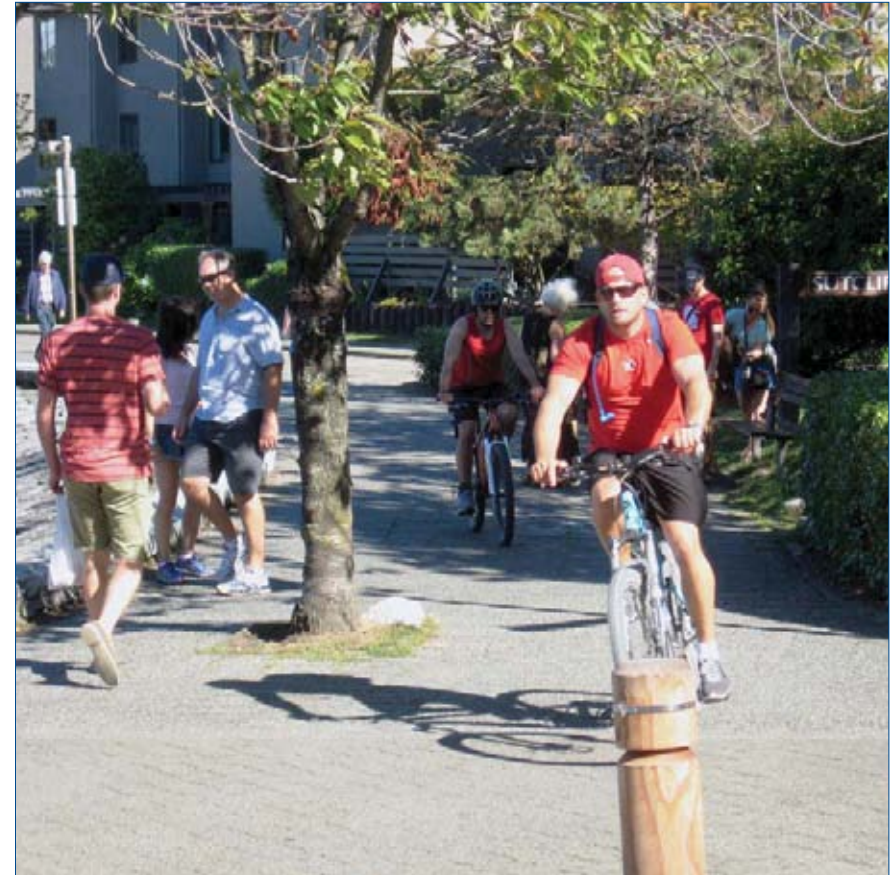
Island Park Walk at The Castings

SEGMENT 5: The Castings/Sutcliffe Park to Ironwork Passage/Spruce Harbour Marina

This segment of the Seaside Greenway is a mix of separated and shared pathways. The pathway splits into a boardwalk for pedestrians and a continuation of the shared bicycle route with local vehicle loading zones at Spruce Harbour Marina. The path transitions back to a shared pathway just east of the Marina parking area.

- East of Sutcliffe Park, cyclists are directed with limited signage and stencils to travel between a series of bollards and trees to stay on the seawall. Unfamiliar cyclists may miss the turn and find themselves continuing on a delivery service road adjacent to residential buildings on the south side of the seawall.
- At The Castings/Forge Walk junction, there is the potential for conflict where the separated cycling path crosses a roundabout with vehicle access.
- The pathway through this segment includes an uneven paving stone surface, which can be very uncomfortable to all users especially those with mobility aids.
- The inconsistency between the mix of separated and shared pathways often create confusion, and there are opportunities to reduce this.

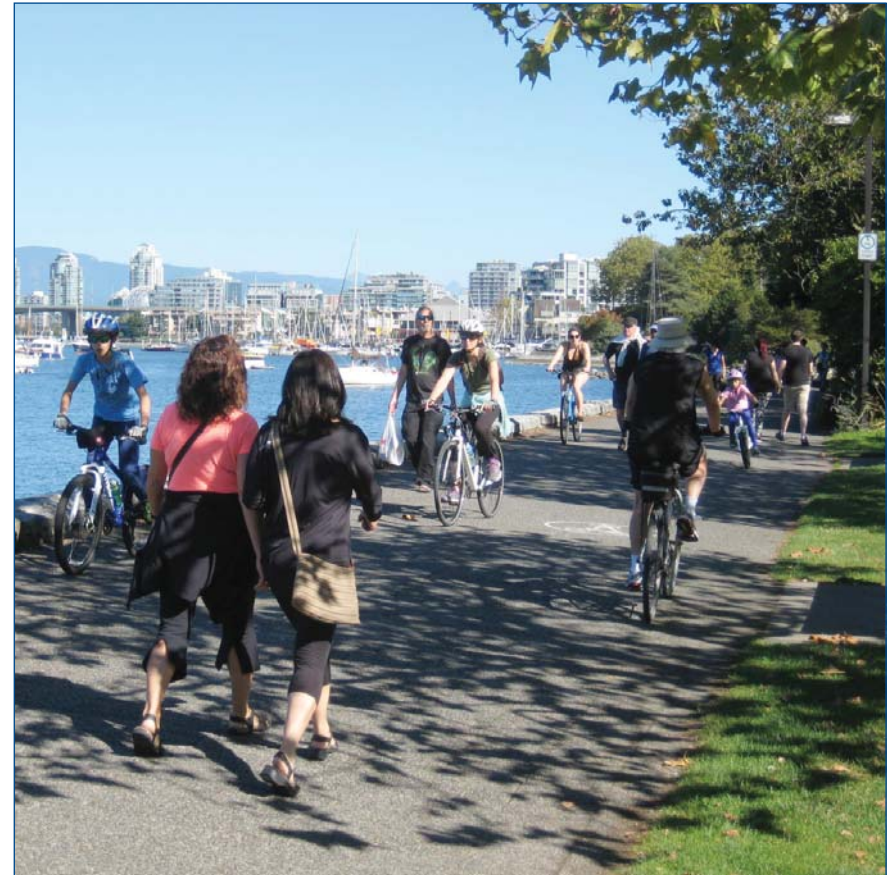
Seaside Greenway at Spruce Harbour Marina parking lot

SEGMENT 6: Ironwork Passage/Spruce Harbour Marina to Greenchain Junction

This segment is primarily a shared pathway adjacent to a community garden, and parkland with an off-leash dog park. There is a local load zone for vehicles at the Greenchain Junction.

- At Spruce Harbour Marina parking lot, there are potential conflicts between pedestrians/cyclists, and vehicles entering and exiting the lot and parking stalls that share the Seaside Greenway.
- The pathway through this segment includes an uneven paving stone surface.

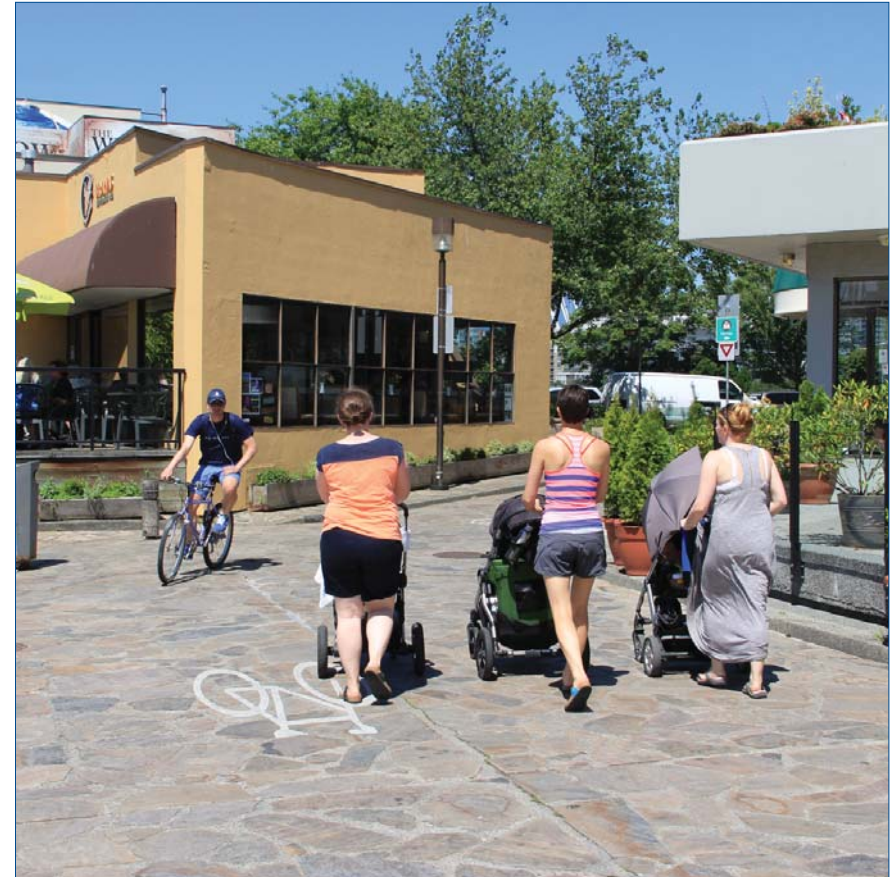
Alleyway that connects Seaside Greenway to Moberly Road

SEGMENT 7: Greenchain Junction to Moberly Road

From Greenchain Junction, the pathway is separated by bollards and benches to create a separate pedestrian area adjacent to the water, and a cycling path adjacent to residential buildings. The separated pathway passes through “Leg-in-Boot Square” with mixed residential and commercial buildings but users do share the space with loading and delivery vehicles. Cyclists cross Moberly Road through a parking lot to connect back onto the seawall. There is local vehicle access to a loading zone.

- The paving stones in this area provide an uneven and uncomfortable surface for pedestrians and cyclists.
- At the alleyway connecting to Moberly Road, the path transitions to a shared use area. Bollards and benches at this transition section may reduce sight lines for pedestrians and cyclists. Local service vehicles also have access to this transition section.
- Besides the loading and drop-off zones, seawall users often find themselves traversing undefined space that can benefit from additional clear guidance.

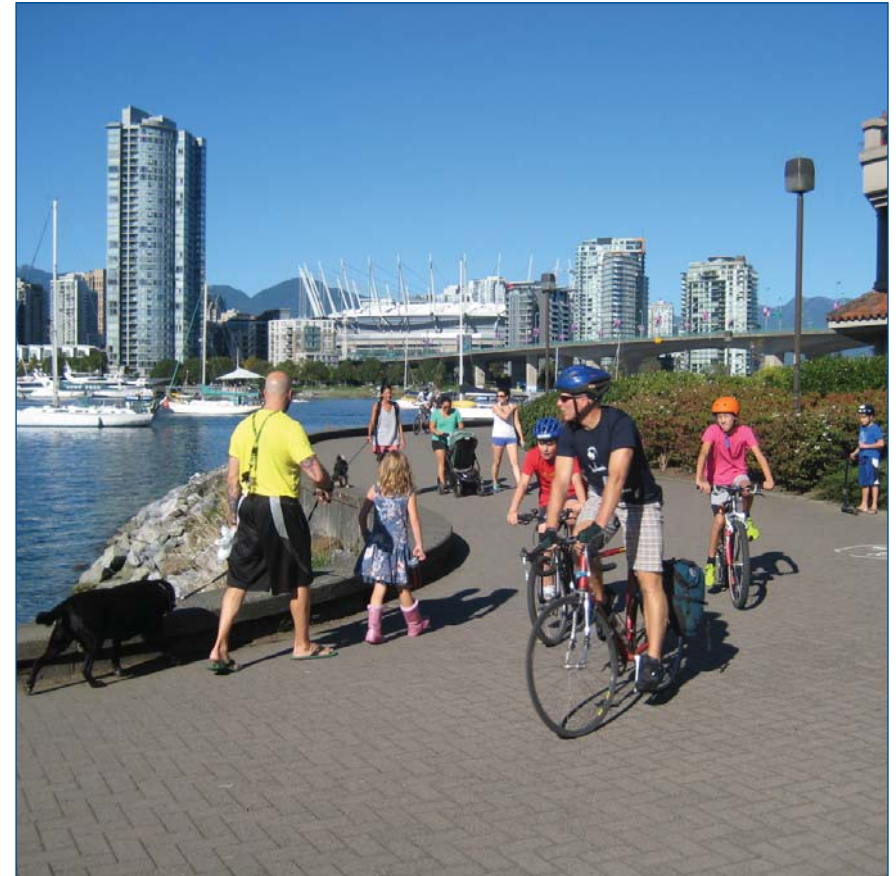
Seaside Greenway between Moberly Road and Spyglass Place

SEGMENT 8: Moberly Road to Cambie Street Bridge/Spyglass Place

The shared pathway is bordered by the seawall embankment and a residential complex.

- There are no public vehicle crossings or access points in this section. However, the pathway curvature and the adjacent landscaping can obstruct sight lines.
