TREE ASSESSMENT PLAN

Client: HOLBORN HOLDINGS LTD.
 Project: LITTLE MOUNTAIN HOUSING
 Address: MAIN STREET AT 37TH AVENUE VANCOUVER BC
 Date: AUGUST 4 2010
 Our File: 10180

TREE INVENTORY LIST

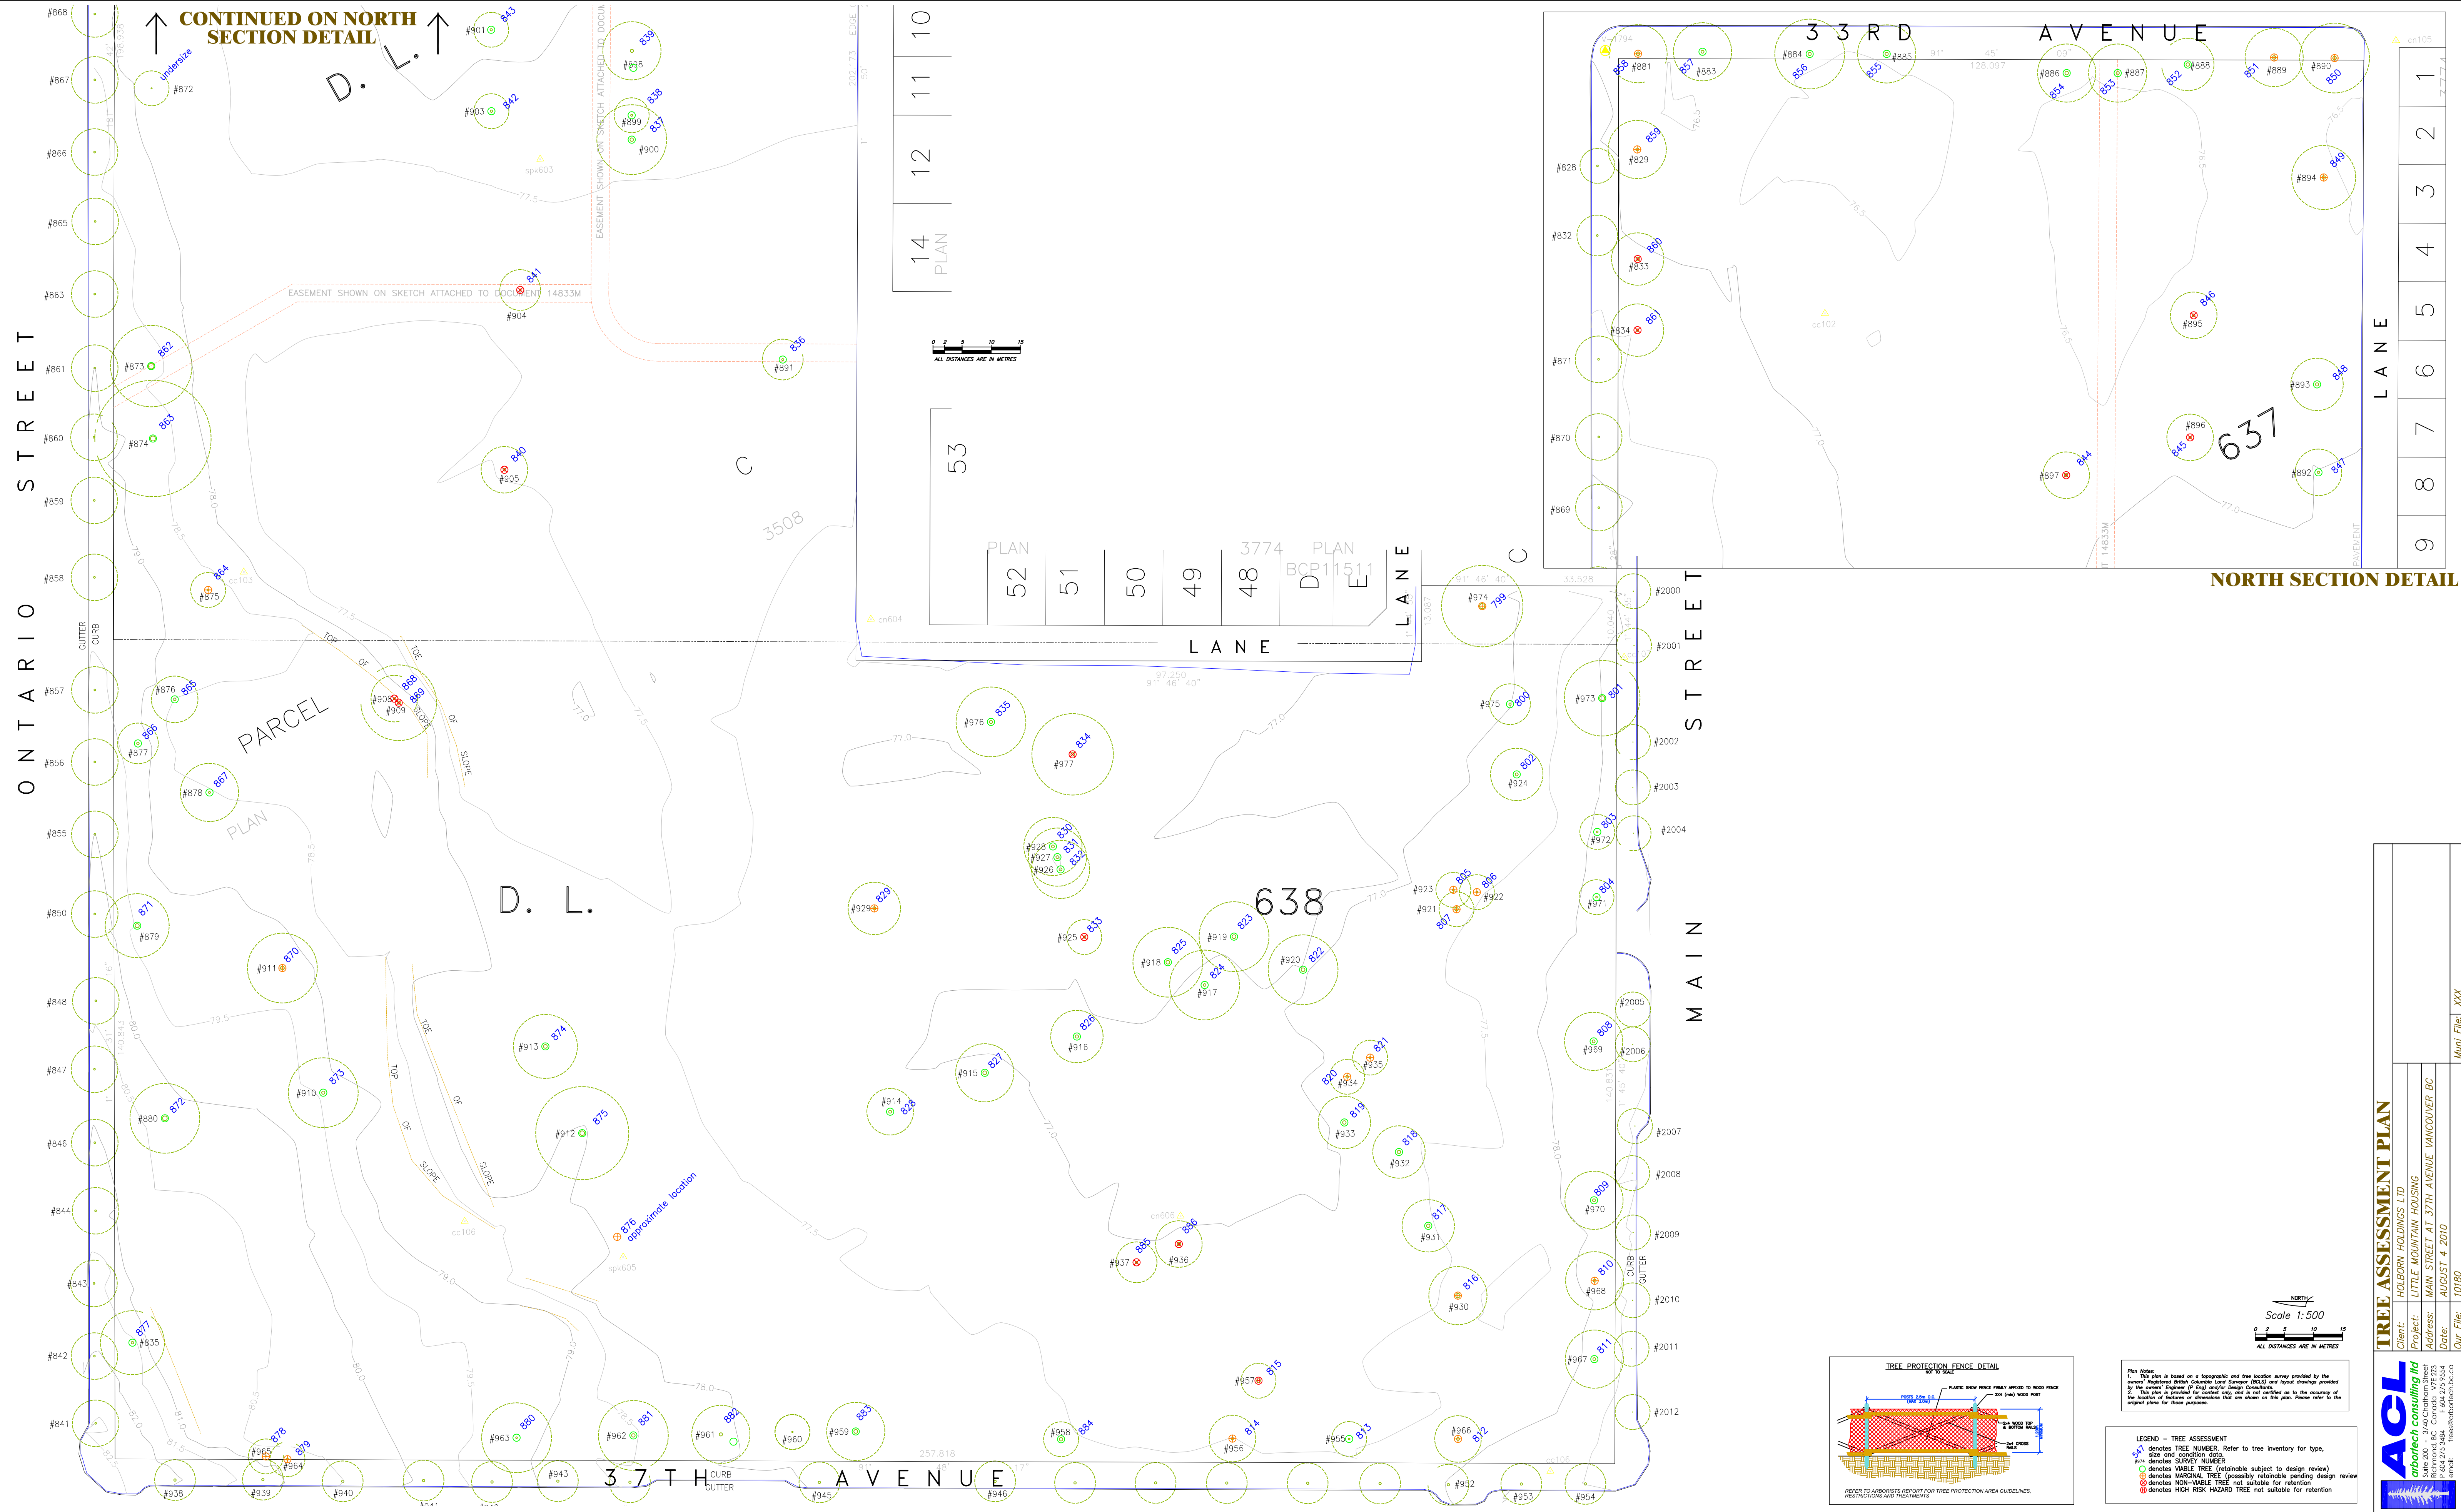
Treatment	Tag	Dbh (cm)	Height (m)	Dripline (radius)	Species	Condition	Notes
RETAIN	799	70	12.6	8	Tulip	Marginal	This tree has been previously headed, resulting in a rounded crown that is approximately 9m in height.
Remove	800	41		2.5	English oak	Viable	There is kink in trunk at 4m above grade, and it appears the area beyond the dripline has been excavated and filled with sand.
RETAIN	801	75	18.7	9	Cooper beech	Viable	The large crown hangs over the city sidewalk.
Remove	802	47		4	Red oak	Viable	This tree has been historically topped, and there are no external signs of decay.
RETAIN	803	27	6.6	3	English Hawthorn	Viable	This tree is infected with bacterial leaf blight; although it doesn't appear to be to severe at this time.
RETAIN	804	29	6.6	3	English Hawthorn	Viable	This tree is infected with bacterial leaf blight; although it doesn't appear to be to severe at this time.
Remove	805	30		3	Sawara Cypress	Marginal	The tree's crown is sparse and thinning, with approximately 30% dieback.

Remove	806	29		3	Sawara Cypress	Marginal	The tree's crown is sparse and thinning, with approximately 30% dieback.
Remove	807	25x2		3	Sawara Cypress	Marginal	The tree's crown is sparse and thinning, with approximately 30% dieback. This twin leader tree joined at the basal union, with slight inclusions extending into the root crown.
RETAIN	808	52	13.3	5	Norway maple	Viable	This tree has healthy and vigorous crown the sweeps over the City sidewalk.
RETAIN	809	63	14.3	6	Norway maple	Viable	This tree has healthy and vigorous crown the sweeps over the City sidewalk.
RETAIN	810	41	11.1	6	Norway maple	Marginal	The crown is very sparse and thinning with a high percent of twiggy die back.
RETAIN	811	51	12.6	7	Norway maple	Viable	This tree has healthy and vigorous crown the sweeps over the City sidewalk.

Treatment	Tag	Dbh (cm)	Height (m)	Dripline (radius)	Species	Condition	Notes
RETAIN	812	42	10.7	7	Norway maple	Marginal	The tree's crown is sparse and thinning.
RETAIN	813	36	8.1	2.5	Lawson cypress	Viable	This tree's has been previously topped resulting, several small diameter replacement leaders, and the multi stem union does not appear to have an significant inclusions within the union.
RETAIN	814	41	12.6	6.5	Norway maple	Marginal	The tree's crown is sparse and thinning.
Remove	815	85		3.5	Lawson cypress	High Risk	This tree's crown comprised of two leaders that join, 3m above grade. There is a deep inclusion that propagates into a crack below the union.
Remove	816	60		8	Horse chestnut	Marginal	The crown has been rounded from previous heading and topping. There is not any signs of decay at these topping sites. Asymmetric crown.
RETAIN	817	50	11.7	7	Horse chestnut	Viable	The crown has been rounded from previous heading and topping. There is not any signs of decay at these topping sites.

RETAIN	818	60	11.6	8	Horse chestnut	Viable	The crown has been rounded from previous heading and topping. There is not any signs of decay at these topping sites.
RETAIN	819	71	13.8	9	Norway maple	Viable	The crown has been rounded from previous heading and topping. There is not any signs of decay at these topping sites.
Remove	820	Multi		3	Holly	Marginal	This tree has been previously headed, and the crown is infested with leafminer.
Remove	821	Multi		3	Holly	Marginal	This tree has been previously headed, and the crown is infested with leafminer.
RETAIN	822	60	18.7	8	Linden	Viable	Infested with aphids. Growing in a grove type setting with three other trees, these trees have merged crowns and should be retained as a group.
RETAIN	823	48	21.3	8	Linden	Viable	Infested with aphids. Growing in a grove type setting with three other trees, these trees have merged crowns and should be retained as a group.

RETAIN	824	49	19.3	8	Linden	Viable	Infested with aphids. Growing in a grove type setting with three other trees, these trees have merged crowns and should be retained as a group.
RETAIN	825	71	20.2	8	Linden	Viable	Infested with aphids. Growing in a grove type setting with three other trees, these trees have merged crowns and should be retained as a group.

Treatment	Tag	Dbh (cm)	Height (m)	Dripline (radius)	Species	Condition	Notes
RETAIN	826	54	18.4	8	Linden	Viable	Infested with aphids.
RETAIN	827	56	19.2	8	Linden	Viable	Infested with aphids.
Remove	828	48		8	Linden	Viable	Infested with aphids, and the crown is slightly sparse.
RETAIN	829	46	17.1	5	Douglas-fir	Marginal	Infested with aphids.
RETAIN	830	57	21.1	8	Hornbeam	Viable	This tree is growing approximately 1m away from another tree and is part of a three tree row.
RETAIN	831	46	21.1	8	Hornbeam	Viable	This tree is growing approximately 1m away from another tree and is part of a three tree row.
RETAIN	832	59	21.1	8	Hornbeam	Viable	This tree is growing approximately 1m away from another tree and is part of a three tree row.
Remove	833	18x2		2	Holly	Non-Viable	Displaying symptoms of Phytophthora ilicis: major crown dieback, and overall crown thinning.
Remove	834	65		7	European birch	Non-Viable	This tree has dead tops, and is infested with Bronze Birch Borer.

RETAIN	835	45	19.6	8	English oak	Viable	Some (15%) twiggy dieback.
RETAIN	836	28	9.6	4.5	Norway maple	Viable	Full crown with some winter moth damage visible.
Remove	837	50		5.5	Hornbeam	Viable	The crown merges with the adjacent tree.
Remove	838	36		5.5	Hornbeam	Viable	The crown merges with the adjacent tree.
Remove	839	53		6	Hornbeam	Viable	
Remove	840	26		3.5	European birch	Non-Viable	This tree is mostly dead, and infested with Bronze Birch Borer.
Remove	841	24		3.5	European birch	Non-Viable	This tree is mostly dead, and infested with Bronze Birch Borer.
Remove	842	40		6.5	Hornbeam	Viable	This tree has been previously topped at 4m above grade, with no central leader and a rounded form. The is located adjacent to the existing asphalt road.
Remove	843	38		5	Hornbeam	Viable	Full healthy and vigorous crown.
Remove	844	46		6	European birch	Non-Viable	This tree is infested with BBB and mostly dead.
Remove	845	29		6	European birch	Non-Viable	This tree is infested with BBB and mostly dead.

Remove	846	36		6	European birch	Non-Viable	This tree is infested with BBB and mostly dead.
RETAIN	847	37	14.7	6	Linden	Viable	This tree has straight singular leader.
RETAIN	848	46	16.7	7.5	Linden	Viable	Rounded form.
Remove	849	48		8	Linden	Marginal	This tree has been previously hydro pruned on the east side, and there is a high volume of water shoots throughout the crown.
RETAIN	850	50	14.1	8	Honey locust	Marginal	Infested with Podgall midge, resulting in 30% of crown dieback.
RETAIN	851	50	15.9	8	Honey locust	Marginal	Infested with Podgall midge, resulting in 30% of crown dieback.

Treatment	Tag	Dbh (cm)	Height (m)	Dripline (radius)	Species	Condition	Notes
RETAIN	852	52	20.1	8	Linden	Viable	Multiple leaders join at the 4m above grade stem union, the union appears to be sound.
Remove	853	43		7	Ash	Viable	Slightly sparse and manifesting symptoms of drought stress.
RETAIN	854	45	21.6	7	Ash	Viable	Slightly sparse and manifesting symptoms of drought stress.
RETAIN	855	40	16.1	6	Linden	Viable	Full crowns with severe aphid infestation.
RETAIN	856	40	15.1	6	Linden	Viable	Full crowns with severe aphid infestation.
RETAIN	857	40	14.3	6	Linden	Viable	Full crowns with severe aphid infestation.
RETAIN	858	43	11.1	6	Norway maple	Marginal	This tree has been previously, headed to 6m in height, resulting in a very rounded crown.
RETAIN	859	44	11.5	6	Norway maple	Marginal	This tree has been previously, headed to 6m in height, slightly asymmetric crown.
Remove	860	52		6	Norway maple	Non-Viable	Previously topped and the crown is asymmetric too the east, and damaged by fire.

Remove	861	36		6	Norway maple	Non-Viable	Mostly dead from fire damage.
RETAIN	862	88	21.1	10	Red oak	Viable	Slightly sparse and manifesting symptoms of drought stress.
RETAIN	863	81	20.6	10	Red oak	Viable	Slightly sparse and manifesting symptoms of drought stress.
Remove	864	35		4	Fruiting cherry	Marginal	The crown is infected with bacterial blight and canker. This tree sweeps to the south west.
Remove	865	42		6.5	Horse chestnut	Viable	Slightly sparse and manifesting symptoms of drought stress.
Remove	866	36		6	Horse chestnut	Viable	Sparse and manifesting symptoms of drought stress.
Remove	867	47		7	Horse chestnut	Viable	This tree is previously headed to 8m above grade, and there is a high volume of water shoots throughout the crown.
Remove	868	Multi		4	European birch	Non-Viable	This tree is mostly dead, and infested with Bronze Birch Borer.
Remove	869	30x2		7	Weeping willow	Non-Viable	This is asymmetric to the southeast and the adjacent birch tree's scaffold limb is embedded in the trunk at approximately 4m causing the trunk to kink.

RETAIN	870	41	17.4	8	English oak	Marginal	This has been historically headed and the majority of the limbs are now marm formed, and several of significant kinks.
RETAIN	871	60	8.7	10	Horse chestnut	Viable	It appears that there several scaffold limbs have been previously removed. Small amount of decay visible.
Remove	872	62		10	Horse chestnut	Viable	It appears that there several scaffold limbs have been previously removed. Small amount of decay visible.
RETAIN	873	42	16.1	10	English oak	Viable	Slightly sparse and manifesting symptoms of drought stress.

Treatment	Tag	Dbh (cm)	Height (m)	Dripline (radius)	Species	Condition	Notes
RETAIN	874	50	19.1	10	English oak	Viable	Slightly sparse and manifesting symptoms of drought stress.
RETAIN	875	60	22.6	10	English oak	Viable	Slightly sparse and manifesting symptoms of drought stress.
RETAIN	876	24	5.7	2.5	Japanese cherry	Marginal	Infected with bacterial blight, and the crown is sparse.
Remove	877	34		8	Linden	Viable	Dense crown with a severe aphid infestation.
RETAIN	878	20	15.3	2	Sitka Spruce	Marginal	Small suppressed and asymmetric crown.
RETAIN	879	26	15.3	3	Sitka Spruce	Marginal	Infested with Cooley spruce gall adelgid.
RETAIN	880	70	18.3	8	Linden	Viable	There is a high volume of water shoots throughout the crown, that have become leaders.
RETAIN	881	58	14.8	9	Norway maple	Viable	Slight sweep to the south.
RETAIN	882	45	14.6	8	Linden	Viable	This tree has been previously headed with a high volume of water shoots throughout the crown.

RETAIN	883	63	21.1	9	Linden	Viable	This tree has been previously headed with a high volume of water shoots throughout the crown.
RETAIN	884	43	14.1	8	Norway maple	Viable	The crown is asymmetric to the east with a slight sweep.
Remove	885	31		7	European birch	Non-Viable	This tree is infected with BBB and is mostly dead.
Remove	886	42		7	European birch	Non-Viable	This tree is infected with BBB and with dieback at the top.
