City of Vancouver

Bridge Engineering Services

Task C1 - Detailed Visual Inspections

Our Ref: 2068-016-RPT-GEN-001-0

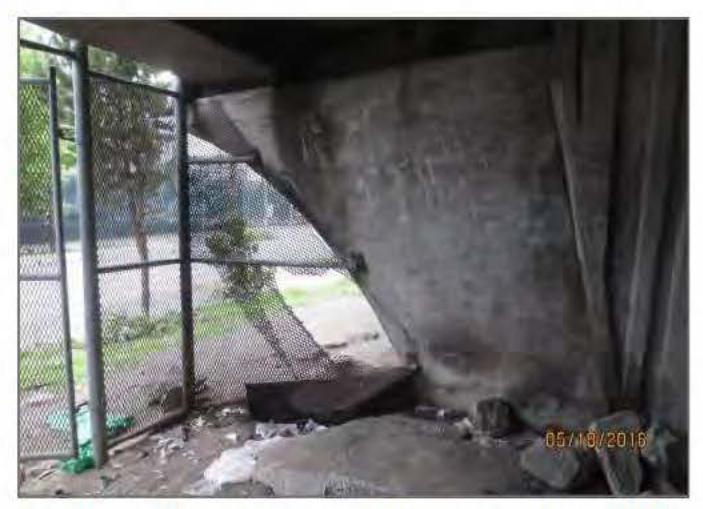
D1. Damaged fencing at on-ramp abutment enclosure (DM2).

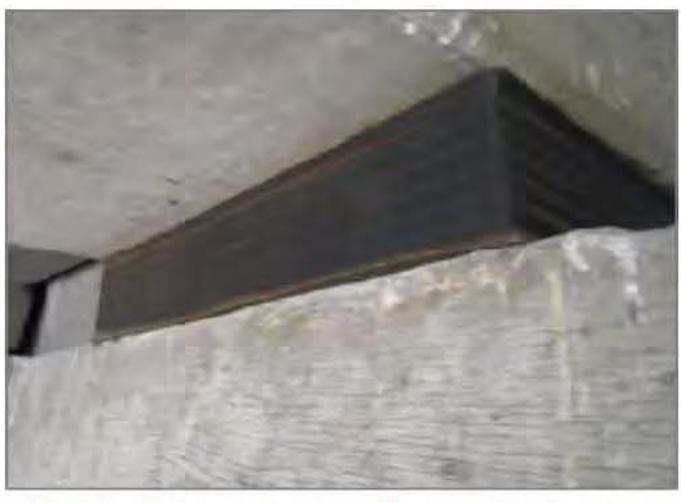
D2. Slight overhang of bearing pad at west abutment (D23).

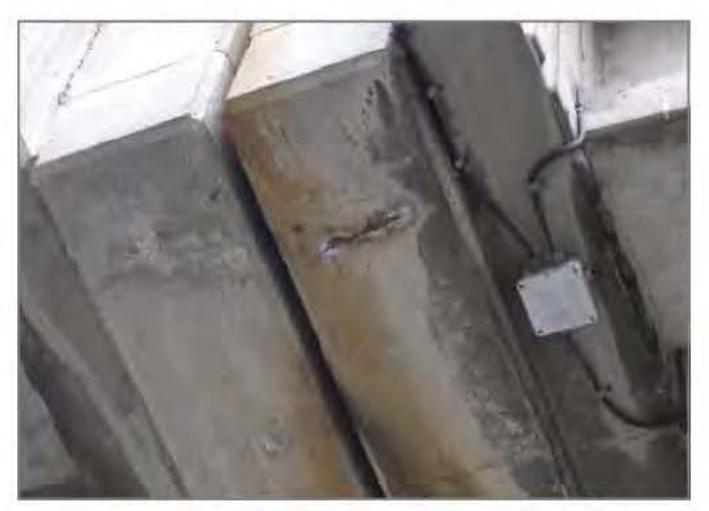
D3. Pier cap soffit spall with exposed rebar at Pier DM5.

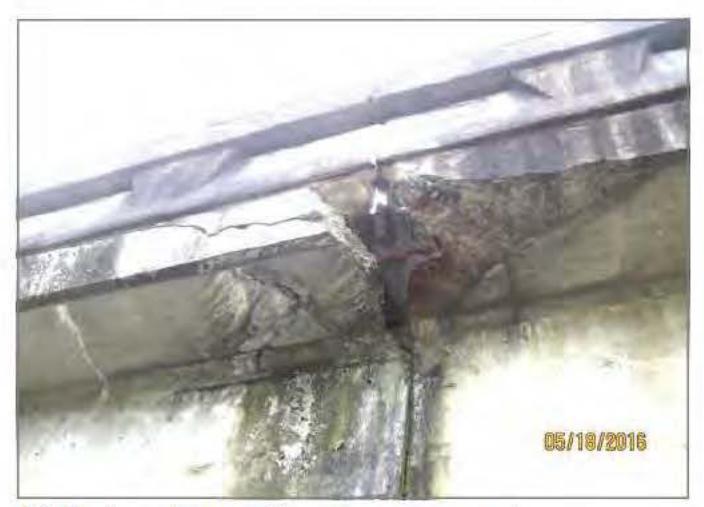
D5. Deck overhang spall on on-ramp approach.

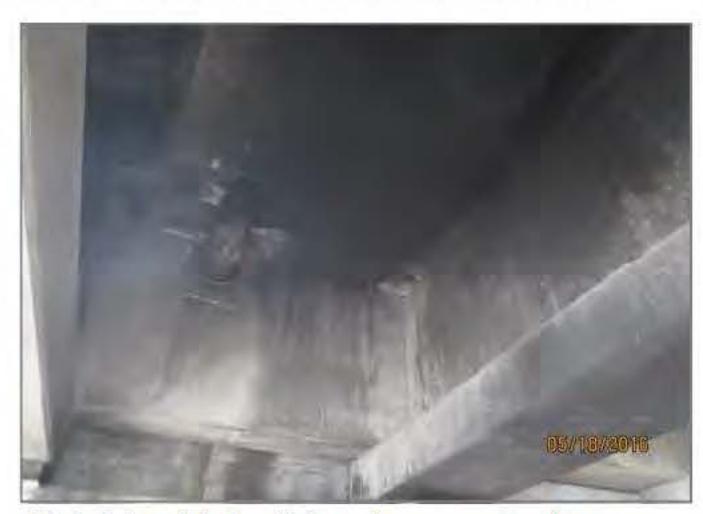
D6. Staining of deck soffit from fire at on-ramp abutment.

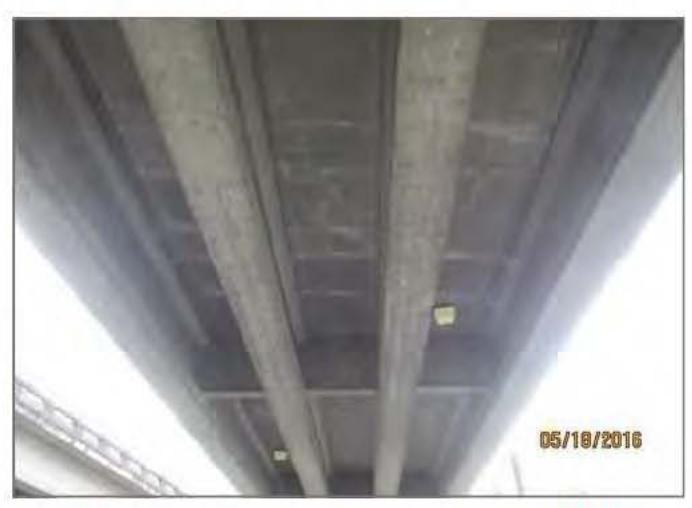
D7. Deck soffit cracks of on-ramp span between DM4-DM5.

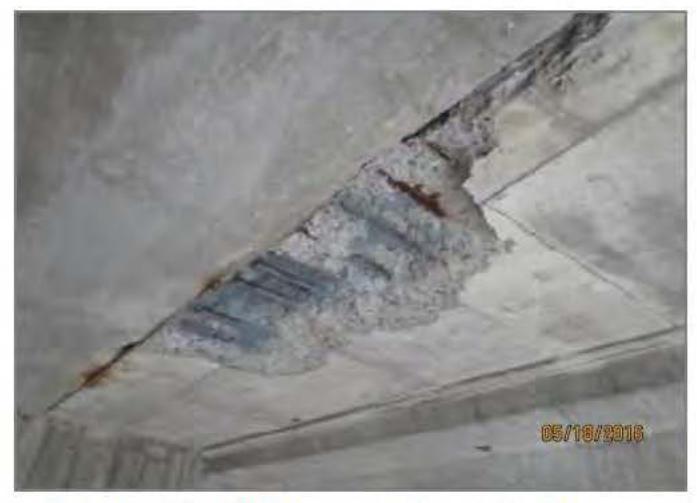
D8. Deck soffit spall with exposed rebar at Pier D6.

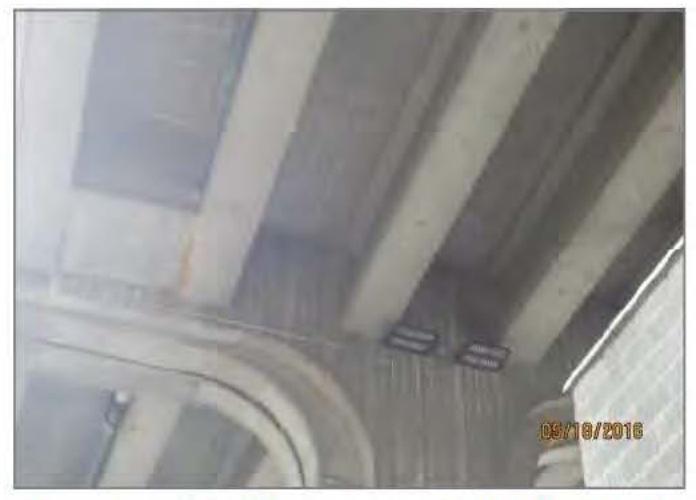
D9. Steel mapping outlines on pier and deck soffit D17-D18,

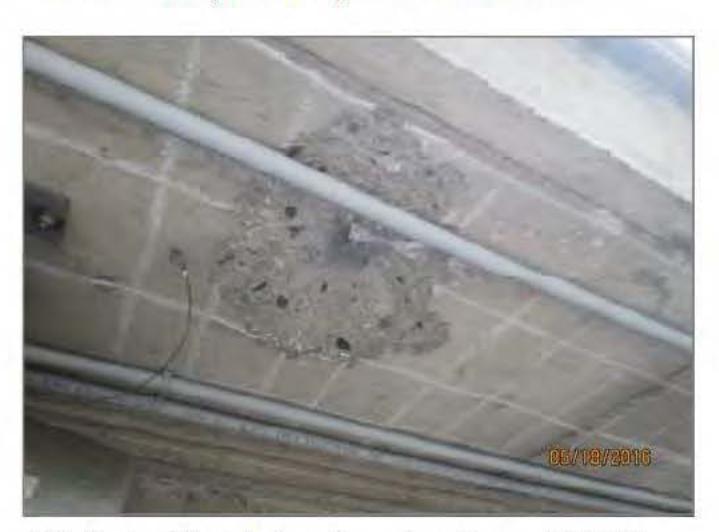
D10. Deck soffit spall at south overhang in span D18-D19.

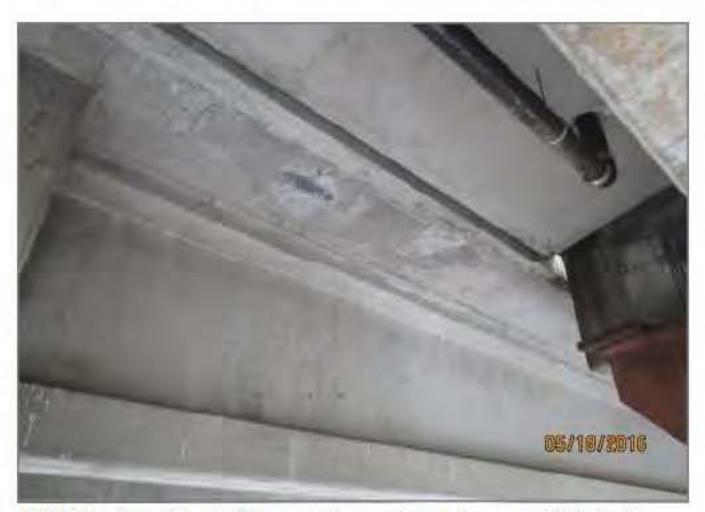
D11. Deck soffit spall at south overhang in span D19-D20.

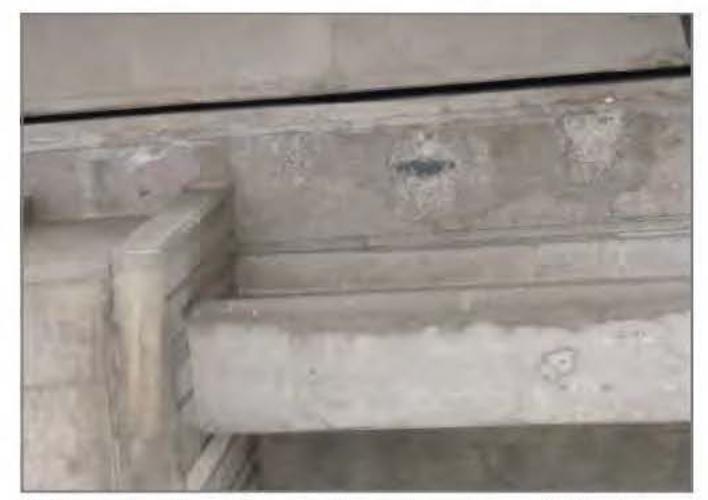
D12. Deck soffit spall at south overhang in span D19-D20.

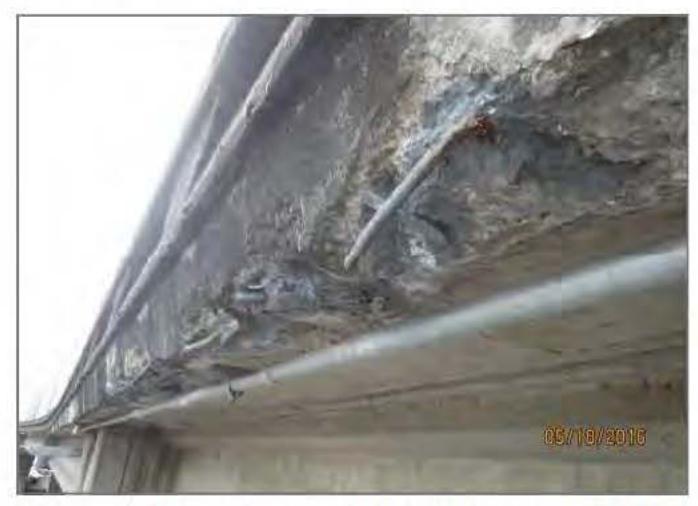
D13. Spalled concrete on north deck overhang span D20-D21.

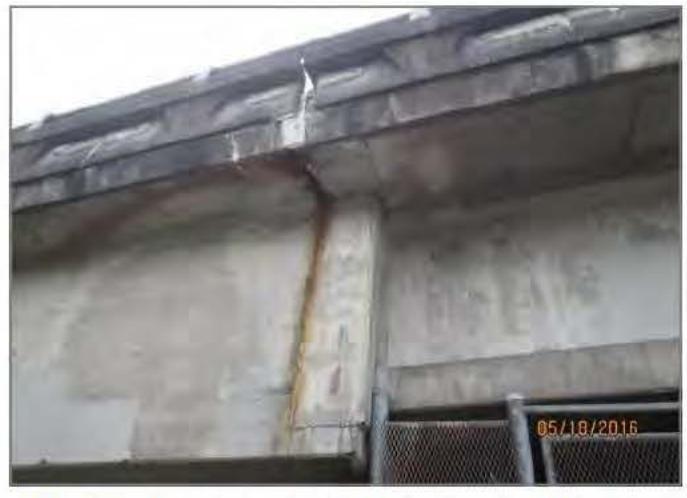
D14. Typical corrosion staining at expansion joint locations.

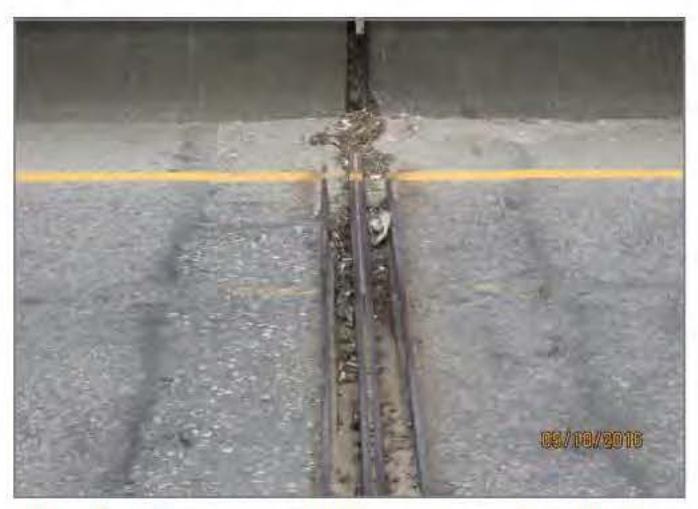
D15. Typical condition of deck joints; torn seals and debris.

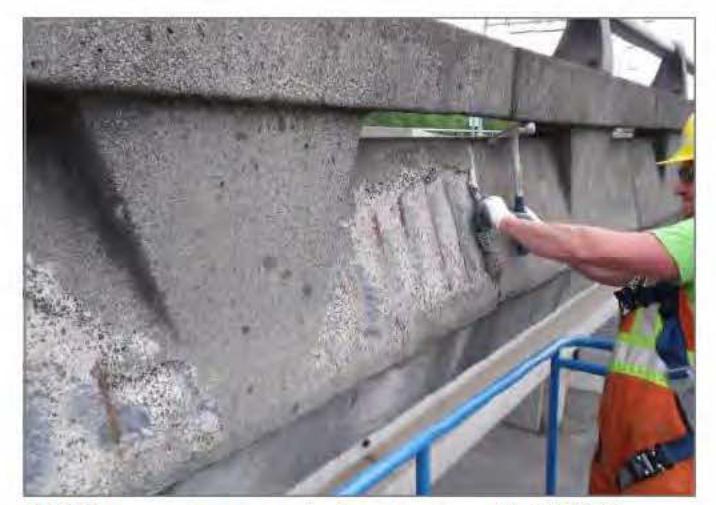
D17. Loose concrete at existing parapet spalls D14-D15.

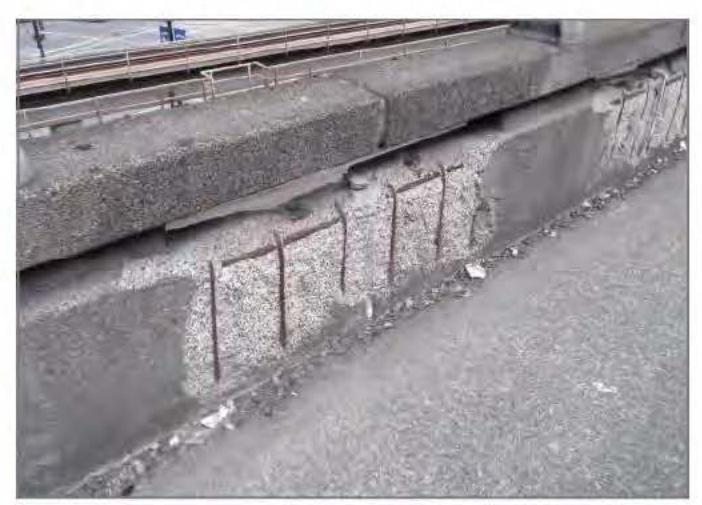
D18. Typical spalls on south face of north parapets.

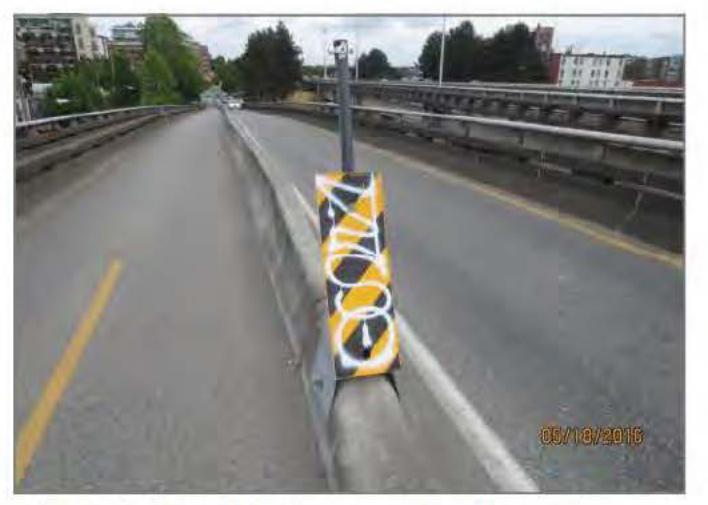
D21. Broken hazard sign at on-ramp bike lane taper.

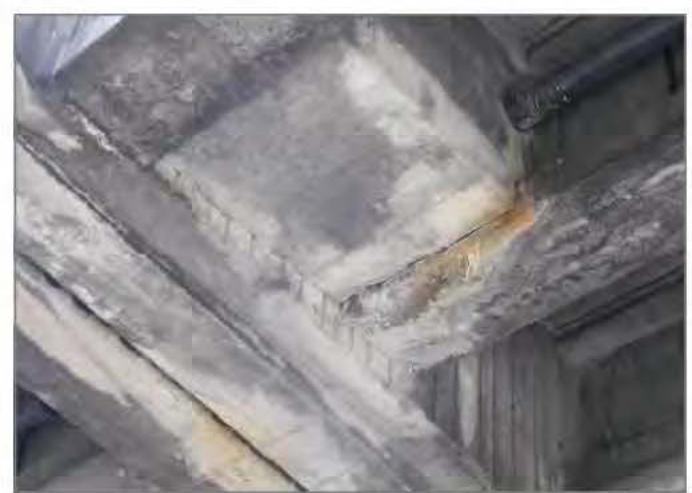
D22. Staining of concrete at base of utility box at Pier D9.

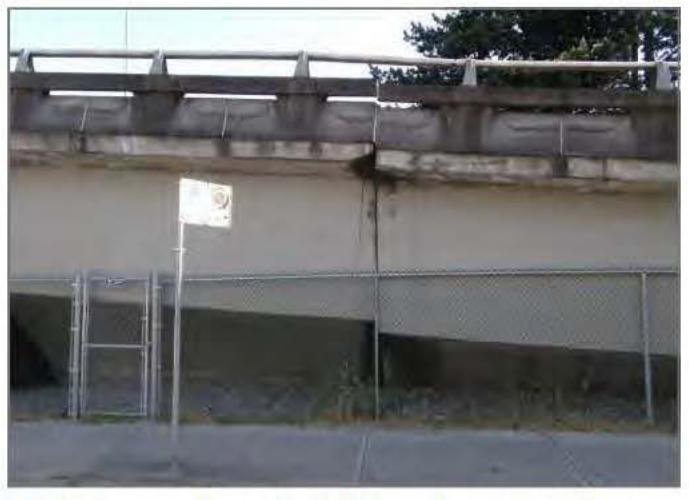
D1. Settlement observed at GM2 east abutment of off-ramp.

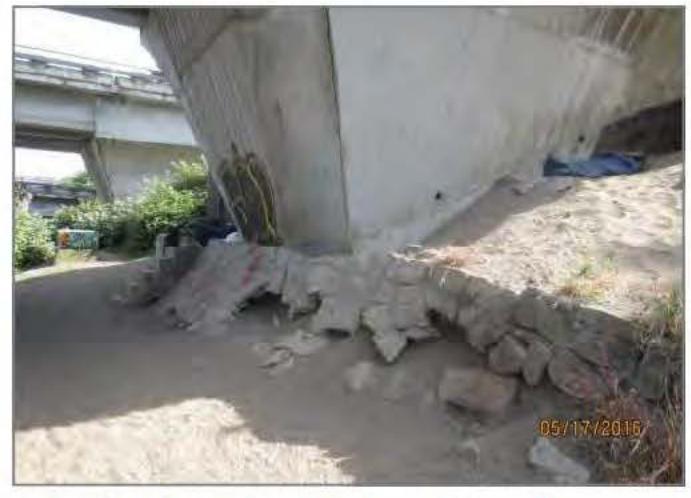
D2. Failure of retaining wall at base of G2 east abutment.

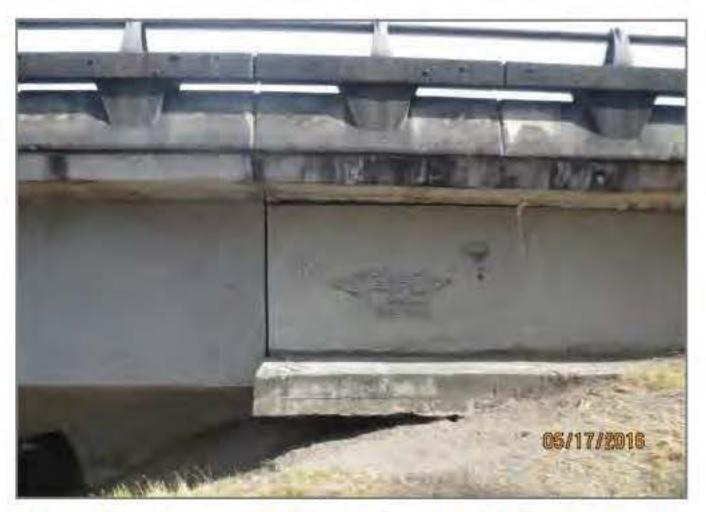
D3. Undercut approach slab south end of G2 east abutment.

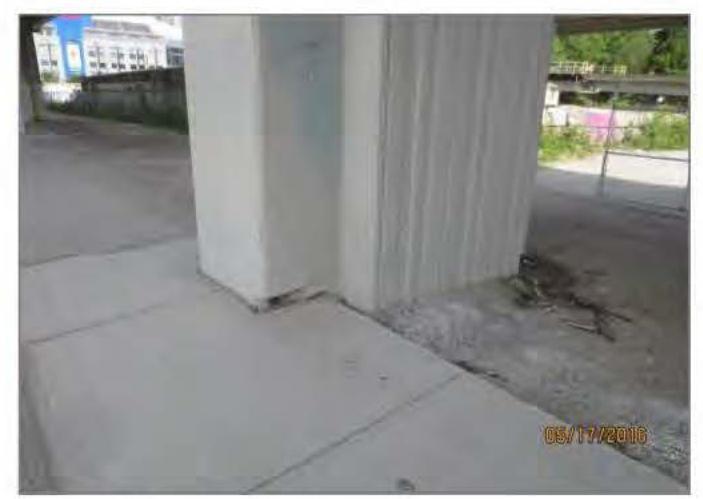
D4. Pier base repair at G10.

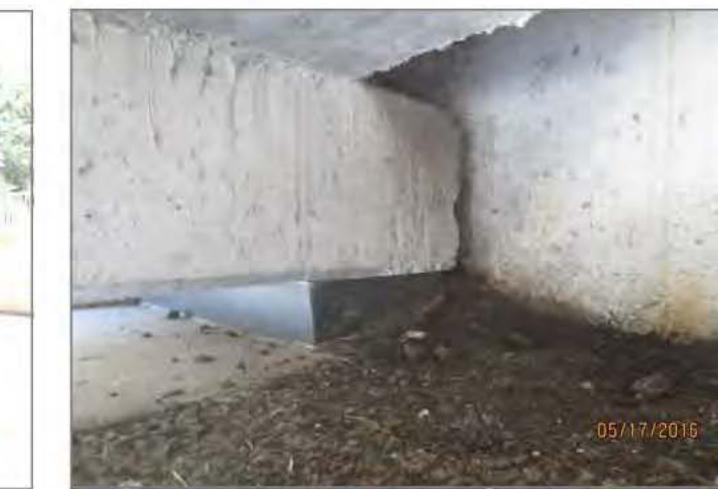
D6. Debris on bearing shelf at G2 east abutment.

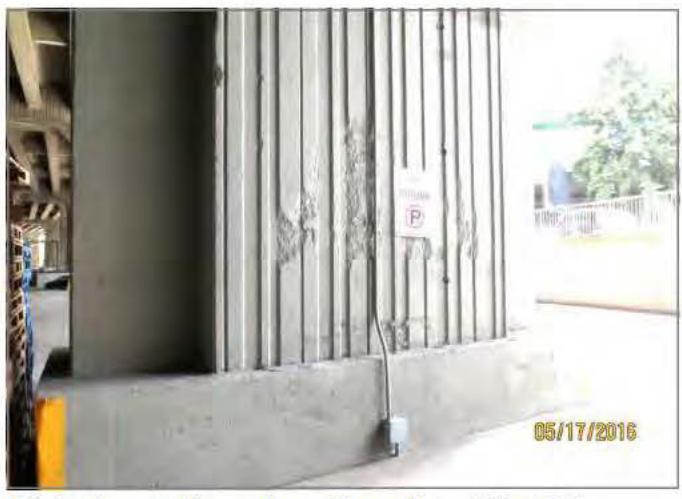
D5. Surface spalling on base of west face of Pier G26.

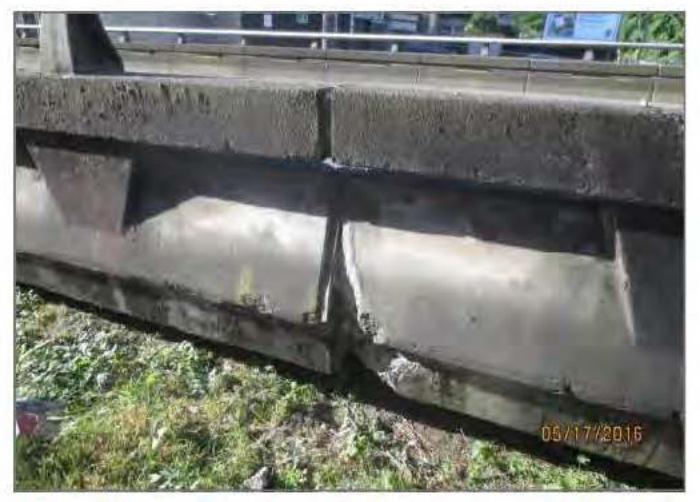
D7. Spalls at deck overhang of off-ramp approach GM1-GM2.

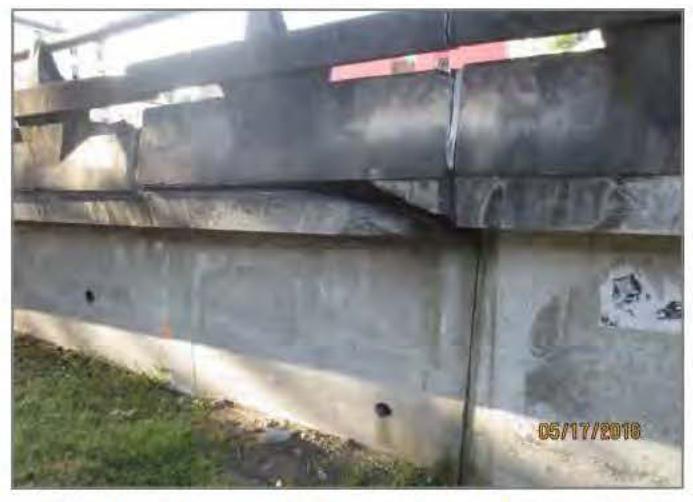
D8. Deck overhang cracking near off-ramp abutment (GM2).

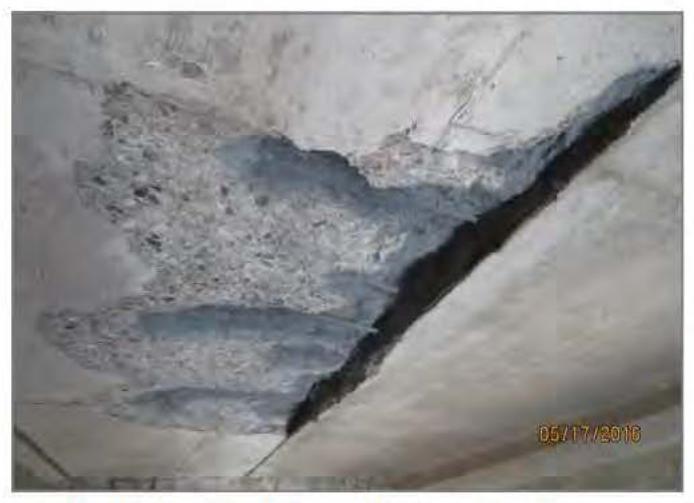
D9. Deck soffit spall with exposed rebar at Pier G6.

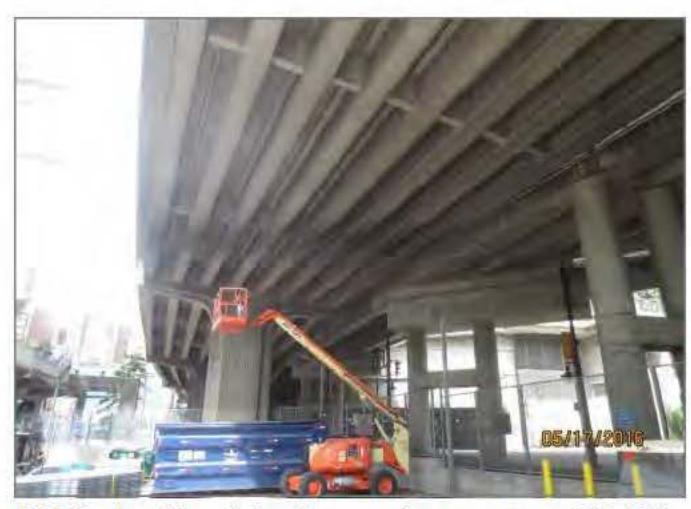
D11. Deck soffit staining above equipment storage G22-G23.

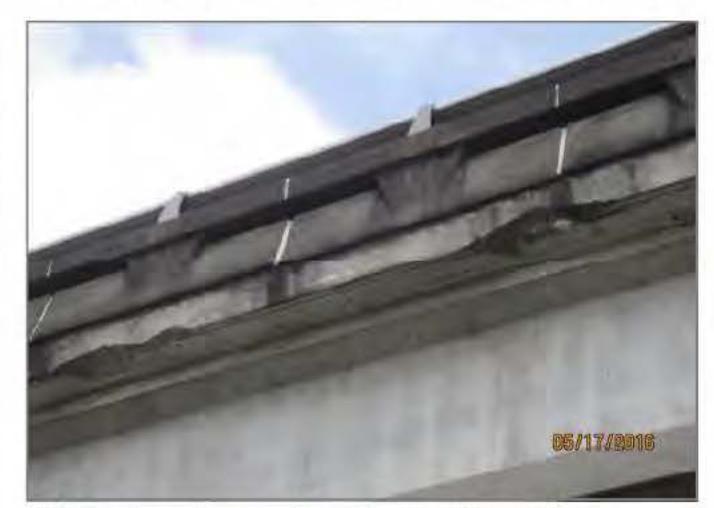
D12. Deck overhang spalls south side of Span G7-G8.

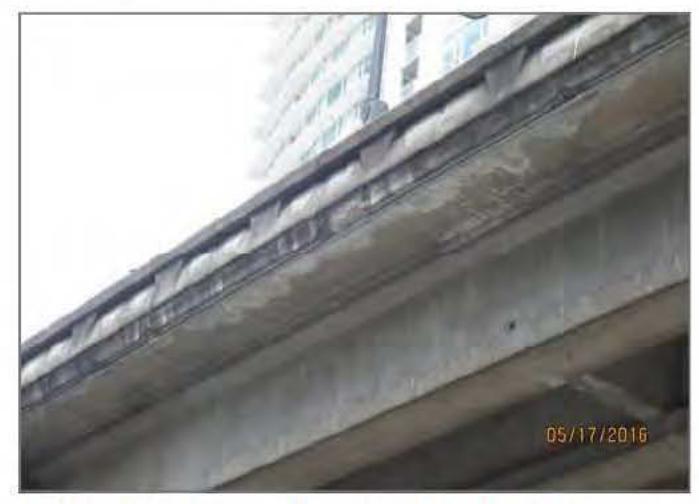
D13. Deck overhang spalls south side near Pier G25.

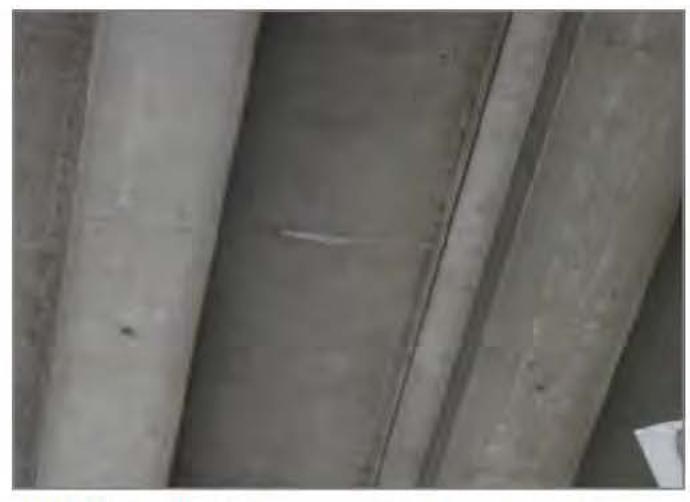
D14. Deck soffit cracks as seen throughout structure.

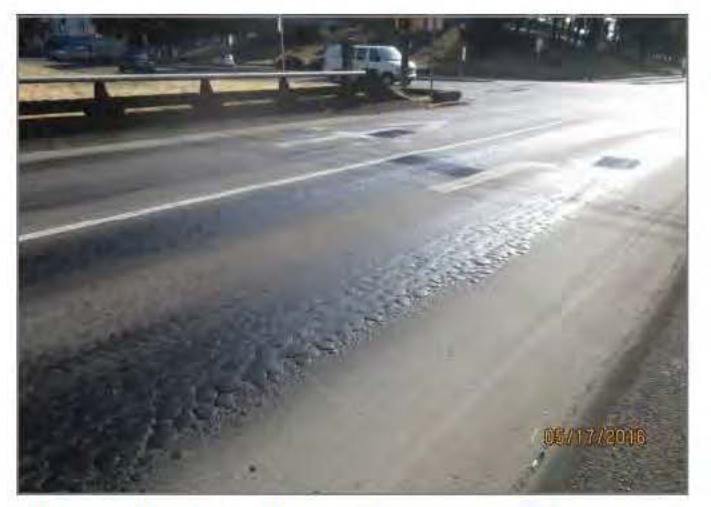
D15. Tar deposits on off-ramp from new Beatty St pavement.

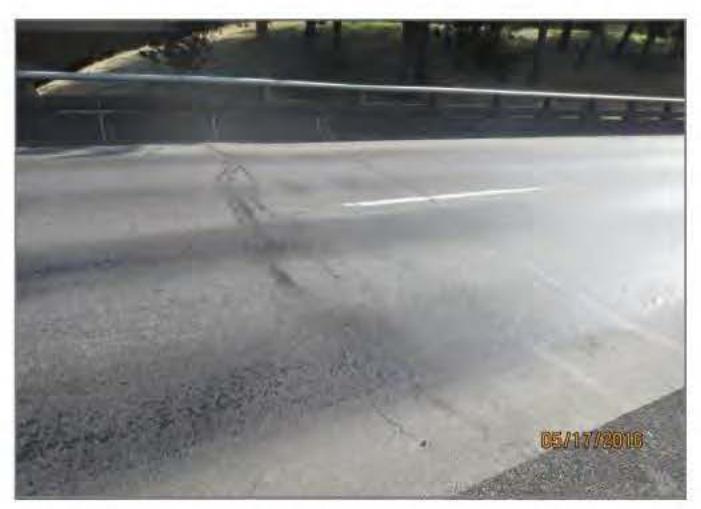
D16. Transverse cracks in roadway at off-ramp approach slab.

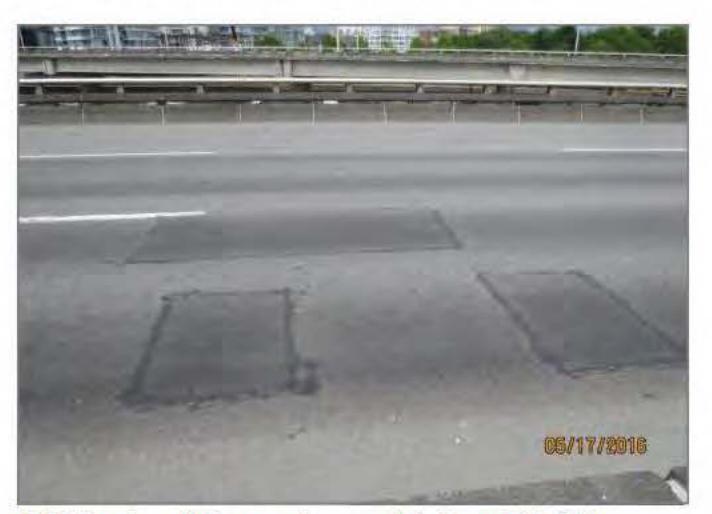
D17. Previous defect repairs sound, in Span G13-G14.

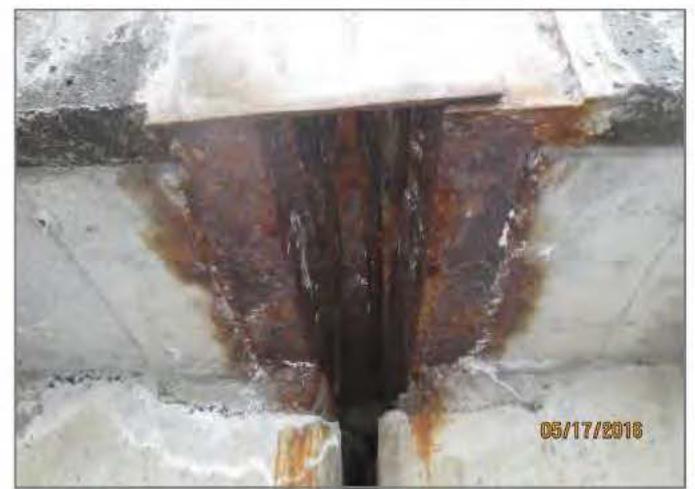
D18. Typical deck soffit corrosion at expansion joint locations.

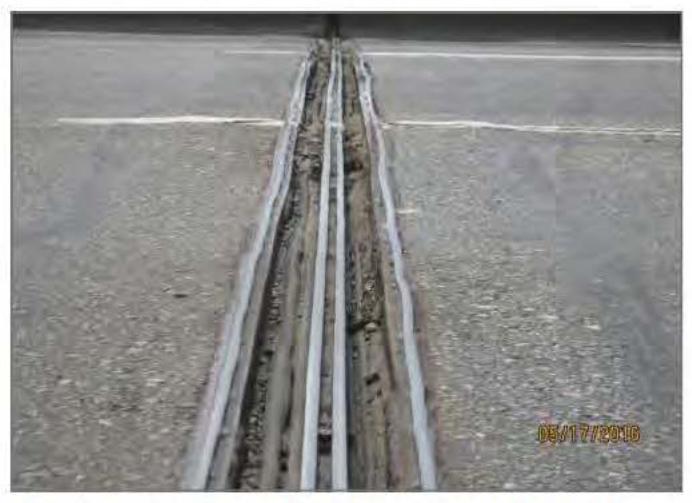
D19. Typical condition of deck joints; torn seals and debris.

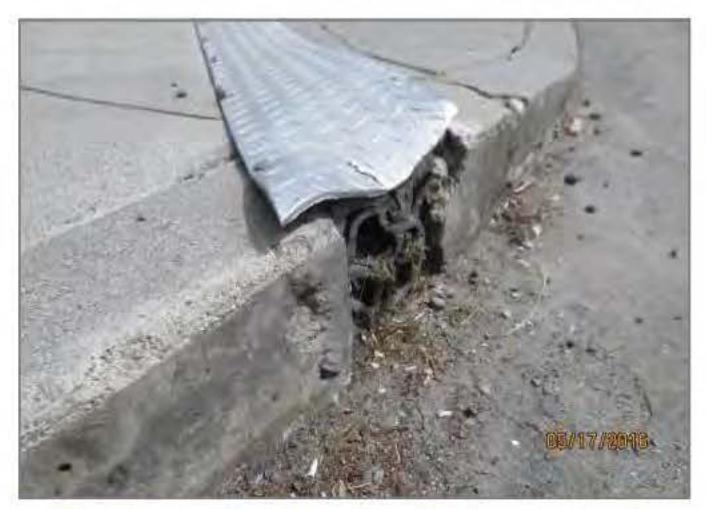
D21. Deck joint cover plate with sharp edge near Pier G26.

ID #	Bridge	Make Safe Deficiencies
D-9	Georgia Viaduct	 Deck Joints: remove sharp edge. Deck Joints: remove trip hazard.
Not Res	ponsive to Request

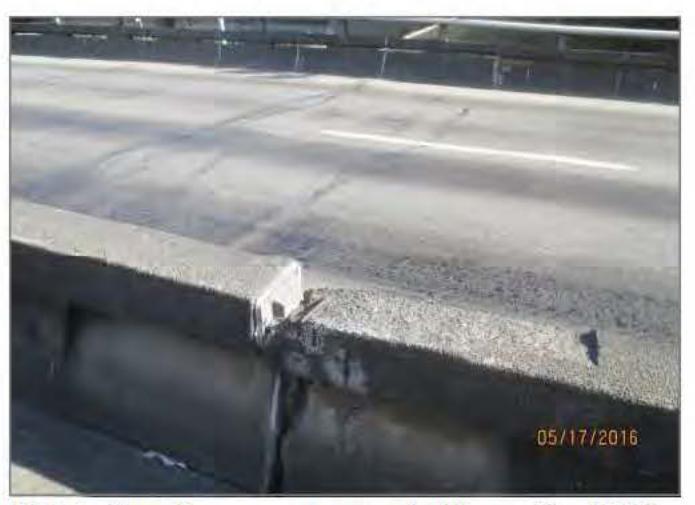
D23. Spalling of parapets at approach slab transition (GM2).

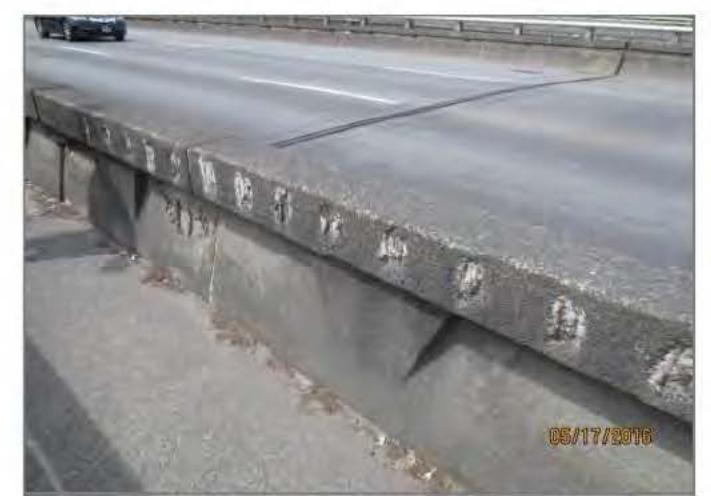
D24. Typical spalls on south face of sidewalk barriers.

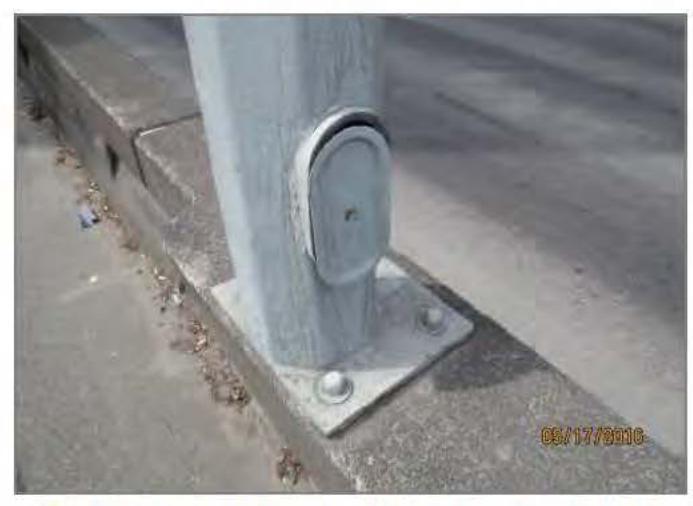
D26. Luminaire with loose hand hole cover plate G18-G19.

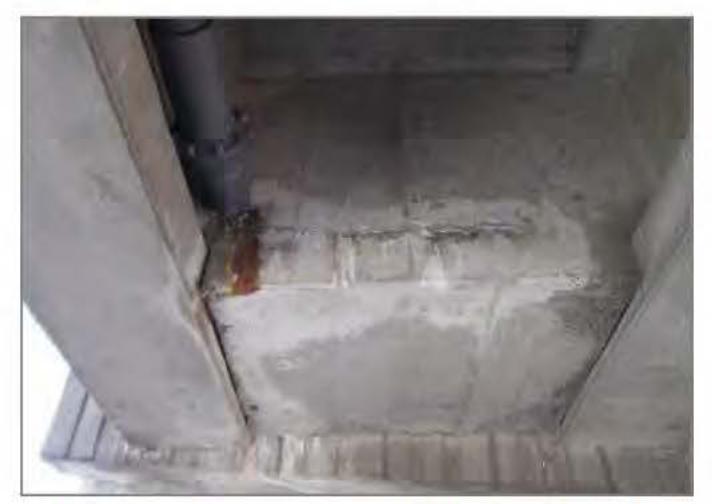
D27. Staining of concrete at base of utility box at Pier G7.

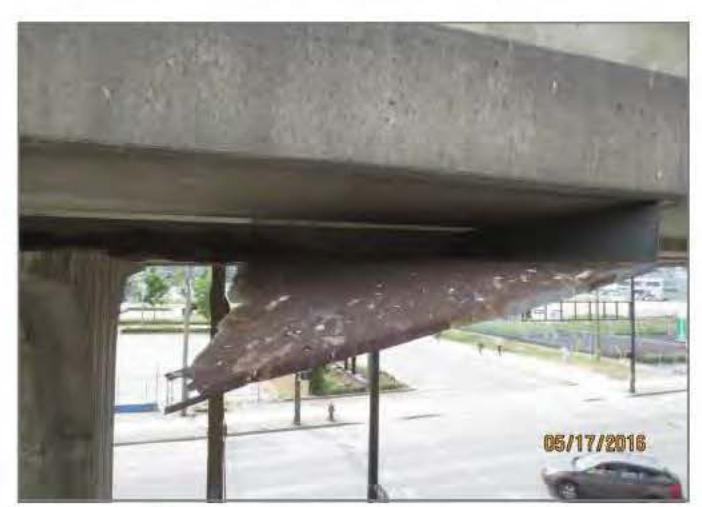
D28. Corroded drip tray below utilities at Pier G13.

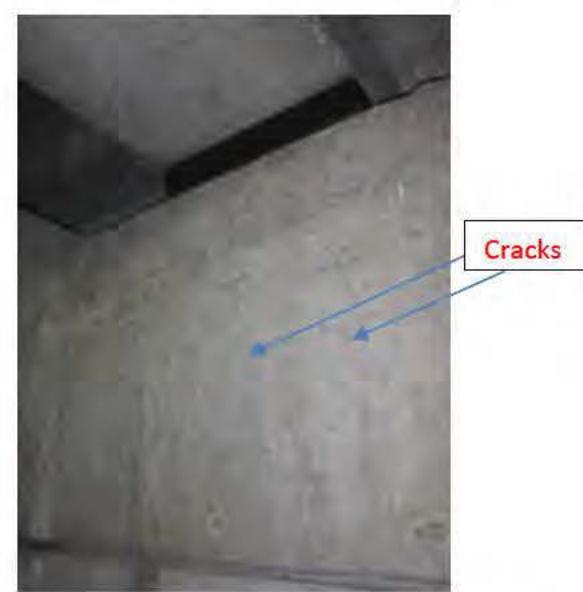
Three vertical cracks were observed in the abutment wall under and just north of the bearing for girder C (third girder from the north) (Figure 10). These cracks are considered to be minor in nature and apart from ongoing monitoring during inspections, no rehabilitation work is deemed necessary.

Figure 10. West abutment: Cracks under Girder C bearing

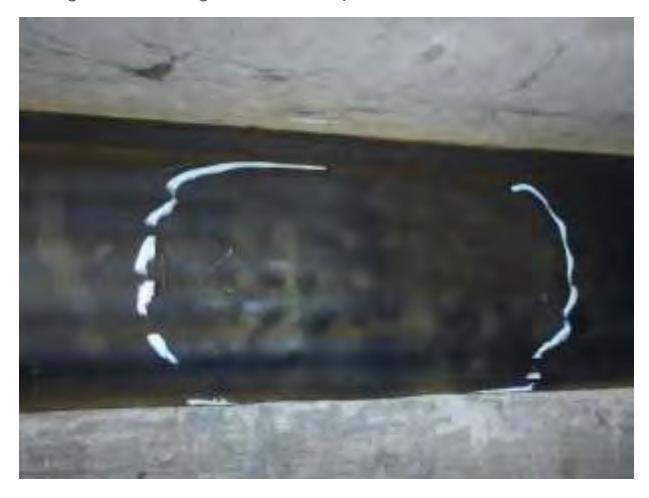
shear deformation capacity of 48 mm (based on CAN/CSA S6-14 §11.6.6.4: "Deformation and rotation"). The bearing at girder A had what appeared to be a fine vertical slice on its east face. This was likely made during manufacture or installation, does not appear to be associated with any structural distress, and is not expected to affect the bearing's performance. We recommend monitoring this bearing in future inspections.

Figure 14. Chalk lines outlining bulging of bearings between reinforcing plates (girder B bearing shown)

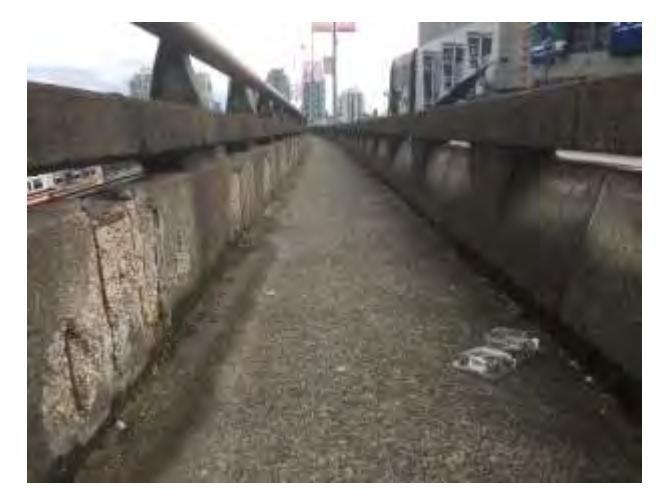
Figure 26. Looking east: North handrails (left) in poor condition, North guardrails (right) in fair condition

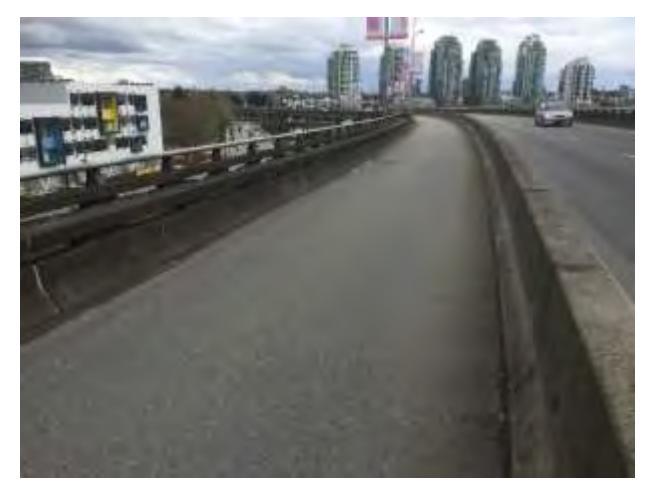
Figure 27. Looking east: North guardrails (left) and median barriers (right) in fair condition

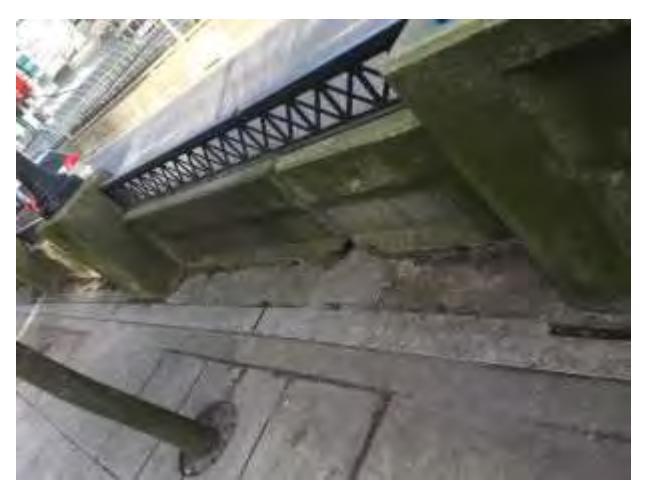
Figure 28. Looking west: South guardrail, span D20-D21: Algae growth

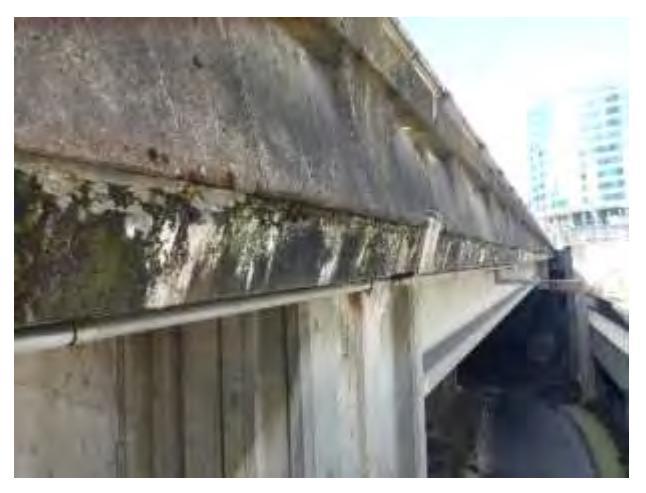
Algal growth and wetness was observed on both the vertical edges of the deck along the entire viaduct (Figure 31). This points to water seepage through the grouted horizontal joint between the precast barriers and the top of the deck. The drip grooves have mostly prevented this water from running down the deck soffit towards the exterior girders (Figure 32).

Figure 31. Seepage, efflorescence, and algal growth on outside edge of deck

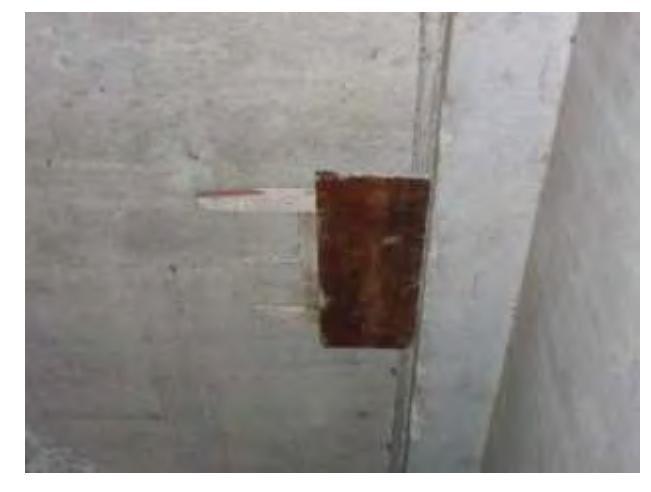
Figure 36. Deck soffit between girders, span D22-D23: Past patch repair

We recommend conducting a detailed deck condition evaluation if the structure is to be retained.

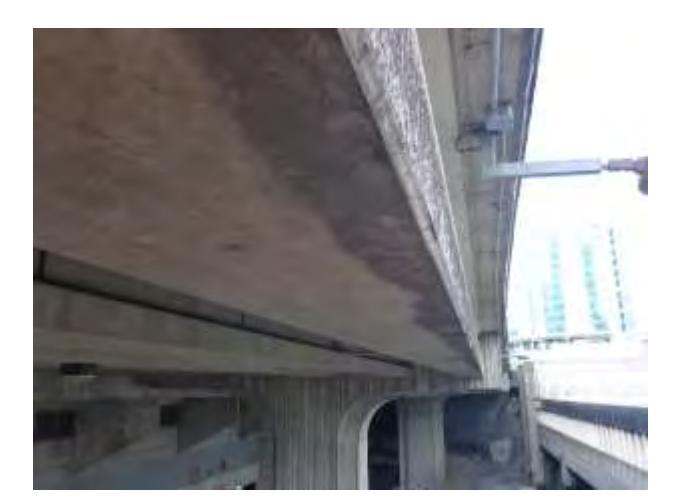
North girders (A) had water stains along north edge of bottom flange (Figure 64). This is likely the result of both (a) water seeping under precast barriers, and (b) degradation due to prolonged exposure to rain, which can be slightly acidic. This defect is not of concern at this time because the girders are uncracked.

Figure 64. Span D20-D21, north girder

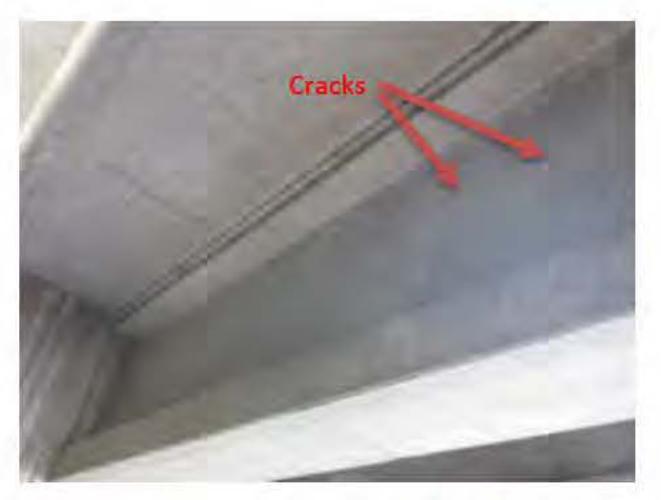
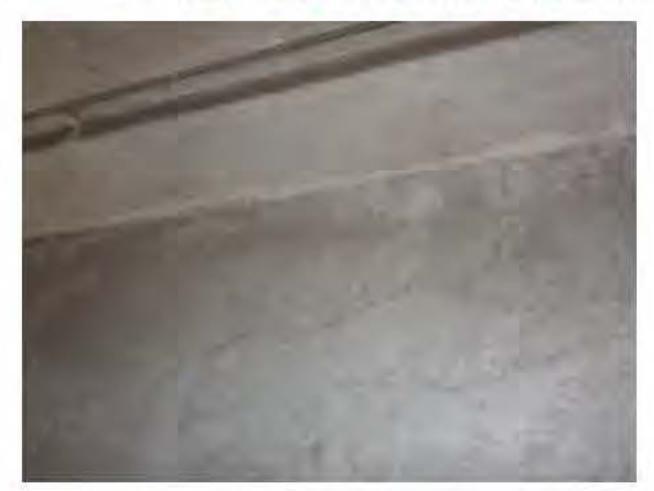
Parallel diagonal cracks were observed on all girders on both sides of pier D22 at a distance of 4 to 5 m from the girder ends (Figure 65). These cracks were typically on an approximate 30° angle from the horizontal down towards the pier, and extended from 300 to 600 mm from top of web. Similar cracks were seen on the west side of full pier D20 (the east side was not inspected). Associated (2009) also spotted these cracks and attributed them to post-tensioning details. The crack locations near pier D22 coincide with loop anchors for post-tensioning tendons at centre piers (Figure 66).

Figure 65. Diagonal cracks at top of web, east of D22

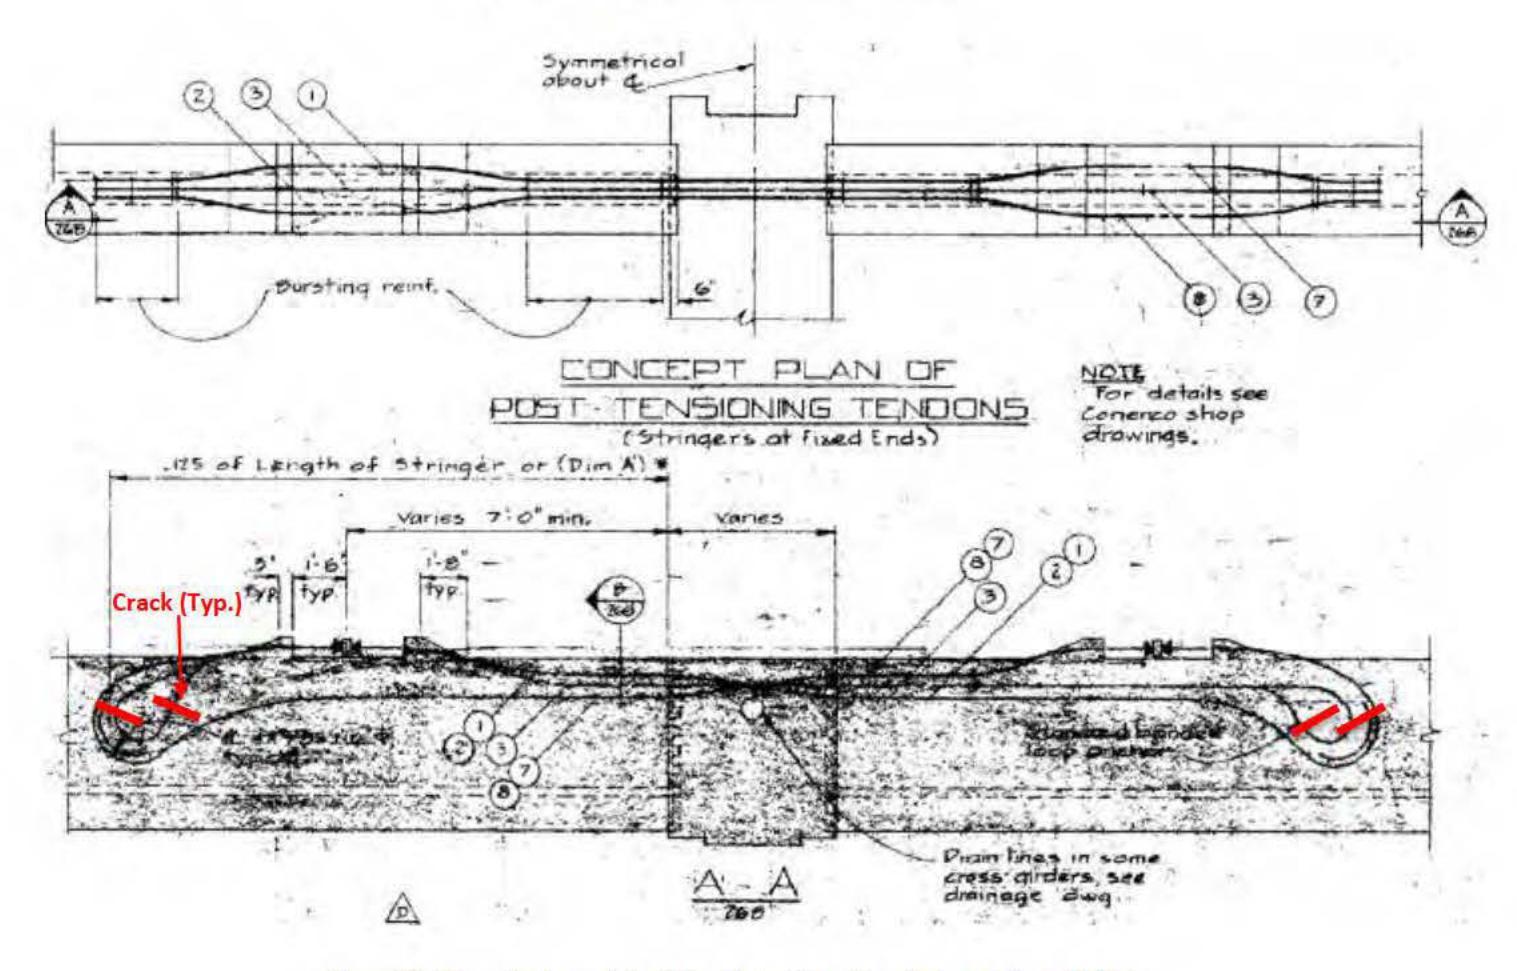
Figure 66. Approximate crack locations relative to post-tensioning tendons at full piers

These loops carry large post-tensioning forces (2,335 kN design force) over a very tight radius (157 mm). High stresses are generated around the tendon anchor loop as the force spreads out into the concrete section. The local tensile stresses generated can cause cracking in the concrete. These cracks are controlled by bursting reinforcement arranged to counter the tensile stresses. Small cracks in the bursting region are acceptable provided their width is within acceptable design limits (Hewson, 2003). The cracks observed near piers D20 and D22 were small, and are thus not cause for concern.

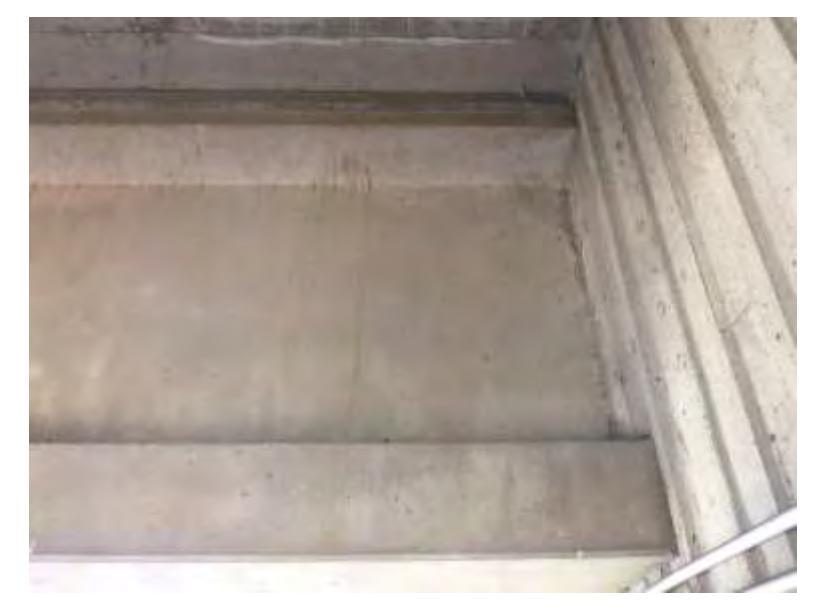
Figure 68. Diagonal crack at top of web, east of D18, typical for all girders

These are not shear cracks, as they are closer than the girder depth from the support point (face of pier cap). They may be due to post-tensioning at top of girders at these locations. These cracks are small, stable and not exposed to road spray, and are therefore not of concern. We recommend these cracks be monitored in future inspections, with no remedial action required at this time.
