Re: Request for Access to Records under the Freedom of Information and Protection of Privacy Act (the "Act")

Project Name: Cobalt Hotel Repairs

Re: Structural Review of 160 E. Hastings St., Vancouver, BC

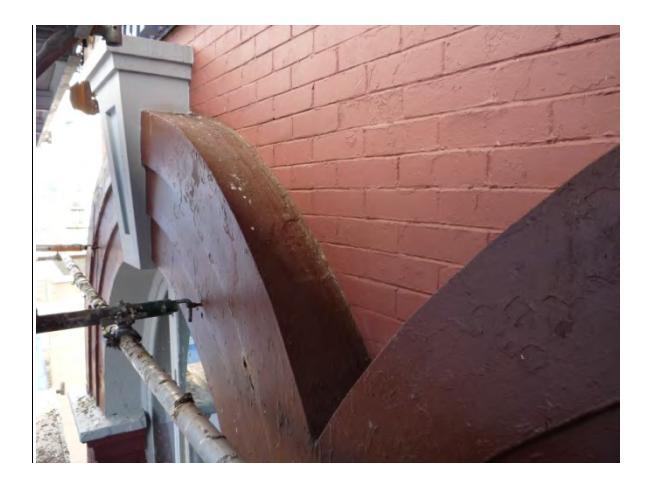
Photo: Brick veneer on north face over concrete archways.

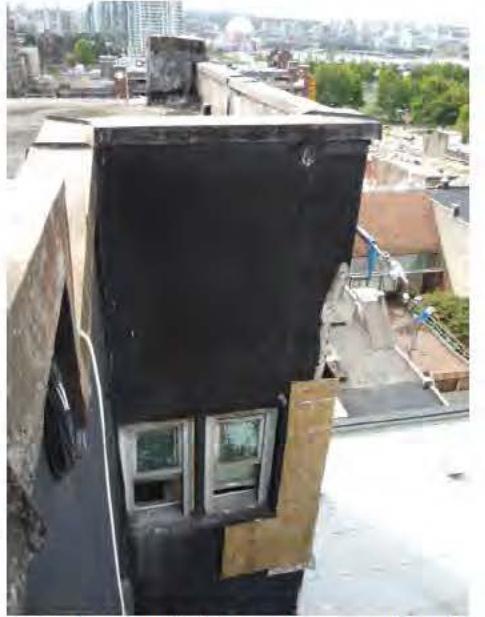
There is a spalled area of concrete on the east property line wall (south end of the light well) that needs to be patched. There is reinforcing steel exposed. The rust on the bars needs to be removed, bonding agent applied and a concrete patch poured. The contractor needs to check the rest of the exposed concrete wall for areas that are spalling or have loose concrete that may spall. These areas will need to be repaired as well.

Photo: spalling and plywood around spalled area at south end of west light well.

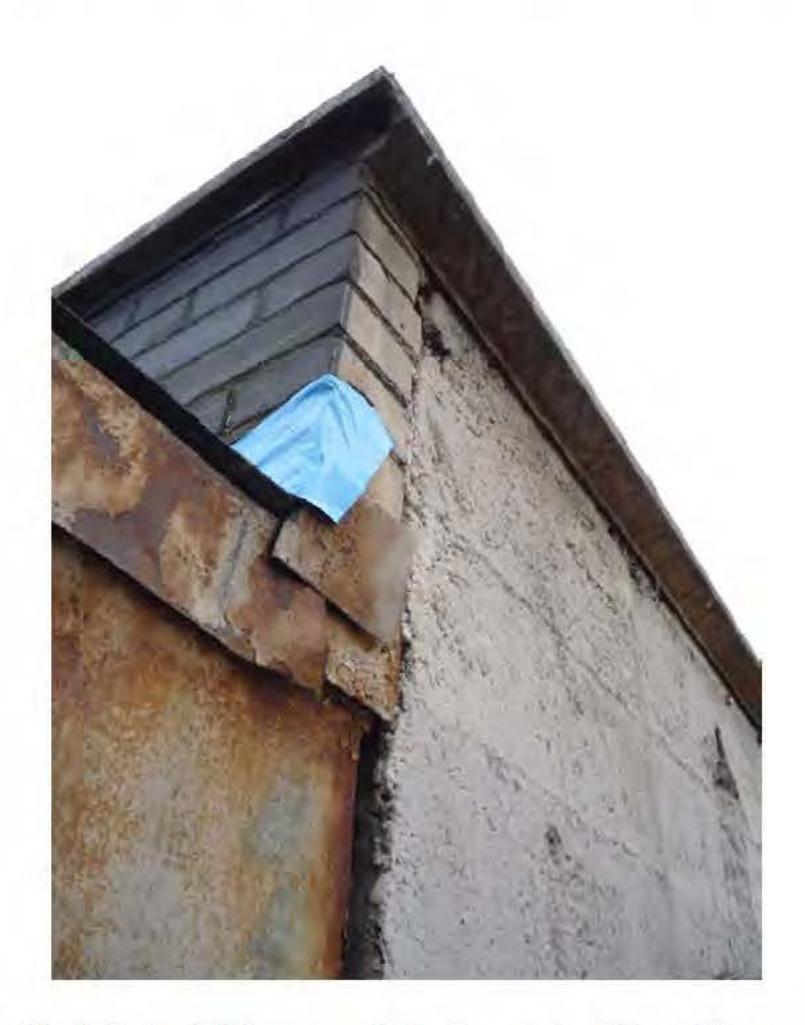
Brick veneer anchors fasten the façade brick to the supporting wall. Without these anchors, sections of a veneer can become unstable and fall away from the building. Most brick veneer anchors on buildings from this era are usually significantly corroded. The veneer can be re-attached with Helical stainless steel anchors that screw through the mortar lines and into the concrete wall behind. Although we could not observe the veneer anchors, it is our experience that the veneer likely needs to be re-attached (simply based on the era of the building). The owner could also investigate further if they wish to confirm the condition of the existing veneer anchors.

Photo: North facing brick veneer above the cornice. West side property line concrete wall.

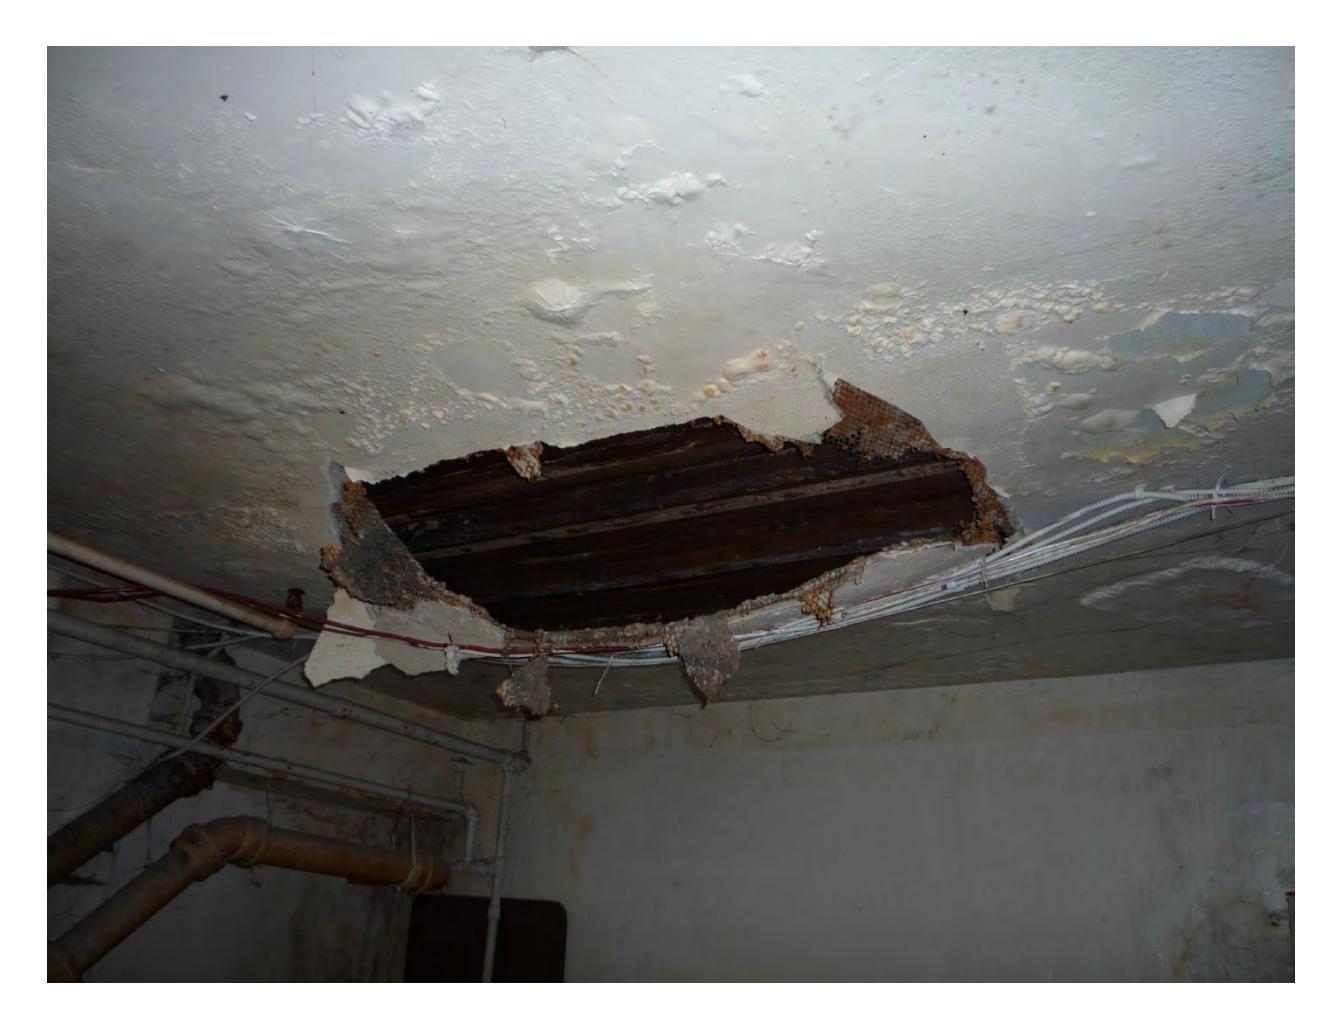
There are sections of the basement ceiling that are peeling away from the wood floor over. We recommend sections of the ceiling be demolished/removed where there are signs of detachment from the ceiling. This is to avoid segments of the ceiling from falling on anyone who

may be working in the basement. The ceiling itself is a non-structural element but the wood laminations and steel beams are structural and may not be removed/altered.

Photo: basement ceiling peeling away from structure.

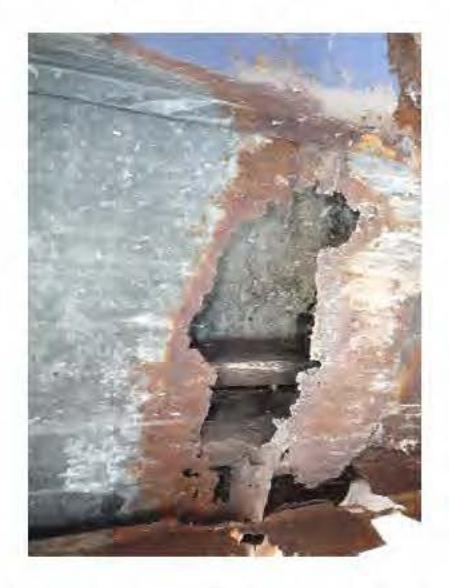
There is significant corrosion on parts of the cornice which needs repair. This is not a structural element but can present a falling hazard if it is not repaired.

Photo: An example of corrosion damage on the cornice. North face concrete wall is behind the cornice.

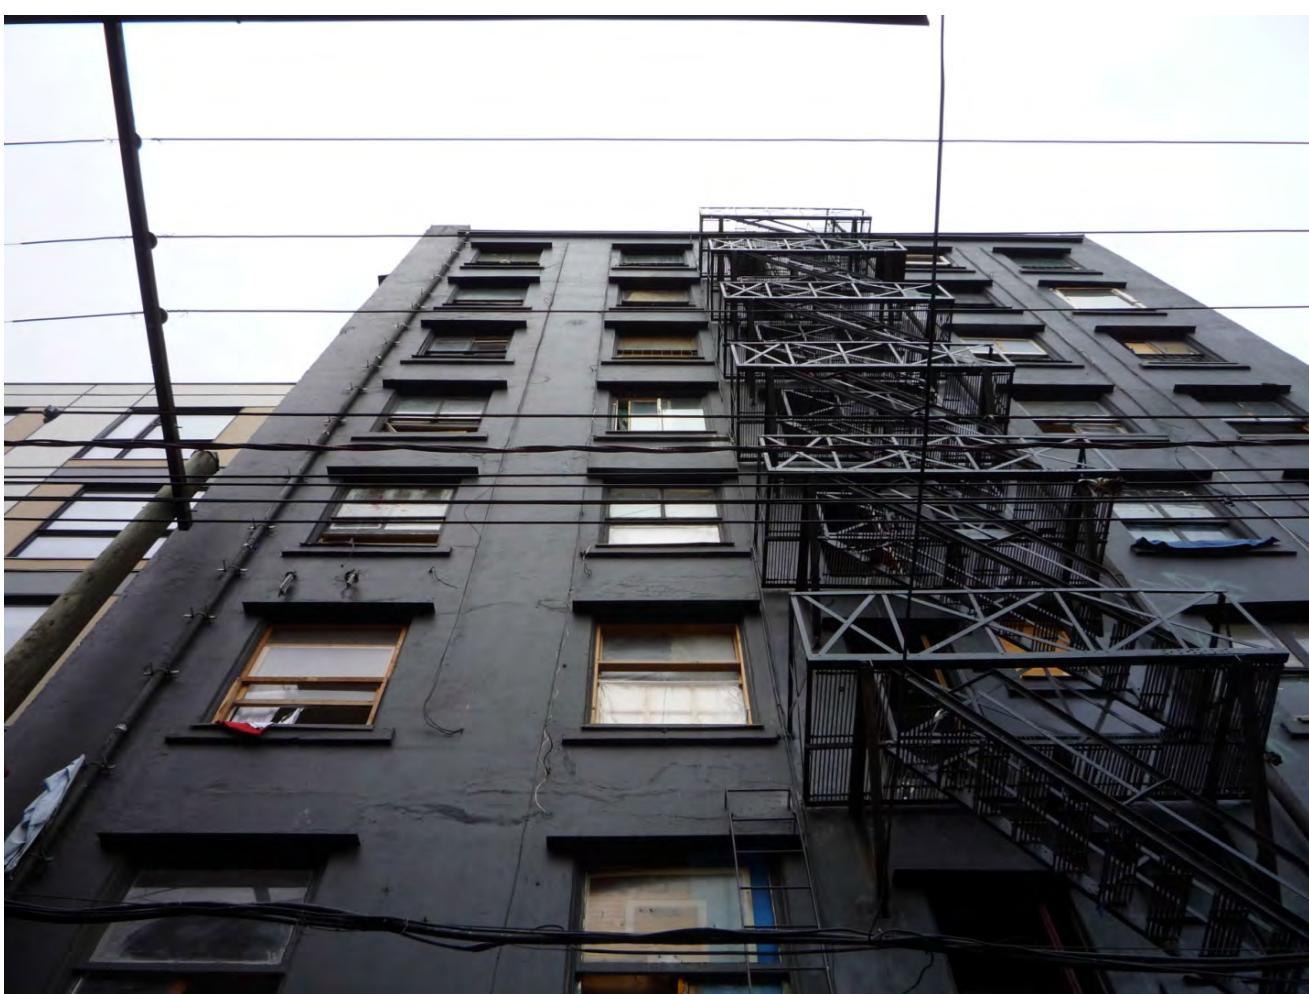
There is significant damage on the fire escape. We went for a second review on September 29,2016 once some of the paint was scraped away. Given the amount of damage and the likely potential for discovering further corrosion it is our opinion that the fire escape should be replaced. This will also allow for additional safety with higher guards and more tightly spaced pickets.

Photo: Fire escape on south side and adjacent hydro lines.

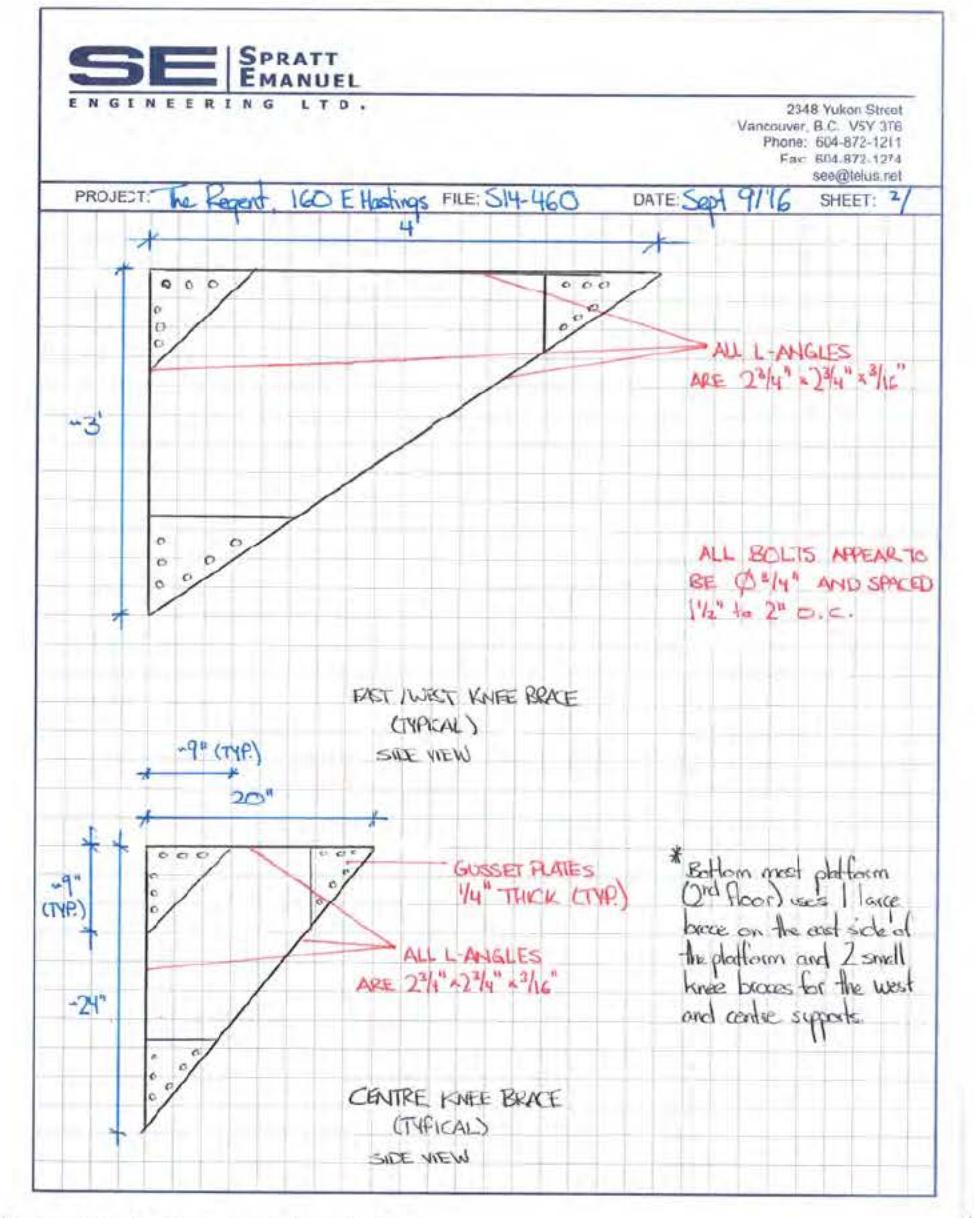
Figure: Sketch of typical support brackets.

- 2nd floor: grating is not properly seated/secured. Knee braces supporting landing are more corroded than other brackets.
- 3rd floor: Centre brace has a spliced in piece to repair a previously corroded strut. East knee brace is badly corroded at bottom connection.
- 4th floor: grating is in poor condition. Many of the slats are not secured to rods and are loose. The bottom bolt of the east knee brace is badly corroded.

- 5th floor: The centre knee brace is more corroded than the other braces (especially at the interface with the wall).
- 6th Floor: The centre knee brace and bottom gusset plate are badly corroded.

Typical issues on the fire escape include bent gusset plates (this may have been done during the original installation). The bent gusset plates trap debris and moisture which promotes corrosion.

There is significant corrosion on some of the stringers. These stringers will have to be replaced or repaired.
