Re: Request for Access to Records under the Freedom of Information and Protection of Privacy Act (the "Act")

Records regarding the St. Paul's Medical Campus development, specifically:

### **PRE-DEMOLITION HAZARDOUS MATERIALS REPORT**

### 310 PRIOR STREET, VANCOUVER, BRITISH COLUMBIA

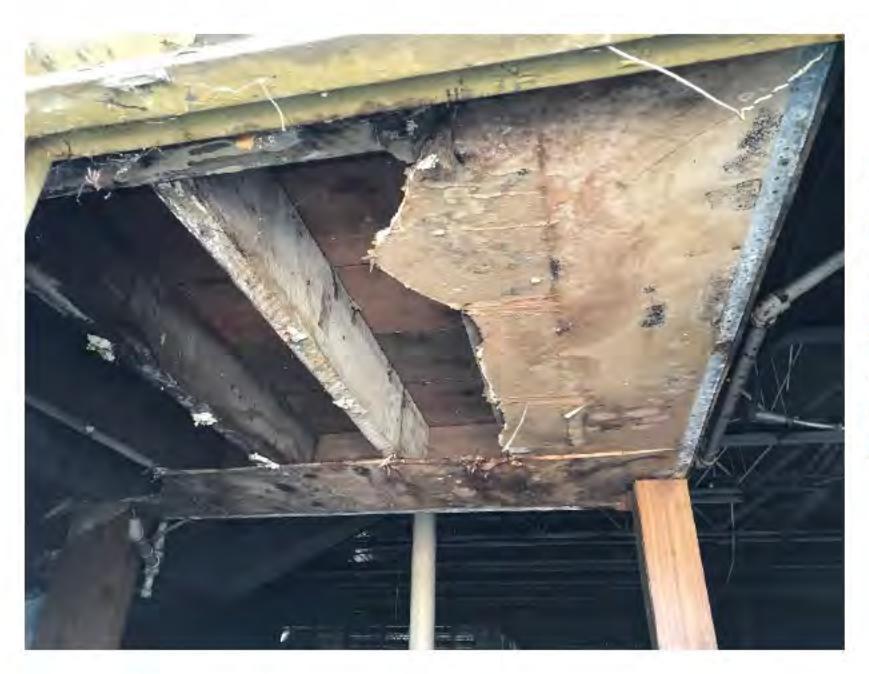
#### Photo 2

**Description**: View of mould growth on damaged drywall on the underside of the stairwell at the Exterior doorway entrance.

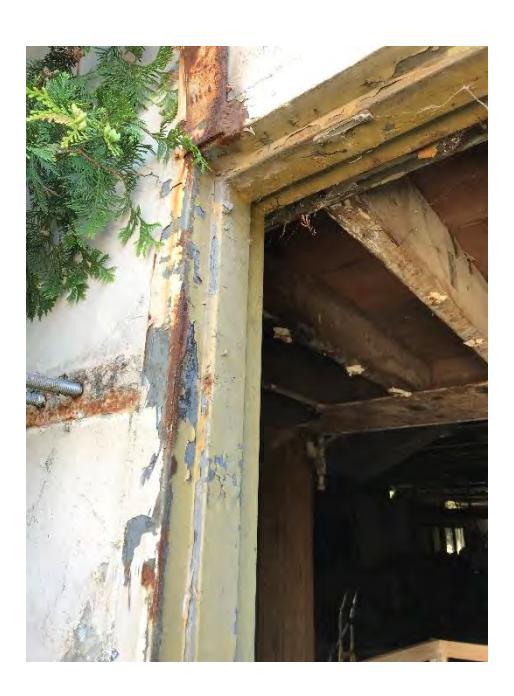
#### Photo 3

**Description**: View of poor condition lead-containing beige paint applied to the walls and doorway at the west side Exterior door.

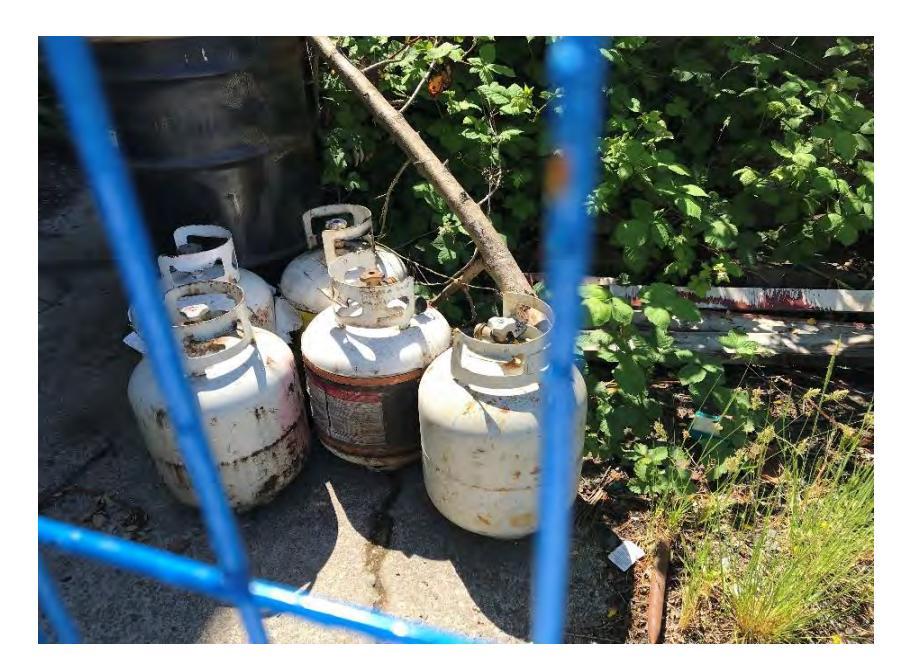
#### Photo 4

**Description**: Five (5) propane tanks located within the rental gate area along the Exterior of the Subject Building.

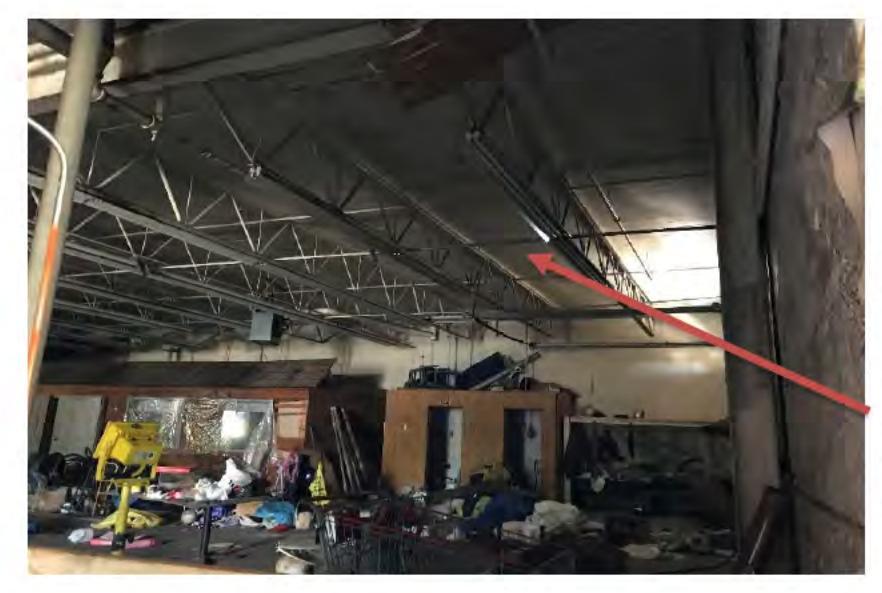
#### Photo 5

**Description**: View of interior of the Subject Building.

PCBs and Elemental Mercury in the form of fluorescent light tubes and ballasts are observed from the west side Exterior door.

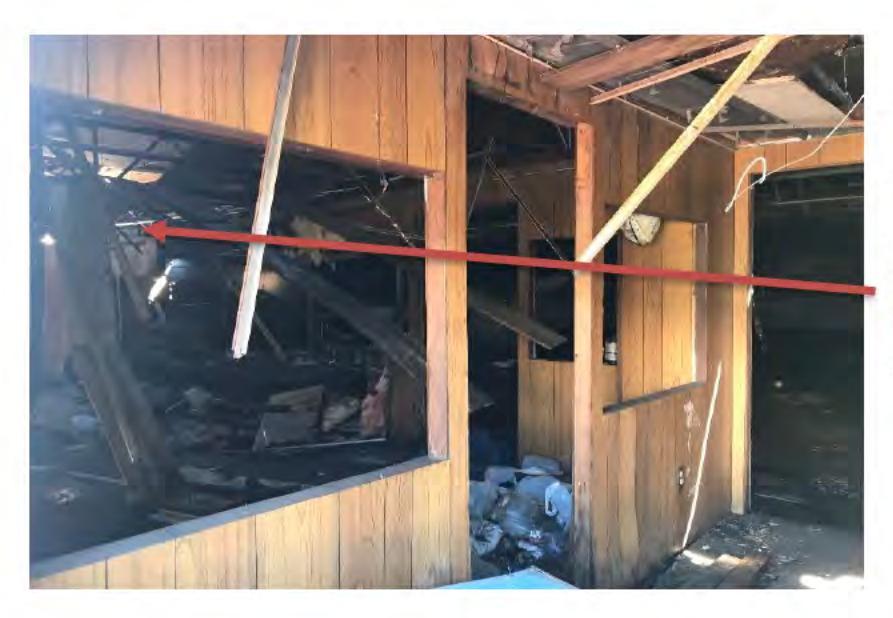
#### Photo 6

**Description**: View of collapsed roof within interior of 2<sup>nd</sup> Floor North Center Office.

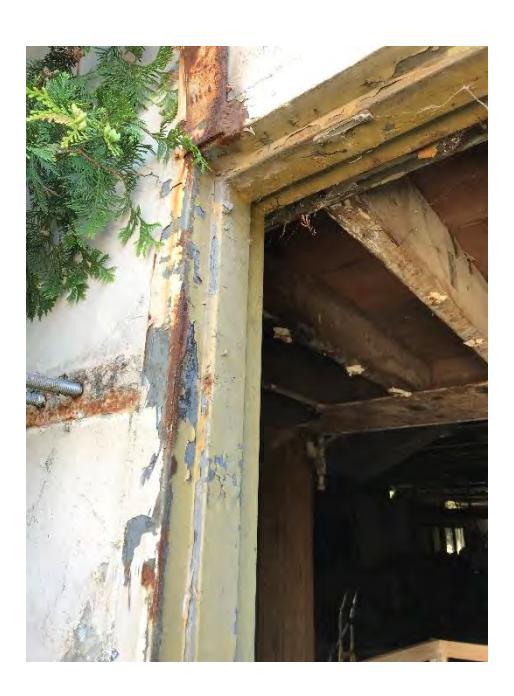
# Photo 3

**Description**: View of poor condition lead-containing beige paint applied to the walls and doorway at the west side Exterior door.

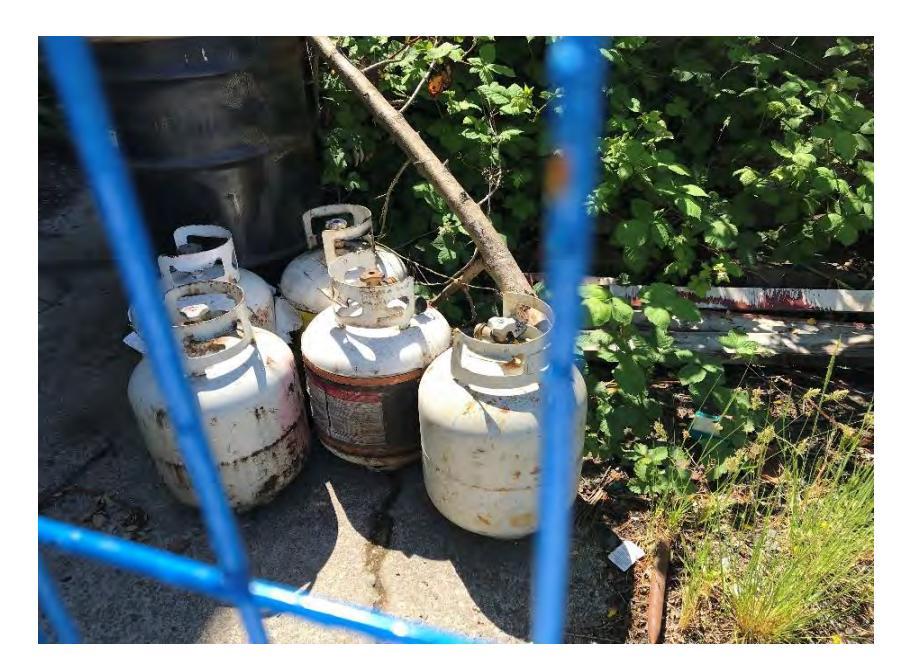
# Photo 4

**Description**: Five (5) propane tanks located within the rental gate area along the Exterior of the Subject Building.

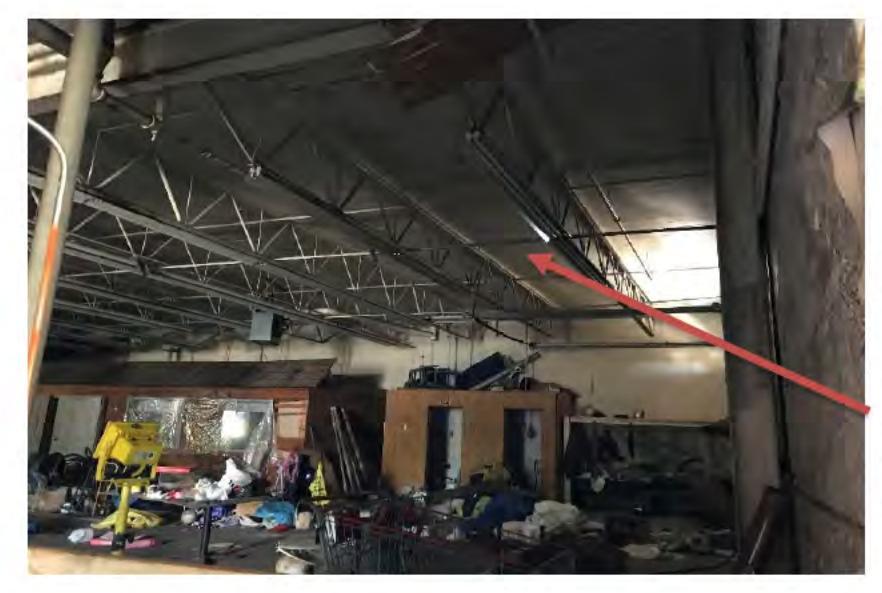
# Photo 5

PCBs and Elemental Mercury in the form of fluorescent light tubes and ballasts are observed from the west side Exterior door.

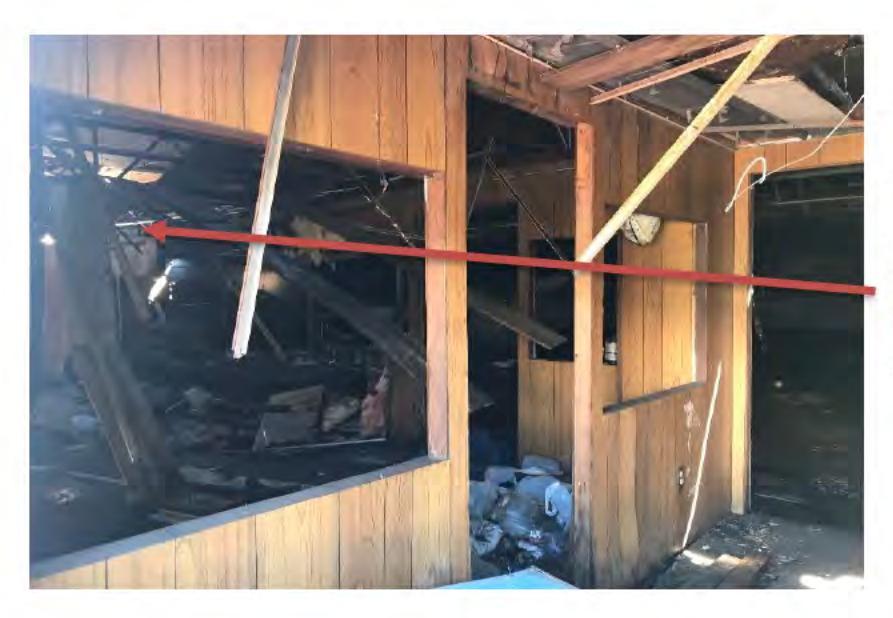
#### Photo 6

**Description**: View of collapsed roof within interior of 2<sup>nd</sup> Floor North Center Office.
