**RESIDENTIAL UNDERGROUND STORAGE TANK REMOVAL
SUMMARY REPORT**

**8420 OAK STREET
VANCOUVER, BC
V6P 4B1**

PERMIT NO. 407 950

RESIDENTIAL UST REMOVAL AND REMEDIATION OF TANK NEST - SUMMARY REPORT

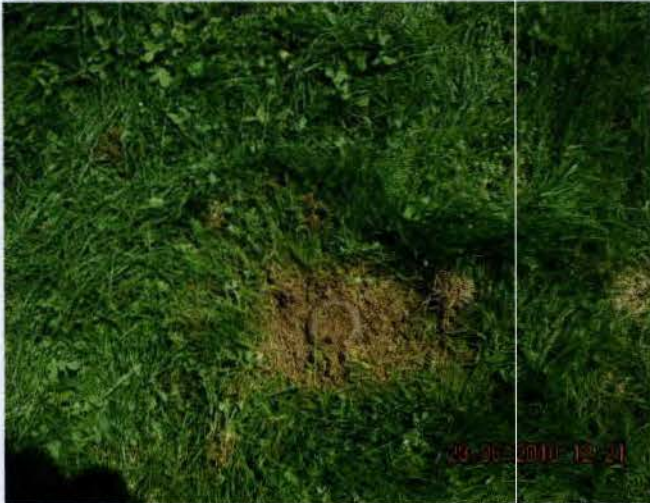
Photo 1 – Filler valve

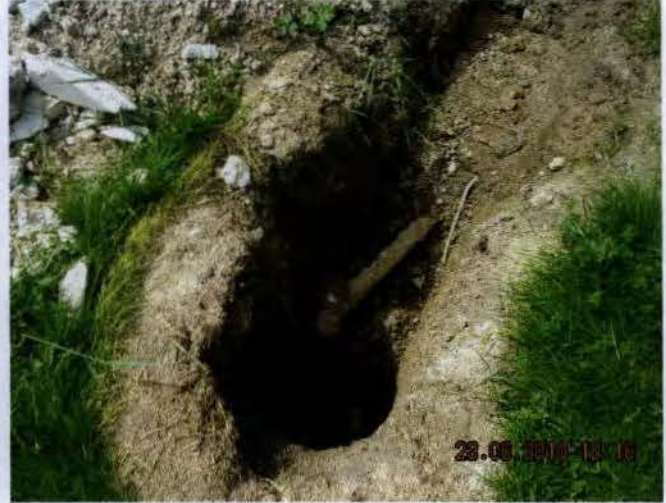
Photo 2 - Vent pipe

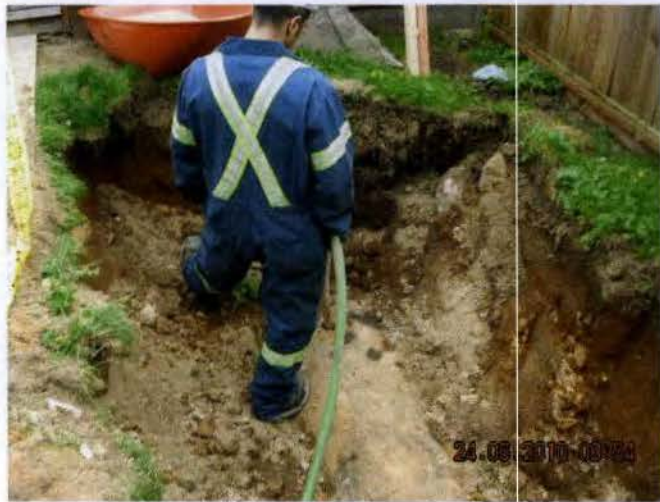
Photo 3 – Pumping out the tank

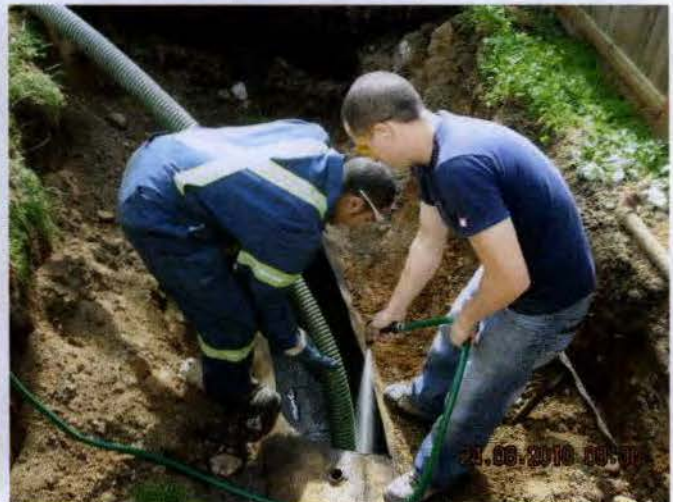
Photo 4 - Rinsing the tank

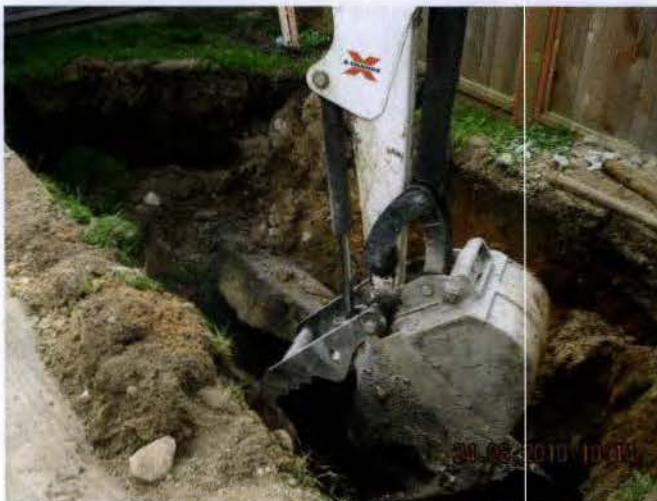
Photo 5 - Extracting the tank

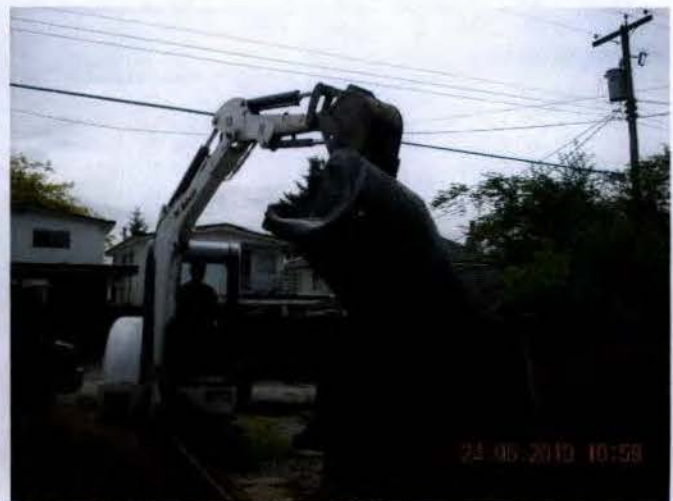
Length:	2.7 m
Diameter:	1.0 m
Capacity:	~ 2,100 L
Type:	Steel. Taken to Allied Salvage and Metals Ltd. in Richmond for recycling
Condition:	A few small perforations no larger than a quarter inch in diameter and a couple of larger holes, about one inch in diameter.
Piping:	All lines removed and recycled with the UST
Contents:	Approx. 2,000 L of oily water pumped out and taken to Sumas Environmental Services in Burnaby for treatment

Photo 6 - Light can be seen shining through one of the perforations

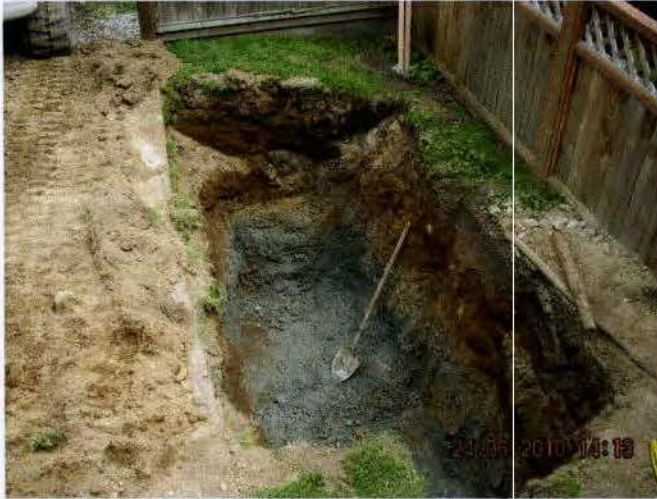
Visual inspection of the empty tank nest suggested substantial leakage and soil contamination (photograph 7); strong petroleum hydrocarbon odours were detected in the soil surrounding the tank. Staining was very pronounced, particularly on the north and south walls; some areas were saturated and exhibited a sheen normally associated with oil (photograph 8). Based on the staining and the odours, the soil was assessed to be above Residential Level (RL) standards; the impact on the soil appeared to be quite severe. The contaminated soil was excavated out; some plumes were found in areas consistent with the location of the biggest perforations in the tank. The north and south excavation walls had to be undermined approximately one metre in order to remove all contaminated soil. After more than fifty tonnes of soil had been removed, it was determined that it was not practical to continue using the excavator; at this point the staining and odour had decreased dramatically, although evidence of some contamination was still present, in the form of a "vein-like" pattern on the

Photo 7 - Signs of contamination

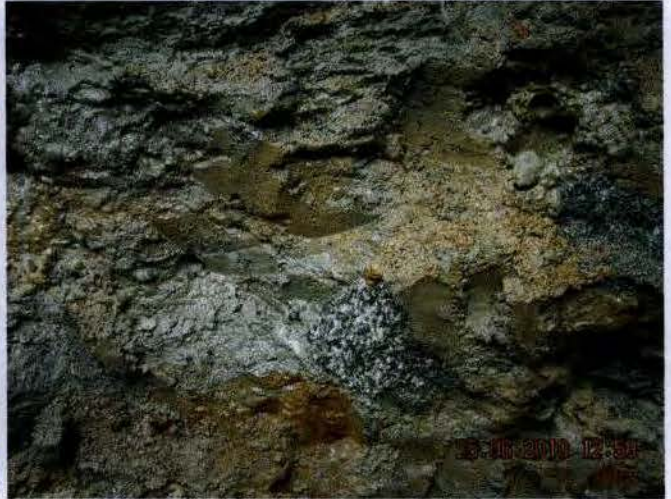
Photo 8 - Oily sheen

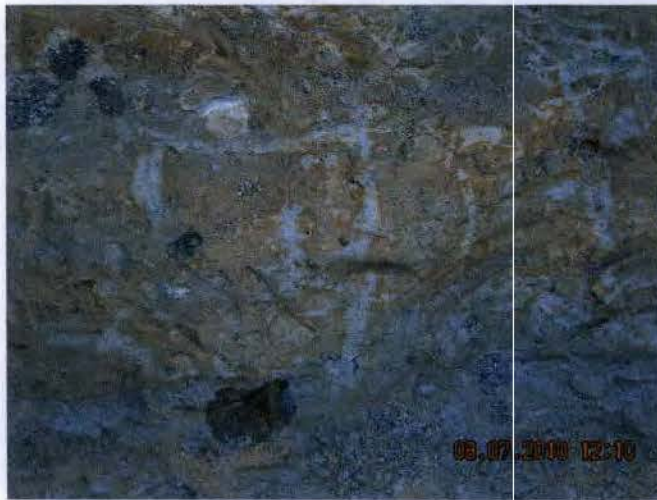
Photo 9 - Impacted soil veins on excavation wall

excavation walls (photograph 9). Hand digging was undertaken to remove the remaining impacted soil (photograph 10)

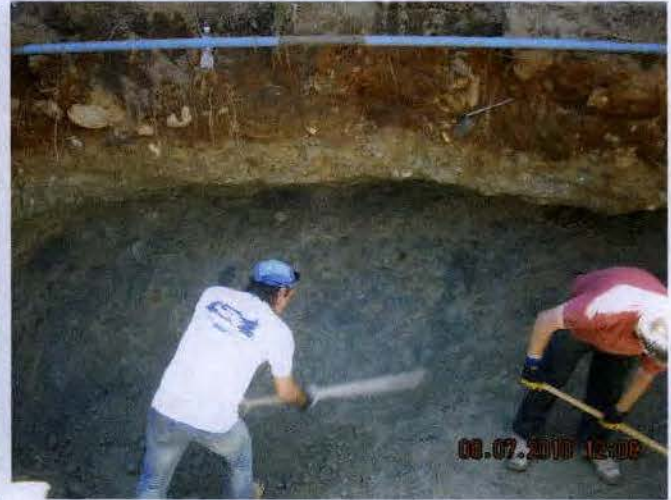
Photo 10 - Hand digging the last remaining impacted soils

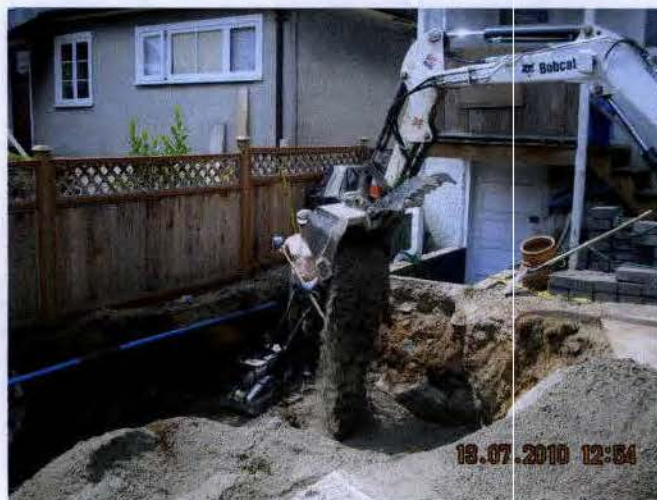
Compacted clean overburden soil that was on top of the tank; clean compacted Sechelt sand. See photograph 11.

Photo 11 - Backfilling and compacting

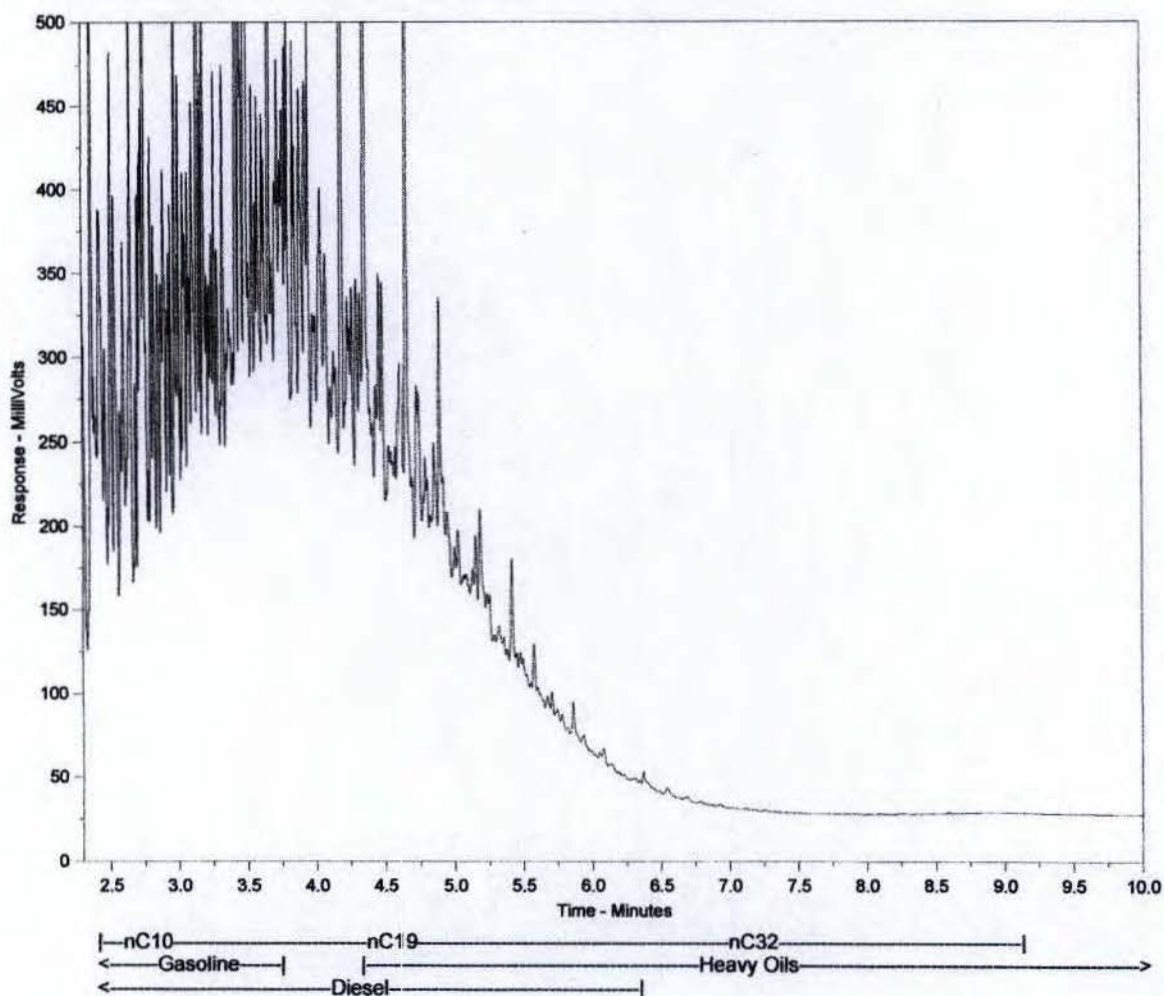
ALS Sample ID: L901968-1
Client Sample ID: STOCKPILE

The scale at the bottom of the chromatogram indicates the approximate retention times of common petroleum products, and three n-alkane hydrocarbon marker compounds.

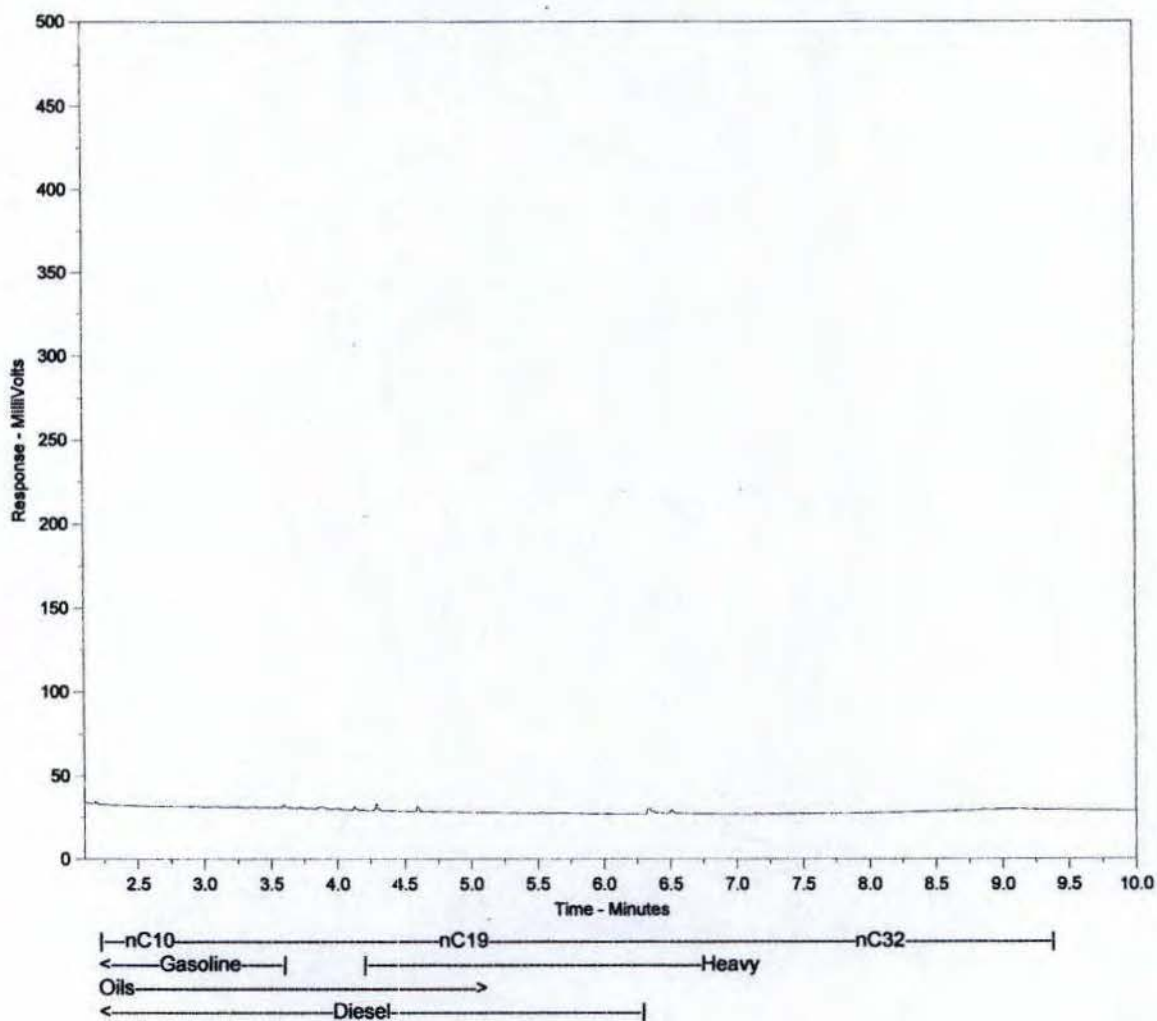
ALS Sample ID: L907383-1
Client ID: BOTTOM

The scale at the bottom of the chromatogram indicates the approximate retention times of common petroleum products, and three n-alkane hydrocarbon marker compounds.

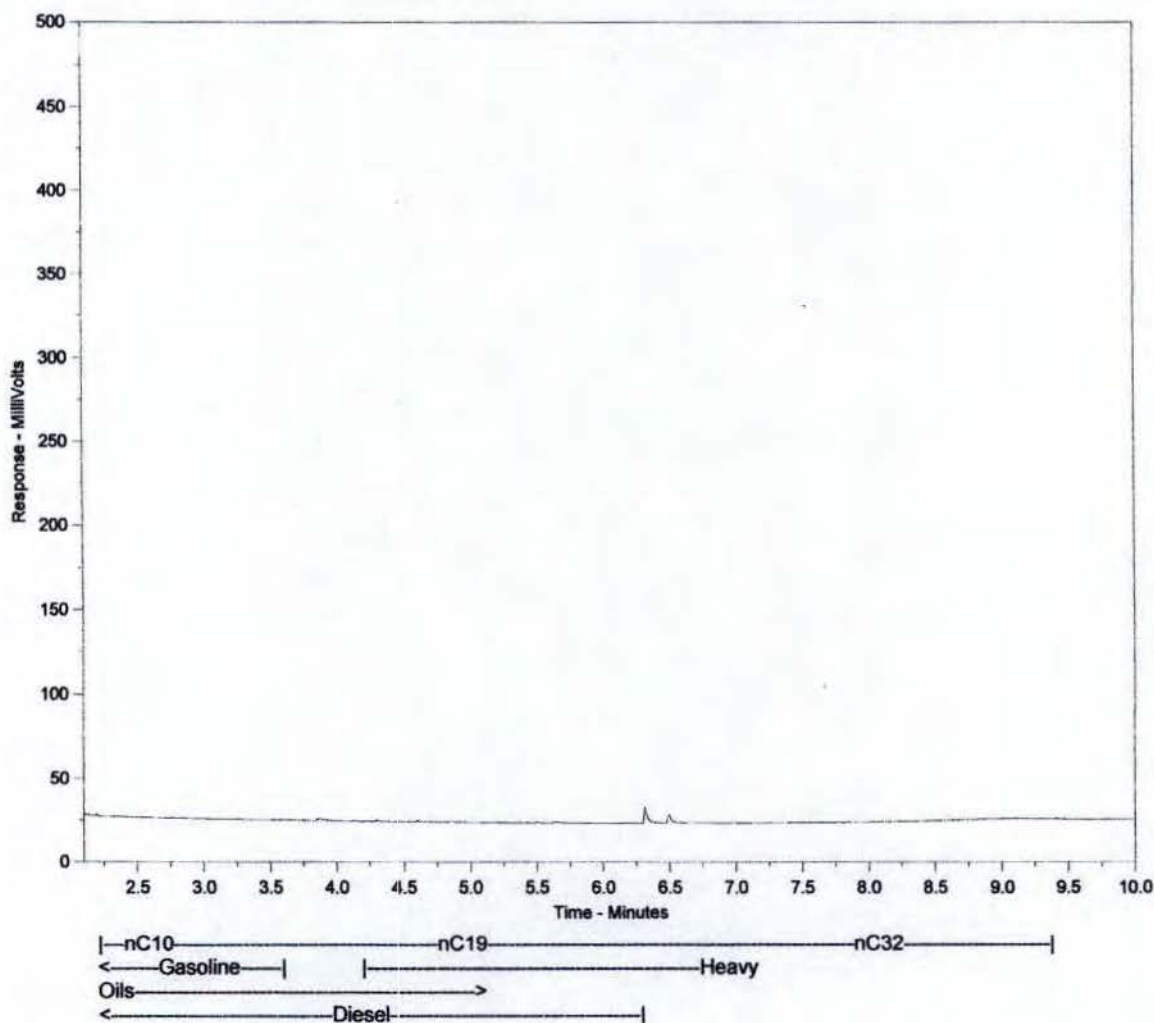
ALS Sample ID: L907383-2
Client ID: NORTH WALL

The scale at the bottom of the chromatogram indicates the approximate retention times of common petroleum products, and three n-alkane hydrocarbon marker compounds.

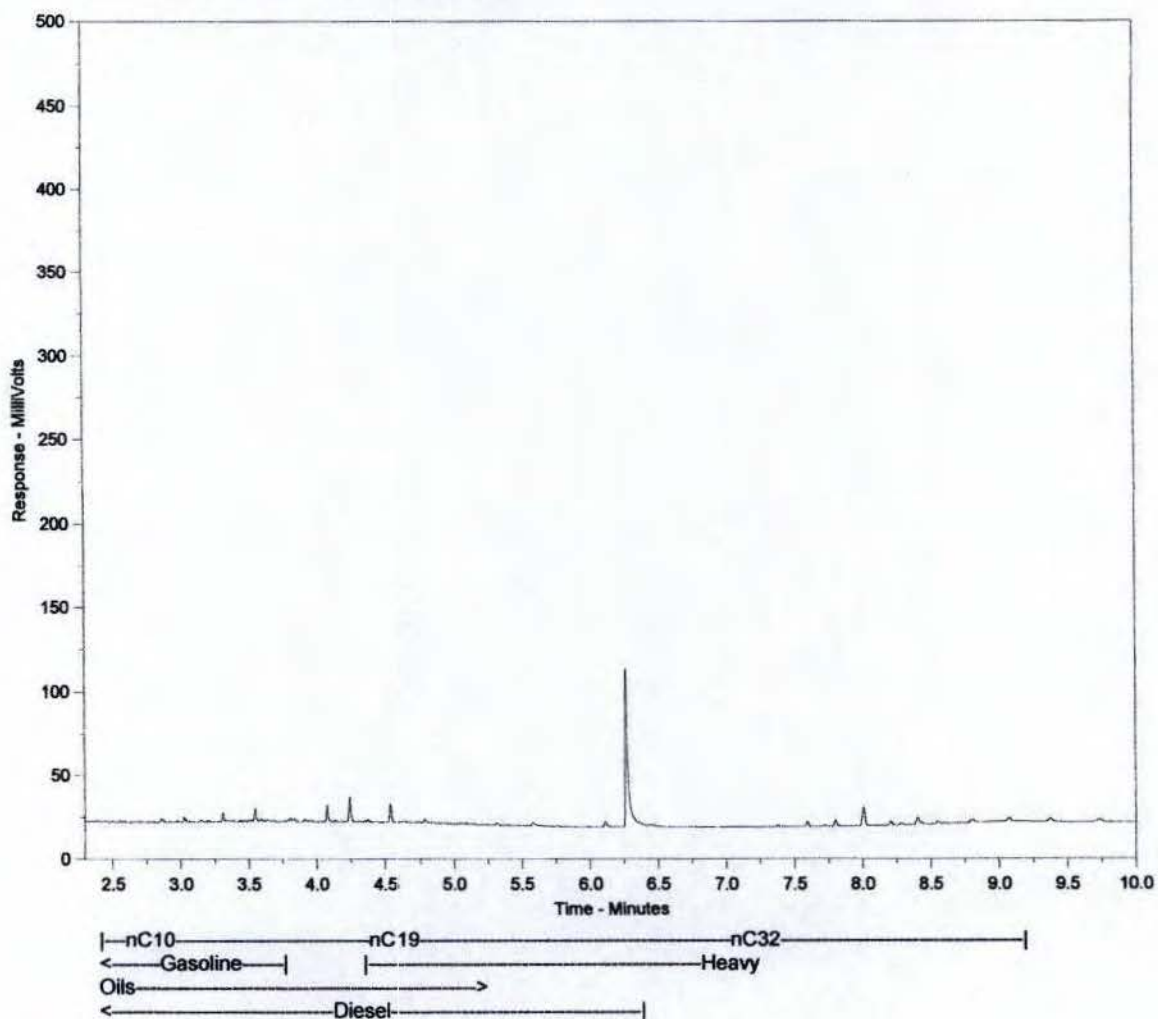
ALS Sample ID: L907383-3
Client Sample ID: SOUTH WALL

The scale at the bottom of the chromatogram indicates the approximate retention times of common petroleum products, and three n-alkane hydrocarbon marker compounds.

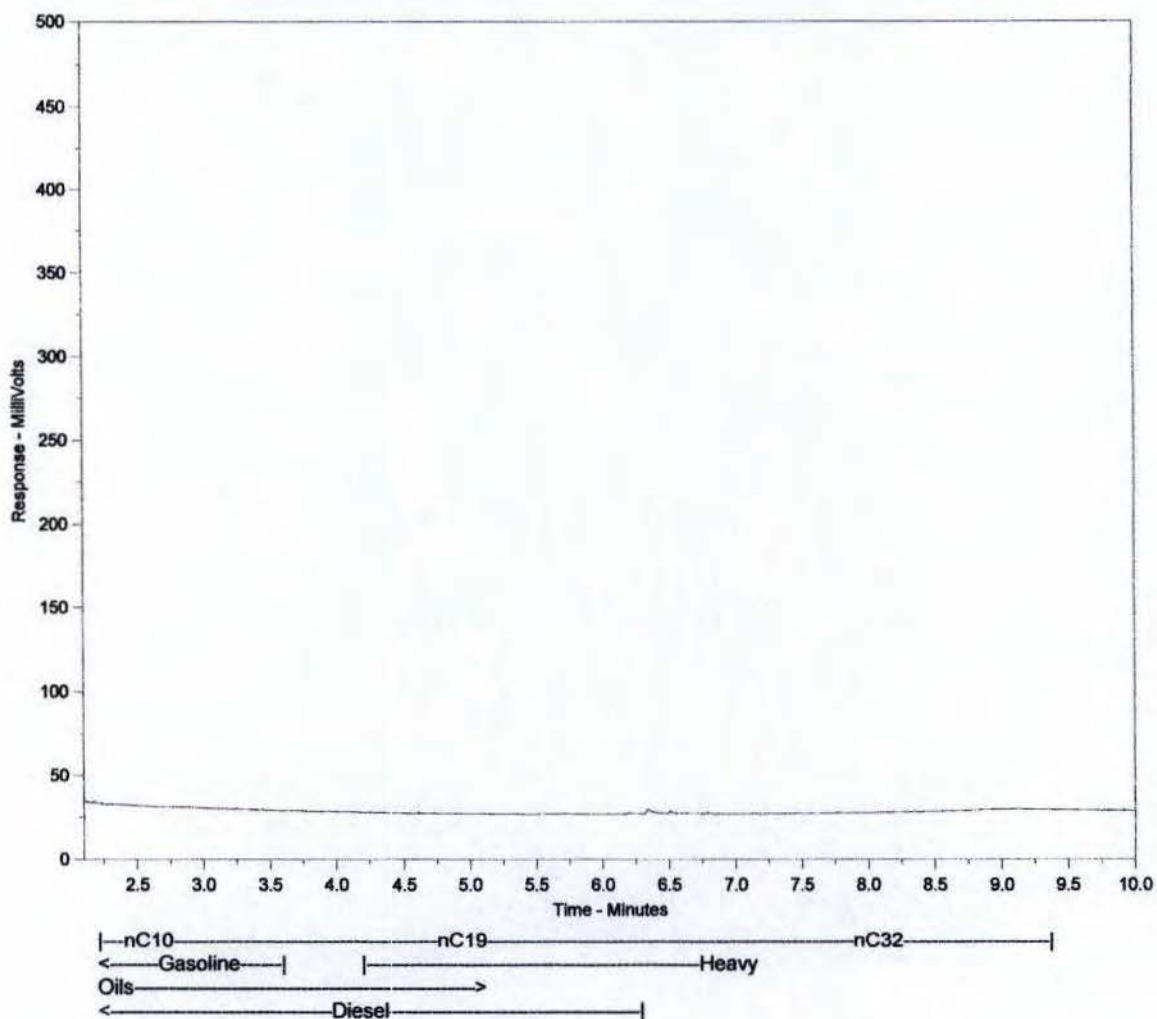
ALS Sample ID: L907383-4
Client ID: EAST WALL

The scale at the bottom of the chromatogram indicates the approximate retention times of common petroleum products, and three n-alkane hydrocarbon marker compounds.

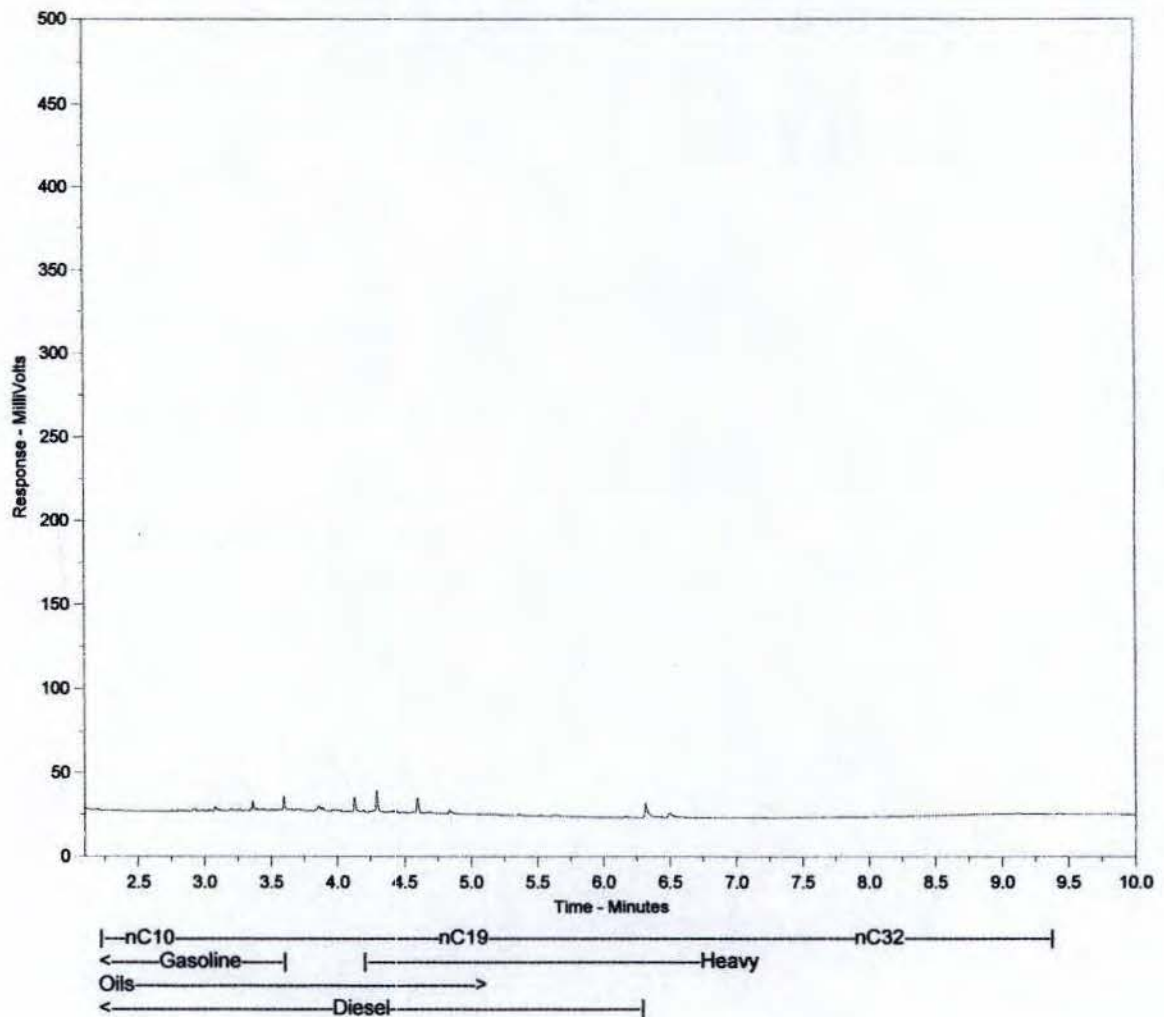
ALS Sample ID: L907383-5
Client ID: WEST WALL

The scale at the bottom of the chromatogram indicates the approximate retention times of common petroleum products, and three n-alkane hydrocarbon marker compounds.
