Existing Ecological Conditions at Proposed New Brighton Park Habitat Enhancement Project PMV Habitat Enhancement Program

Prepared for:
Port Metro Vancouver
100 The Pointe, 999 Canada Place
Vancouver, BC V6C 3T4

Prepared by:
Hemmera Envirochem Inc.
18th Floor, 4730 Kingsway
Burnaby, BC V5H 0C6

File: 302-035.04
June 2015

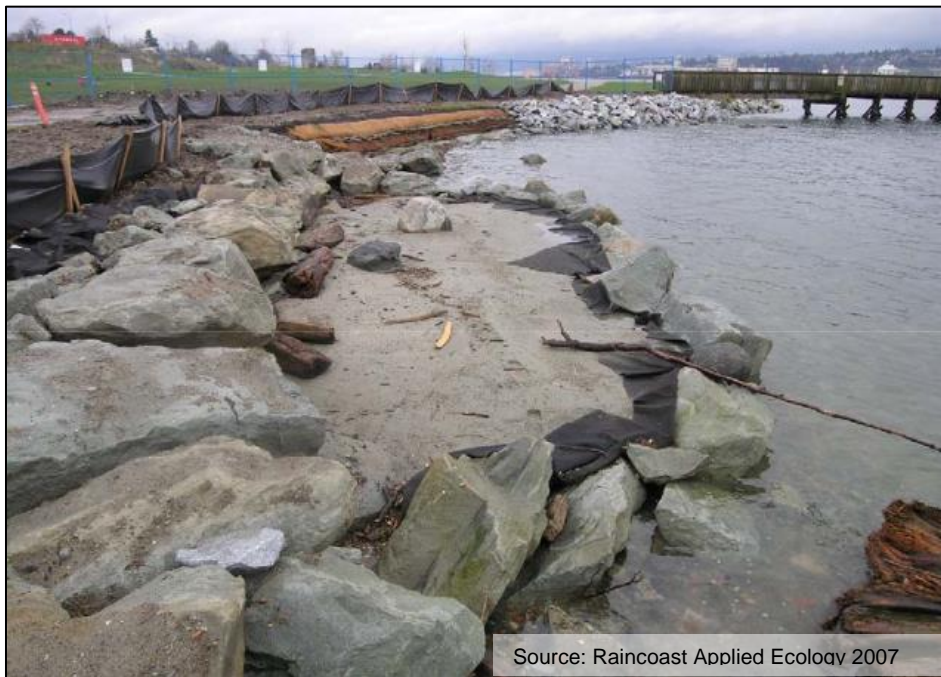
Photo 2 Completed Shoreline Stabilization with Dune Grass Bench in Foreground Bioengineered and Boulder Banks in Background (facing west)

Infilling of the shoreline ceased around the early 1970's (**Appendix A**). However, wave-related erosion along the eastern portion of the park prompted shoreline stabilization works by Kerr Wood Leidal and Raincoast Applied Ecology in 2006-2007. The project included stabilizing the backshore with large boulders for armouring and bioengineered banks (using Hooker's willow (*Salix hookeriana*), wattle and geotextile soil wrap; **Photo 2**), and the re-working of rip rap groynes. To improve the marine riparian habitat value of the site, native dune grass (*Lymus mollis*) benches were created at the seaward toe of the stabilized banks (**Photo 2**) and on the tops of the groynes. Dune grass and large-leaved lupine (*Lupinus polyphyllous*) meadows were created at the tops of some banks, and riparian shrub (thimbleberry (*Rubus parviflorus*), Nootka rose (*Rosa nutkana*), snowberry (*Symphoricarpus albus*), red flowering currant (*Ribes sanguineum*), and mock-orange (*Philadelphus lewisii*)) and tree (black cottonwood (*Populus trichocarpa*)) habitats were created along the tops of the stabilized banks.

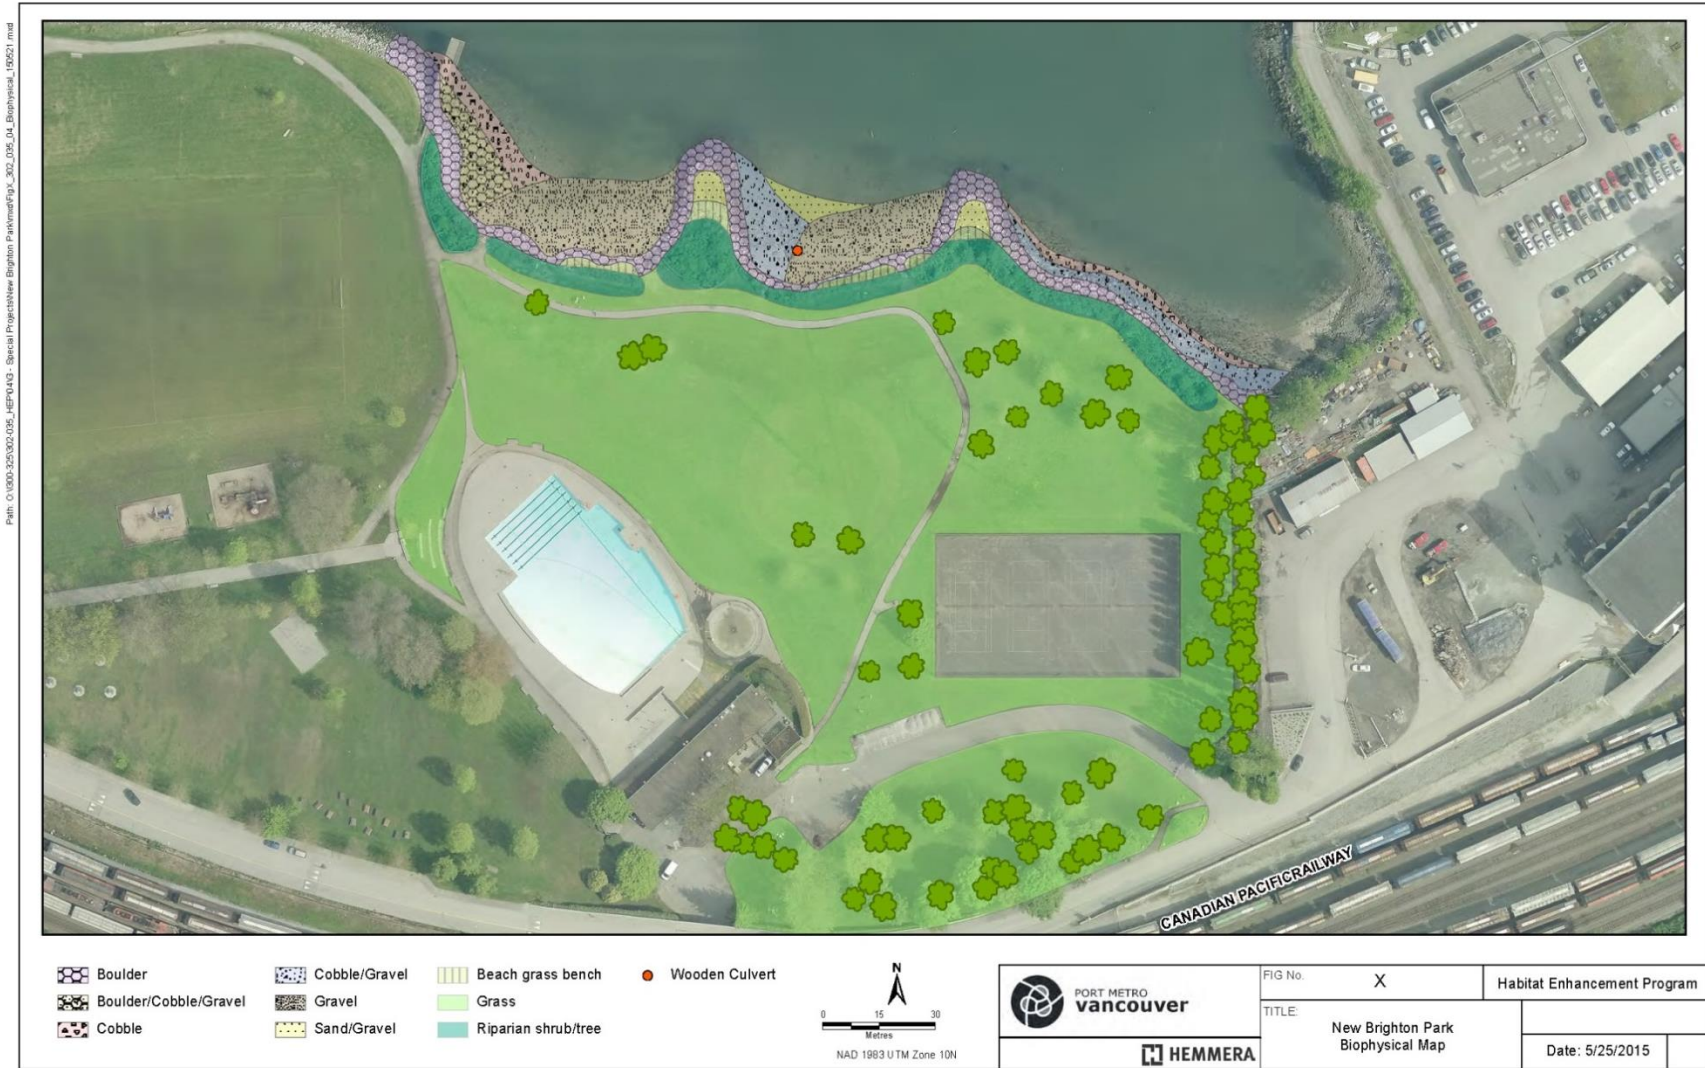
Figure 7 New Brighton Park Biophysical Map

The upland park area is relatively flat, sloping up to an overpass at New Brighton Road near the southern bounds of the park. Organic soil, covered with grass and the occasional landscaped tree, is interspersed with gravel pathways and an access road to New Brighton Pool (**Figure 7, Photo 3; Appendix B**). A section of the newly enhanced Renfrew Creek (**Section 3.1**) at Creekway Park is located along the southern edge of New Brighton Road. The Creekway Park water feature receives water flow from stormwater in the Hastings Park catchment. This section of the water feature consists of a series of weirs to retain storm water. Flows in the cobble lined stream channel were low during the biophysical assessment. The stream channel follows a steep gradient to a corrugated steel half arch culvert that discharges into a storm drain on the north side of the New Brighton Road overpass. From this location, the stormwater is culverted under the park and discharges through a wooden outlet into the intertidal beach in Burrard Inlet (**Figure 7; Appendix B**).

Burrard Inlet is an industrial port that is heavily developed with armoured slopes, bulkheads and ship loading facilities, which reduces fish and wildlife habitat values. Due to prior shoreline stabilization and creation of marine riparian habitat (**Section 3.1**), the shoreline of the proposed enhancement area consists primarily of large boulders and elevated dune grass benches (**Figure 7, Photo 4 and Photo 5**).

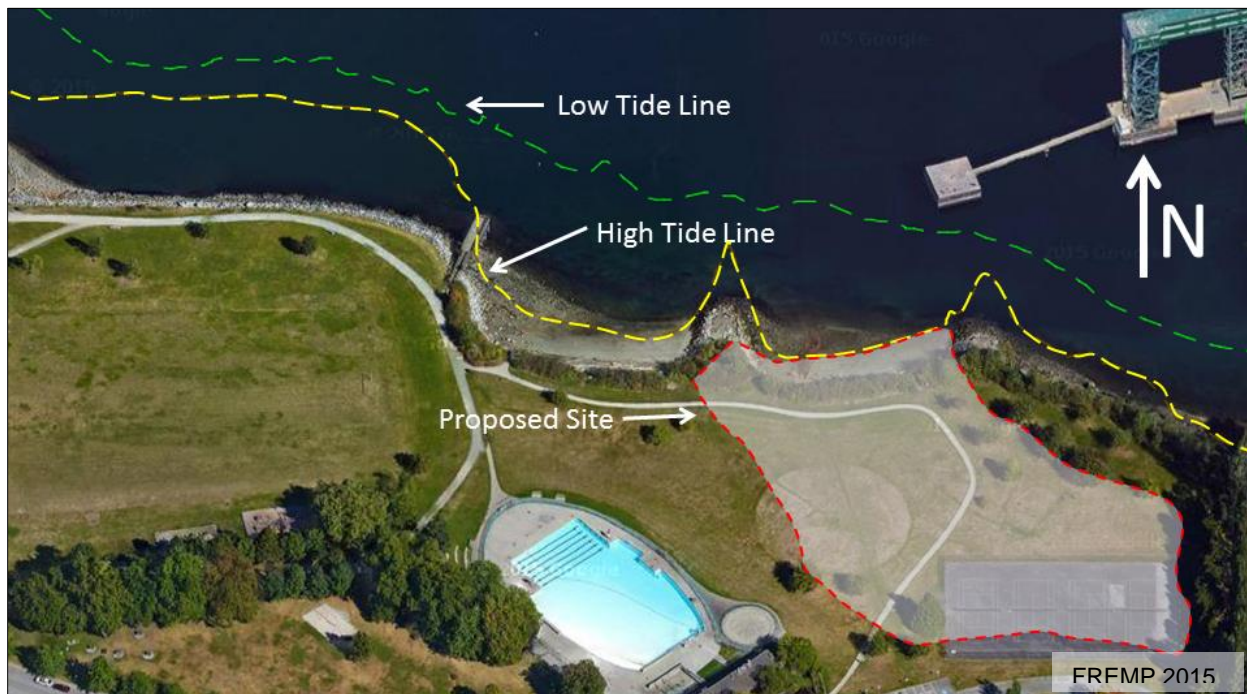
Figure 9 High and Low Tides Lines at the Project Site

Three moderately sloping intertidal beaches, separated by two rock groynes, run along the waterfront in the eastern portion of New Brighton Park. The Burrard Inlet Environmental Action Program (BIEAP) Atlas characterizes intertidal substrate types along Burrard Inlet. According to the atlas, the intertidal beaches at the eastern end of the park are comprised of cobble, fine gravel, and sand with some boulder (**Figure 8; FREMP 2015**). This characterization was confirmed during the biophysical assessment (**Figure 7, Photo 4; Appendix B**). Tides along New Brighton Park are semi diurnal and the tidal range exceeds 5 m (**Appendix B, Table 1; Figure 9**).

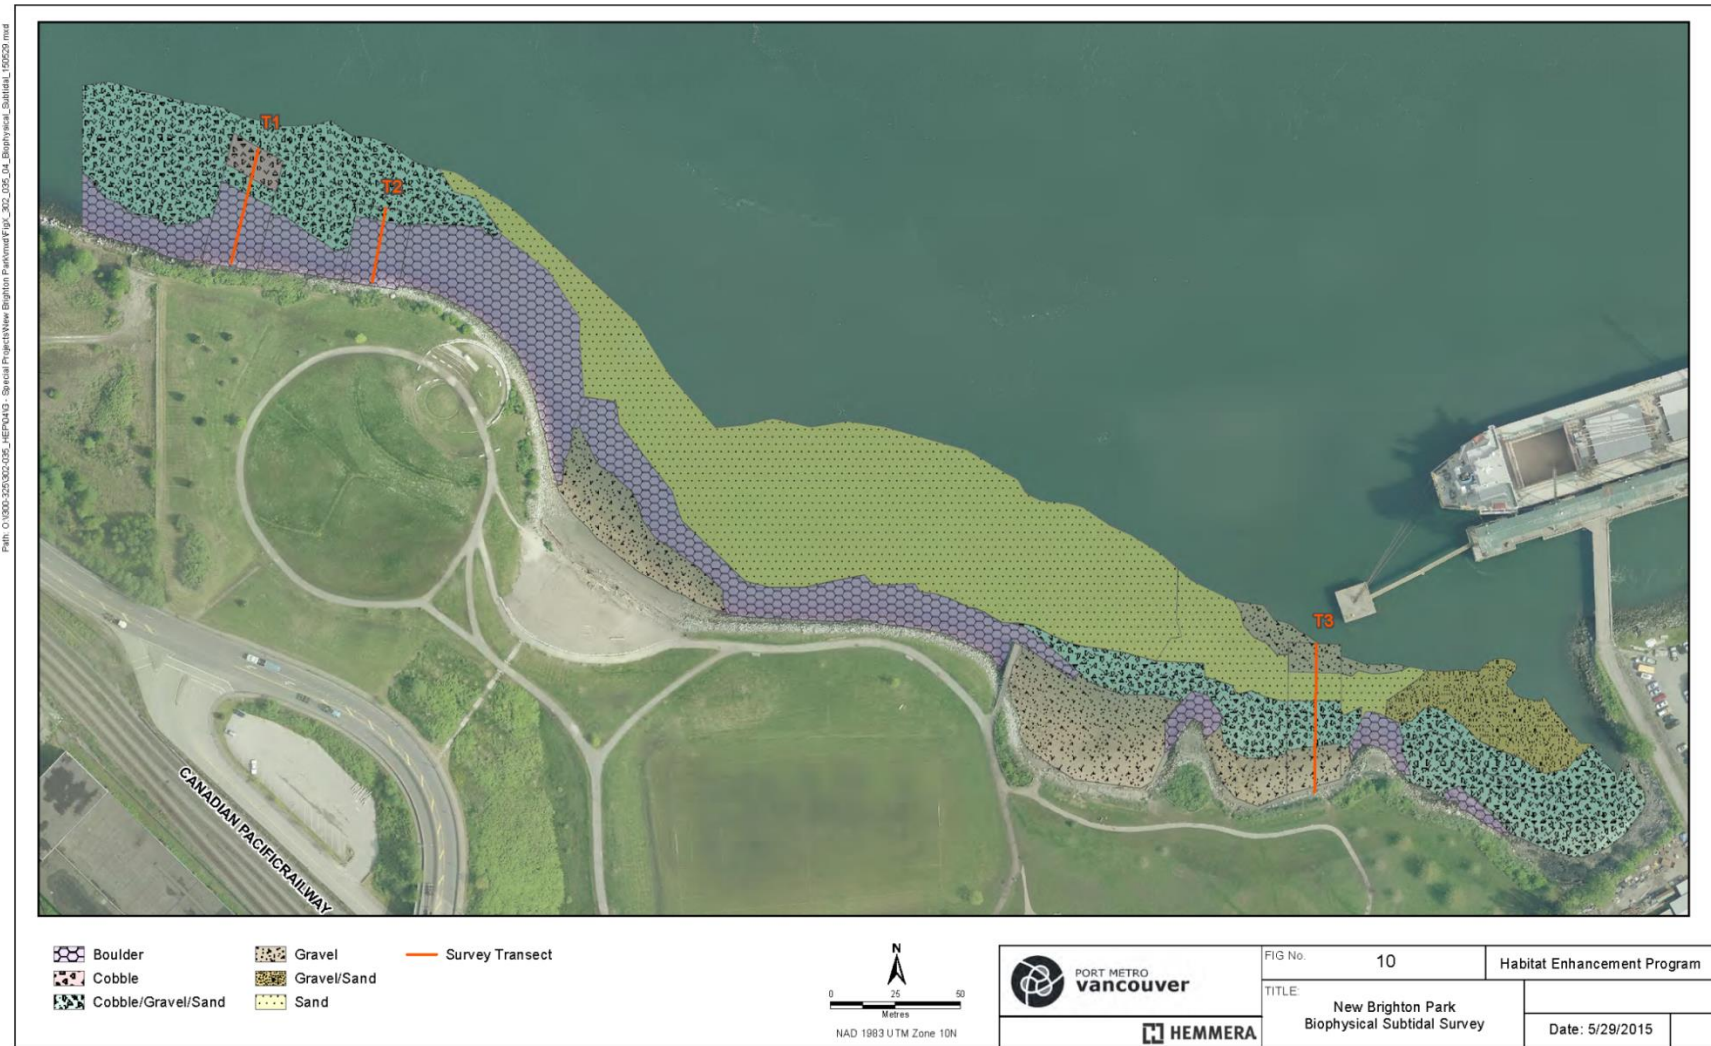
Figure 10 New Brighton Park Biophysical Subtidal Map

SCUBA survey results (west and east) characterized the sediment types present in the nearshore area (**Figure 10**). To the west, the deeper subtidal zone (9 m – 5 m) is characterized by coarser sediments (cobble to gravel). The shallower portions were predominantly rip rap, which is described as boulders (from 5 m depths and shallower). There was a greater proportion of boulder habitat along the west side of the park. The eastern transect followed a shallower grade, typical of a coarse sediment beach (sand, gravel, cobble, and shell debris). The shallow grade resulted in a longer transect than was required to survey the western transects. At depth (4 m), substrate was primarily comprised of a gravel, sand, and shell debris mix, which transitioned into coarser materials (cobble and larger shell debris) at approximately 0 m CD (**Photo 6, Appendix C: Hemmera Biophysical Assessment: Dive Survey Results**). The random swim survey at the west end indicated that the nearshore was made up of large sediment (boulder), while a mix of cobble, gravel, and sand sediment was observed in areas deeper than approximately 4 m CD. The random swim survey at the east end of the site determined the presence of softer sediments, gravel, and sand, mixed with cobbles.

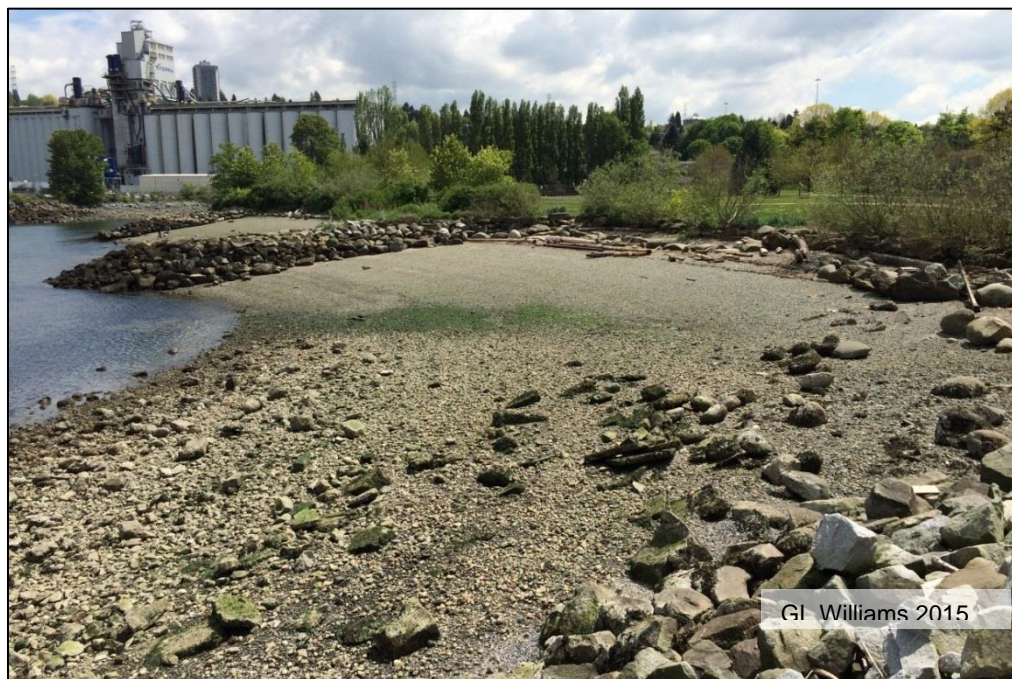
Photo 4 Rock Groynes Separating Scalloped Intertidal Beaches with Varying Substrates and Boulder Banks Looking East

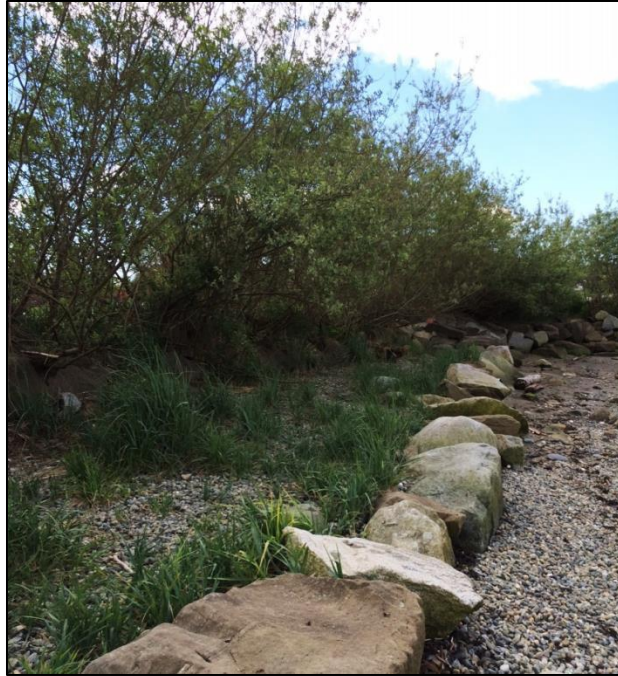
Photo 5 Dune grass Bench Created with Boulders and Sand Fill below Riparian Shrub Backshore Habitat

The riparian shrub and tree habitat bordering the shoreline bank (above HWM) consisted of native species, many of which were planted during shoreline stabilization works in 2006-2007 (**Section 3.1; Photo 7**). A full list of native shrub species is presented in **Appendix B Table 2**. Black cottonwood (*Populus balsamifera*) and red alder (*Alnus rubra*) were interspersed in this band of habitat. Several narrow dune grass benches were observed during the biophysical assessment (**Photo 5**).

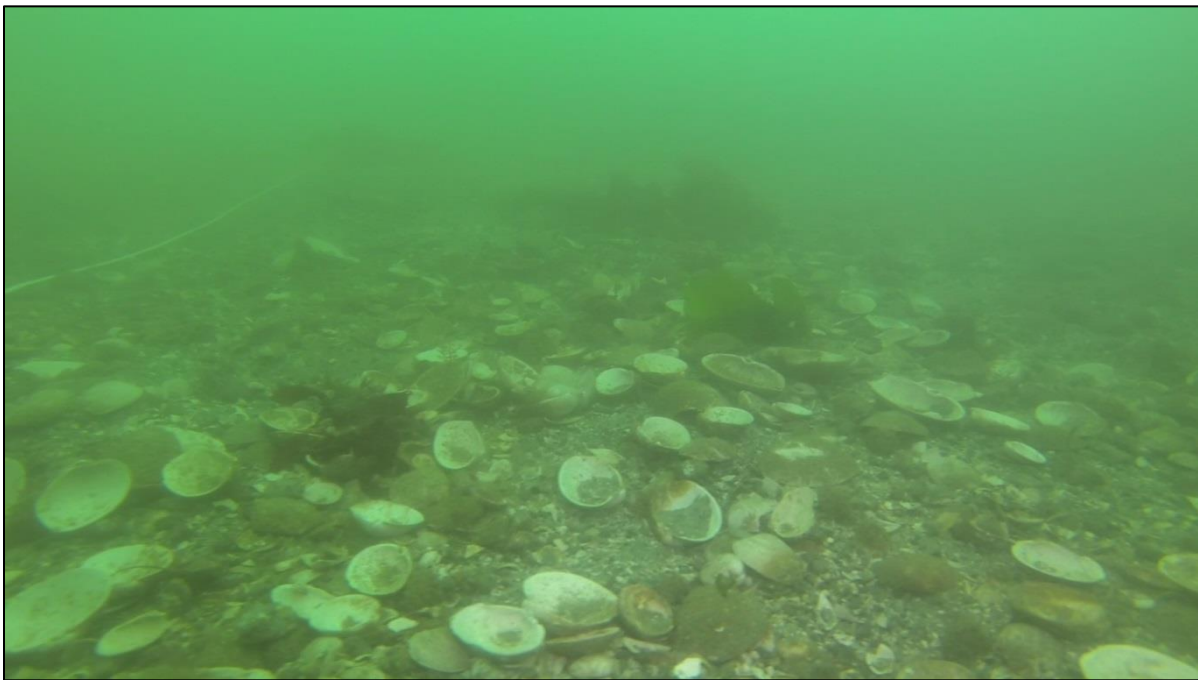
Photo 6 Gravel, Cobble, Shell Debris Sediment Nearshore of Intertidal Beach from Transect 3

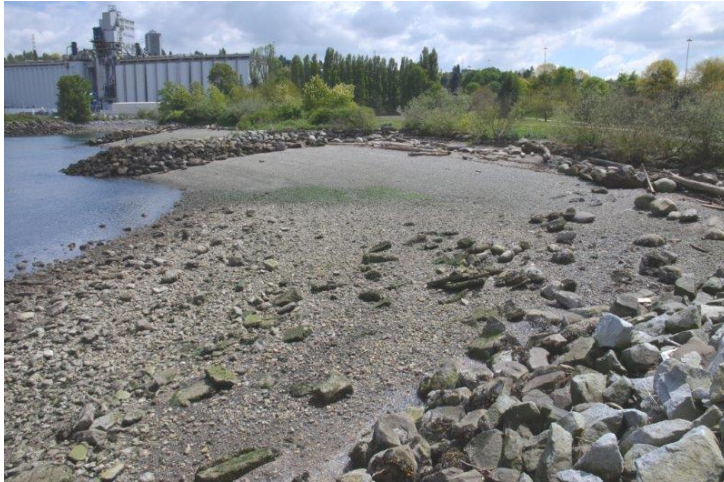
Photo 1. Extended rounded rock groins separating scalloped intertidal beaches.

The entire Burrard Inlet shoreline within the study area has been reconstructed for shoreline protection purposes, with large diameter rounded rock groins constructed to create three scalloped beach areas (Photo 1). The existing intertidal habitat consists of a wide, moderately sloping beach covered in unconsolidated cobble, gravel, and sand beach sloping up to an upper intertidal rock berm (Photo 2). A beach grass bench is situated just above the higher high water level and a band of native shrubs planted along the top of bank (Photo 3). At the western limit of the study area, a timber pile supported observation deck exists (Photo 4).

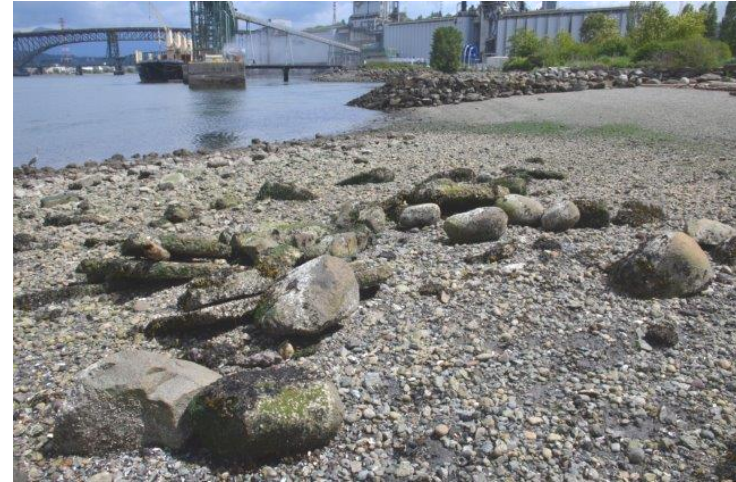
Photo 2. Boulder, cobble, gravel, and sand beach substrates.

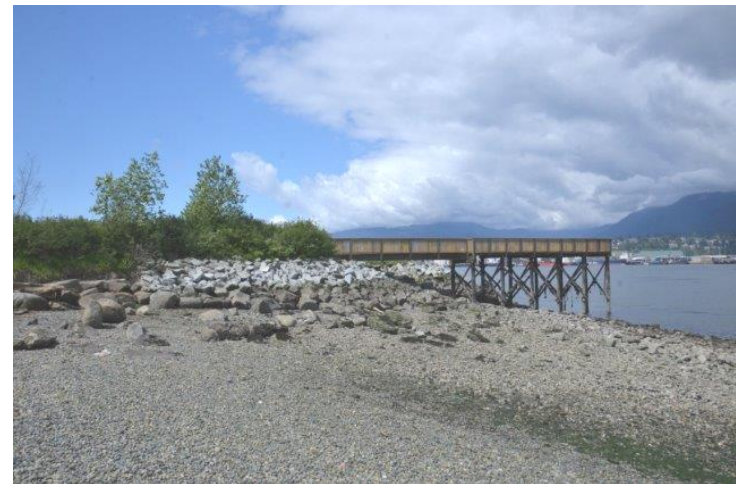
Photo 4. Timber pile supported observation deck at the western limit of study area.

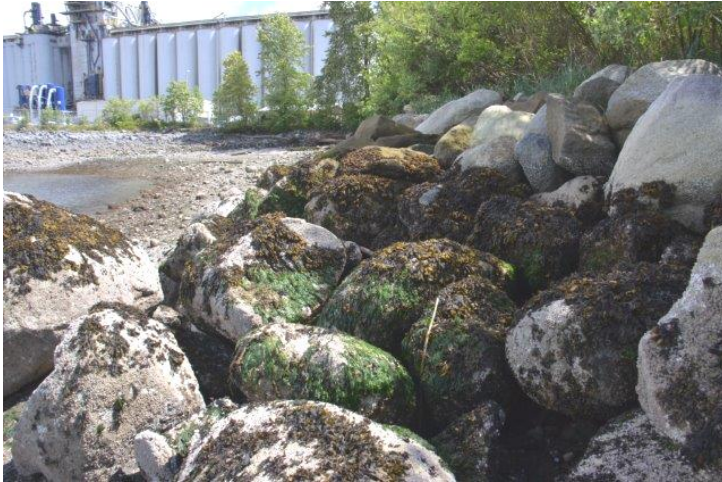
Photo 5. Luxuriant growth of macroalgae on large rounded rock installed for bank armoring.

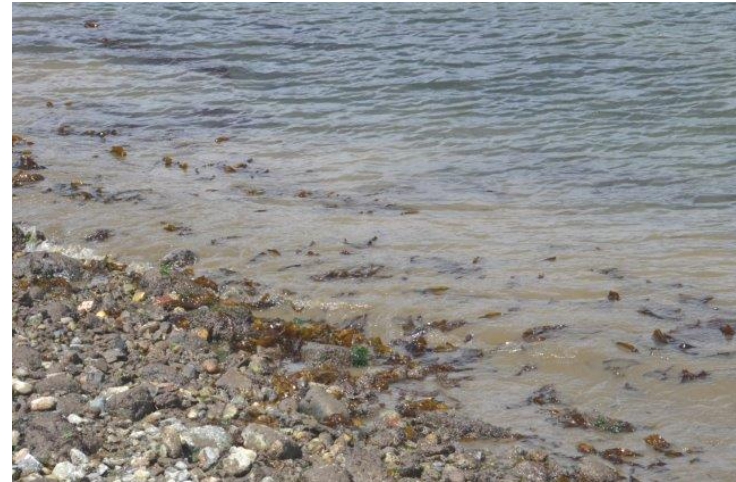
Photo 6. Bull and sugar kelps colonizing rock substrate in the lower beach intertidal zone.

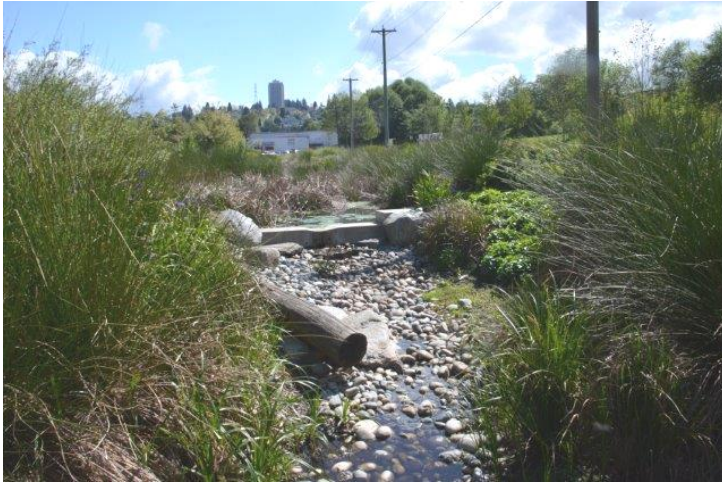
Photo 13. Daylighted Renfrew Creek showing weir and cobble-gravel lined channel in Creekside Park.

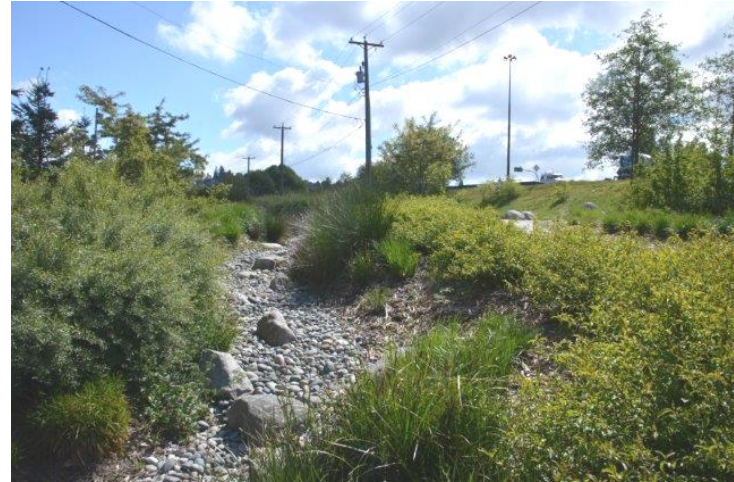
Photo 14. Steep section of daylighted stream channel with minimal waterflow in May 2015.

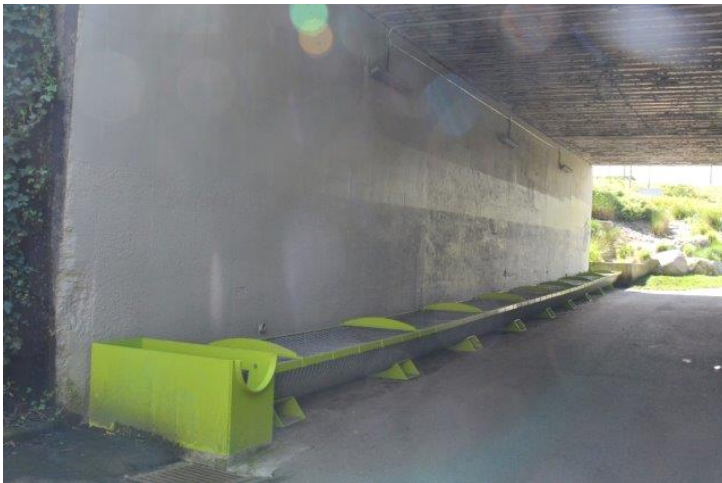
Photo 15. Aboveground flume transports flows from daylighted stream to underground culvert that discharges into Burrard Inlet.

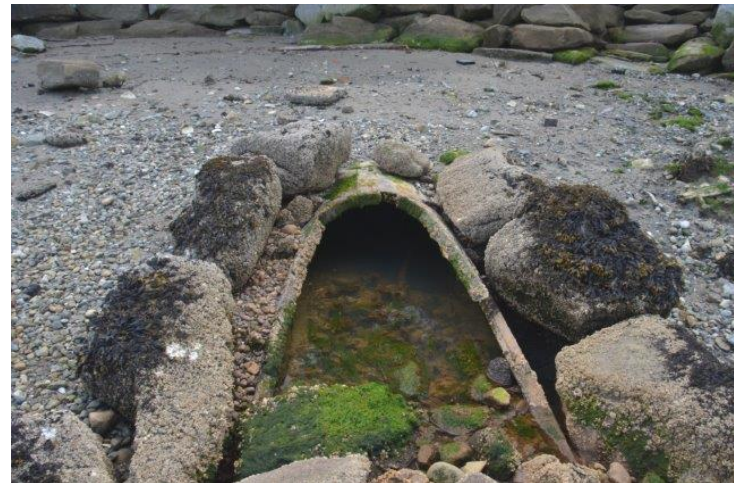
Photo 16. Wooden culvert beach outlet of Renfrew Creek that discharges into Burrard Inlet.
