2.1 SEGMENT 2 W 1st Ave to Anderson St

Our Recommendation

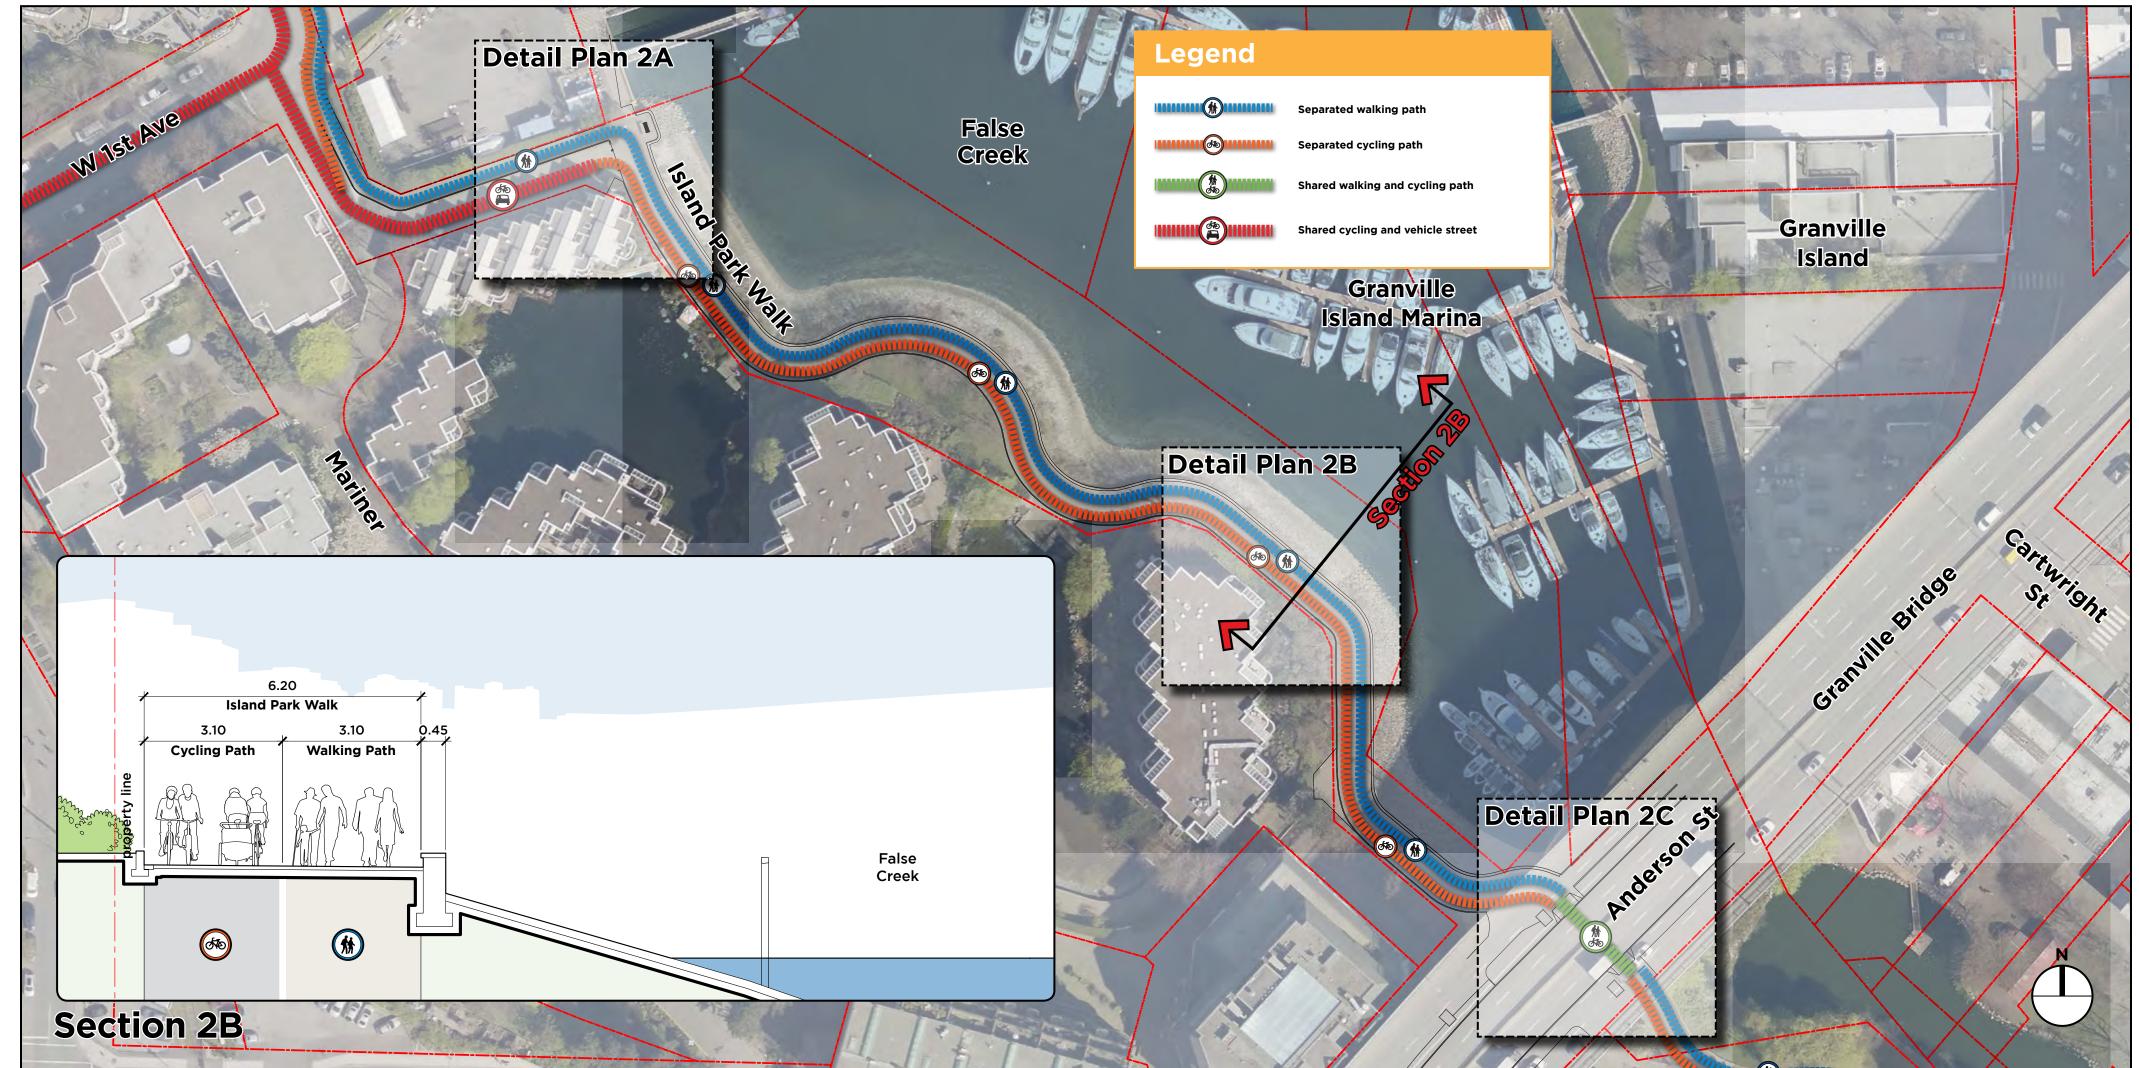
Refer to Board 2.2 for Detail Plans

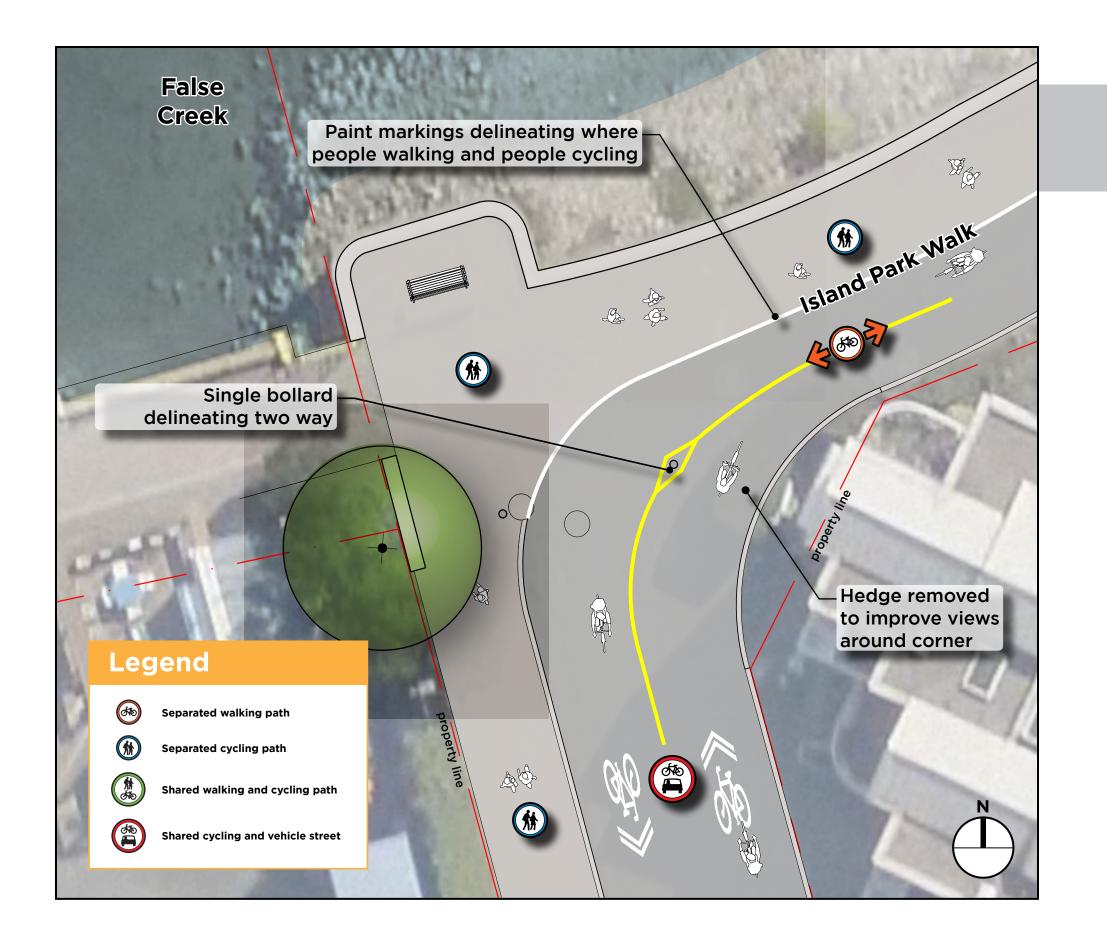
Detail Plan 2A

Reconfigure the sharp corner near the fish market on Island Park Walk.

Recommended Solutions	Why?	When?
Reconfigure the sharp corner near the fish market on Island Park Walk. See Detail Plan A, Board 2.2	Overgrown vegetation and bollards reduce visibility and present hazards around this tight corner. High foot	2016
Key components of design:	traffic volume near the fish market	• • •
 Trimmed vegetation on both sides of path. 	increases the potential for conflict.	6 6 6
 Relocated bollards. 		• • •
		•

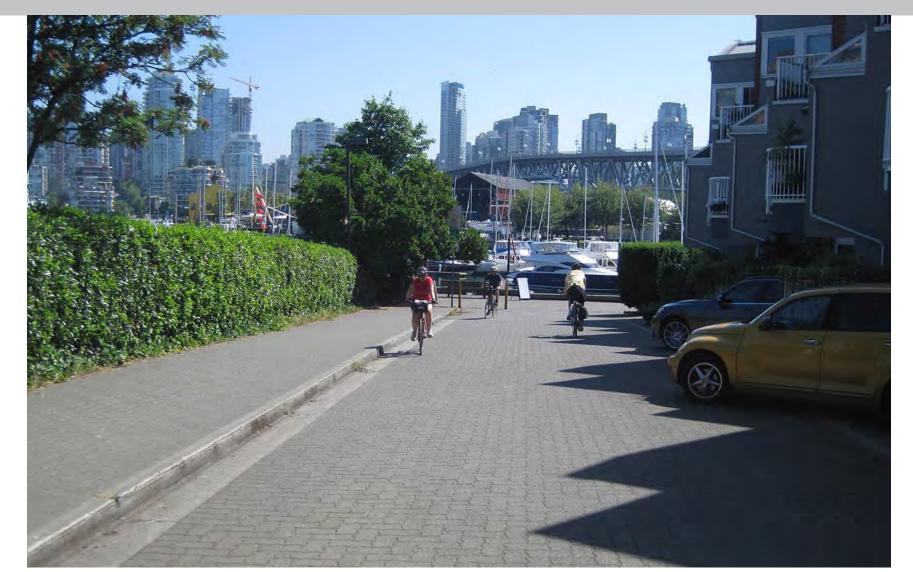
Existing view, Creekside Drive and Island Park Walk looking toward Granville Island

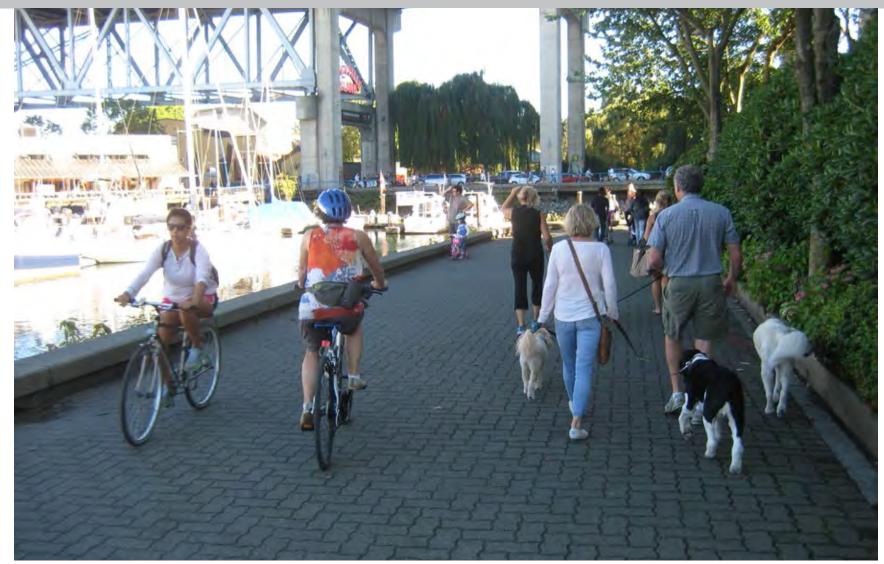
Existing view, Island Park Walk looking East toward Anderson Street

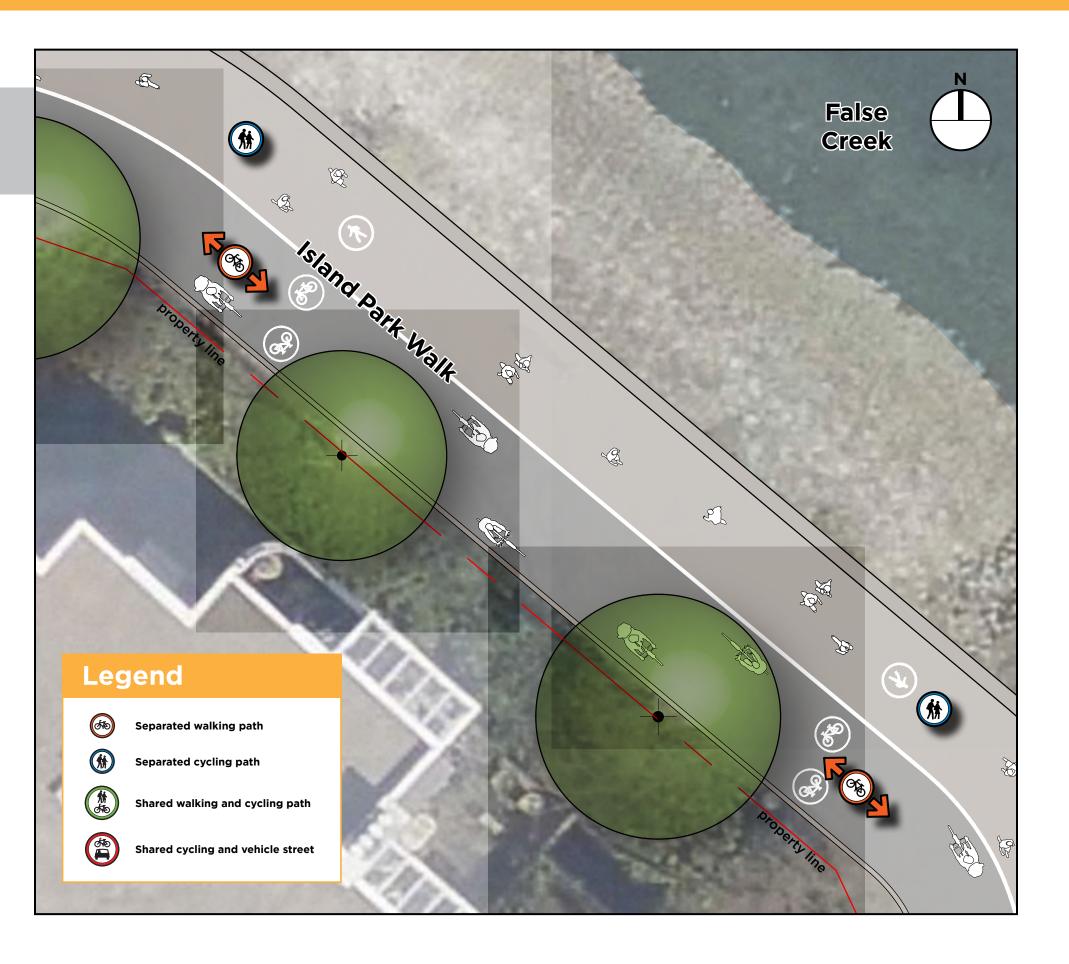
Detail Plan 2B

Provide painted separation and signage to clearly mark walking and cycling paths.

New curb edge to improve walking path. Painted pavement markings and signage to clearly mark walking and cycling paths. 		
Provide painted separation and signage to clearly mark walking and cycling paths. See Detail Plan B, Board 2.2	Separated paths improve safety and comfort for all Seawall users.	2016
Key components of design: • Existing 6.2m path maintained.		• • • • • • • • • • • • • • • • • • •
Re-paint the crossing at Anderson Street to include separate crossings for people walking and cycling. See Detail Plan C, Board 2.2 Key components of design: • 3.0m wide crosswalk and 3.0m wide bike crossing.	The crossing at Anderson Street does not have a signal and is not painted as a cross-bike. Bridge piers south of the crossing limit visibility for people driving.	2016
Future Considerations	Why?	•
Monitor effectiveness of improvements at Anderson Street crossing and consider installing a traffic light to clarify right of way. Work with Granville Island (CMHC) to improve access to the island for people using all modes of transportation along Anderson Street, consistent with their upcoming transportation plan.	More substantial changes need to be consistent with Granville Island's long-term transportation plan.

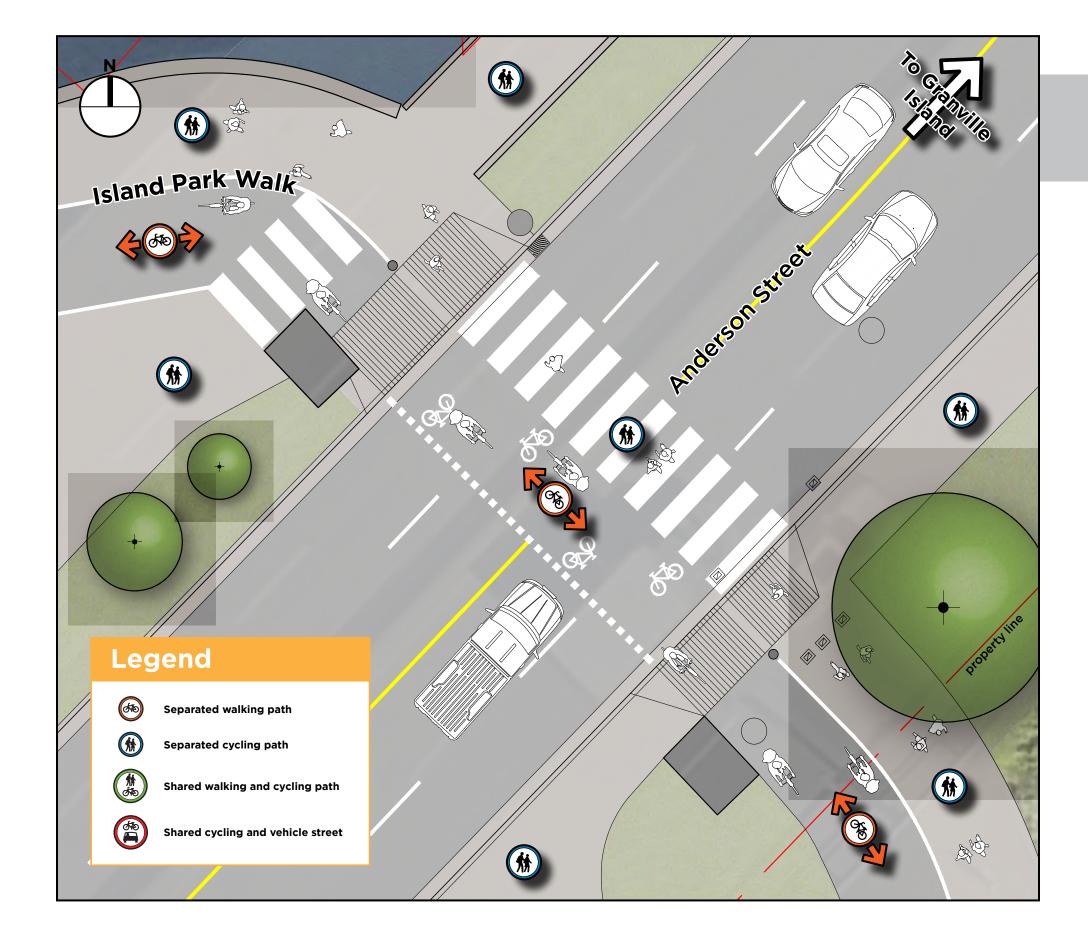
Detail Plan 2C

Re-paint the crossing at Anderson Street to include separate crossings for people walking and cycling.

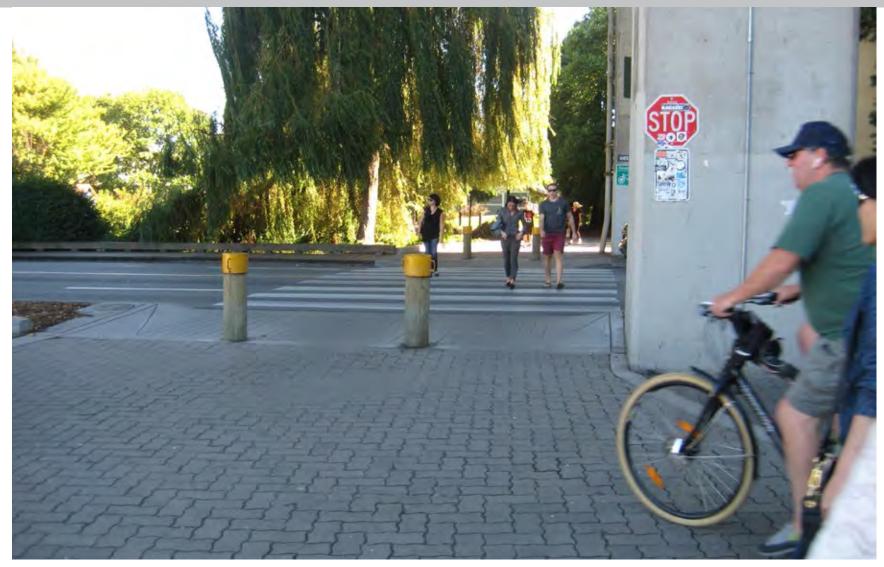
Existing view, East side of Anderson Street looking West
