## Summary of 10<sup>th</sup> Ave (Hospital Zone) Guided Tour - October 25, 2018

### General Comments: Phase 1 Area (west of Willow, and between Cambie and Ash Streets)

### General Comments: Phase 2 Area (east of Willow)

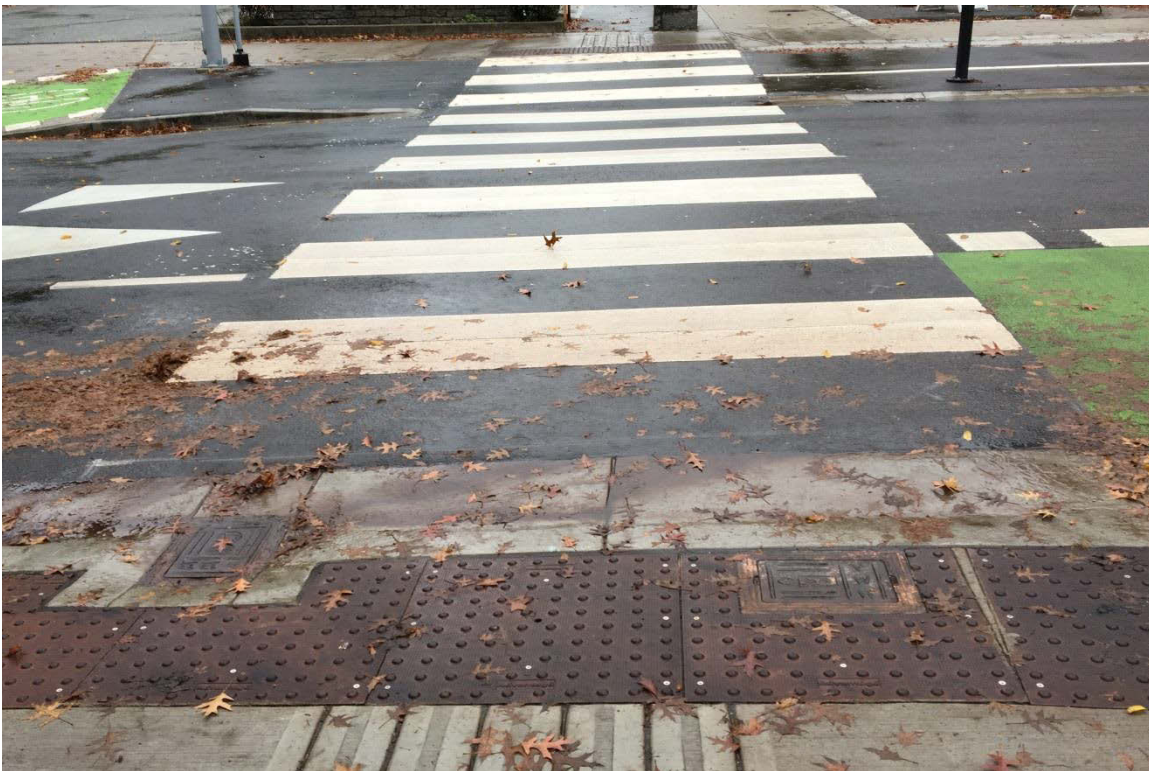
Figure 2 - Crosswalk at east side of Willow St (facing south)

- Concern raised that when are crossing the street heading south, they aren't realizing that they are crossing a bike lane on the south side of the crosswalk. (see Figure 2)

- Committee members noted that it's much easier to see the pedestrian crossings with the zebra stripes now. However, in the case of the east crosswalk, the spacing of the zebra stripes is such that there can be a large gap at the curb letdown which means it isn't necessarily clear to someone with low vision when they are entering the roadway (see Figure 2).

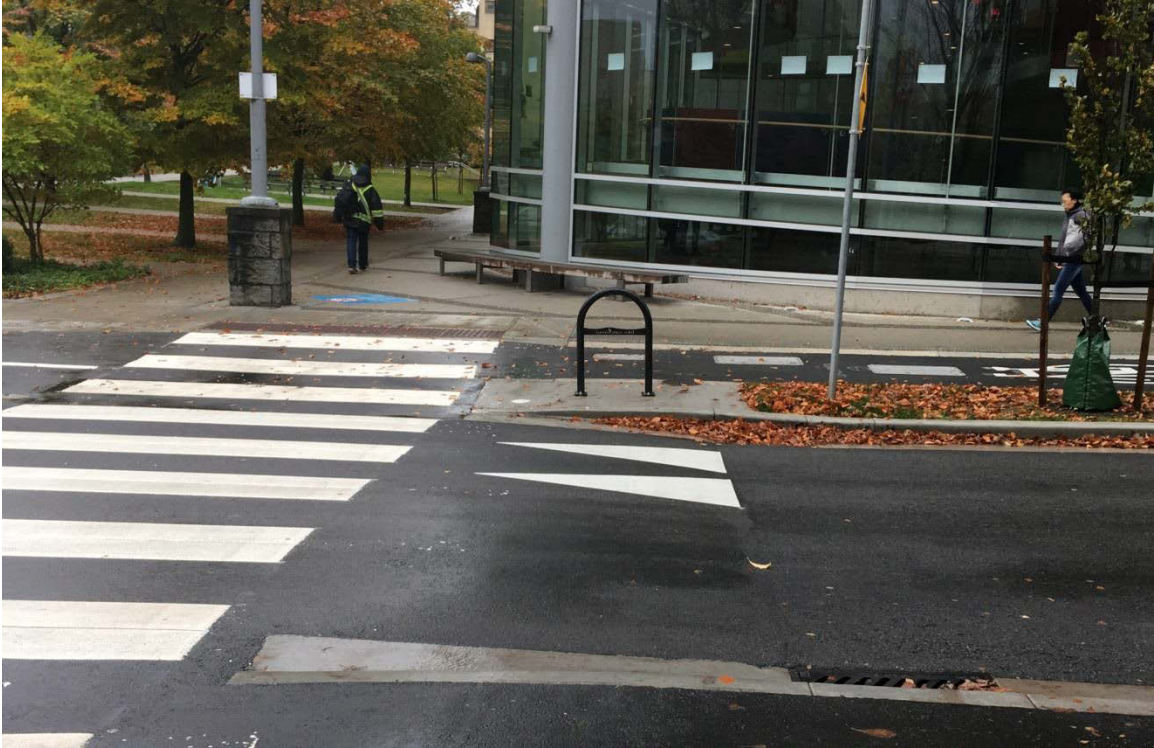
Figure 3 - Crosswalk and bike rack at west side of Willow St (facing south)

- Concern raised with respect to the bike rack at the southwest corner, with a feeling that it is too close to crosswalk and parked bikes would encroach on the crosswalk (see Figure 3)

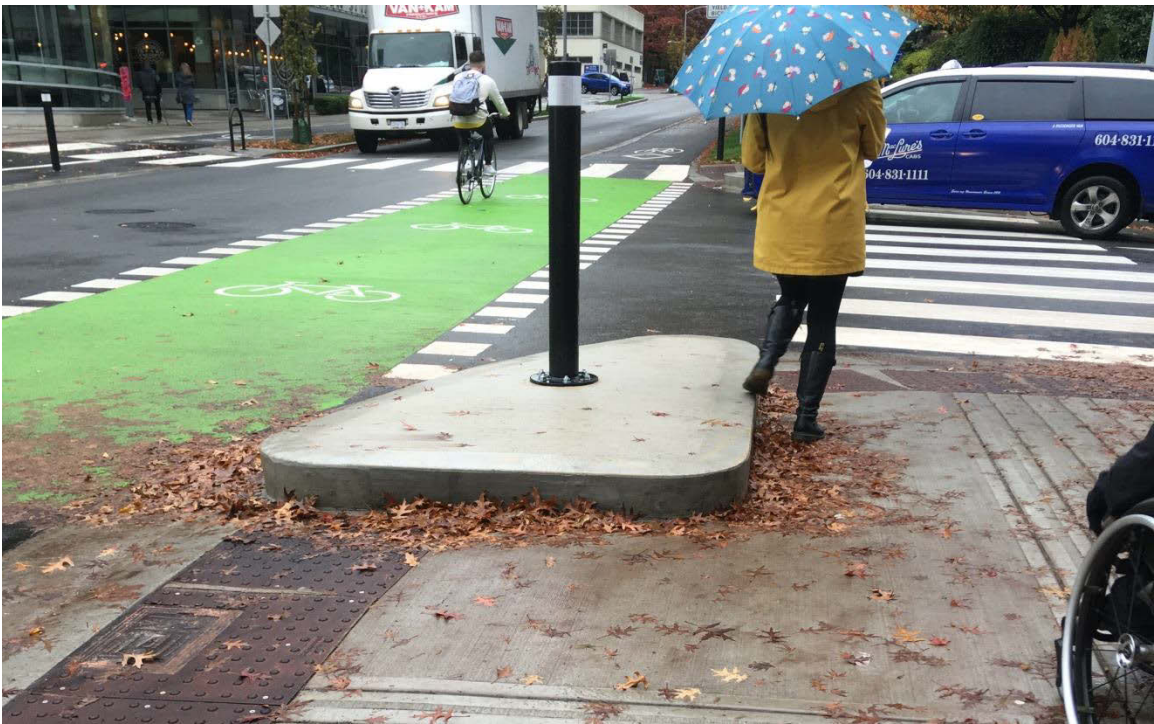
Figure 4 - Concrete island on northeast corner of Willow St and 10th Ave (facing west)

- Staff clarified that the large concrete island with a bollard at the northeast corner is to prevent vehicles from encroaching on the pedestrian space. Some expressed concern that pedestrians are occasionally using it as a space to smoke or congregate. Concern also raised about conspicuity of this island for drivers, with some members wondering if yellow paint could help (similar to that used at the Oak St intersection) (see Figure 4).

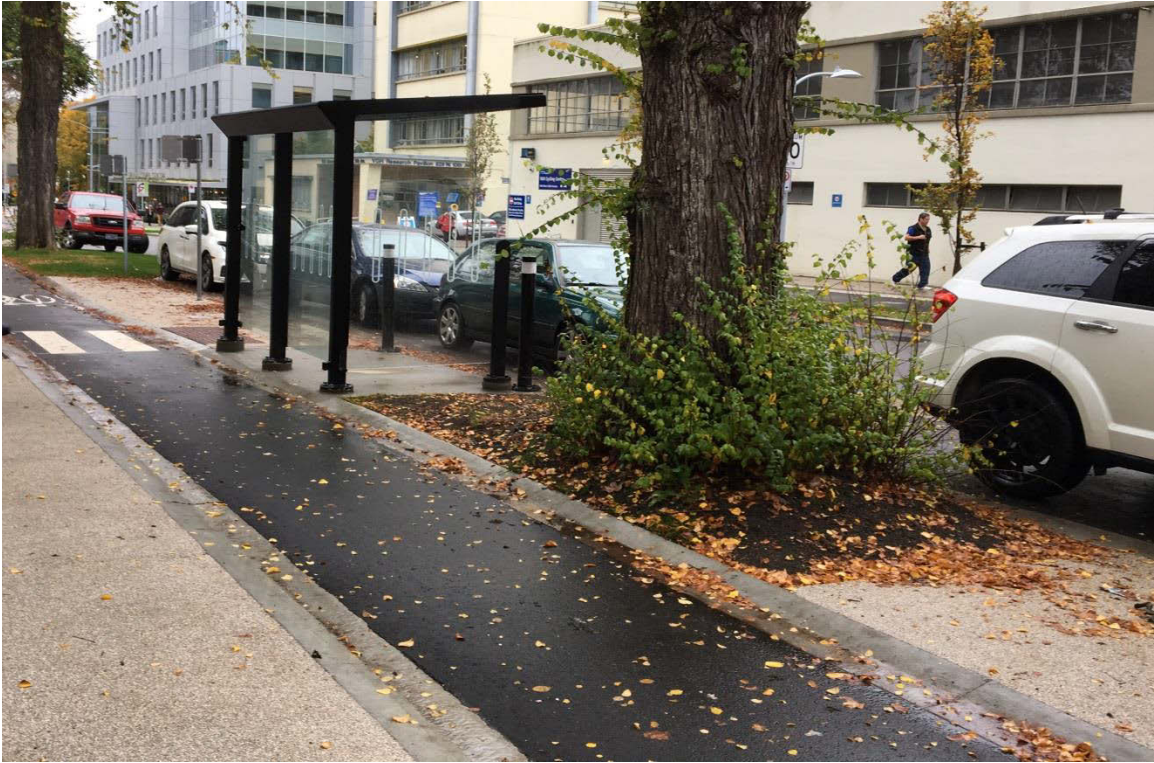
Figure 5 - Pedestrian shelter and rubber sidewalk on south side of 10th Ave between Willow and Laurel Streets (facing east)

- Staff pointed out the pedestrian shelter that was recently installed, although it is still waiting for a bench (see Figure 5).
- Staff pointed out that the segments of rubber sidewalk (called "Eco-Flex porous rubber pavement") was used because it is permeable (to help provide air and water to adjacent tree roots), easier to repair, and has a thinner profile than a concrete sidewalk (see Figure 5). It was pointed out that the rubber is so soft that for wheelchair users the rubber sidewalk segments did require some additional effort. There was some discussion of the rubber sidewalk potentially being a balance problem for some pedestrians or that the change in texture might confuse pedestrians with vision impairment, but it was not clear how much of an issue this may be.

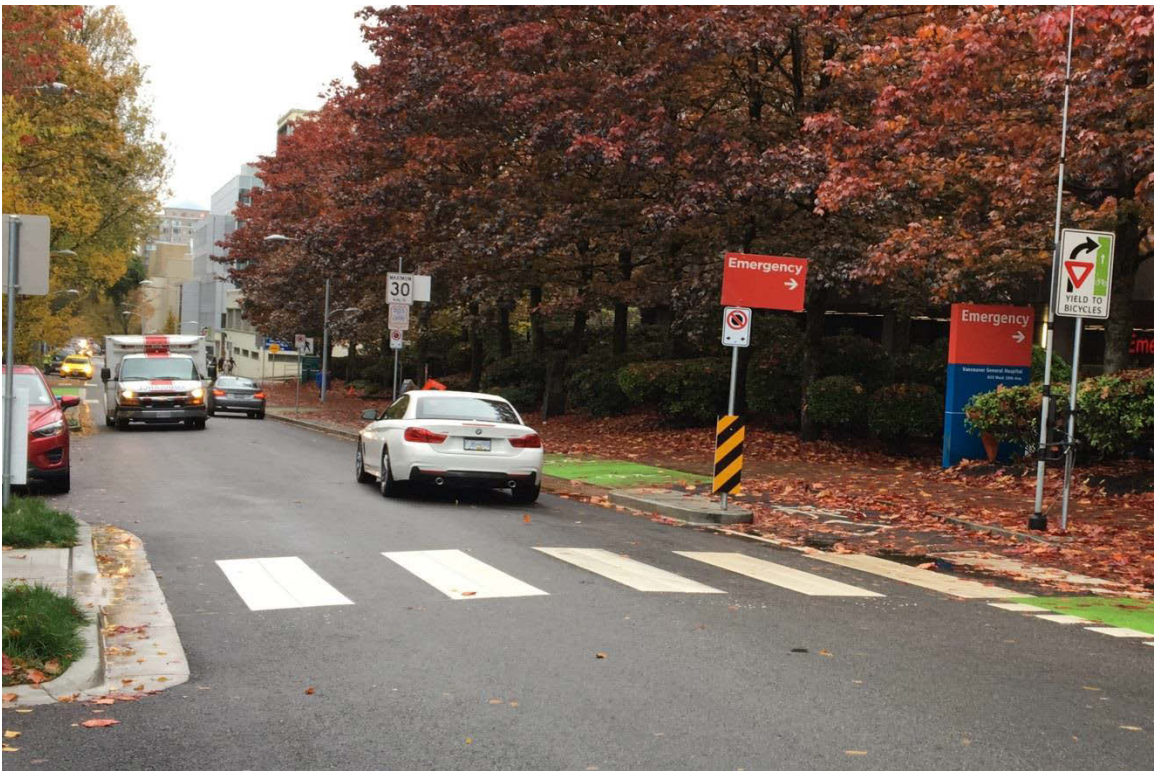
Figure 6 - VGH Emergency entrance driveway signage at Laurel St (facing east)

- There are concerns about speed of bikes going downhill past the VGH Emergency entrance driveway. Staff noted that an 'Emergency' sign was added outside the Emergency entrance following initial conversations with BC EHS (see Figure 6) and that staff are shooting video of the driveway and are discussing results with BC EHS.

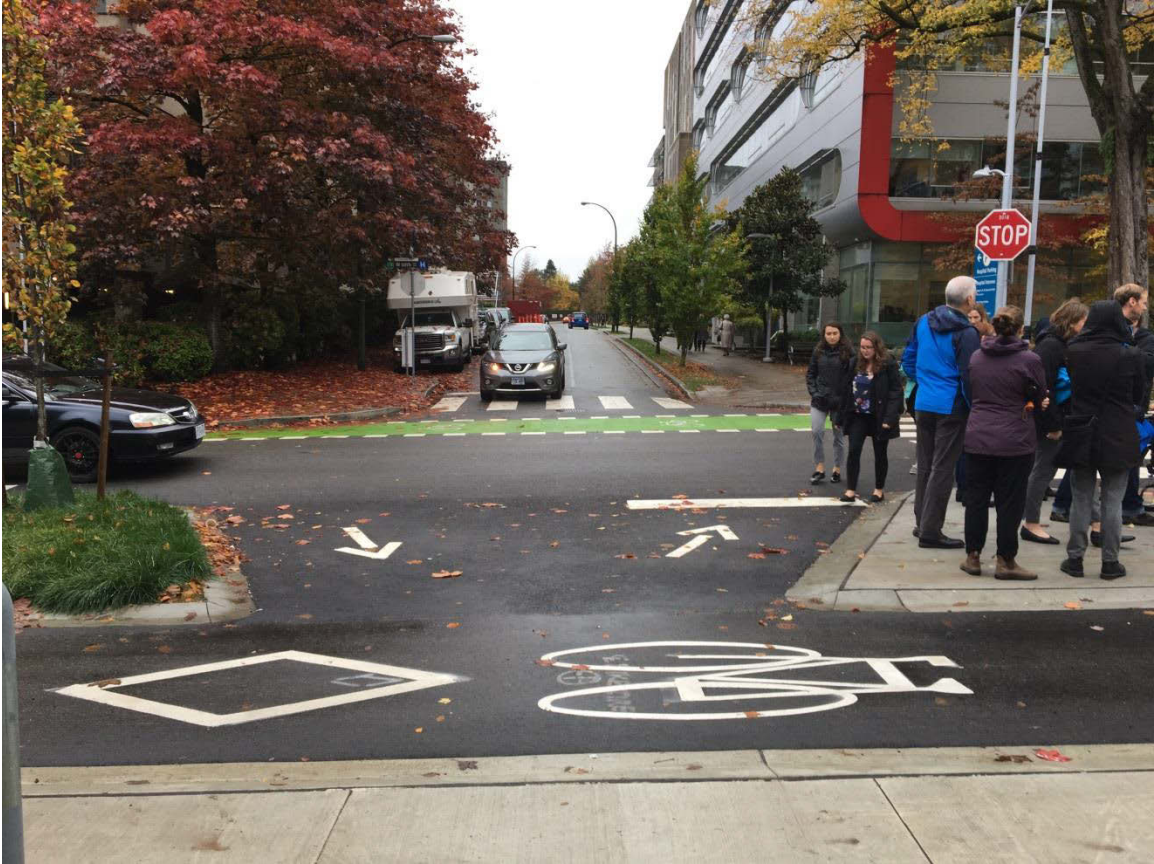
Figure 7 - Stop sign for cyclists on north side of 10th Ave at Laurel St (facing south)

- Some felt that the stop sign for bikes headed south at Laurel is too high and would be hard for cyclists to see (see Figure 7)

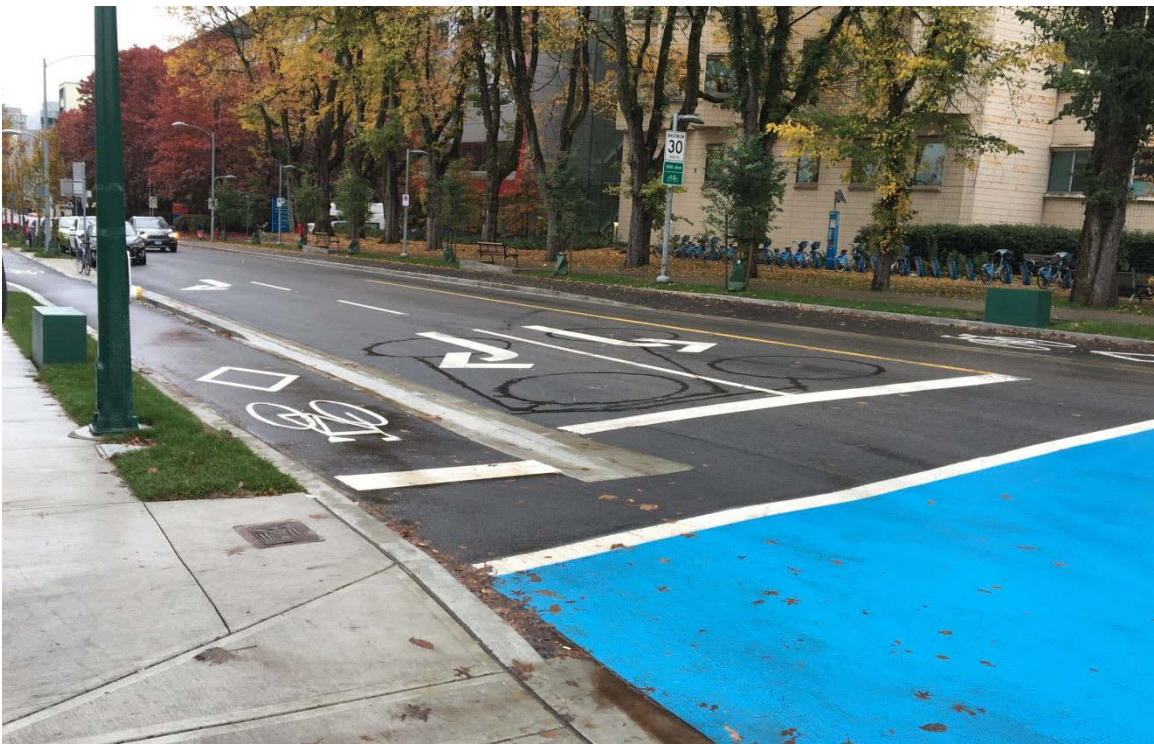
Figure 8 - Green bases on 10th Ave near Oak St for future 'Hospital Zone' gateway signs (facing east)

- Staff pointed out that the green wooden boxes on both sides of roadway are covering bases for the future “Hospital Zone” gateway signs at the western end of the corridor (see Figure 8)

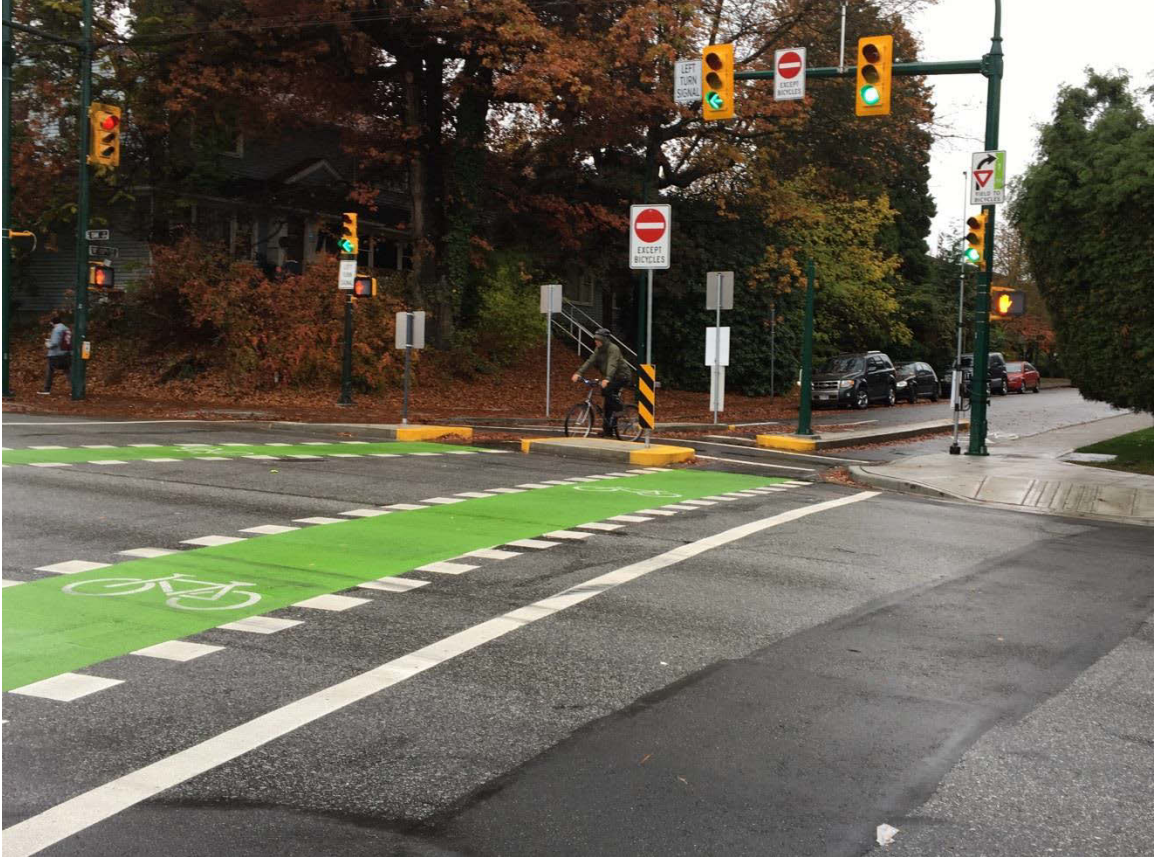
Figure 9 - Intersection at 10th Ave and Oak St (facing west)

- Staff pointed out that the words “Hospital Zone” painted on crosswalks are off to the side because they’re primarily for people entering the area.
- Staff noted that all new sidewalks have been built to follow the City’s new standard with provide smooth control joints at regular intervals (see Figure 9)
