From: Steve Boyce [<mailto:steve.boyce@activeearth.ca>]
Sent: Wednesday, January 21, 2015 3:48 PM
To: Kwan, Linda
Cc: Mayberry, Jennifer
Subject: Tank closure - 498 Drake (1300 Richards)

HAZARDOUS MATERIALS REPORT FORM

Sure Hazmat and Testing has, in accordance with your request, completed an investigation for hazardous materials and to identify any immediate hazards to workers during the demolition of the building located at 1300 Richards Street in Vancouver, BC. The scope of work included all accessible areas of the building. The investigation was destructive in nature throughout the 2nd floor and included limited demolition of walls and floors to determine the presence of any concealed hazardous materials. The investigation was non-destructive throughout the 1st and 3rd floors. We report the following:

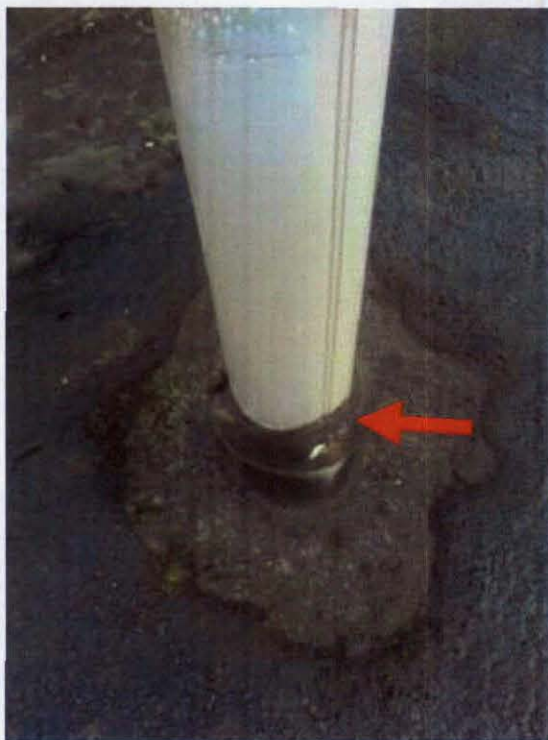
Photo # 1 – Asbestos-containing vent flashing mastic

All asbestos-containing materials must be removed prior to demolition activities by a qualified hazardous materials contractor using appropriate work procedures as defined by WorkSafe BC.

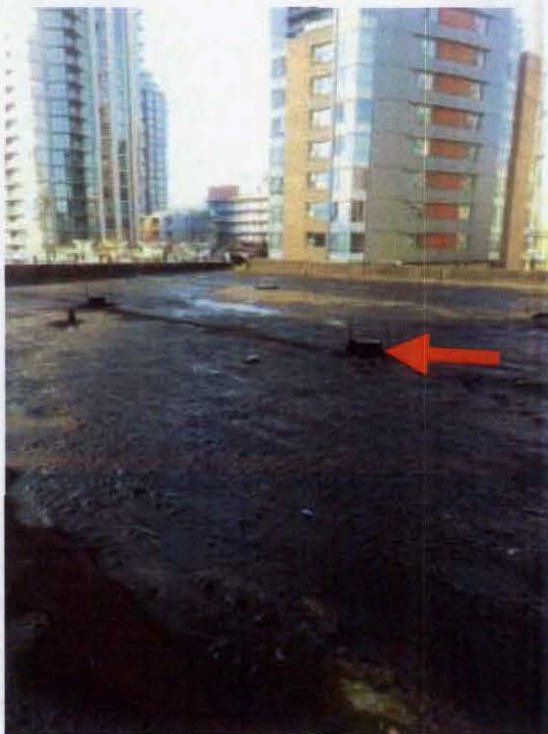
Photo # 2 – Asbestos-containing mastic on stumps

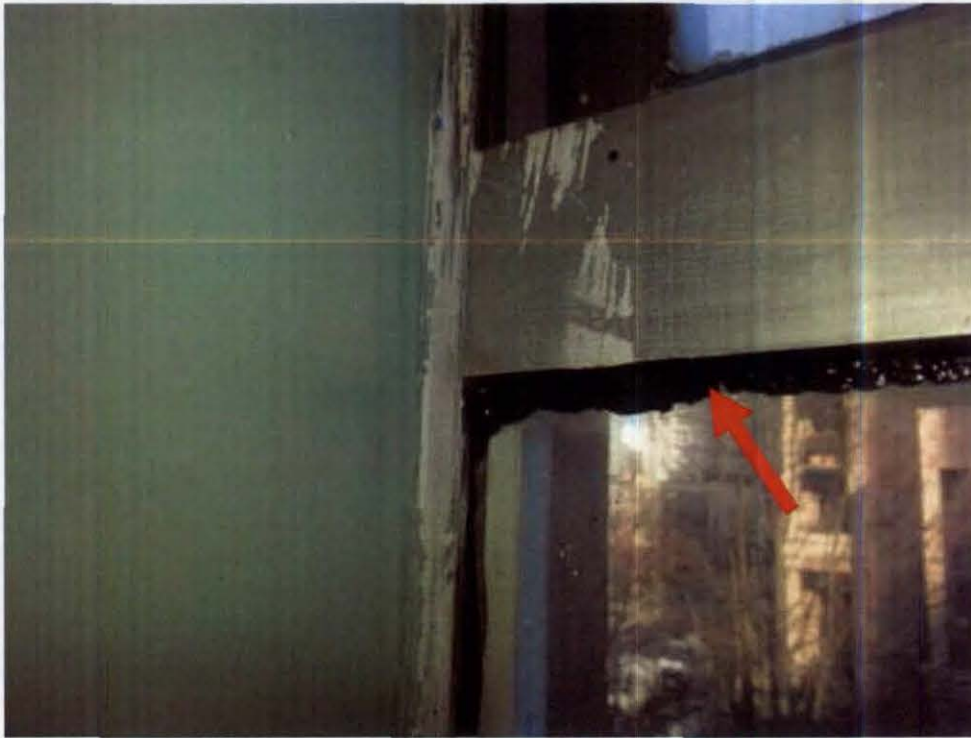
Photo # 3 – Asbestos-containing window glazing mastic

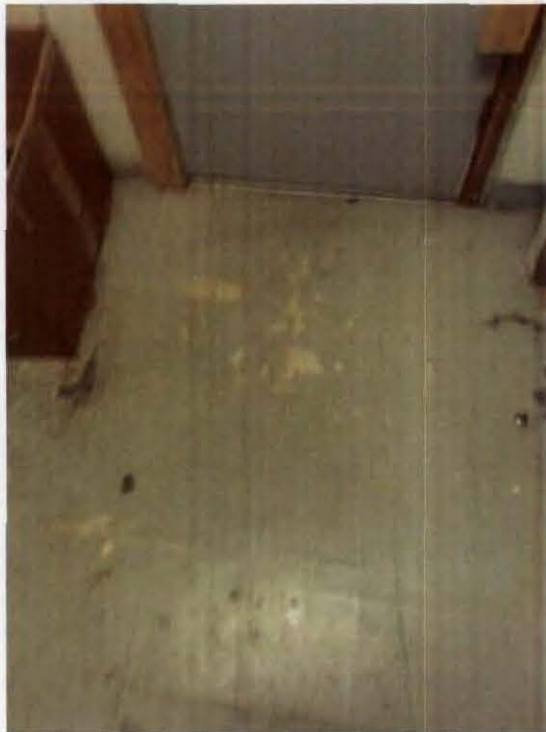
Asbestos-containing vinyl floor tiles were observed in the following locations

Photo # 4 – Asbestos-containing vinyl floor tiles present in areas on the 3rd Floor

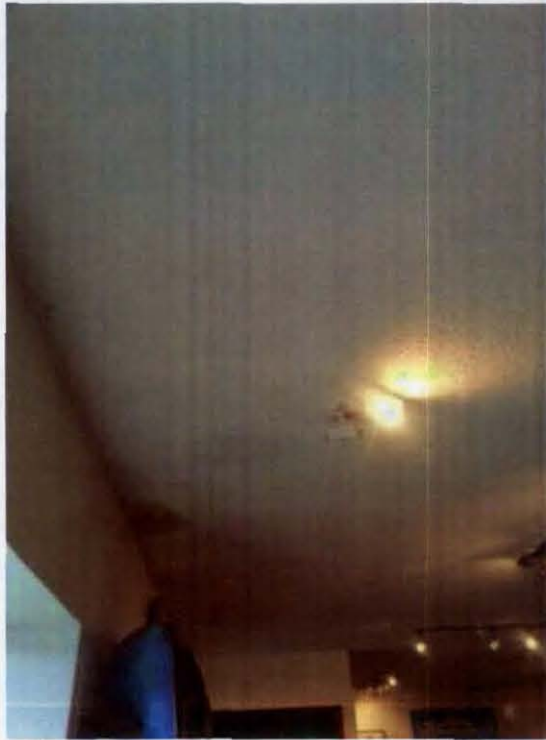
Two (2) samples of texture coat were collected from Suite 301. Both samples were determined to be asbestos-containing. Asbestos-containing texture coat was only observed in this suite.

Photo # 5 – Asbestos-containing ceiling texture finish in Suite 301

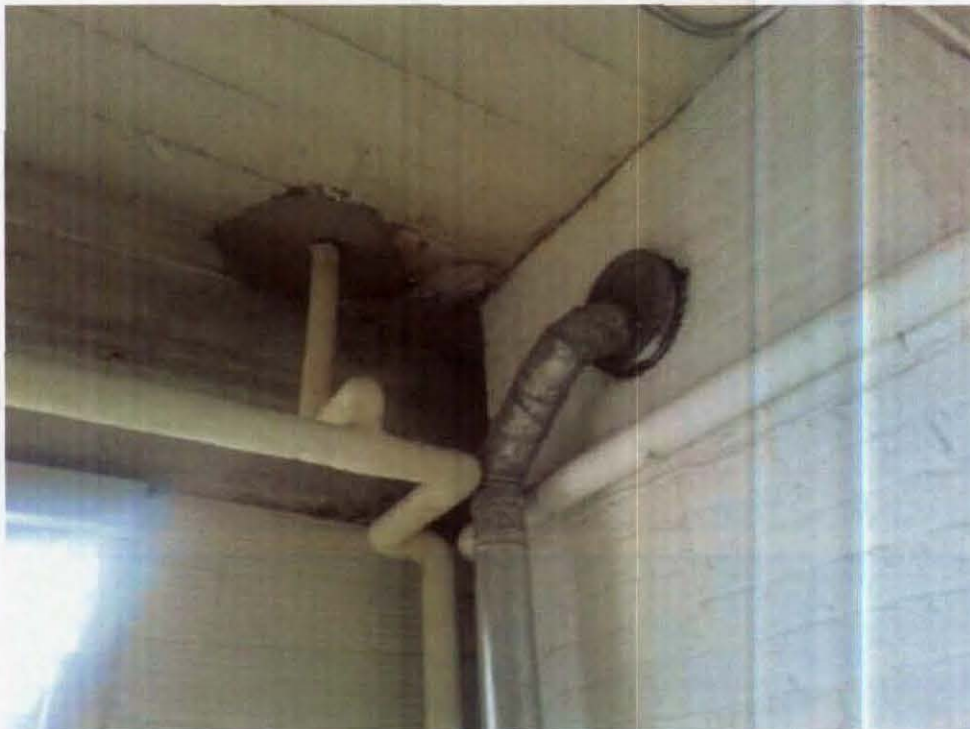
One (1) sample of parging cement was collected from pipe elbows within Suite 200 and was determined to be asbestos-containing. Pipe elbows were also observed within the suite across the hall from Suite 200.

Photo # 6 – Asbestos-containing paring cement on pipe elbows within Suite 200.

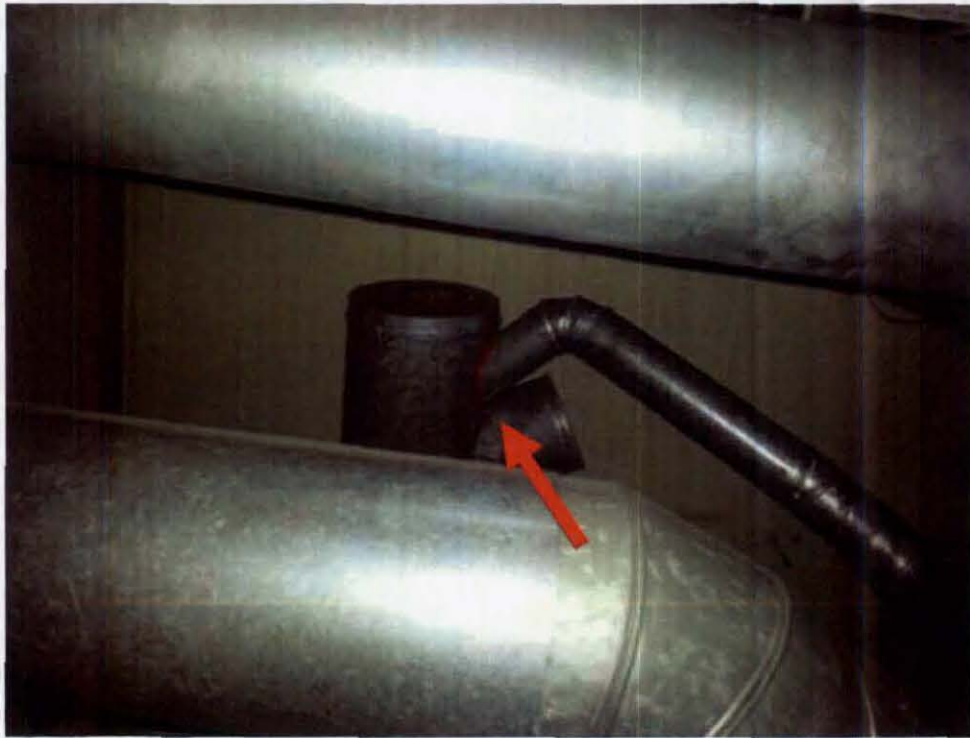
Photo # 7 – Assumed asbestos-containing red duct mastic

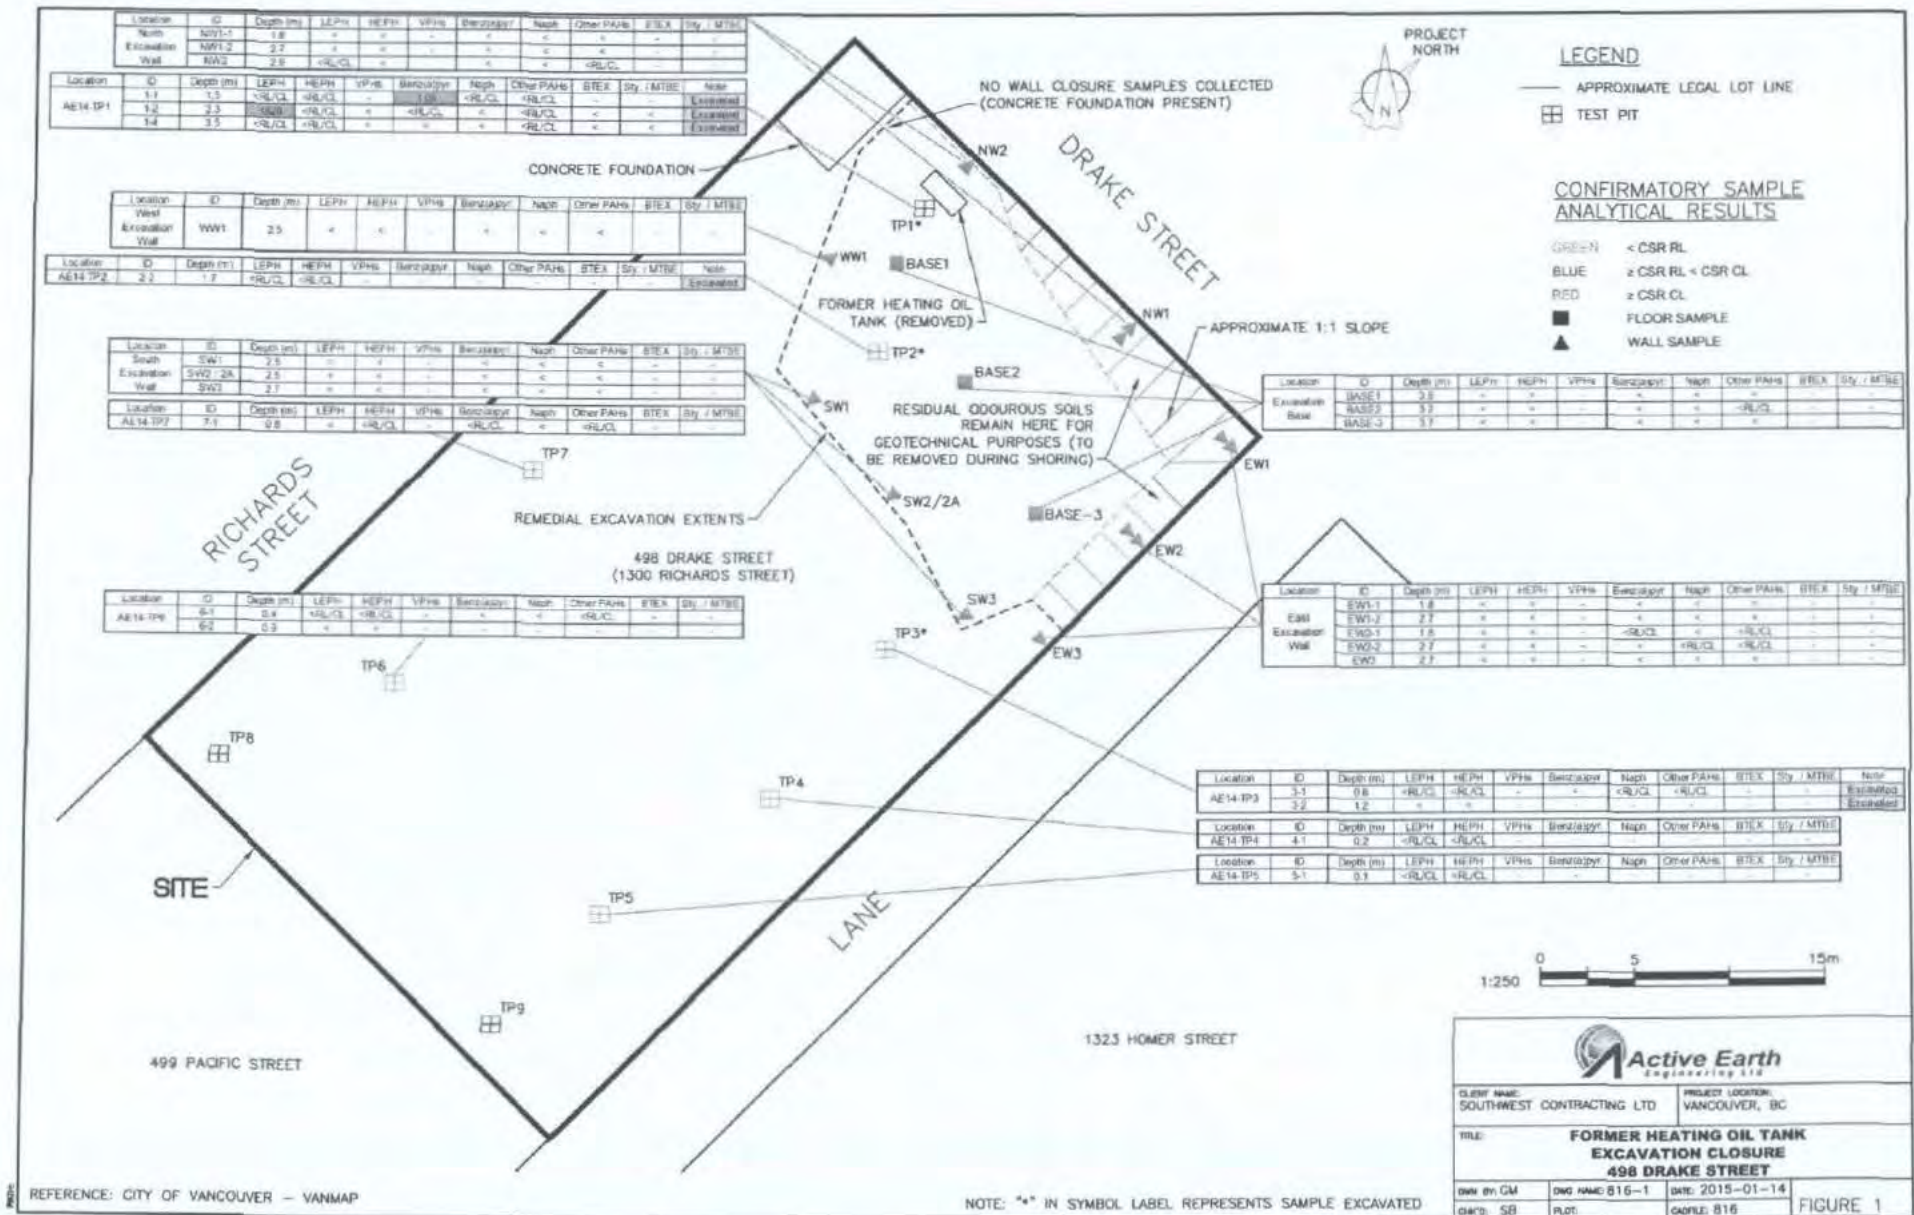
FIGURES

Wall Financial Corporation is undertaking the Site redevelopment for mixed commercial and residential use. The former heating oil tank was uncovered during demolition of the previous Site structures. The Site location and current on-Site conditions are shown on the attached Figure.

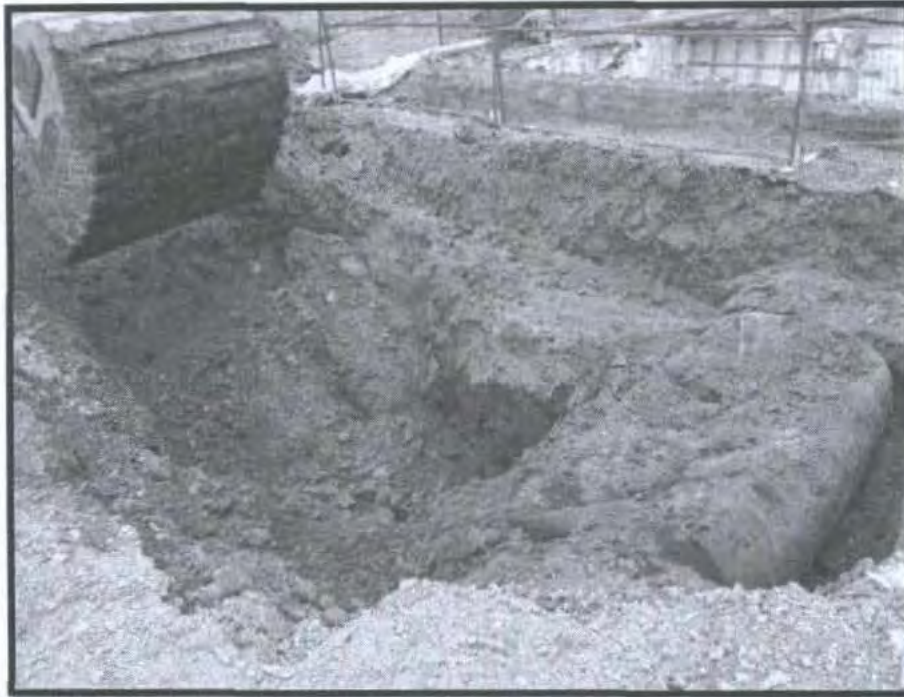
The UST measured 1.1m in diameter by 2.4m in length (approximately 1900L capacity), was constructed of single-wall steel, and was observed to be moderately corroded with holes noted in the base. The UST contained water, trace residual heating oil, and oily sludge. The decommissioning proceeded as follows:

Photo 1 – Looking west. Uncovering of the former heating oil UST prior to tank decommissioning.

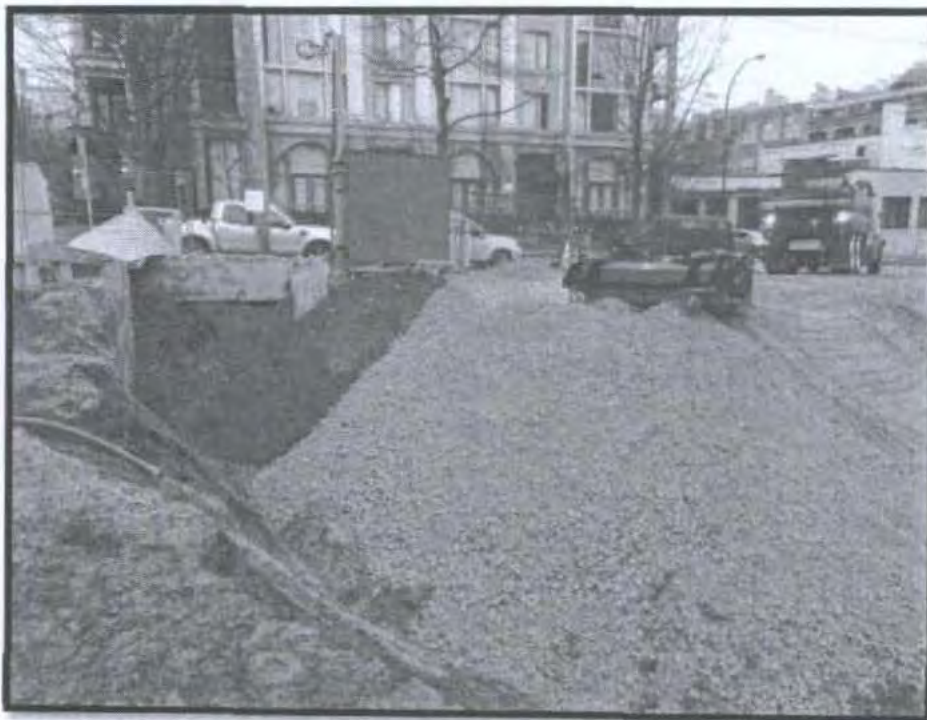
Photo 2 – Looking north. Shows the remedial excavation in the vicinity of the former UST. Backfill sand/gravel has been placed to support the adjacent Drake Street sidewalk.

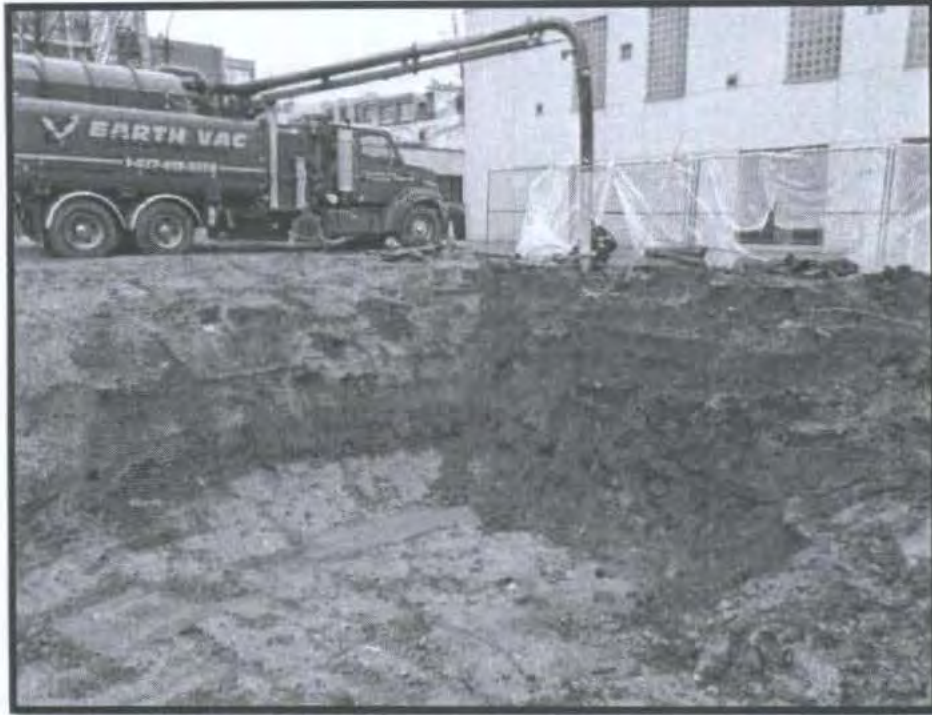
Virtually all RL+ contamination has been removed from the site. A narrow band of odourous soil (possibly RL+) remains ON-SITE along the edge of the excavation. This soil cannot be safely removed until we are able to proceed with shoring. This soil will be disposed as RL+ for added due diligence.

Photo 3 – Looking northeast. Shows the completed remedial excavation toward the lane and Drake Street Sidewalks. Residual soil at Site boundary to be removed during excavation trimming. Collection of closure samples shown via hydro-vacuum truck along Site boundary.

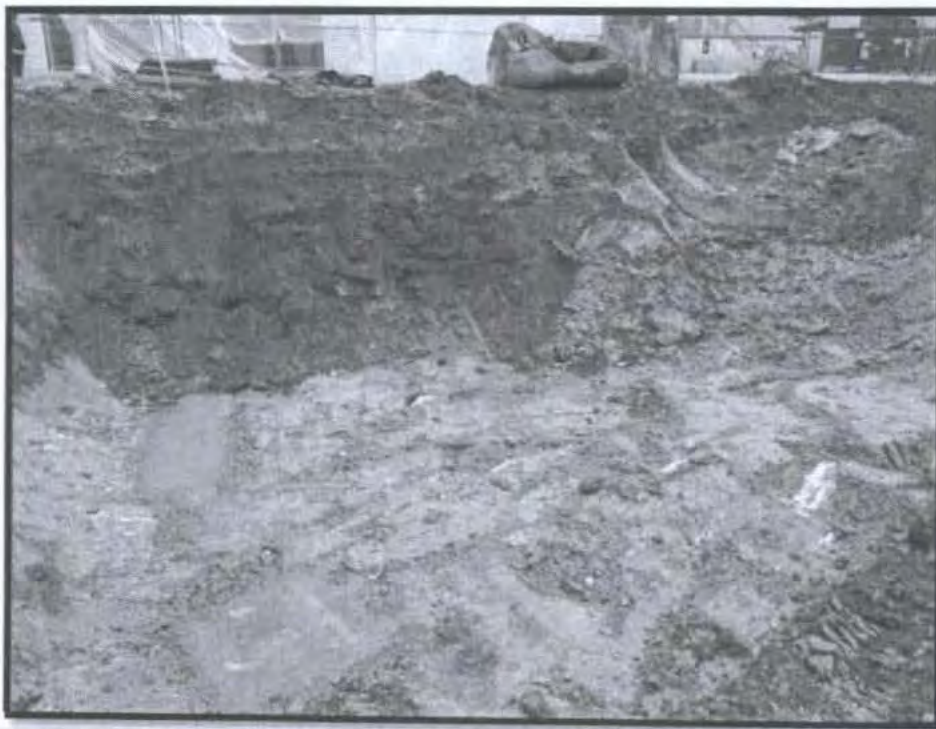
Photo 4 – Remedial excavation looking east (toward the lane).
